# Flight below the minimum safe altitude involving Beechcraft Baron 95-B55, VH-CBG

5 km north-east of Parafield Airport, South Australia, on 13 May 2021

**ATSB Transport Safety Report**

AO-2021-021

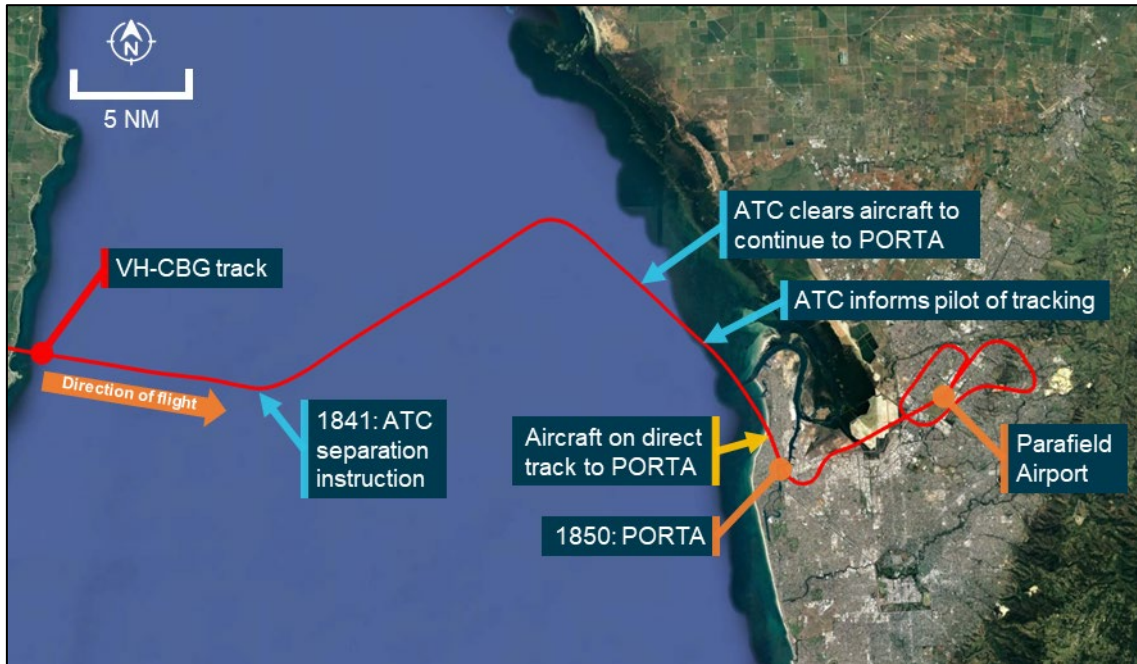
**Figure 2: Aircraft track from 1838 to 1901**

At 1847, the pilot was instructed to resume navigation to PORTA. The pilot recalled switching the autopilot back to NAV mode to track toward PORTA, but the aircraft continued along the previously assigned heading, about 20° to the left of the track to PORTA. Shortly after, ATC requested the pilot to confirm tracking, and after the pilot acknowledged, the aircraft gradually turned right over the next minute until 1849, when it tracked toward PORTA.

At 1850, the aircraft was travelling south-east, descending over PORTA at a ground speed of 165 kt (the forecast wind was 20 kt from the south-west) and the autopilot initiated a turn towards the Parafield Airport non-directional beacon (NDB). The aircraft did not turn as quickly as the pilot anticipated, so the autopilot was disconnected, and the pilot completed the turn manually before re-engaging the autopilot.

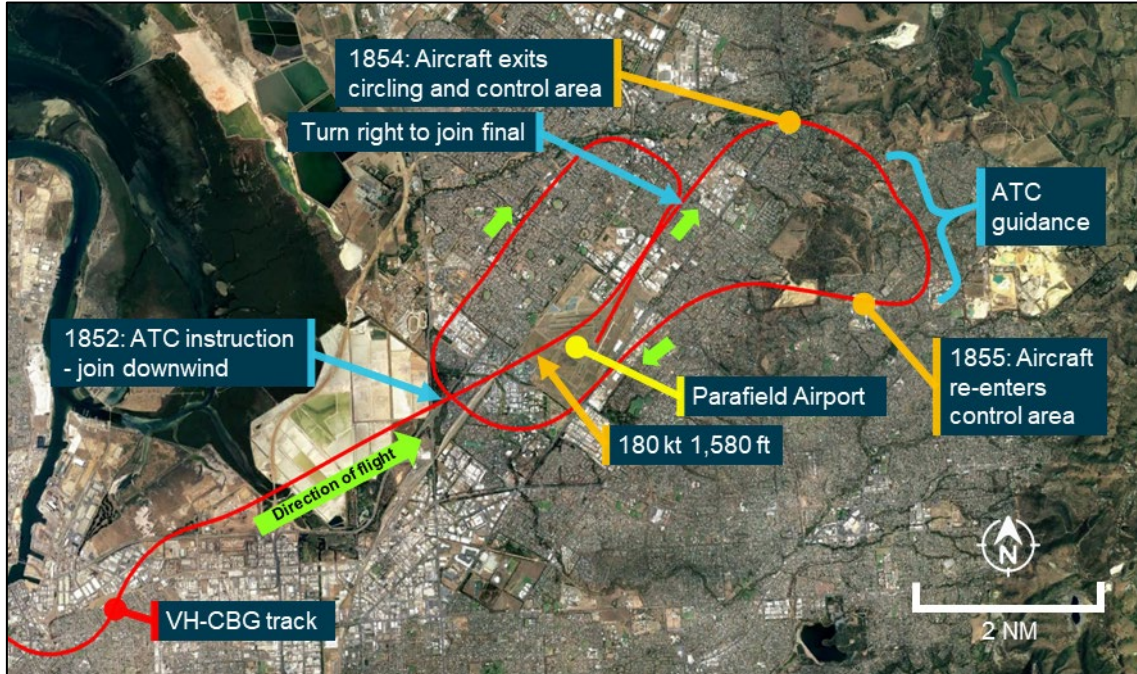
**Figure 3: The approach**

Eighty seconds later, the aircraft descended below 1,700 ft above mean sea level (AMSL) at a ground speed of 180 kt with a 20 kt tailwind. The controller then instructed the pilot to join the right downwind leg of the circuit for the runway. After the pilot acknowledged the instruction, the aircraft continued toward the airport before commencing a slight left turn onto a heading of 022° magnetic, consistent with a downwind heading, but almost directly overhead the runway (Figure 3).

The aircraft passed over the control tower, in line with the upwind leg of the circuit for the reciprocal runway (03L) and descended to about 1,330 ft. At the same time, another aircraft was at 700 ft and turning onto the final leg of the circuit for runway 21R, so the tower controller instructed the pilot of CBG to maintain 1,500 ft. At this time, the pilot believed (incorrectly) that the aircraft was positioned on the downwind leg for runway 21R. Seventeen seconds later, the controller instructed the pilot to make a right turn with the intention of repositioning the aircraft to join final for runway 21R via a teardrop turn.

At 1854, the pilot started a right turn, during which the aircraft proceeded outside both the circling area and Parafield control area (see the section titled *Airspace*) at an altitude of 1,400 ft and a groundspeed of 157 kt. During the right turn, the pilot could not see the runway and continued flying south-east at 1,400 ft while looking for it.

After the pilot confirmed the intention to return to Parafield, the aircraft continued tracking away from the airport and the controller then instructed the pilot to track direct to the airport, maintain 1,500 ft, and join the upwind leg of the circuit. At 1855, with the aircraft still travelling south away from the airport, the controller requested confirmation that the pilot could see the airport. The pilot acknowledged and turned the aircraft towards Parafield Airport.

As the approach progressed, the pilot's situational awareness became increasingly compromised, resulting in the aircraft being manoeuvred beyond both the circling area and the Parafield control area at an altitude significantly below the minimum sector altitude.

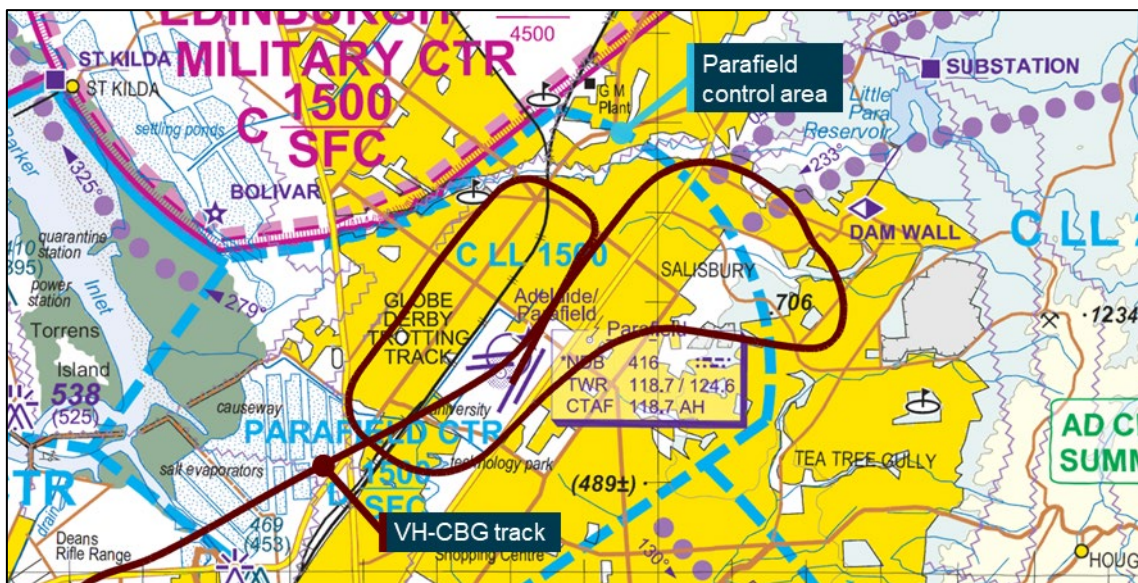
Figure 4: Parafield control area

Parafield Airport is situated within Class D terminal airspace extending from the ground level up to an altitude of 1,500 ft. This airspace was controlled by an air traffic controller situated in the Parafield control tower. The airspace bordered both the Royal Australian Air Force Base Edinburgh airspace to the north and Adelaide Airport airspace to the south (Figure 4). The airspace east of Parafield Airport was non-controlled up to 2,500 ft, with Adelaide Airport Class C airspace above that altitude.

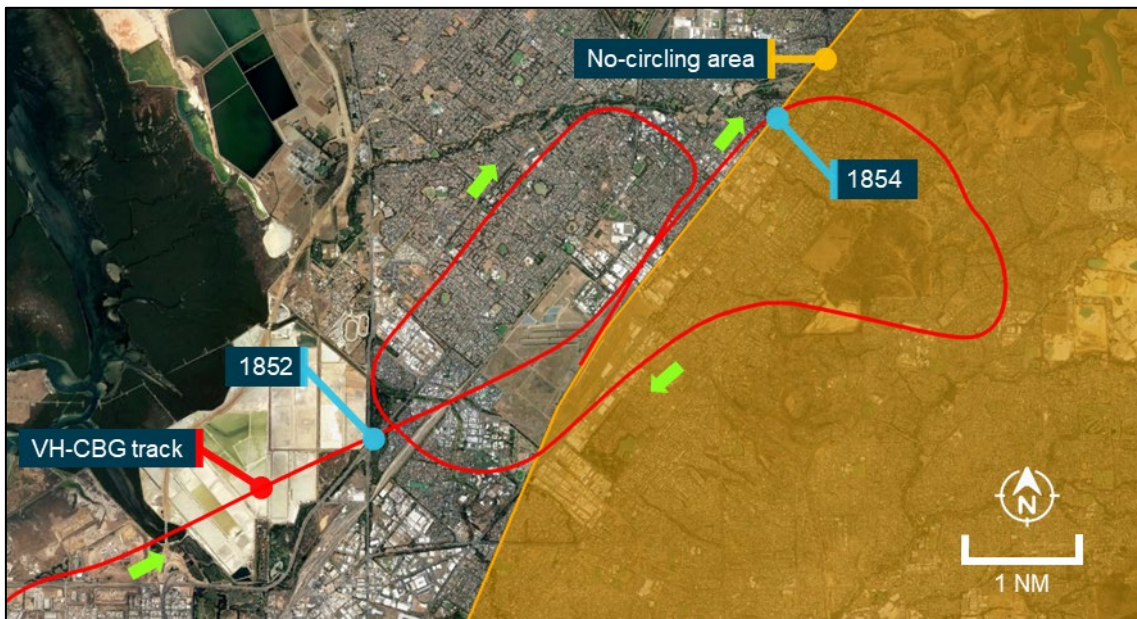
**Figure 5: Circling area**

The circling area is an area bounded by arcs drawn from the runway thresholds, with the radius of the arcs dependent on an aircraft's performance category (Category A to E). The performance categories are based on an aircraft's approach speed range. The Beechcraft Baron 95-B55 was a Category B aircraft with a circling area of 2.66 NM.

The Category B circling area provides obstacle clearance of not less than 300 ft at an altitude not below the appropriate minimum altitude for circling, which in this case was 1,580 ft. Circling was prohibited to the east of runway 21R at Parafield Airport due to relatively high terrain (Figure 5).
