Safeworking Breach of Road-Rail Vehicles

Crystal Brook, South Australia, 10 June 2021

Rail Occurrence Investigation (Short)

RO-2021-006

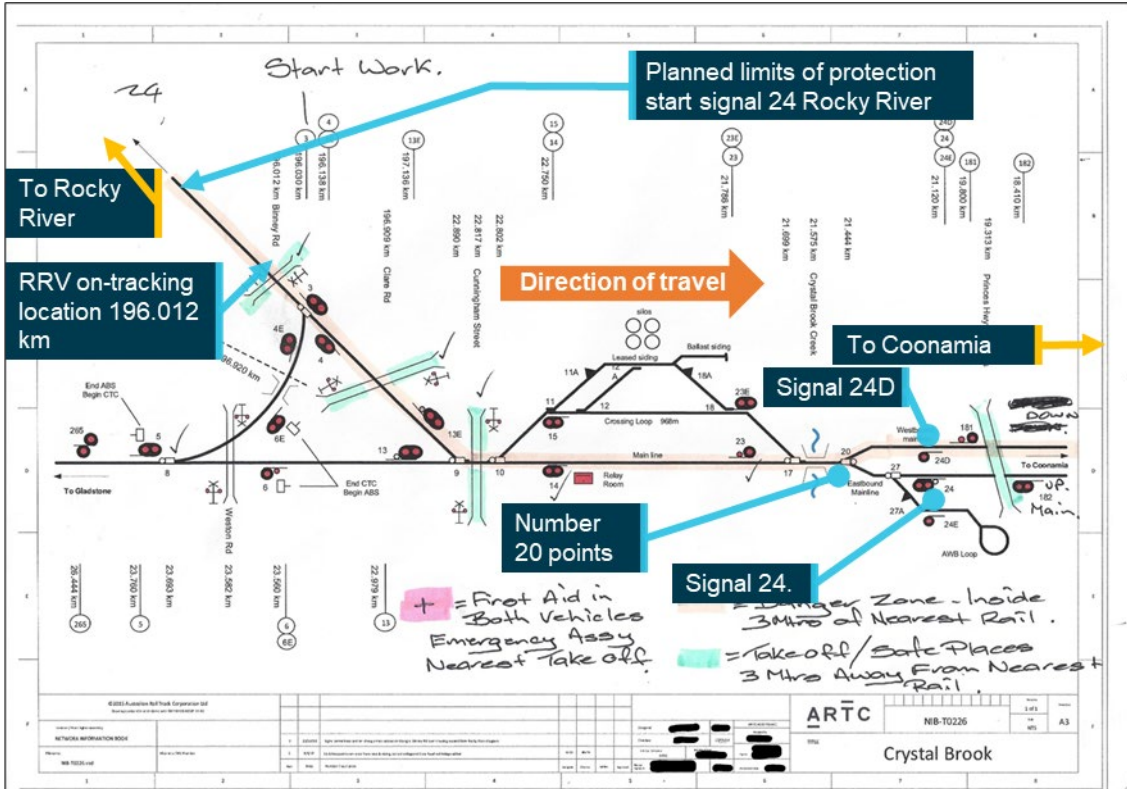
Figure 4: Competent worker map of Crystal Brook showing intended limits of protection for RRVs

To provide protection for the travel, a track worker level 2² (TW) assigned to the SPENO RRVs planned the protection required using a Worksite Protection Plan and Worksite Protection Plan Map that was marked with the limits of protection for Train Running Information³ (TRI) travel (signal 24 Rocky River through the Westbound Mainline), RRV on-tracking location (196.012 km) and intended travel path denoted in light brown on Map (Figure 4).

In addition, the track worker level 2 requested the protection limits start at signal 24 Crystal Brook, instead of signal 24 Rocky River. Signal 24 Rocky River encompassed their planned start location of Binney Road at the 196.012 km, which was the location they briefed the work crew and had annotated on their work plan. This resulted in the network controller applying Blocking Facilities on the incorrect section of track.

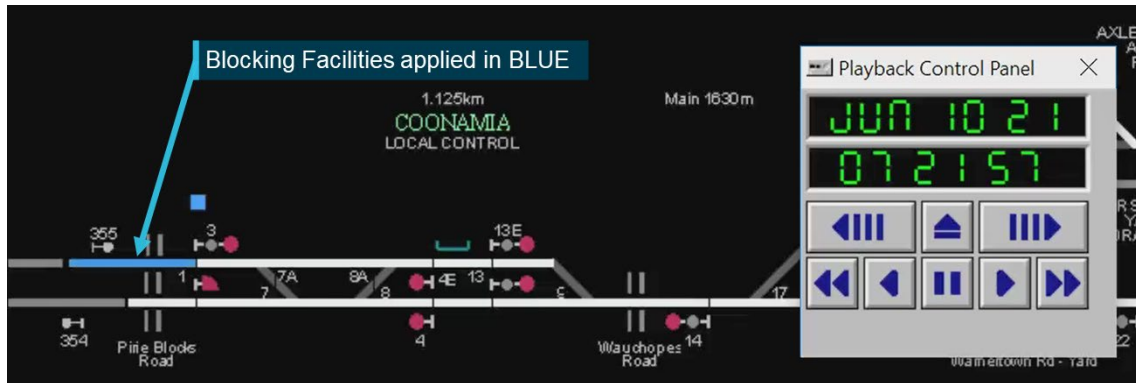
Figure 5: Phoenix showing Blocking Facilities applied (blue section)

The NC noted Crystal Brook had a signal 24 and signal 24D and asked the TW if they required both the Eastbound Mainline and the Westbound Mainline for the intended work. The TW responded that they only required the Westbound Mainline for the travel, and the NC then stated that signal 24D was the protecting signal for that line.

After the signals for limits of protection were agreed, at about 0722 the NC placed Blocking Facilities⁶ from signal 24D at Crystal Brook to signal 3 at Coonamia (Figure 5).

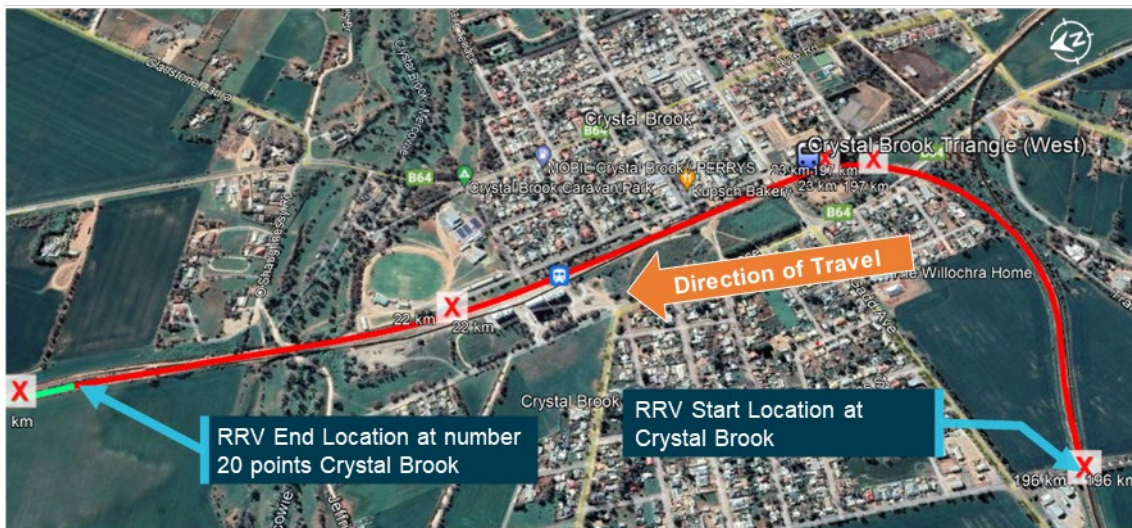
Figure 6: Path of RRV's outside of protection

The NC questioned the work crew's current location, and after confirmation, the NC informed the crew that they were outside of the limits of protection. The TW then explained to the NC that they had on-tracked the RRVs at the 196.012 km Binney Road Level Crossing, which was about 3 km prior to the start limits of the protection applied by the NC. Figure 6 depicts the travel of the RRVs outside of their protection limits in red. The RRV end location and green section of track indicate the location of where the original protection limits started. (Figure 6).

On the morning of 10 June 2021, while preparing for scheduled maintenance work on a section of track between Crystal Brook and Spencer Junction, South Australia, the protection officer for the work crew contacted the network control officer to obtain train running information and establish protection limits. During the discussion between the track worker level 2 and network controller, the exact location that the work crew would on-track was not clearly communicated and confirmed. Inclusion of the on-track location would have also provided an opportunity for the network control officer to recognise that the requested protection was inappropriate for the area of work. Consequently, the RRV on-tracked outside the limits of protection.

SPENO have undertaken a review and made amendments to processes for on-tracking of RRVs. The proposed amendments include the provision to remove the single point of failure of the TW being responsible for identifying and communicating the location which RRV's would on-track in rail networks.

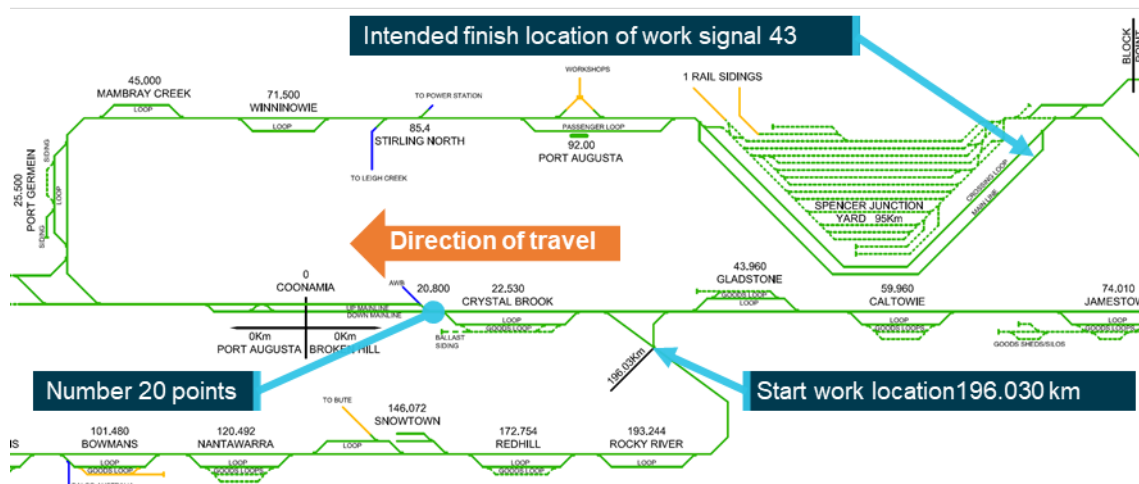
Figure 7: SPENO Work Order from Crystal Brook to Spencer Junction

The SPENO work order information had kilometrage from 196.030 km at Crystal Brook to signal 43 at Spencer Junction (Figure 7). The SPENO crew attended the TW pre work briefing at about 0715. The SPENO Supervisor stated that the TW had mentioned the limits of protection would be signal 24 Rocky River to signal 3 Coonamia.
