Take-off from a closed runway involving Fairchild Industries SA226-T, VH-LDQ

Gunnedah Airport, New South Wales, on 20 August 2020

ATSB Transport Safety Report

AO-2020-056

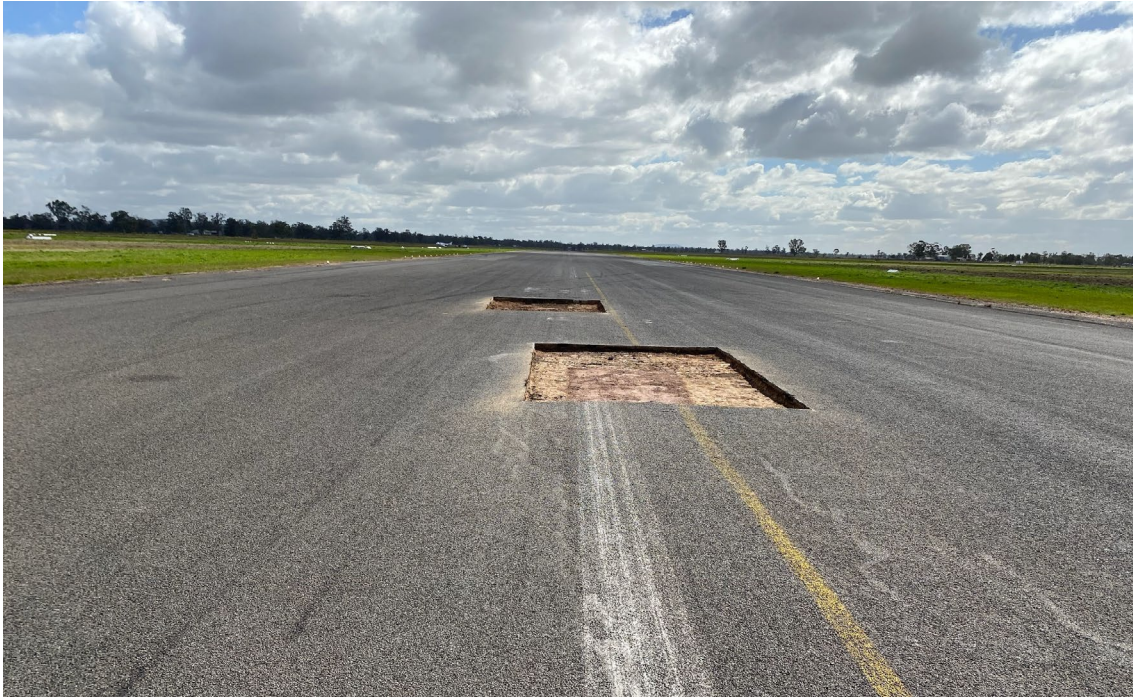
About 5 minutes later, the pilot commenced the take-off run on runway 29 after taxiing by the works in progress (Figure 3) to the threshold and turning around. The pilot reported seeing patches on the pavement in the distance. As the aircraft accelerated and progressed along the runway, it became apparent to the pilot that there were two holes excavated from the runway pavement (3 m wide by 5 m long), which were about 30 cm deep (Figure 1). The pilot attempted to avoid the holes but was unable to clear them with the aircraft's left main landing gear.

Figure 1: Pavement work in progress on runway 29

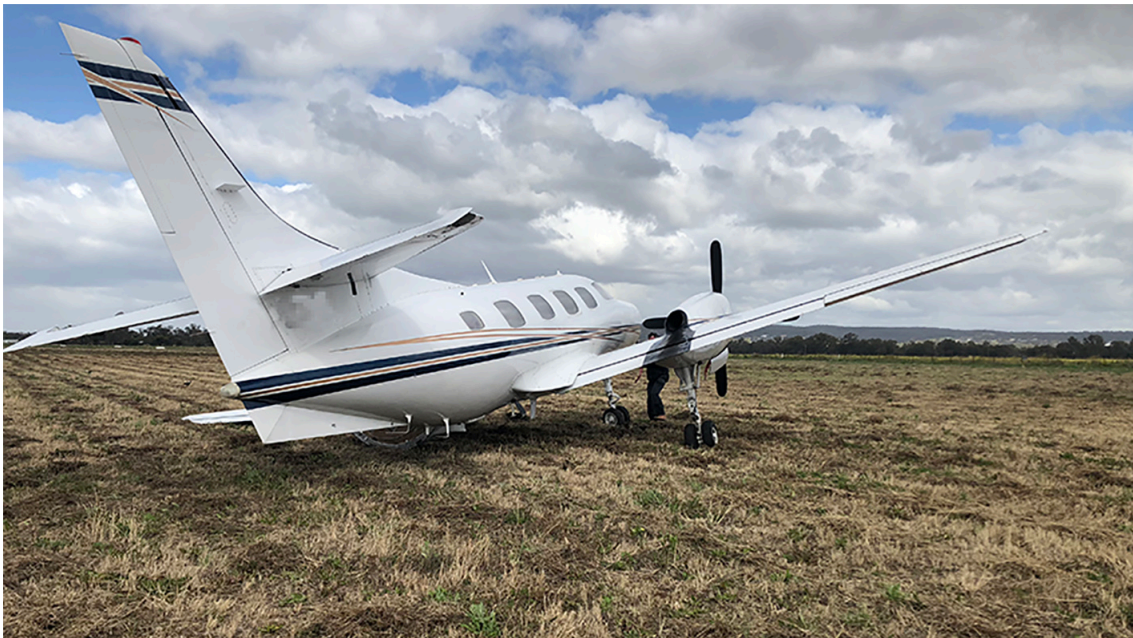
The aircraft sustained damage to the left main landing gear assembly that resulted in it collapsing and the left propeller striking the ground. The aircraft veered off the runway and came to rest outside the flight strip (Figure 2).

Figure 2: Aircraft's position after the attempted take-off

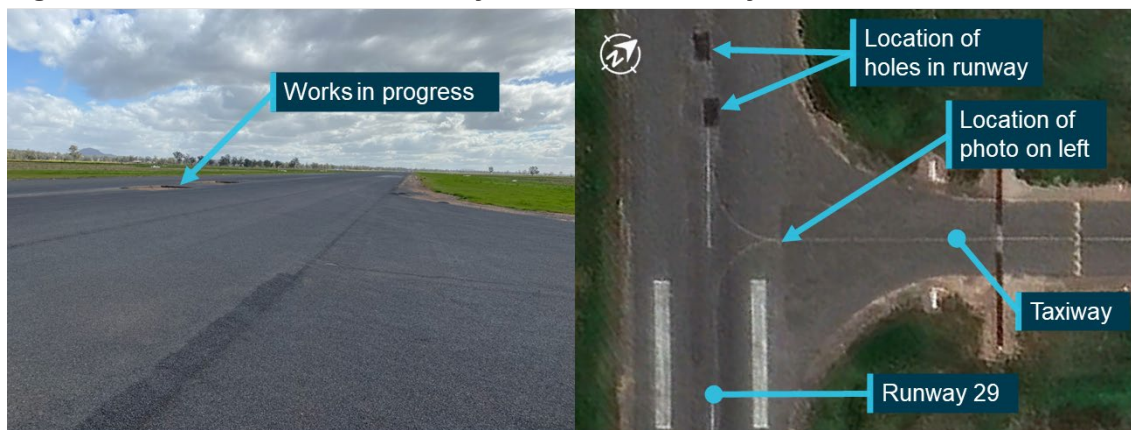
On 14 August 2020, following jet operations that had been conducted with a pavement concession,³ the aerodrome reporting officer (ARO) at Gunnedah Airport identified some lifted pavement in the centre of runway 29. The damage was located about 215 m along the runway from the runway 29 threshold, 15 m past the taxiway intersection (Figure 3).

Figure 3: Location of holes on runway in relation to taxiway

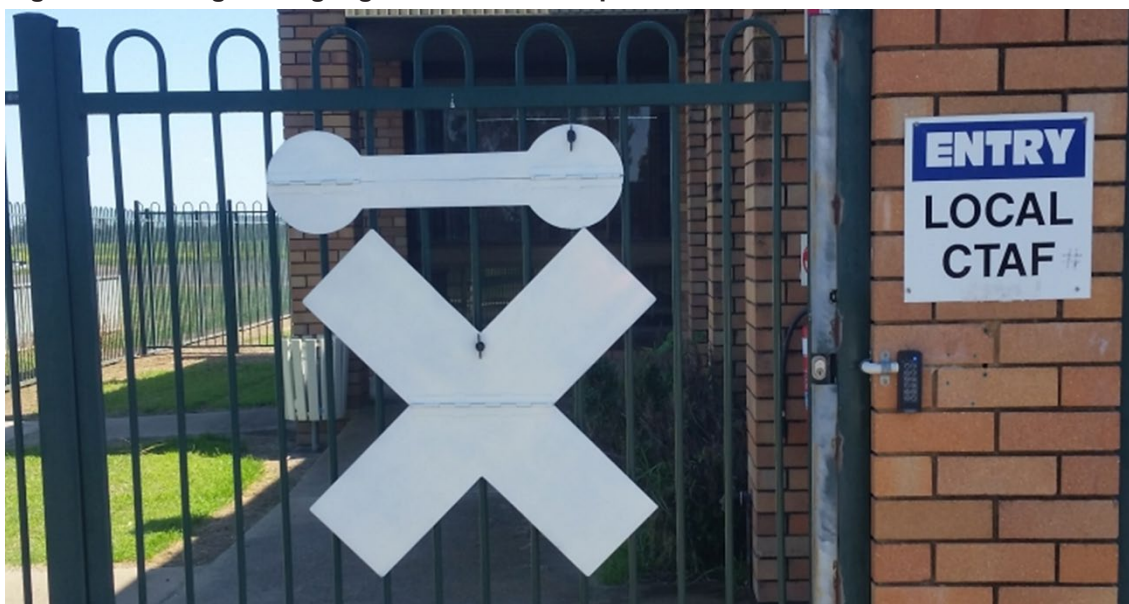
Figure 4: New signals signage at Gunnedah airport

Gunnedah Airport operator has added folding signs to all entry gates to the airfield that will reflect any ground signals active in the signals area (Figure 4). They have also updated their contact details with CASA.
