In-flight break-up, Stolp Acroduster II SA-750, VH-YEL

16 km north-east of Caboolture Airfield, Queensland, 18 August 2021

ATSB Transport Safety Report

AO-2021-032

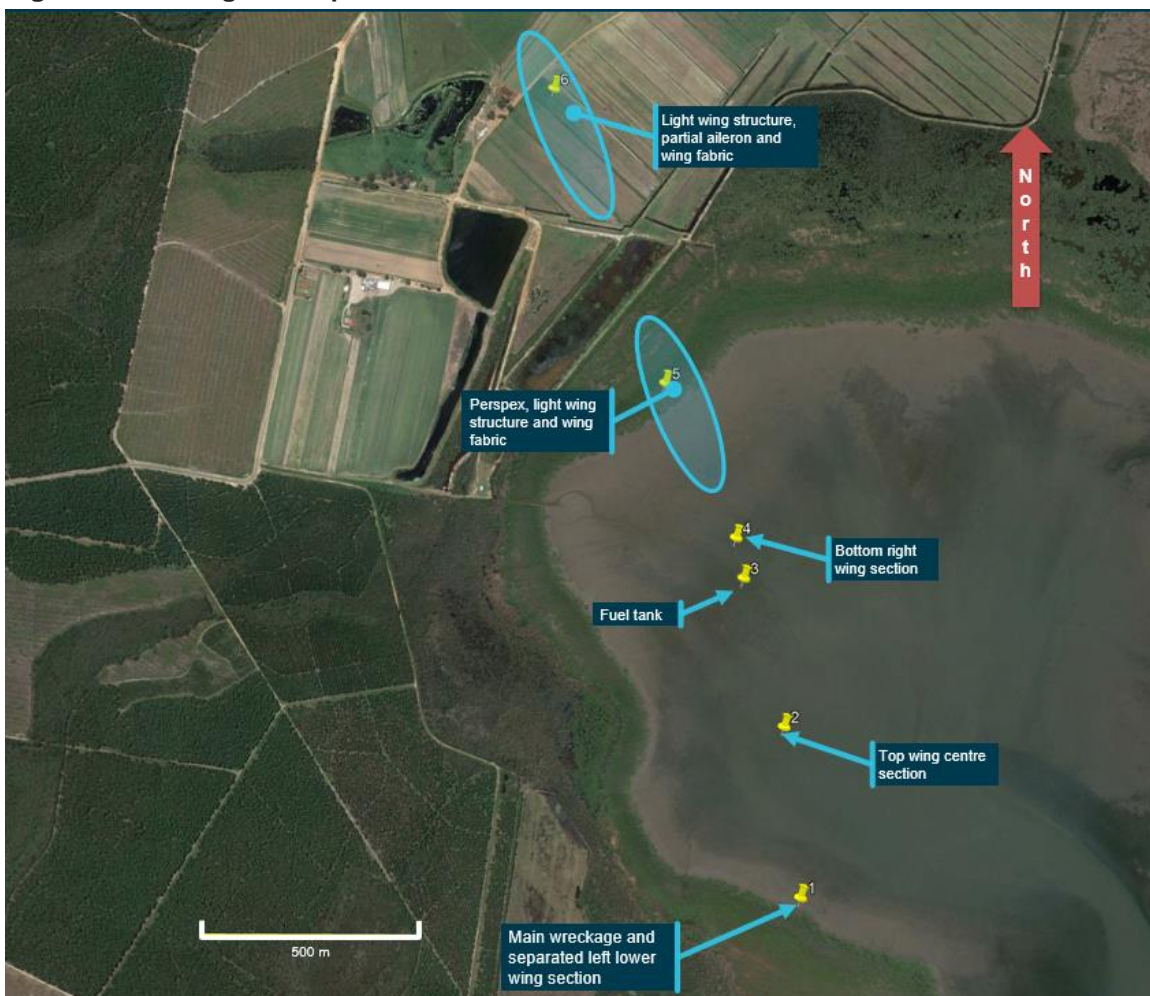
Figure 5: Wreckage trail spread over mud flats and farmland

The wreckage of VH-YEL was distributed over a distance of about 2.4 km, oriented in a north-west to south-east direction. The main wreckage consisted of the fuselage, tail section, and outer-wing sections, attached to the fuselage by the flying wires. The majority of the scattered debris consisted of wooden sections of wing structures, fabric from the wing skins, panels and perspex from the windshield. The largest sections that had separated from the fuselage were the left lower wing outboard section and the upper-wing centre section (Figure 5).

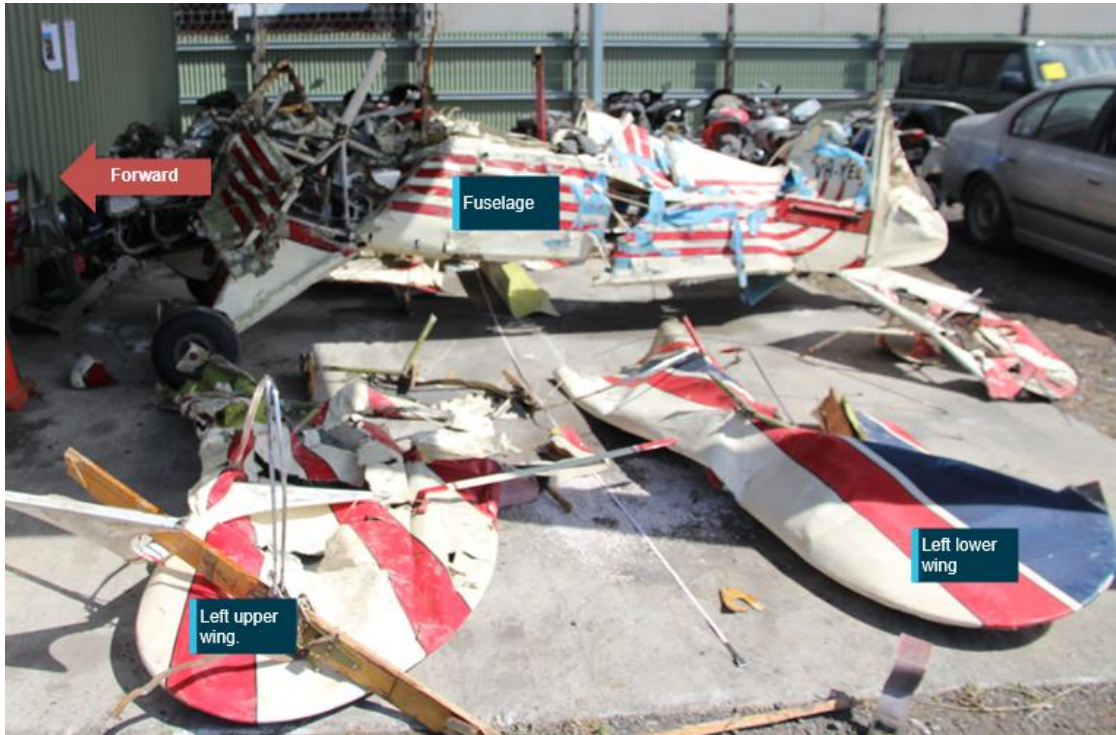
Figure 6: VH-YEL as recovered and partially reassembled

The main wreckage was recovered by barge at the changing of the tide and was transported to a secure storage facility for examination. The aircraft parts were reconstructed for the examination (Figure 6). The examination revealed:

- The majority of the parts were accounted for with the exception of the right interplane strut.
- The aircraft flight controls had no pre-impact defects identified.
- The fuselage, wings, flying and landing wires had no pre-impact defects identified.
- The forward cabane strut upper-wing attachment point eye bolts to the centre-wing structure were examined and fatigue cracks were identified in the fracture surfaces.

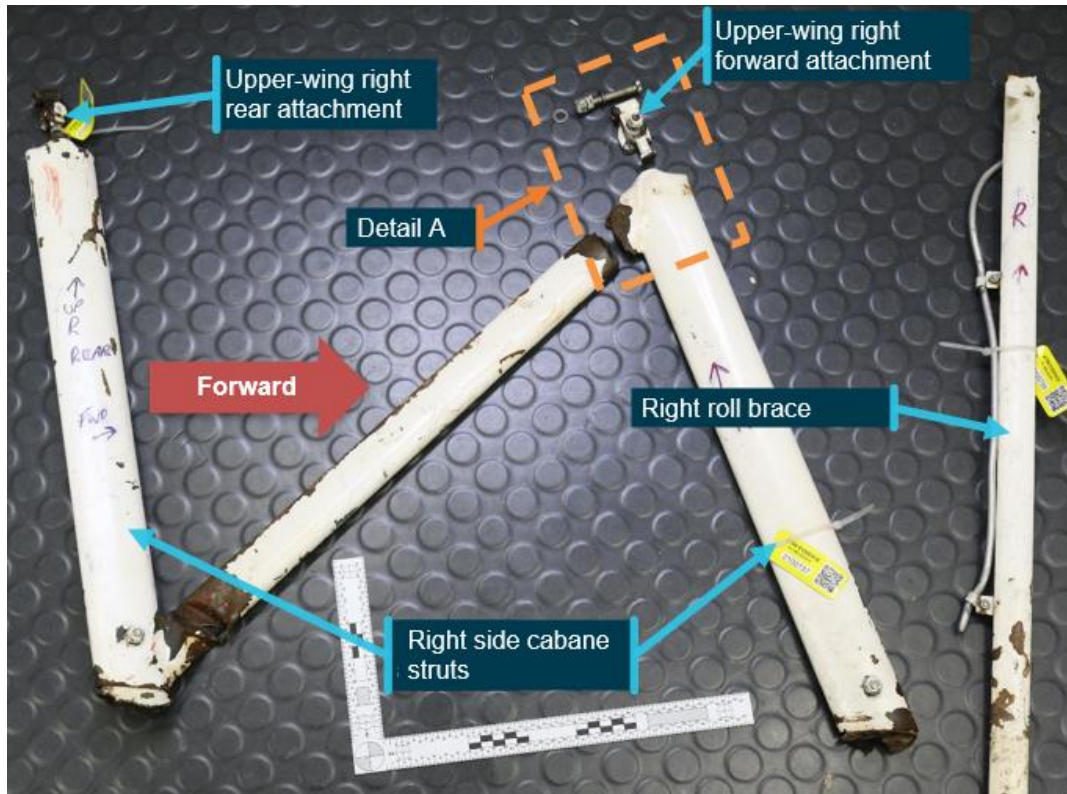
Figure 7: Right side cabane struts, roll brace and upper-wing attachment points

All of the cabane struts, roll braces and attaching hardware were retained for more detailed examination. Figure 7 shows the right-side cabane struts and roll brace, and the area notated as Detail A (also see Figure 8) shows the fractured upper-wing attachment point.

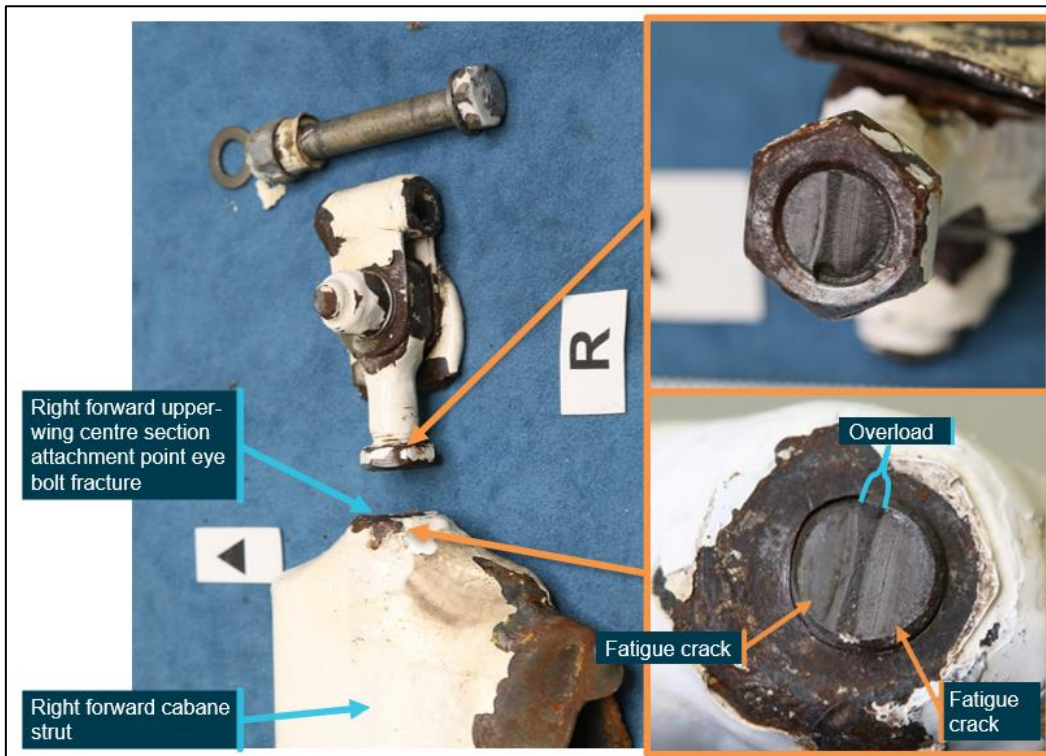
Technical examination of the cabane struts from the centre-wing structure of the aircraft confirmed that there was fatigue cracking on the fracture surfaces of the eye bolts that had been fitted in the upper-wing forward position on the left and right cabane struts. The fatigue cracking had initiated in the thread root of each eye bolt at its termination into the cabane strut.

The right eye bolt had sustained fatigue cracking through about 90 per cent of the cross-section, and the left eye bolt had sustained about 40 per cent fatigue cracking through its cross-section. Final fracture of the eye bolts had occurred instantaneously by overstress due to a reduction in overall tensile strength (Figure 8 and Figure 9).

Figure 8: Right-side cabane strut forward upper-wing attachment eye bolt showing evidence of significant fatigue cracking through the threaded portion (Detail A from Figure 7)

From the preliminary examination findings, it is indicative that fatigue cracking and then fracture of the eye bolts has led to structural instability of the centre-wing section and a consequential in-flight break-up of the upper-wing structure.

The Australian Transport Safety Bureau advises all owners, operators and maintainers of Stolp Acroduster SA-700/750 aircraft to consider the safety implications of the initial findings of this investigation regarding the fatigue cracking on forward cabane strut upper-wing centre-section attachment eye bolts, and take action where considered appropriate to ensure that their aircraft remain airworthy.

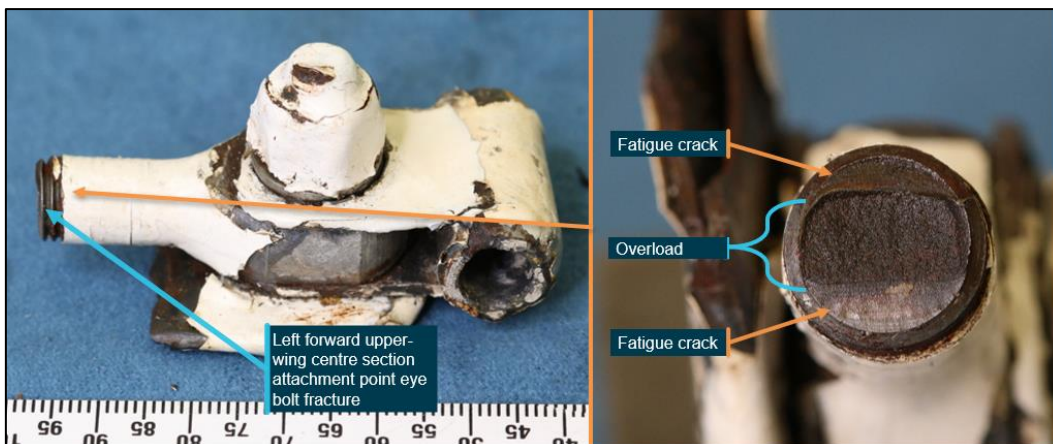
Figure 9: Left-side cabane strut forward upper-wing attachment eye bolt showing evidence of fatigue cracking through the threaded portion

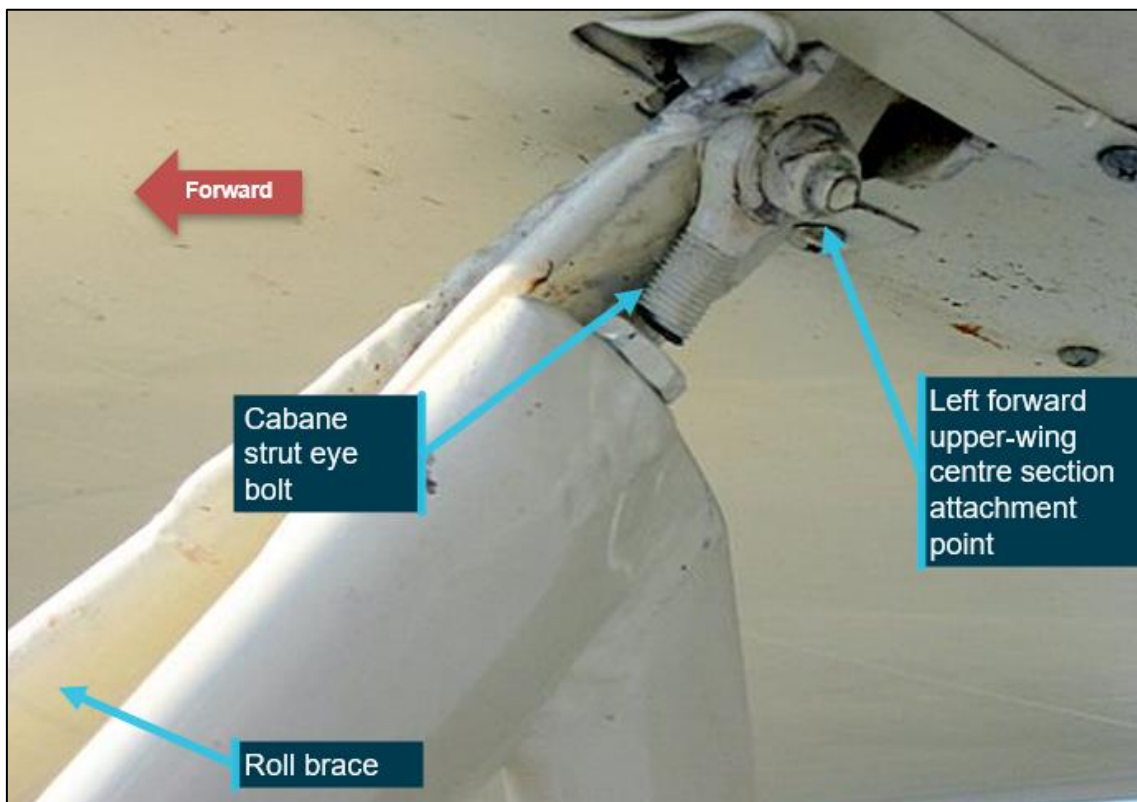
Information provided by industry experts familiar with the aircraft type indicates that there has been a history of cabane strut eye bolt cracking in the same area of the threaded section as occurred with VH-YEL. The ATSB was provided with a picture of an Acroduster SA-750 that had a left forward upper-wing cabane strut eye bolt fractured completely through its threaded section. The left roll brace was the only remaining structure providing support for that section of the wing (Figure 10).

Figure 10: Previous example of another Acroduster SA-750 with a wing attachment eye bolt that had completely fractured through the threaded section

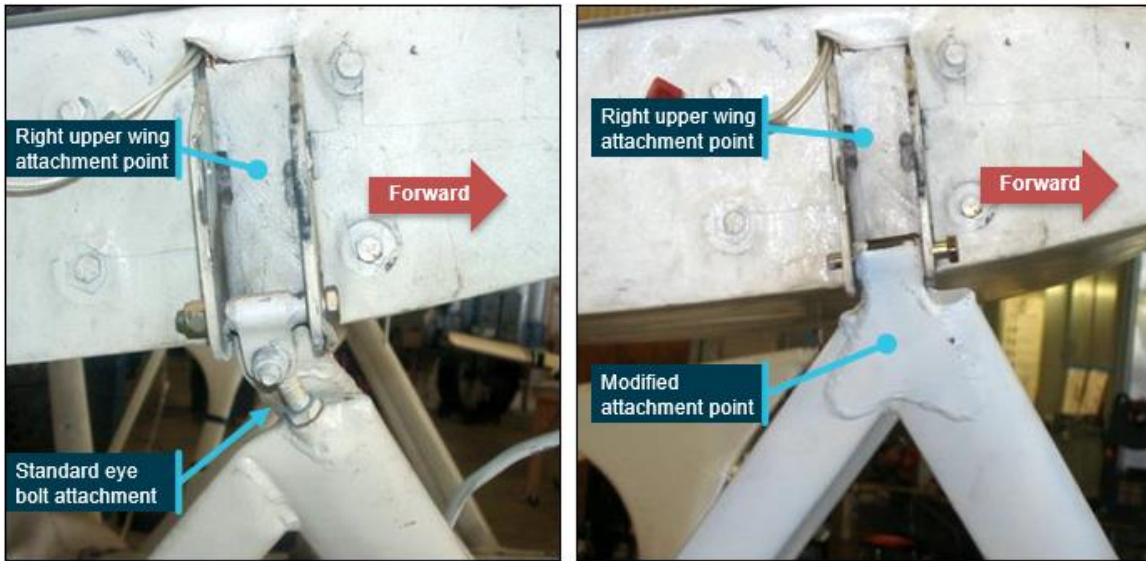
The ATSB was advised that some aircraft owners of Acroduster aircraft have made modifications to the upper-wing attachment points. The modification removed the eye bolts and replaced them with a welded structure, which attached directly to the upper-wing attachment point (Figure 11). The ATSB notes that the modification shown is not approved by the aircraft design owner and advice should be sought from a suitably qualified aeronautical engineer on any design changes undertaken.

Figure 11: Right-side upper-wing centre-section attachment point with a standard eye-bolt attachment on the left and a modified attachment on the right
