Are your wing attachment points serviceable?

Stolp Acroduster upper-wing attachment point, eye bolt fatigue cracking resulted in an in-flight break-up.

AO-2021-032-SAN-01:

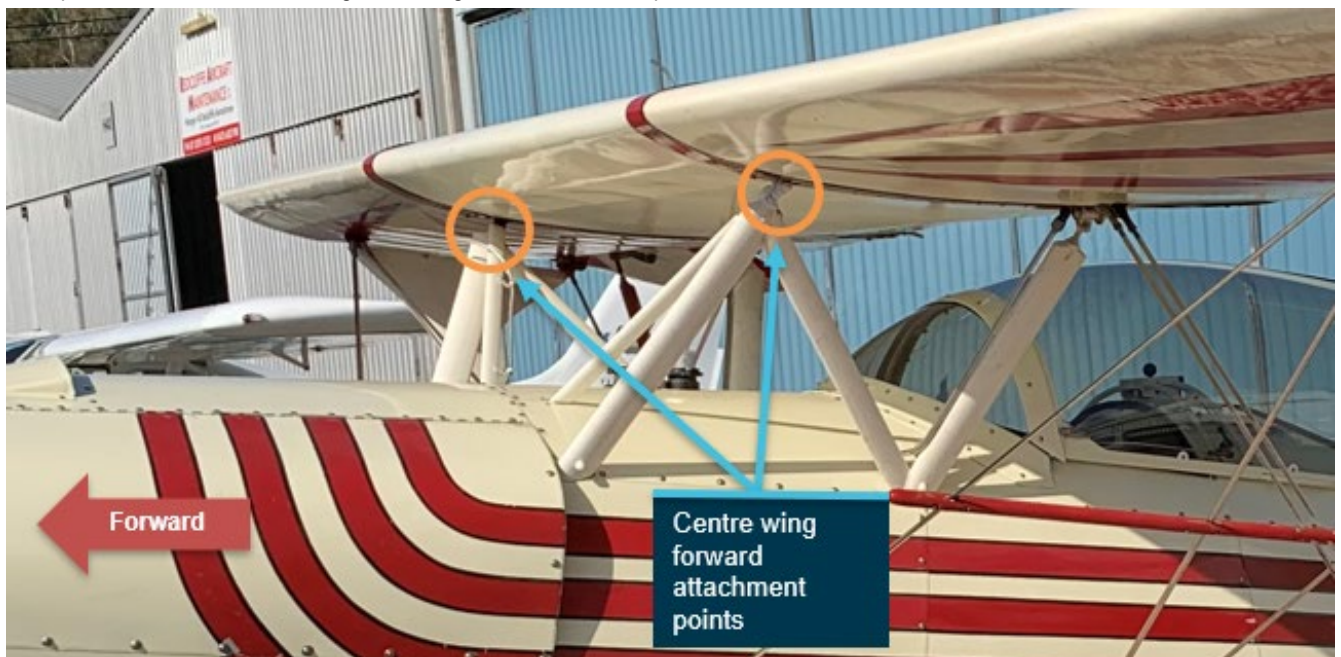
The centre section of the upper wing was located away from the main aircraft wreckage. Technical examination of the cabane struts from the centre section confirmed that there was fatigue cracking on the fracture surfaces of the eye bolts that had been fitted in the upper-wing forward position on the left and right cabane struts. The fatigue cracking had initiated in the thread root of each eye bolt at its termination into the cabane strut.

Stolp Acroduster II SA-750 showing centre wing forward attachment points locations

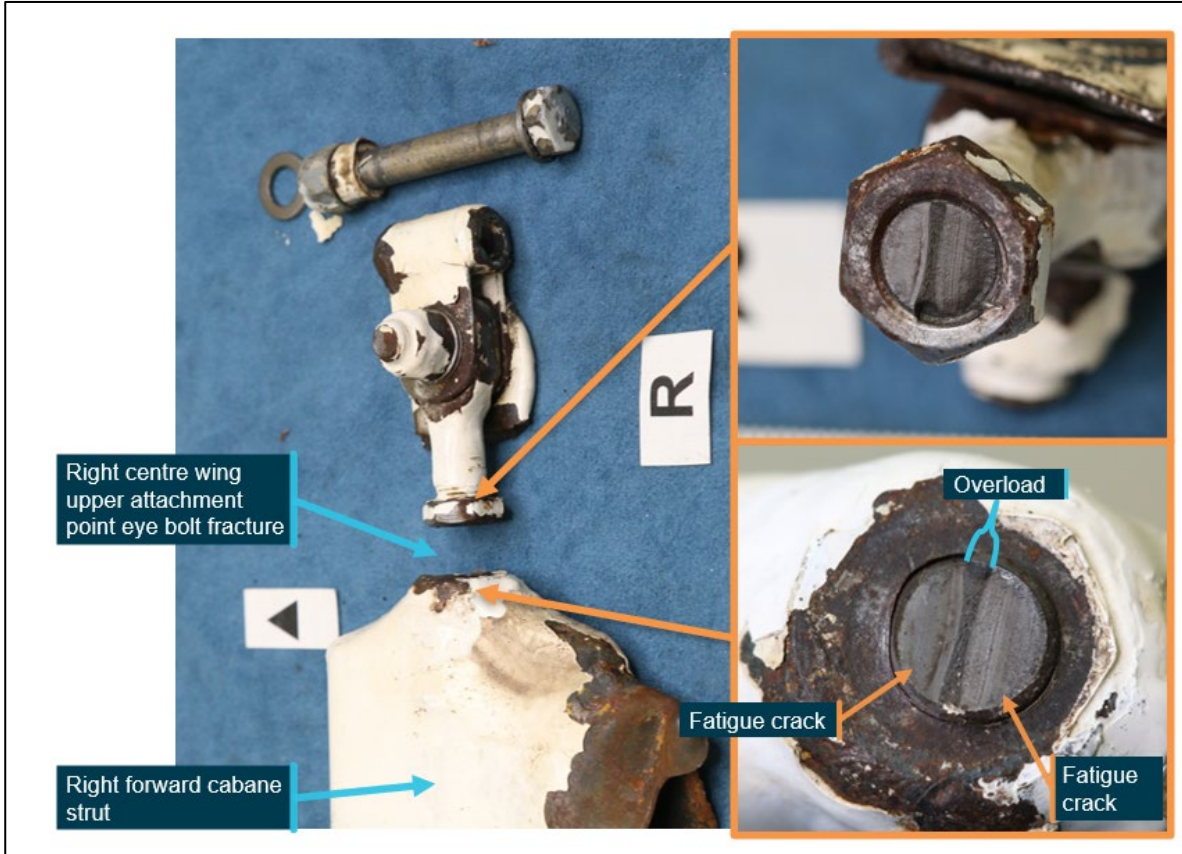
The right eye bolt had sustained fatigue cracking through about 90 per cent of the cross-section, and the left eye bolt had sustained about 40 per cent fatigue cracking through its cross-section. From the preliminary examination findings, it is indicative that fatigue cracking and then fracture of the eye bolts has led to structural instability of the centre-wing section and a consequential in-flight break-up of the upper-wing structure.

Right forward cabane strut showing fractured eye bolt

This aircraft type has had previous instances of cracking in the same area of the cabane strut upper-wing attachment eye bolts, through the threaded sections. The location of fatigue cracking in the forward upper-wing attachment eye bolts makes identifying fatigue crack during visual inspections difficult and in some cases impossible without removing the eye bolts from the cabane strut. The aircraft type does not have a specific detailed scheduled inspection of the eye bolts to ensure their ongoing airworthiness. It also does not have a time-life replacement of the eye bolts at set periods.

The Australian Transport Safety Bureau advises all owners, operators and maintainers of Stolp Acroduster SA-700/750 aircraft to consider the safety implications of the initial findings of this investigation regarding the fatigue cracking on forward cabane strut upper wing attachment eye bolts, and take action where considered appropriate to ensure that their aircraft remain airworthy.
