# In-flight break-up involving Cessna T210M, VH-SUX

25 km north-east of Mount Isa Airport, Queensland on 26 May 2019

## **ATSB Transport Safety Report**

AO-2019-026

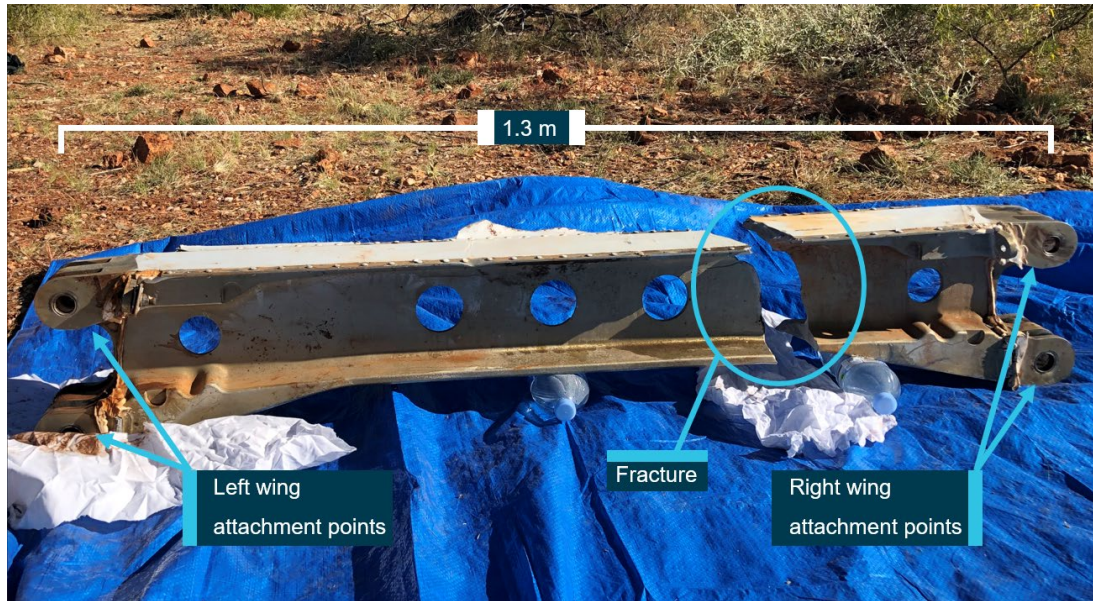
**Figure 12: The fractured carry-through structure as removed from the wreckage viewed from the rear**

to flight. The wing spar carry-through structure attached to the left wing showed a fracture surface that corresponded with the remaining carry-through section from the right wing (Figure 12).

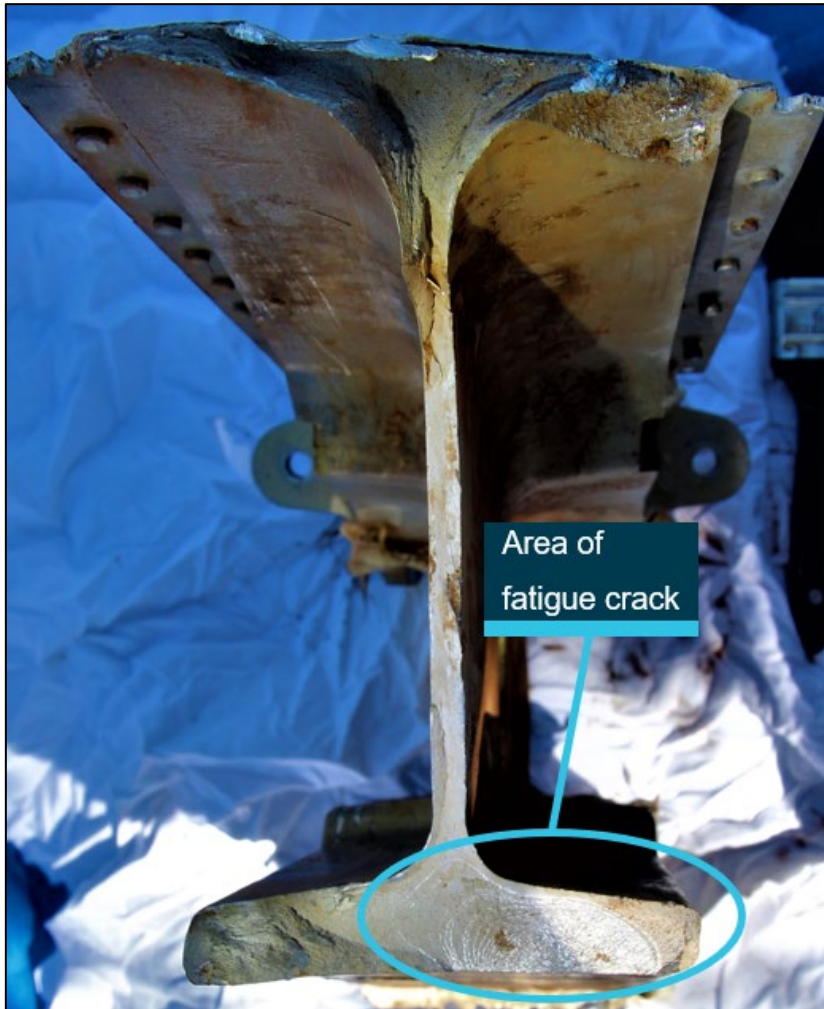
On-site site examination of the wreckage indicated the right wing and part of the wing spar carry-through (see the section titled *Wing spar carry-through structure*) had separated from the aircraft. Preliminary examination of the carry-through spar identified that it had fractured through an area of pre-existing fatigue cracking inboard of the wing attachment lugs (Figure 13).

**Figure 13: Main spar carry-through fracture surface showing area of fatigue cracking on the lower spar cap**

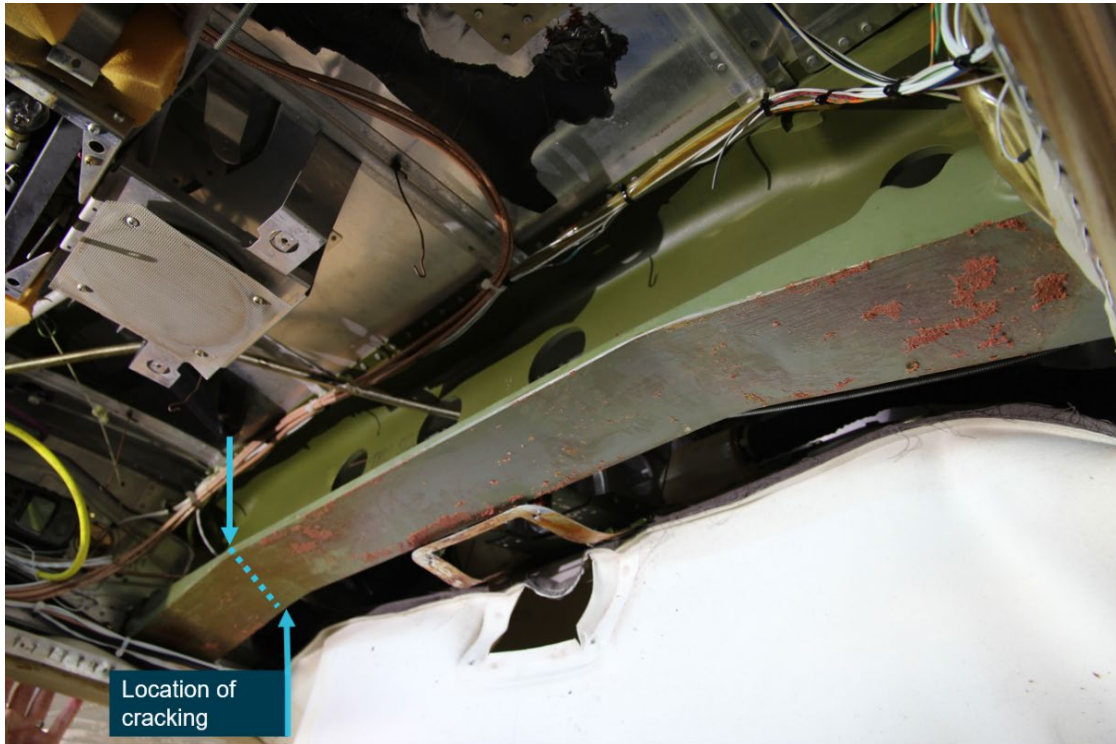
A visual inspection of the carry-through structure showed that it had fractured just outboard of a thickness transition between the wing lug base region and the central beam; approximately 290 mm from the right root rib attachment lug (Figure 14).

**Figure 14: An exemplar Cessna 210N wing spar showing the approximate location where cracking had developed on the carry-through from SUX**

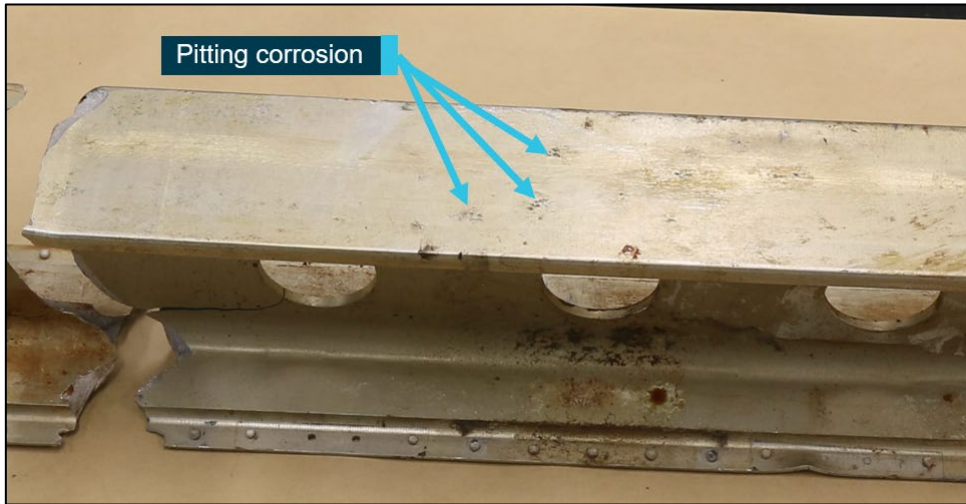
The visual examination also identified that pitting corrosion damage had developed at multiple discrete locations along the underside surface of the spar (Figure 16). The corrosion damage was also identified adjacent to the fracture plane and confined to the underside surface with no evidence of corrosion on other parts of the structure.

**Figure 16: Carry-through underside surface showing pitting corrosion.**

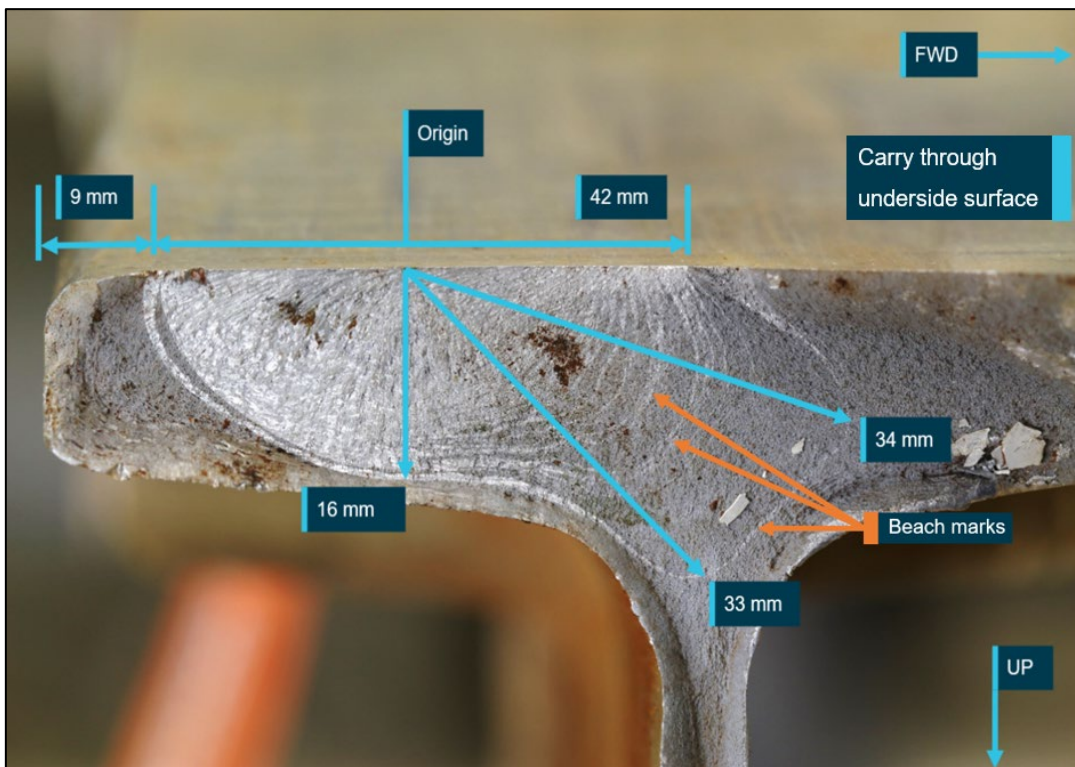
**Figure 17: Key measurements of the fatigue portion along the fracture surface**

Note that cracking has commenced on the underside surface (inverted in figure) of the carry-through spar.  
Source: ATSB

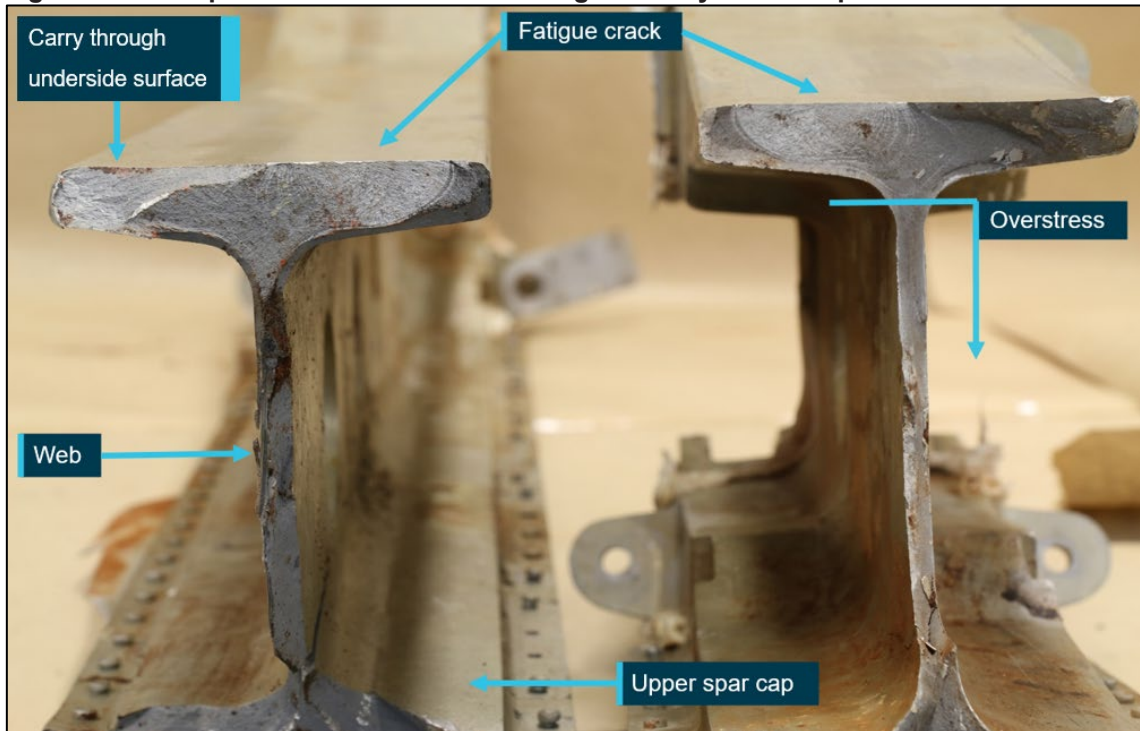
The fractured section of the carry-through spar was examined at varying magnifications using a binocular microscope. The lowermost section of the carry-through spar contained two separate failure mechanisms. Most obvious, was a region of generally flat fracture containing a series of concentric marks (beach marks), consistent with the typical appearance of fatigue cracking (Figure 17). The remaining regions on the fractured spar presented a dull, fibrous and angular appearance consistent with ductile fracture from overstress conditions (Figure 18).

**Figure 18: The spar fracture surfaces showing a side-by-side comparison**

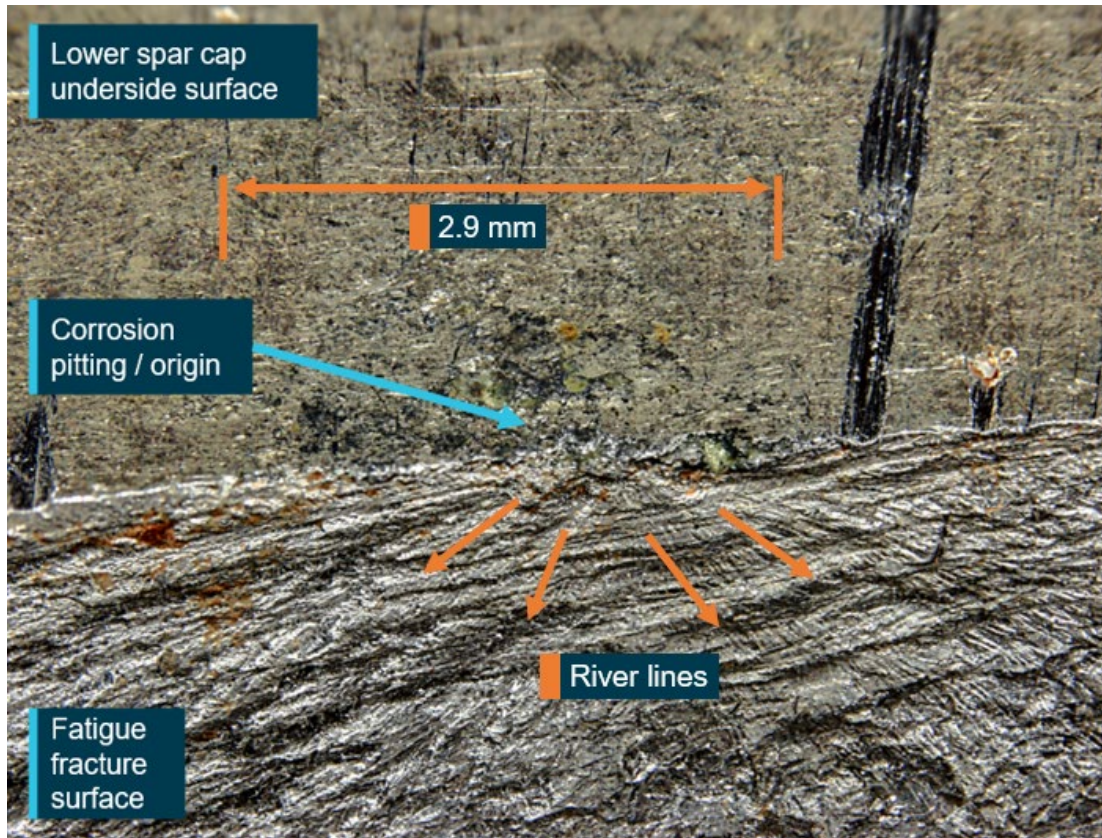
The concentric radiating features present on the fracture showed that fatigue cracking had initiated at a localised underside surface position. A series of ridges (river lines) across the fracture plane at the intersection with the underside surface indicated that fatigue cracking had initiated from a discrete origin (Figure 19). Further inspection revealed that the crack origin was associated with the presence of pitting corrosion that had penetrated and damaged the spar (Figure 20).

**Figure 19: Close-up view of the fracture surface surrounding the corrosion pit cluster at the fatigue crack origin**

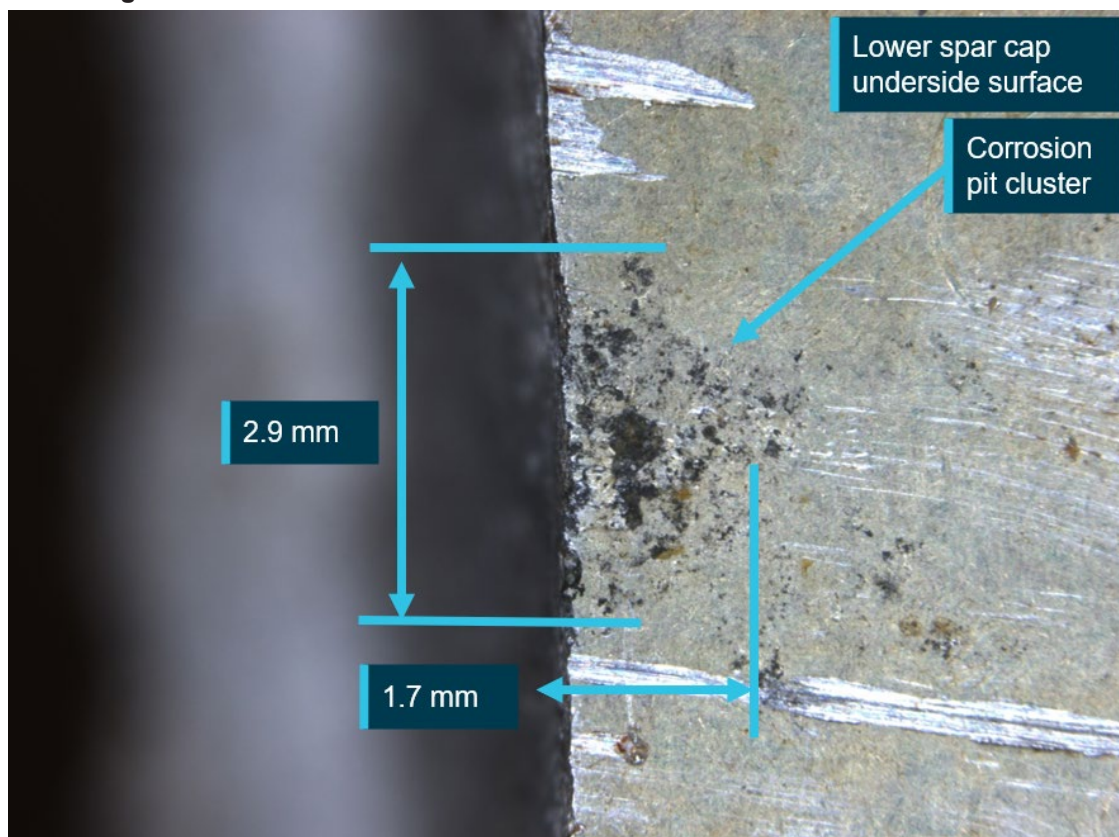
**Figure 20: View of the underside surface showing a corrosion pit cluster at the fatigue crack origin**

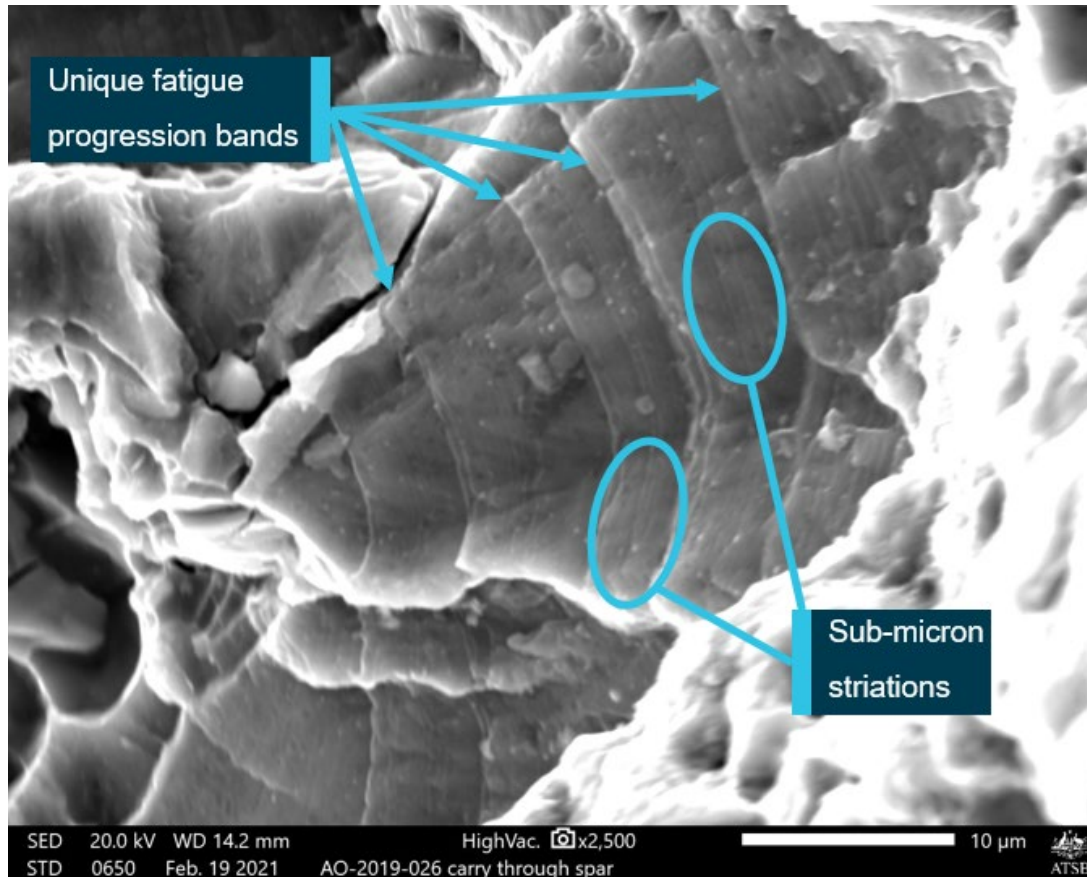
The fatigue portion of the fracture was a mixture of predominantly transgranular striations interspersed with some ductile tearing. The fatigue cracking was clearly identifiable through the presence of 'river' lines that were directed from a single region of corrosion pitting on the underside surface.

**Figure 21: Scanning electron microscopy of the fracture surface**

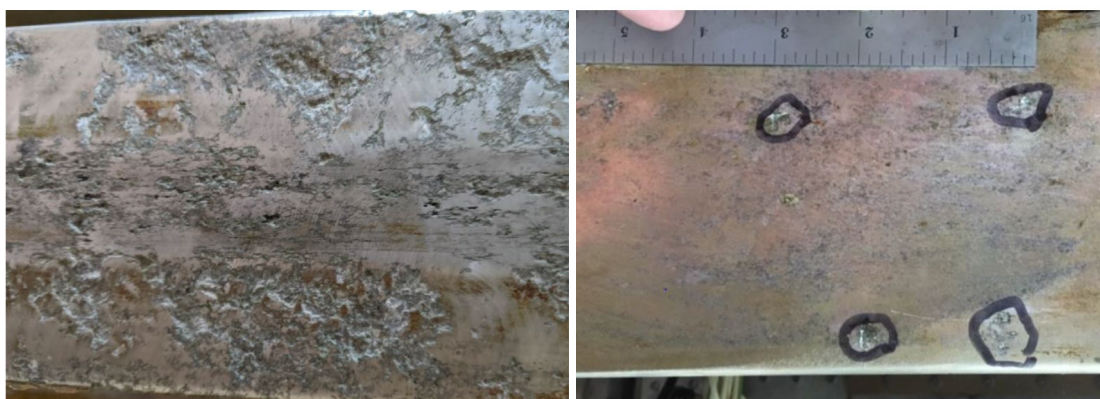
**Figure 24: Examples of severe carry-through structural corrosion damage identified through SEL 57-06 inspections**

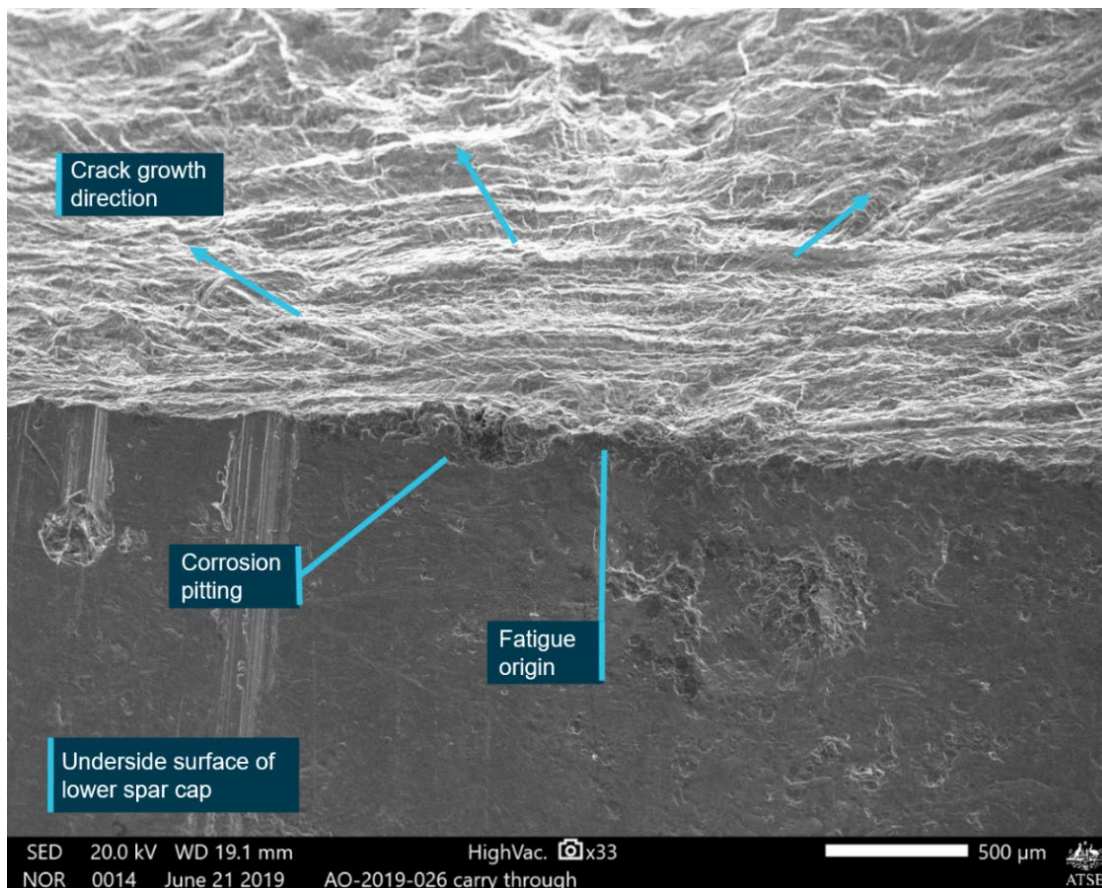
**Figure A1: Scanning electron microscopy of the fracture surface, key features are identified at the fatigue crack origin**

It was confirmed that the fatigue cracking initiated from a single corrosion pit cluster which then propagated through the structure from that location.  
Source: ATSB

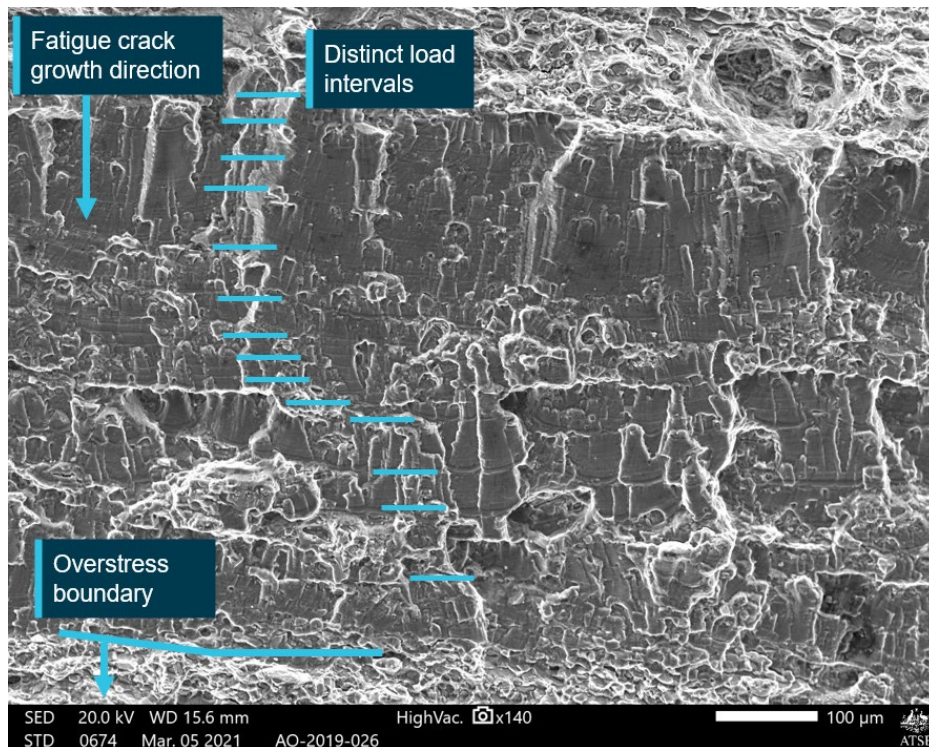
**Figure A3: Scanning electron microscopy of the fracture surface close to the overstress boundary**

Well defined distinct load intervals (or crack arrest marks) and striations were identified along the entire fatigue portion of crack growth up until the overstress fracture.

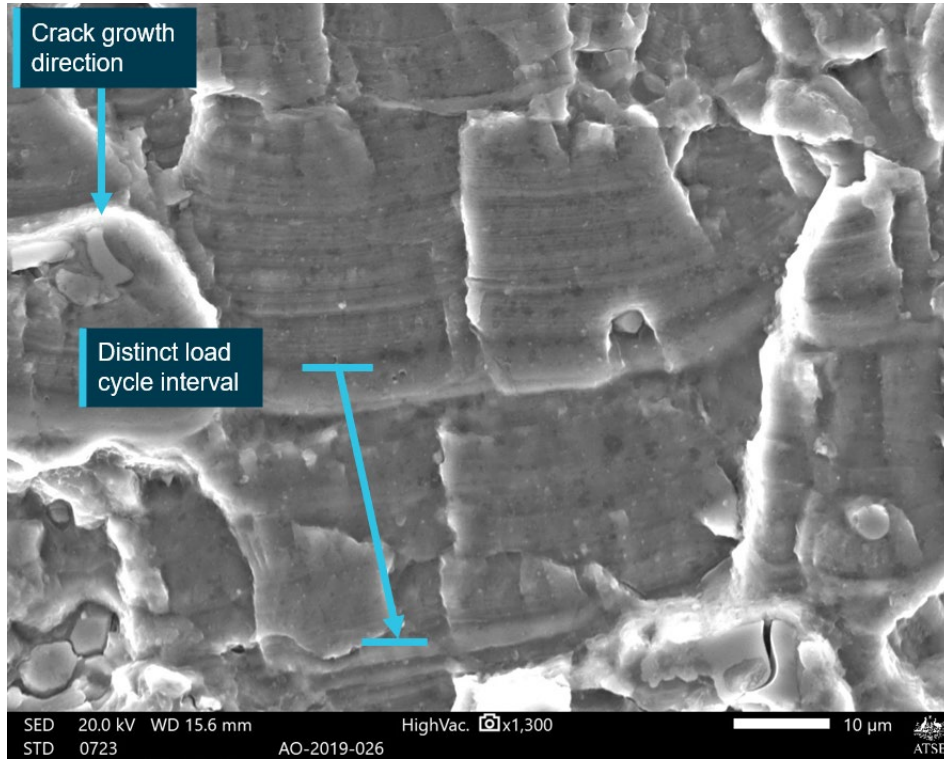
**Figure A4: Scanning electron microscopy: closer view of the crack arrest marks near the overstress boundary**

*The distance between each distinct band indicates a distinct load interval that is probably a take-off and landing cycle.*  
Source: ATSB

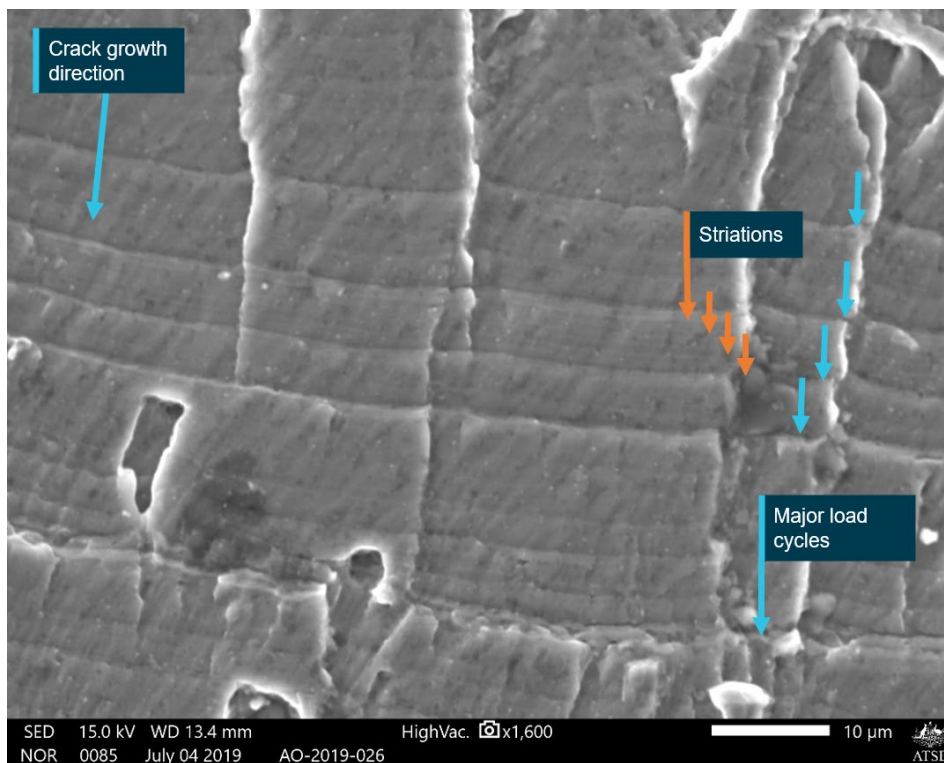
*A combination of well-defined striations and arrest marks (major load cycles) were identified along the entire portion of the fatigue fracture.*  
Source: ATSB

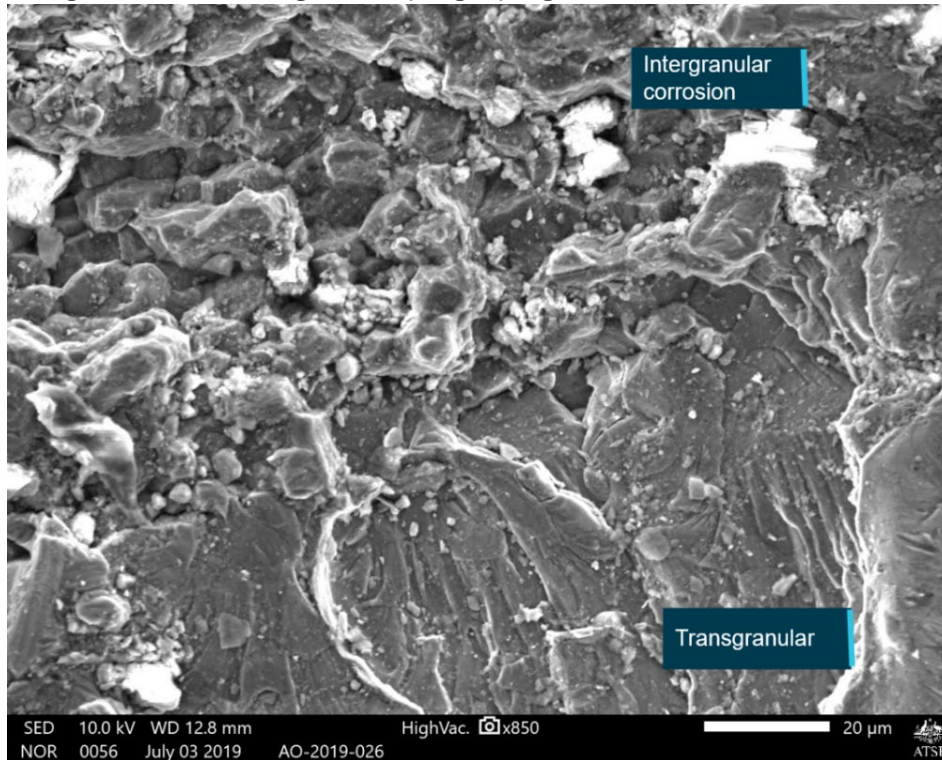
**Figure A6: Scanning electron microscopy image near the crack origin identifying the intergranular and transgranular (fatigue) regions**

The corrosion pitting led to intergranular corrosion and the subsequent development of transgranular fatigue cracking.  
Source: ATSB

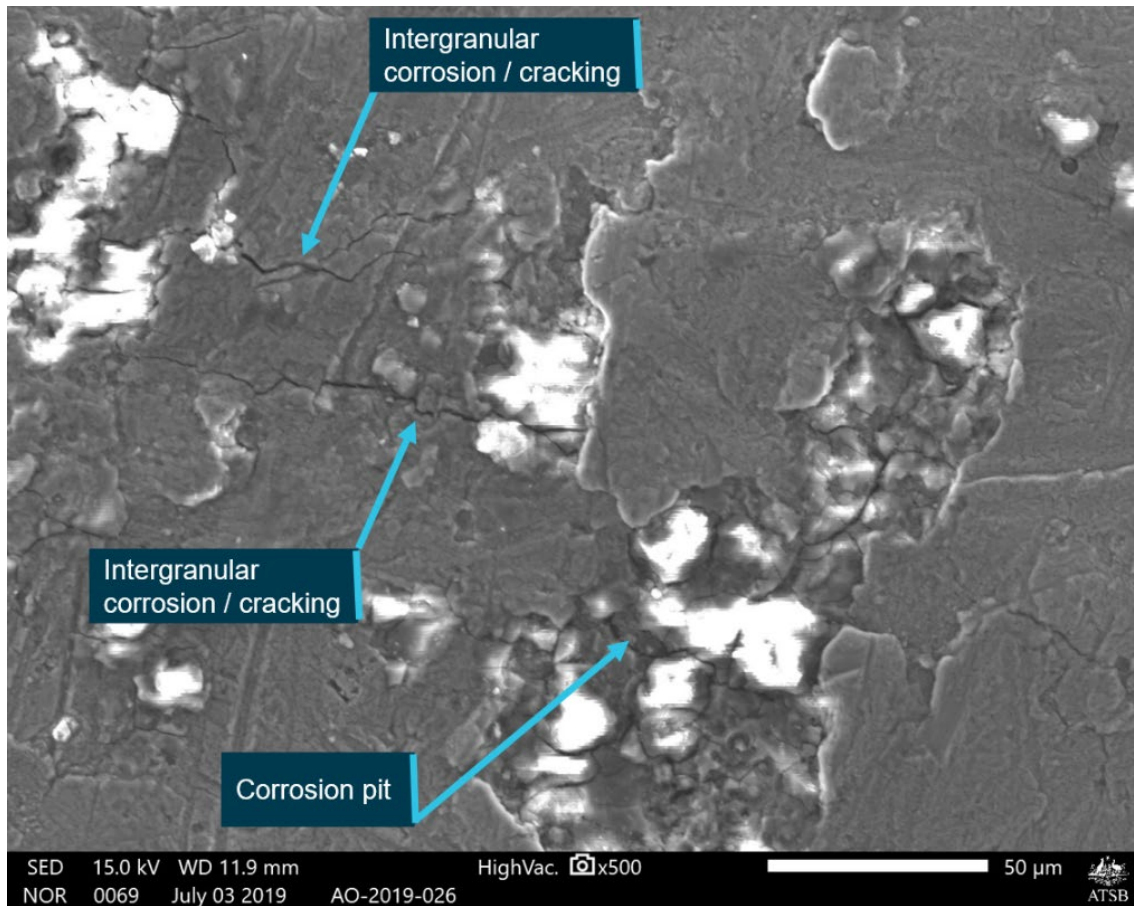
Intergranular corrosion/cracking has initiated from the corrosion pits.  
Source: ATSB

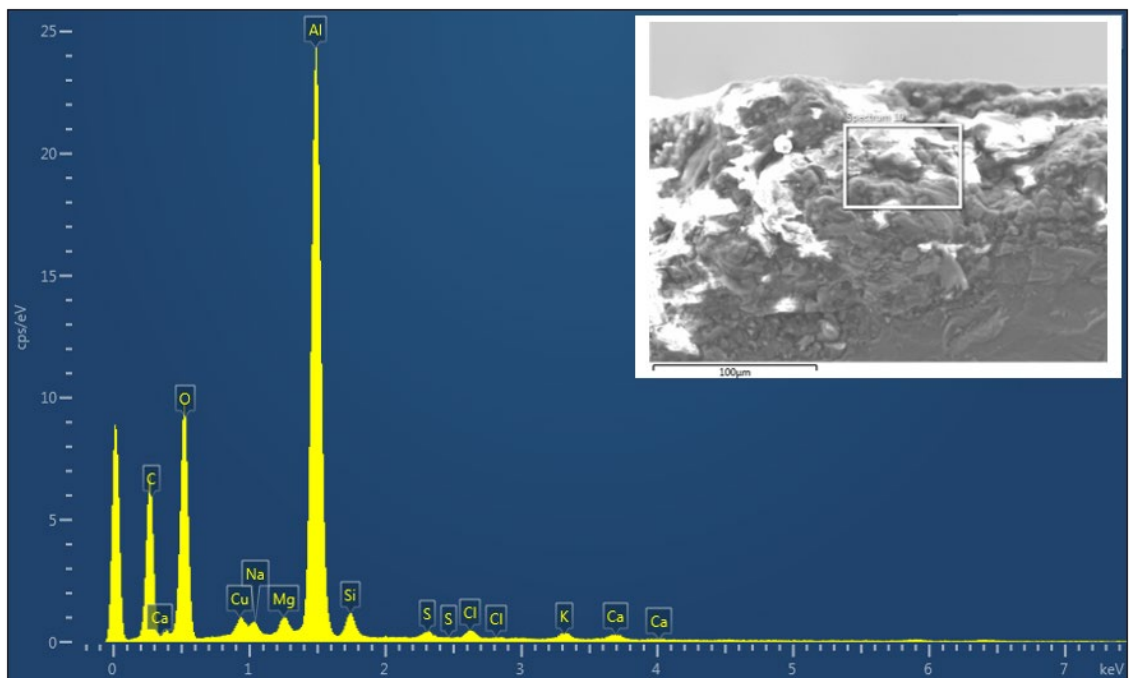
The elements sodium (Na) and chlorine (Cl) were identified as a constituent of the corrosion product, along with the elements representative of the 2014-alloy.  
Source: ATSB

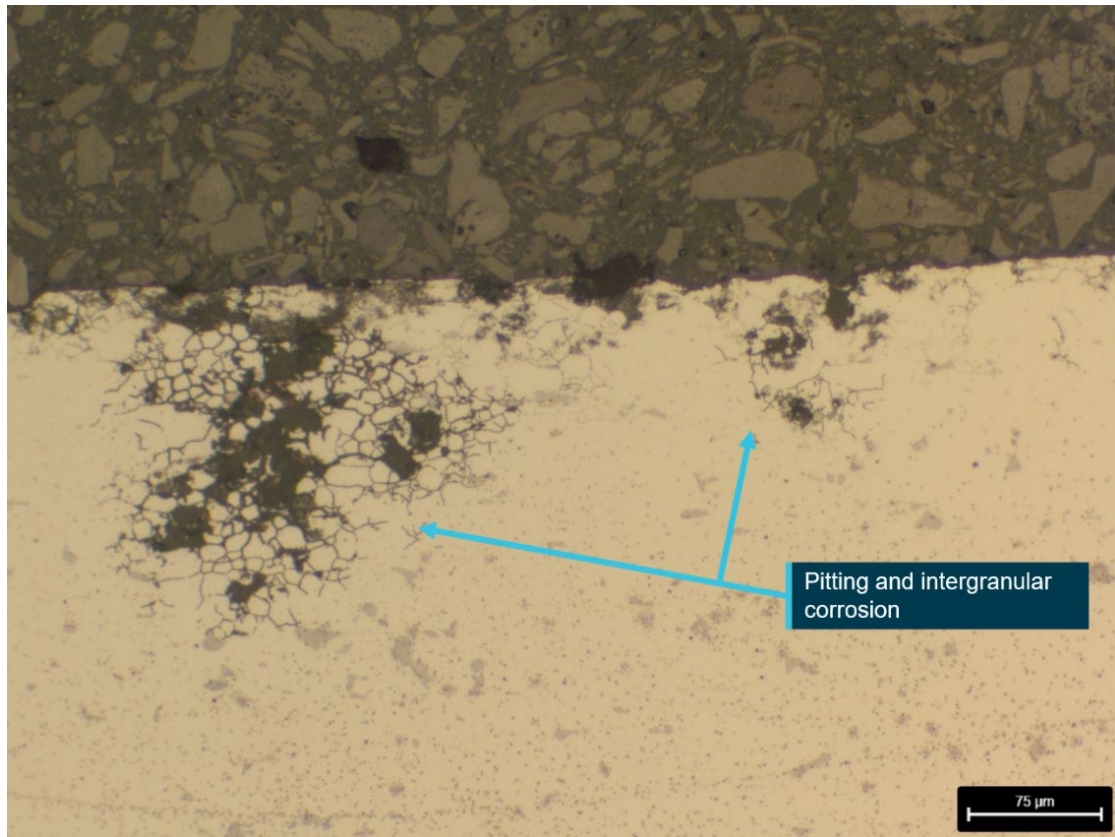
**Figure A10: Metallurgical cross-section through a region of pitting damage from the carry-through spar**

*The corrosion has progressed from the underside surface. Intergranular corrosion has then developed within alloy surrounding the surface pits*  
Source: ATSB

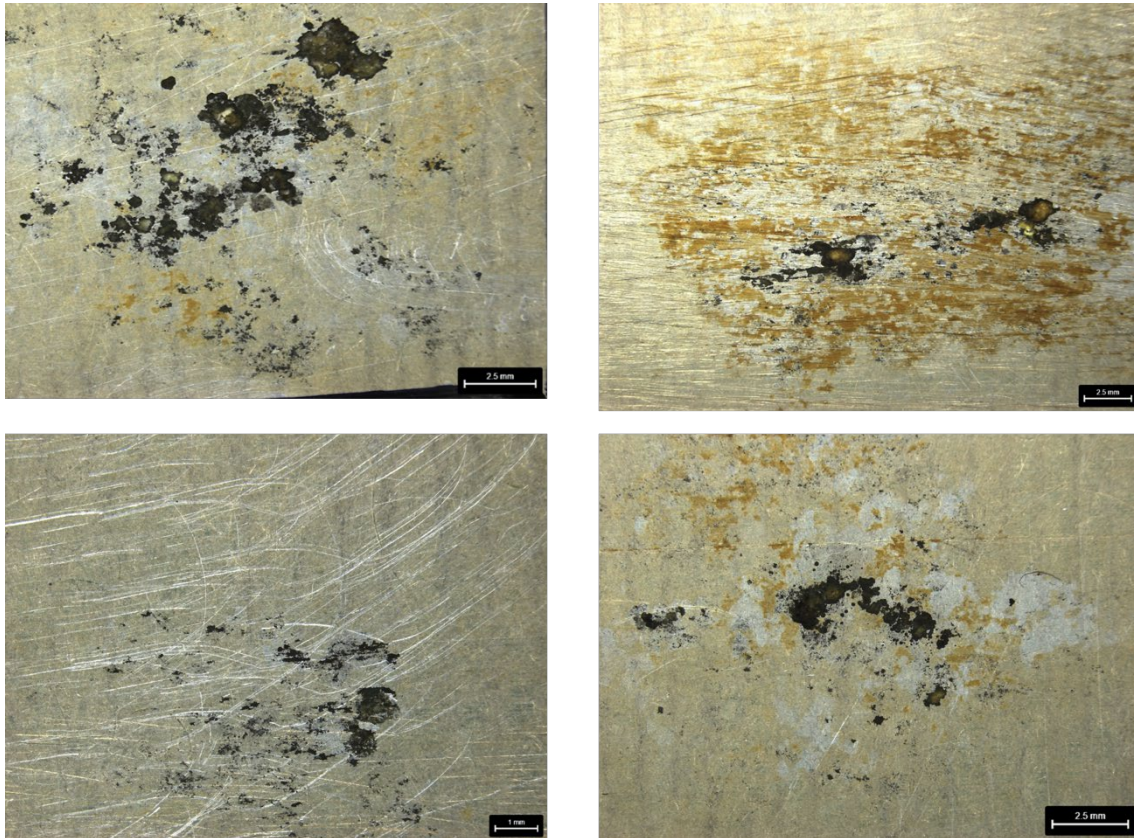
**Figure A11: Close-up images of some of the corrosion damage identified on the underside surface of the component**
