In-flight break-up involving Cessna T210M, VH-SUX

25 km north-east of Mount Isa Airport, Queensland on 26 May 2019

ATSB Transport Safety Report

AO-2019-026

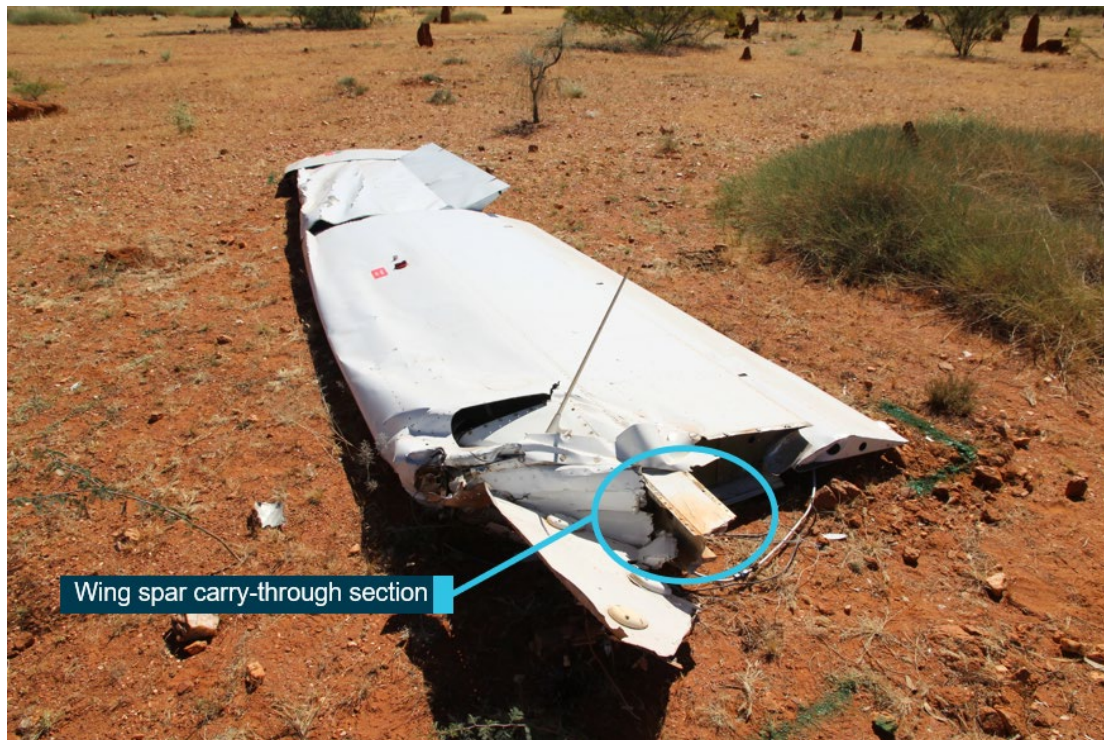
Figure 11: Separated right wing viewed from the inboard end

On-site site examination of the wreckage indicated the right wing and part of the wing spar carry-through (see the section titled *Wing spar carry-through structure*) had separated from the aircraft. Preliminary examination of the carry-through spar identified that it had fractured through an area of pre-existing fatigue cracking inboard of the wing attachment lugs (Figure 13).

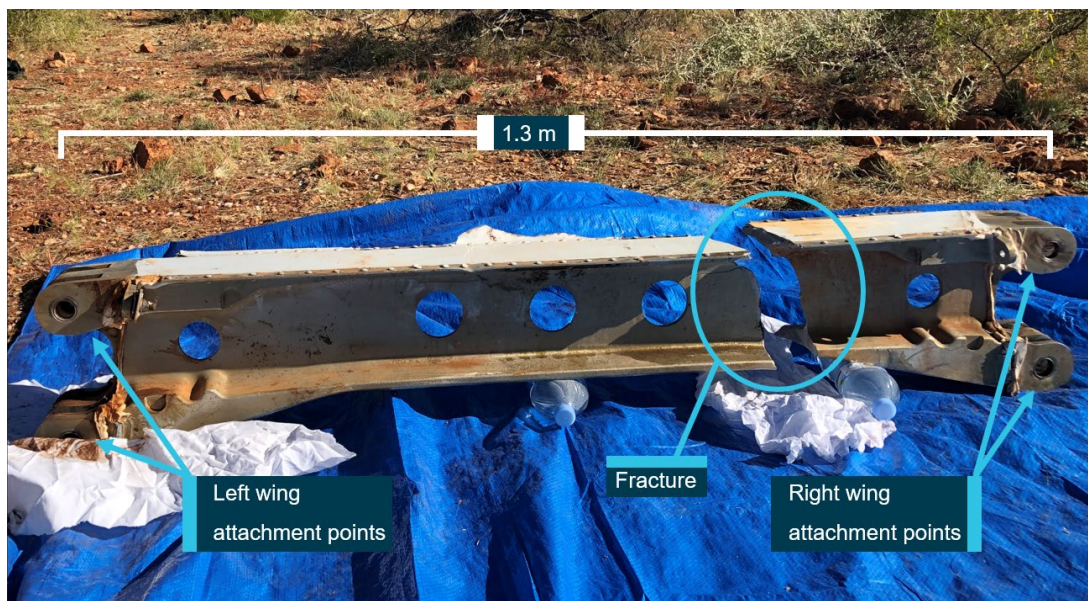
Figure 12: The fractured carry-through structure as removed from the wreckage viewed from the rear

All major aircraft components were accounted for at the site. The structure was significantly disrupted with the aircraft fuselage, tail, and left wing located towards the end of the wreckage trail. The left wing was fractured into two pieces, resting upside down and in the opposite direction to flight. The wing spar carry-through structure attached to the left wing showed a fracture surface that corresponded with the remaining carry-through section from the right wing (Figure 12).

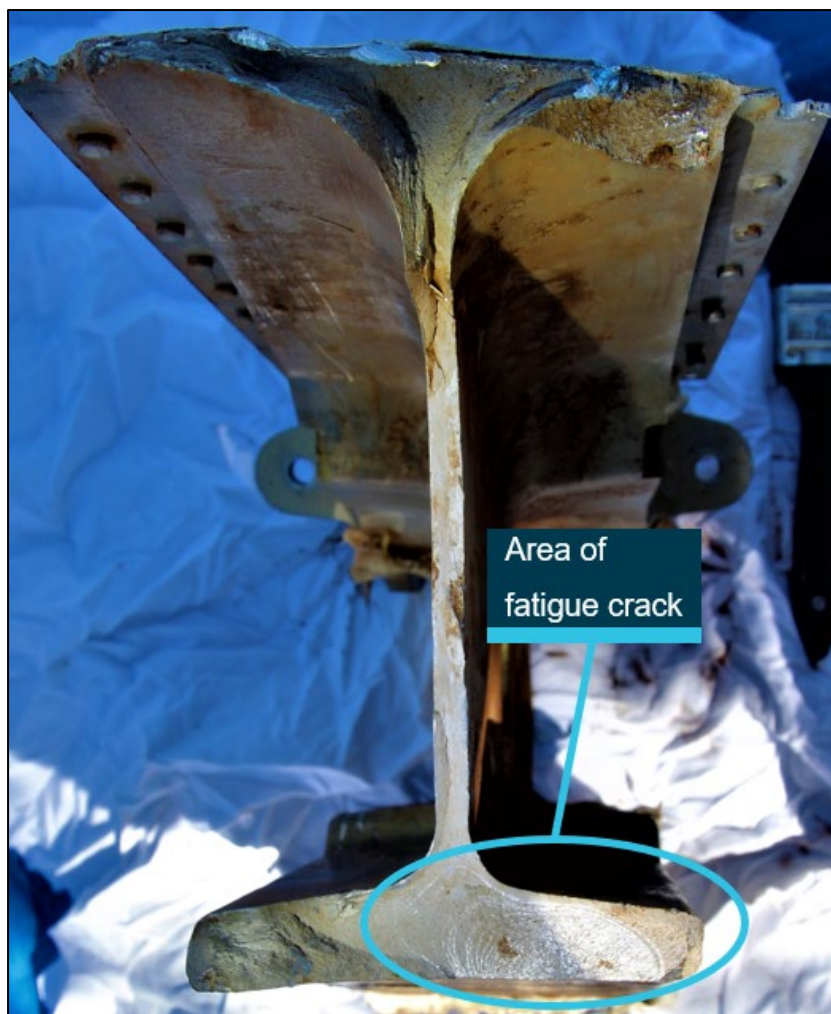
Figure 13: Main spar carry-through fracture surface showing area of fatigue cracking on the lower spar cap

The ATSB found that a pre-existing fatigue crack in the aircraft's wing spar carry-through structure propagated to a critical size resulting in an overstress fracture of the structure and separation of the right wing.

Note: The two brown blemishes in the area of fatigue cracking were substances deposited onto the fracture surfaces during the accident.

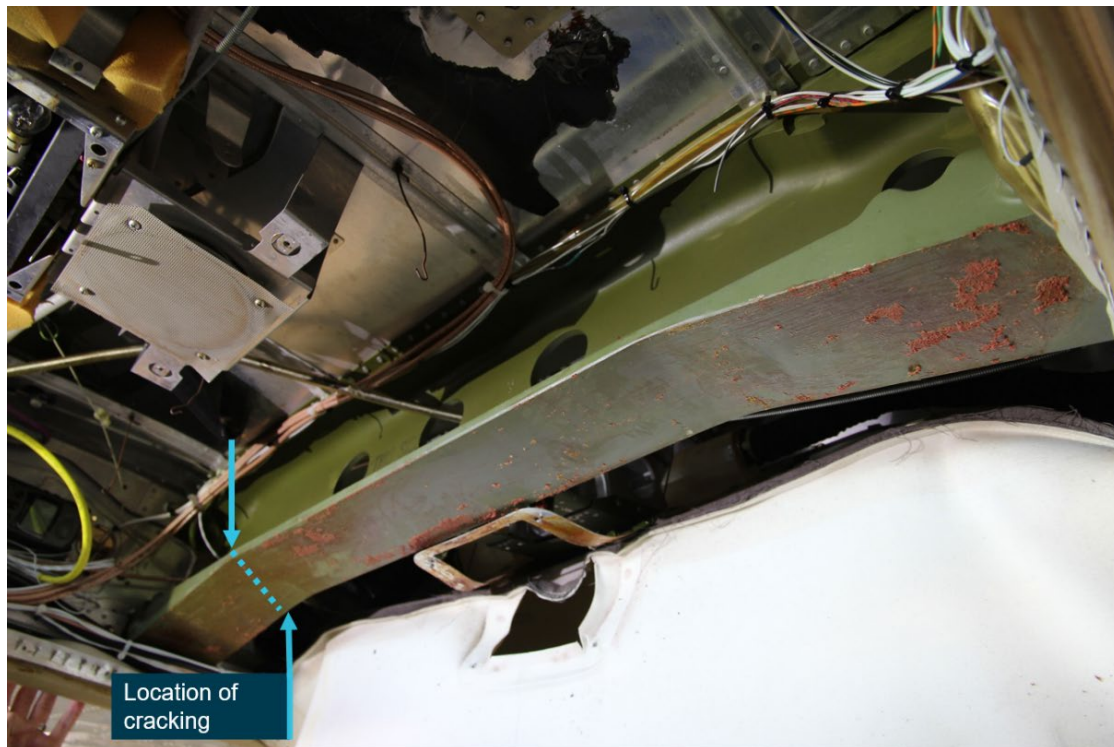
Figure 14: An exemplar Cessna 210N wing spar showing the approximate location where cracking had developed on the carry-through from SUX

A visual inspection of the carry-through structure showed that it had fractured just outboard of a thickness transition between the wing lug base region and the central beam; approximately 290 mm from the right root rib attachment lug (Figure 14).

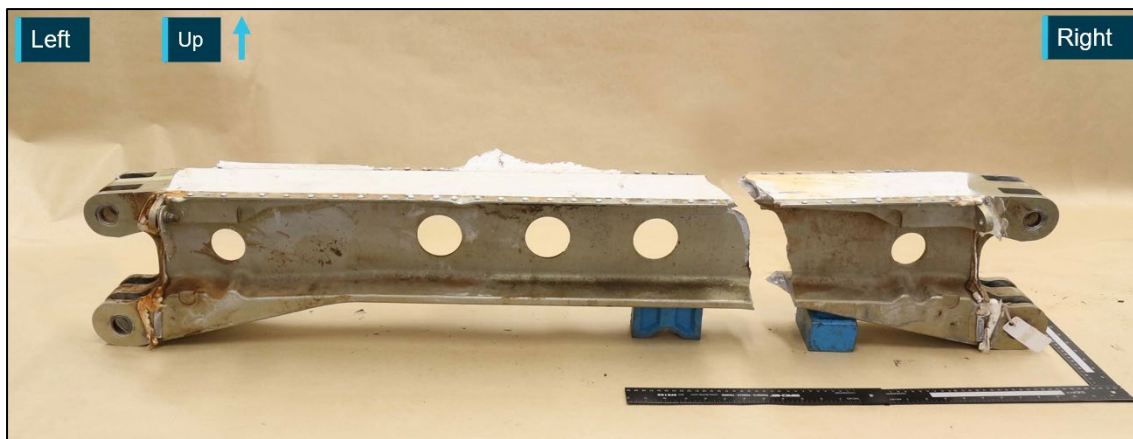
Figure 15: The carry-through spar in the ATSB laboratory

Almost the entirety of the spar was a light yellow/green colour, which was consistent with the application of the specified corrosion inhibiting chromate surface film. No evidence was found to indicate the chromate had been reapplied since manufacture. The foam section normally glued to the underside surface of the carry-through structure was absent. The uppermost portion of the spar had been painted white, consistent with the C210M design where that portion of the spar formed a segment adjoining the external roof skin panels of the aircraft (Figure 15).

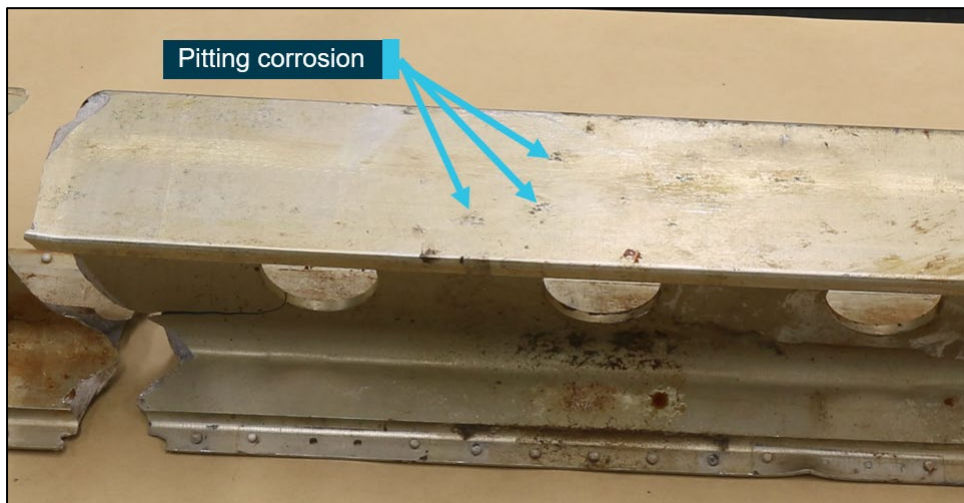
Figure 16: Carry-through underside surface showing pitting corrosion.

The visual examination also identified that pitting corrosion damage had developed at multiple discrete locations along the underside surface of the spar (Figure 16). The corrosion damage was also identified adjacent to the fracture plane and confined to the underside surface with no evidence of corrosion on other parts of the structure.

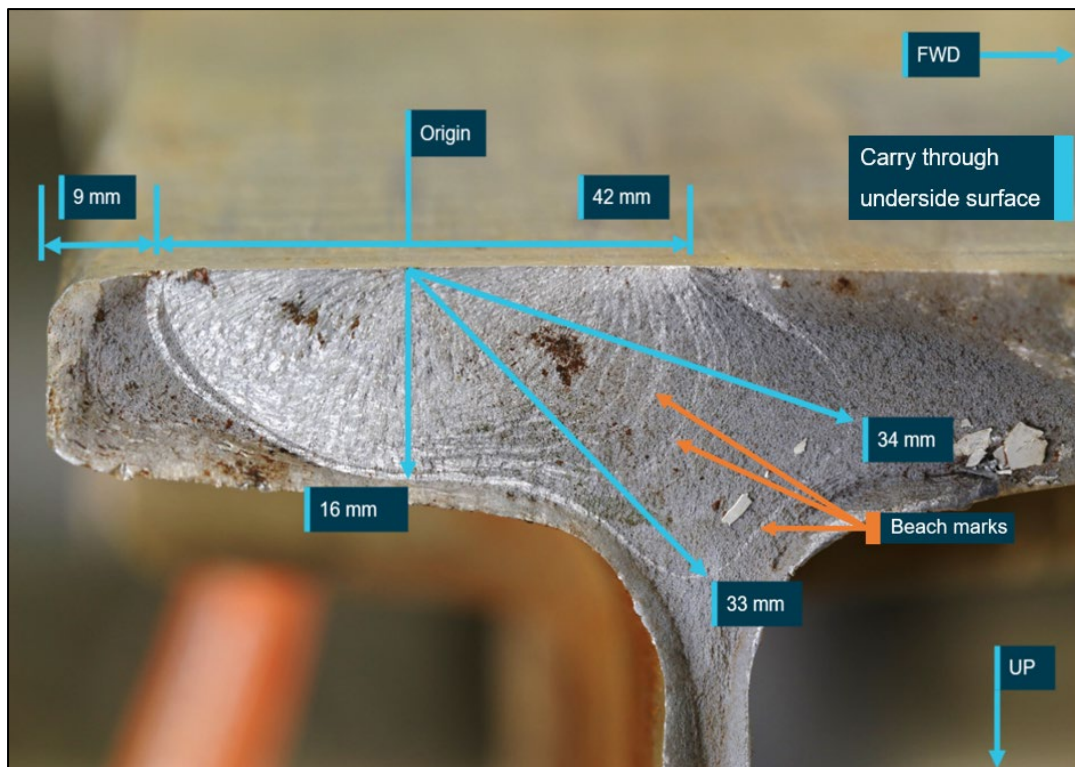
Figure 17: Key measurements of the fatigue portion along the fracture surface

Note that cracking has commenced on the underside surface (inverted in figure) of the carry-through spar.

Measurements of the significant features from the fractured spar structure showed that the fatigue cracking grew transversely in a vertical plane before reaching a critical depth of approximately 16 mm toward the web. When measured from the underside surface, the crack had a surface length of approximately 42 mm. The extent of fatigue cracking in the critical section of lower flange was calculated to represent close to 38 per cent of the cross-sectional area of the spar that was in tension (during positive-G flight).

The fatigue crack that had initiated within the lower spar cap reached a critical depth of about 16 mm (measuring 42 mm in length along the underside surface), at which point structural failure occurred. Tear bands developed as the crack increased in depth as it progressed through the structure toward the web. The tear bands showed that the stresses within the structure were increasing and further indicated that the rate of crack growth was accelerating as it progressed.

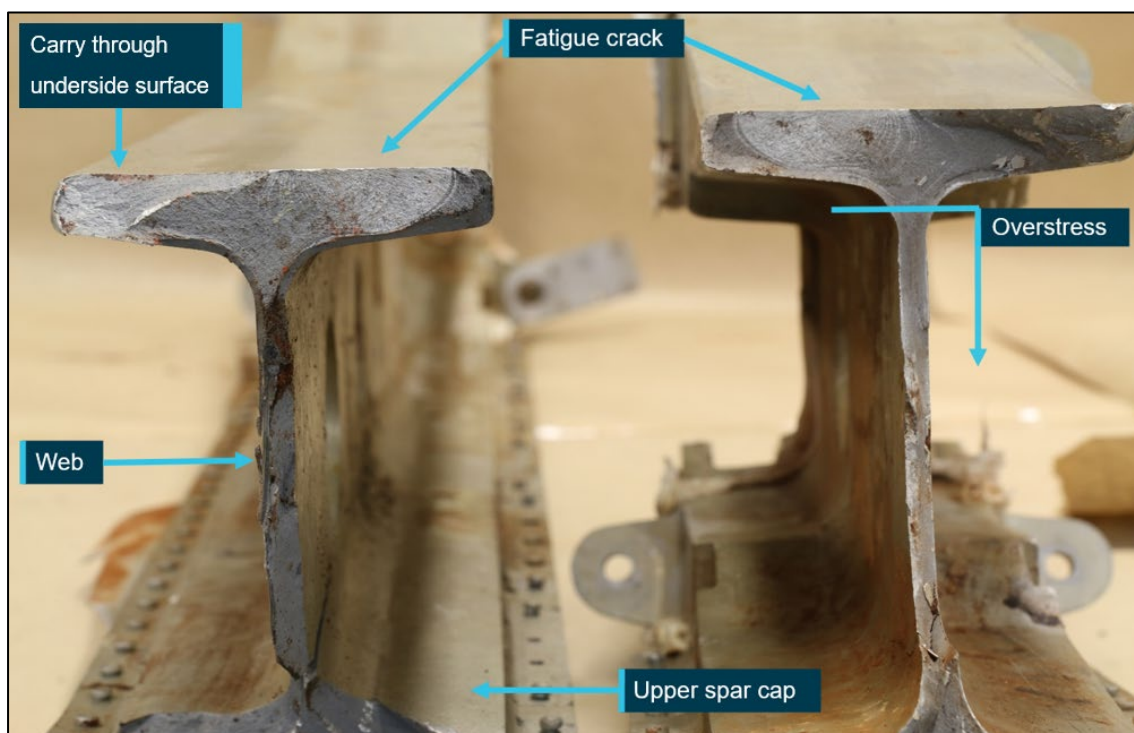
Figure 18: The spar fracture surfaces showing a side-by-side comparison

The fractured section of the carry-through spar was examined at varying magnifications using a binocular microscope. The lowermost section of the carry-through spar contained two separate failure mechanisms. Most obvious, was a region of generally flat fracture containing a series of concentric marks (beach marks), consistent with the typical appearance of fatigue cracking (Figure 17). The remaining regions on the fractured spar presented a dull, fibrous and angular appearance consistent with ductile fracture from overstress conditions (Figure 18).

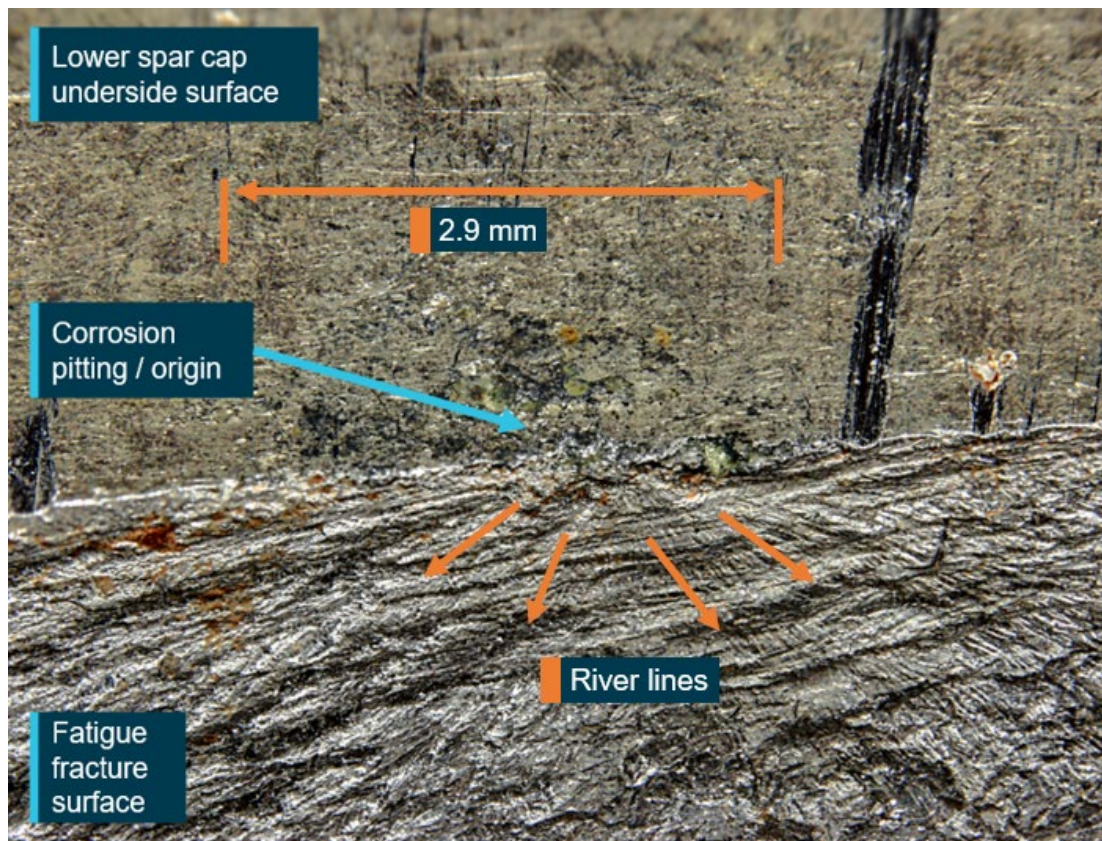
Figure 19: Close-up view of the fracture surface surrounding the corrosion pit cluster at the fatigue crack origin

The concentric radiating features present on the fracture showed that fatigue cracking had initiated at a localised underside surface position. A series of ridges (river lines) across the fracture plane at the intersection with the underside surface indicated that fatigue cracking had initiated from a discrete origin (Figure 19). Further inspection revealed that the crack origin was associated with the presence of pitting corrosion that had penetrated and damaged the spar (Figure 20).

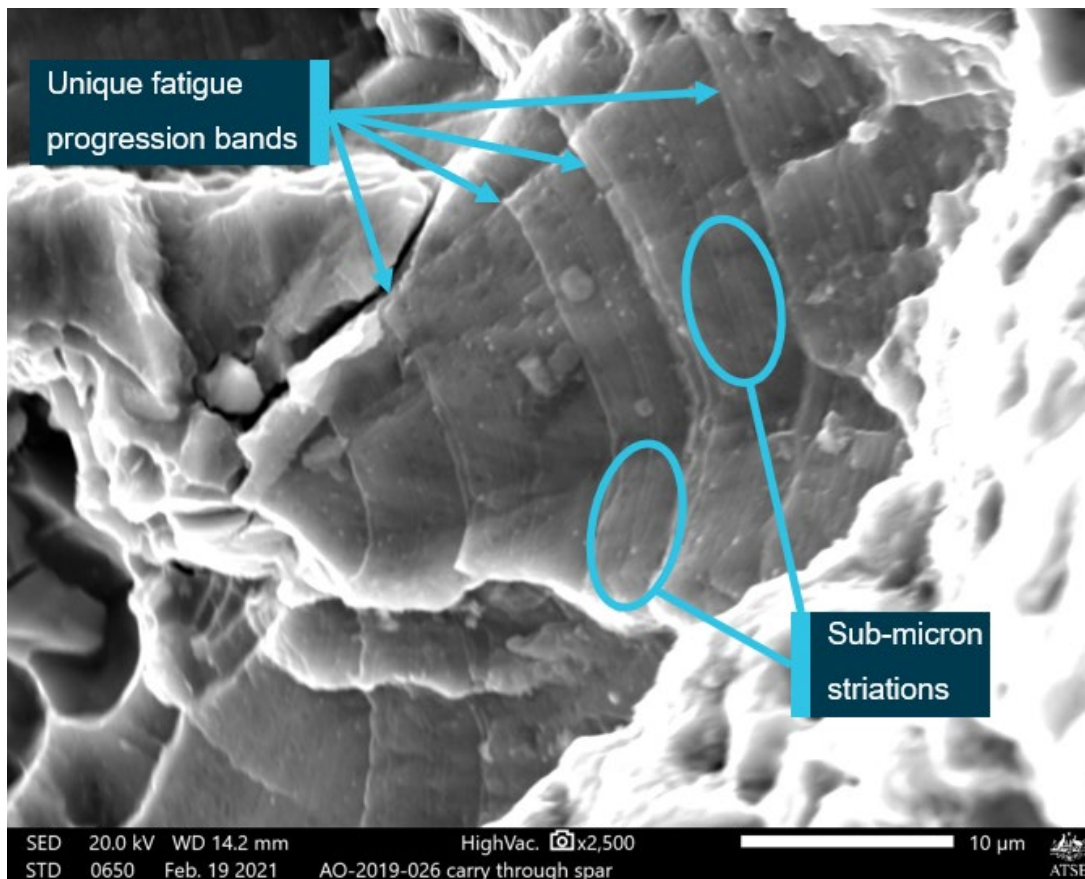
Figure 21: Scanning electron microscopy of the fracture surface

Distinct fracture morphologies (origin, fatigue and overstress) from the section of lower carry-through spar were confirmed via examination in the scanning electron microscope. SEM of the fracture origin identified that the corrosion pit damage that initiated the cracking was characterised by an amorphous corrosion product. The corrosion damage transitioned into an underlying zone of intergranular cracking at the base of the pit, before transitioning toward fatigue cracking. Other corrosion pits that were examined on the underside surface of the carry-through spar were also identified to have generated fine intergranular corrosion cracks that penetrated into the base alloy.

The fatigue portion of the fracture was a mixture of predominantly transgranular striations interspersed with some ductile tearing. The fatigue cracking was clearly identifiable through the presence of 'river' lines that were directed from a single region of corrosion pitting on the underside surface.

The overstress region was defined almost entirely by micro-void coalescence, features that confirmed that the final fracture was ductile in nature.

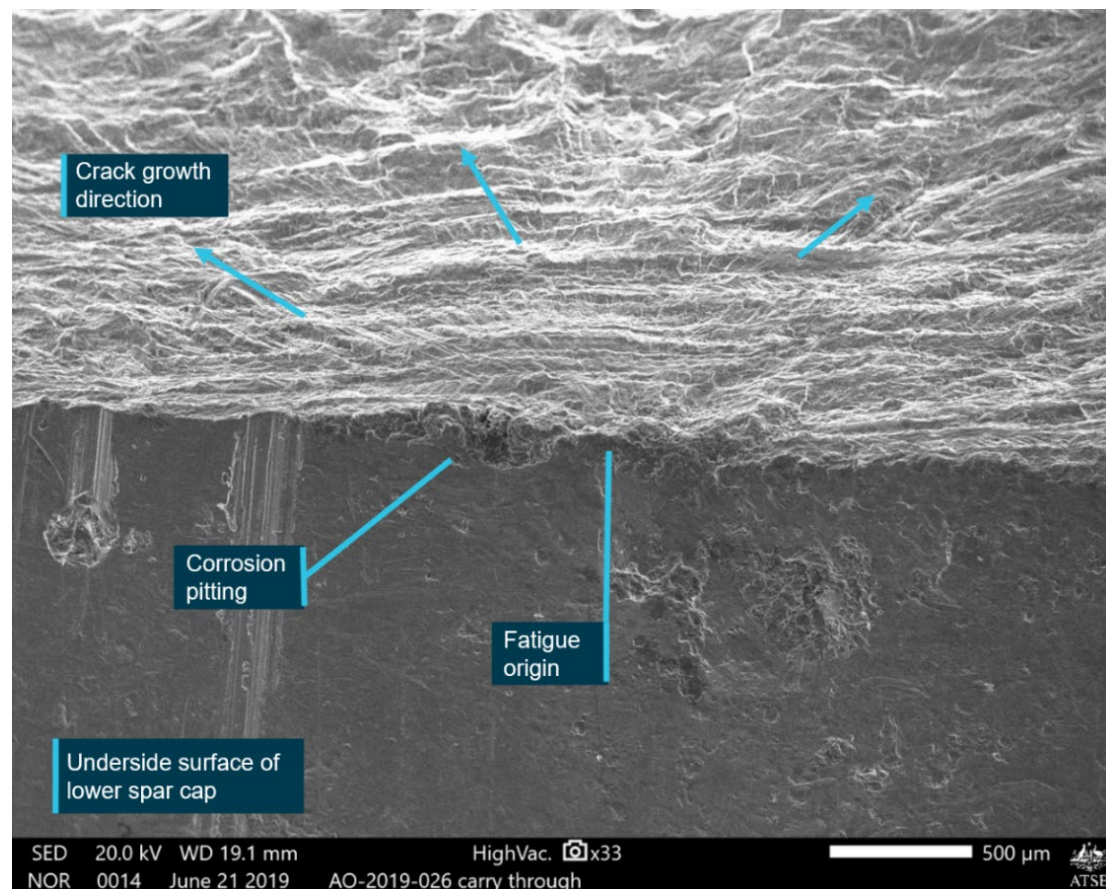
Figure A1: Scanning electron microscopy of the fracture surface, key features are identified at the fatigue crack origin

It was confirmed that the fatigue cracking initiated from a single corrosion pit cluster which then propagated through the structure from that location.

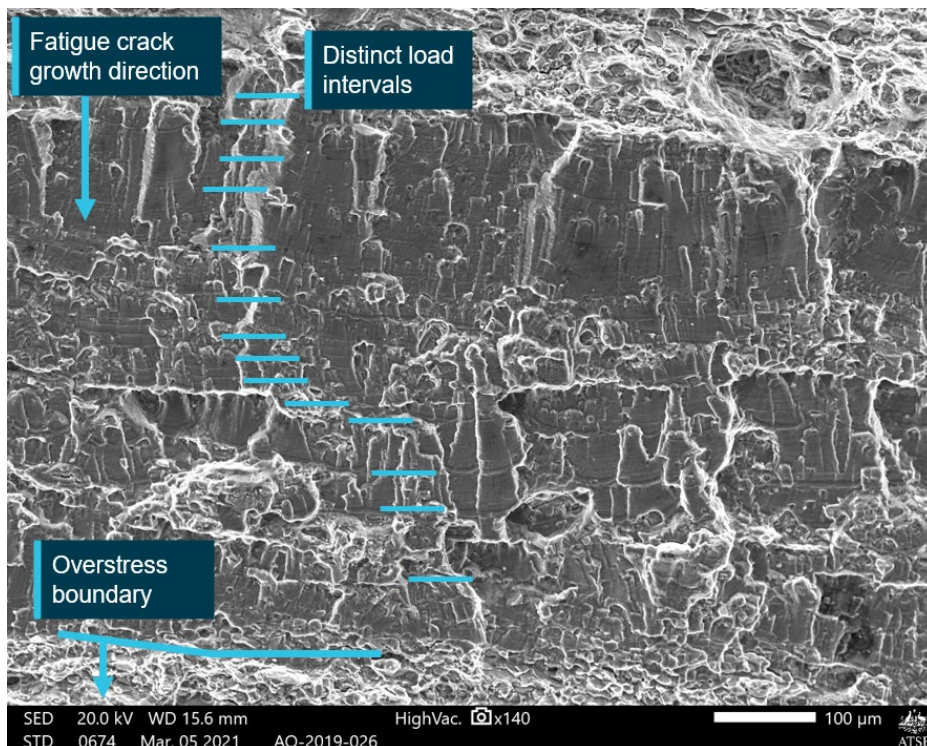
Figure A3: Scanning electron microscopy of the fracture surface close to the overstress boundary

Well defined distinct load intervals (or crack arrest marks) and striations were identified along the entire fatigue portion of crack growth up until the overstress fracture.

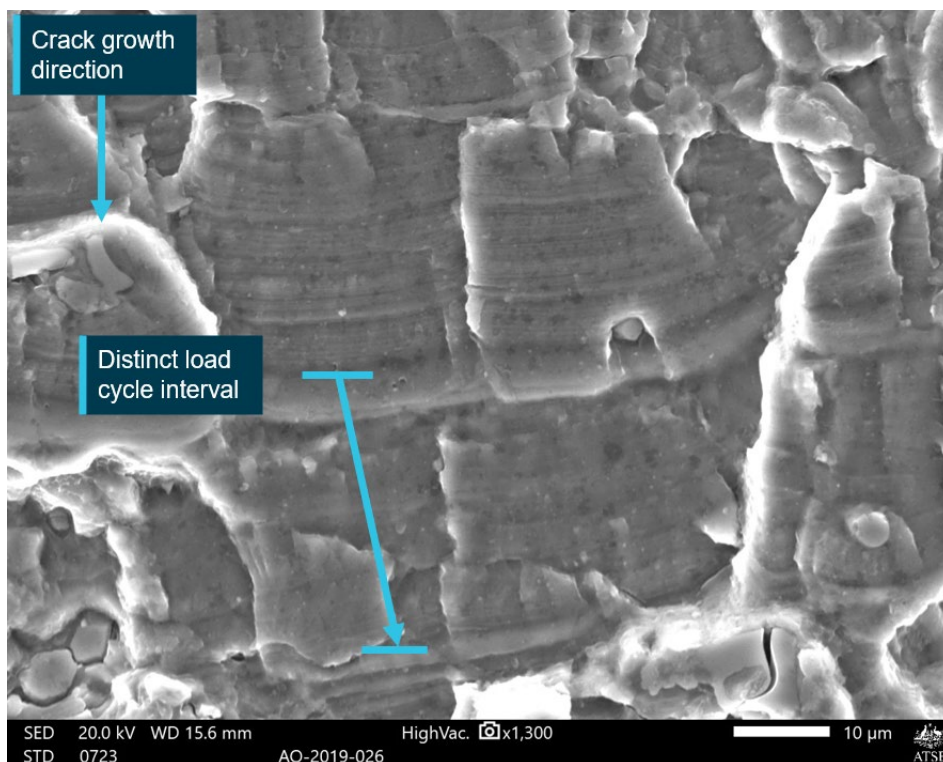
Figure A4: Scanning electron microscopy: closer view of the crack arrest marks near the overstress boundary

The distance between each distinct band indicates a distinct load interval that is probably a take-off and landing cycle.

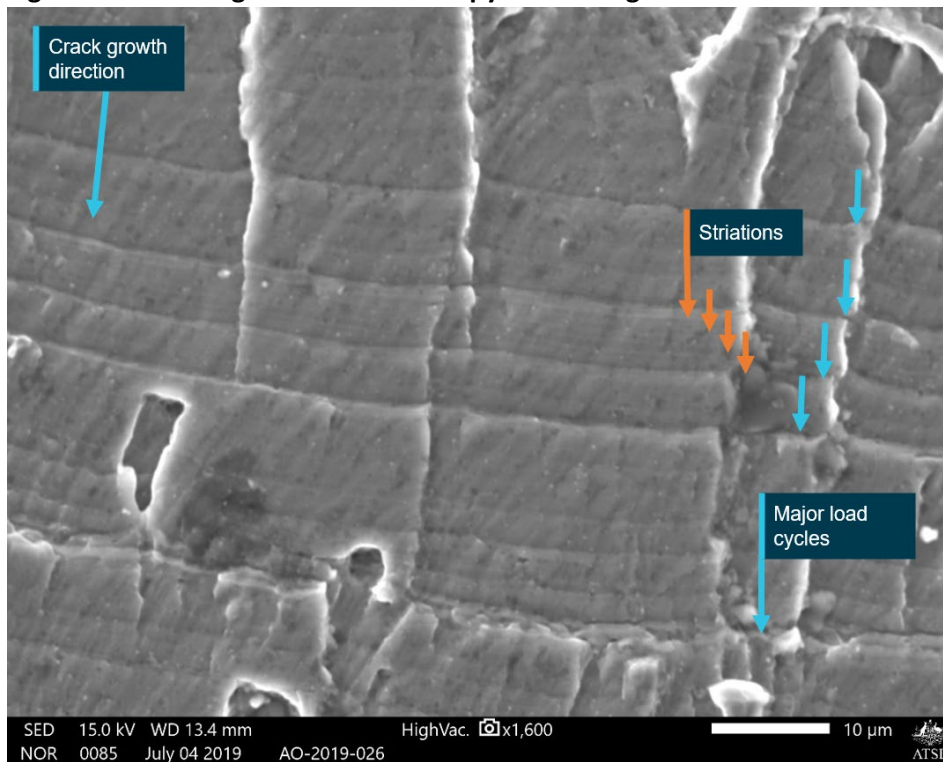
Figure A5: Scanning electron microscopy of the fatigue fracture surface

A combination of well-defined striations and arrest marks (major load cycles) were identified along the entire portion of the fatigue fracture.

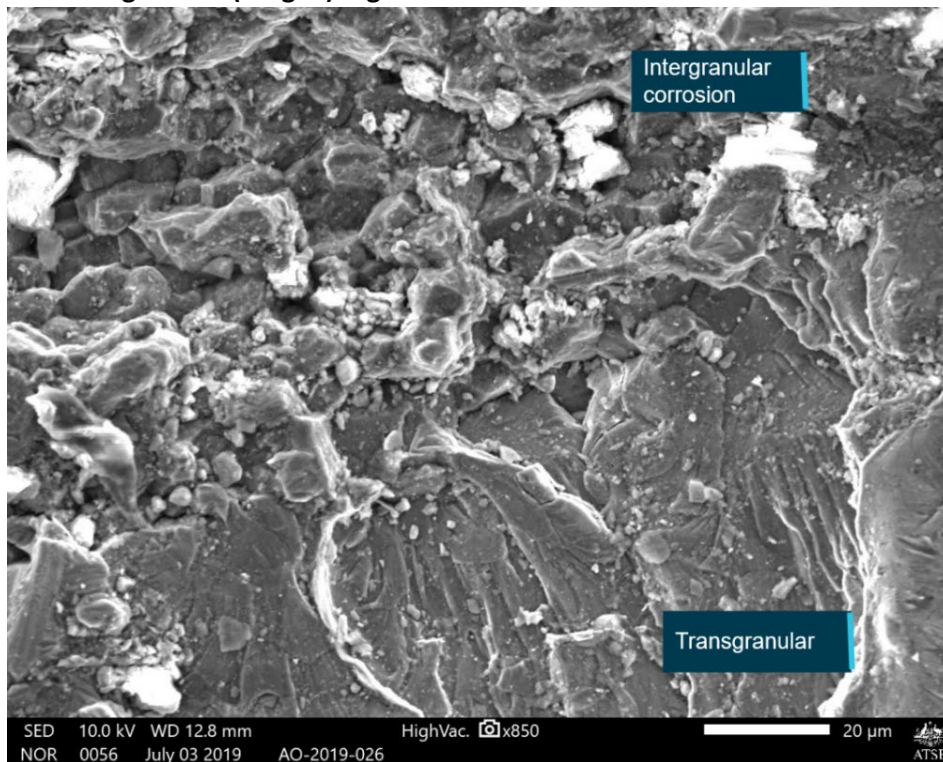
Figure A6: Scanning electron microscopy image near the crack origin identifying the intergranular and transgranular (fatigue) regions

The corrosion pitting led to intergranular corrosion and the subsequent development of transgranular fatigue cracking.

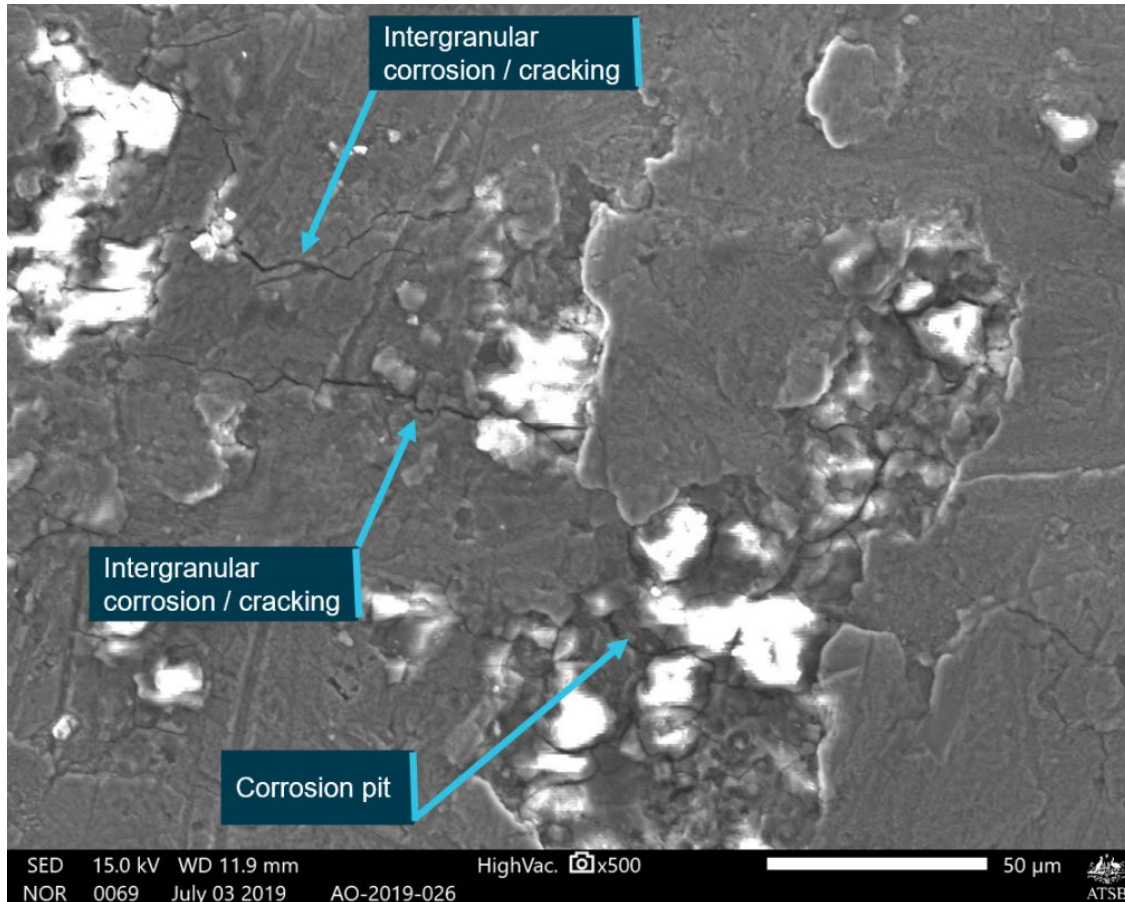
Figure A7: Scanning electron microscopy of the underside surface

Intergranular corrosion/cracking has initiated from the corrosion pits.

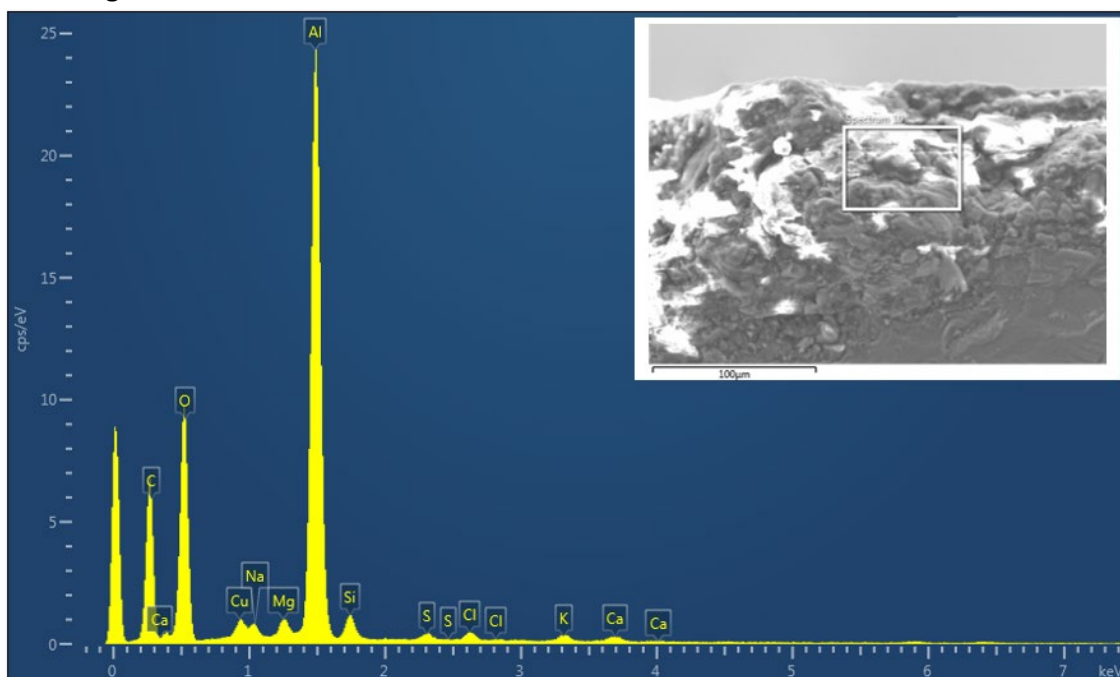
Figure A8: EDS spectra of the corrosion product within the base of the corrosion pit at the fatigue crack origin

The elements sodium (Na) and chlorine (Cl) were identified as a constituent of the corrosion product, along with the elements representative of the 2014-alloy.

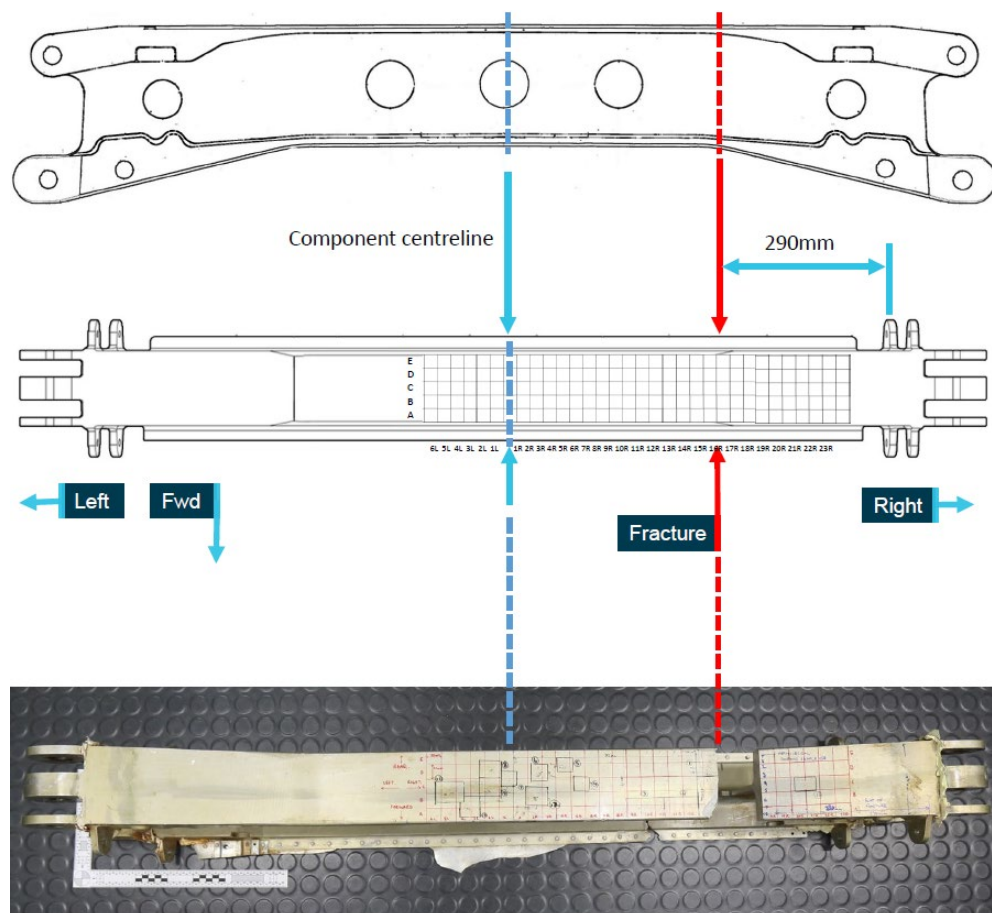
Figure A9: Mapping out and measuring the corrosion damage on the underside surface of the carry-through

Table A2: Pit depth measurement from the underside of the carry-through indicated a range of corrosion damage with a maximum measured depth of 0.30mm

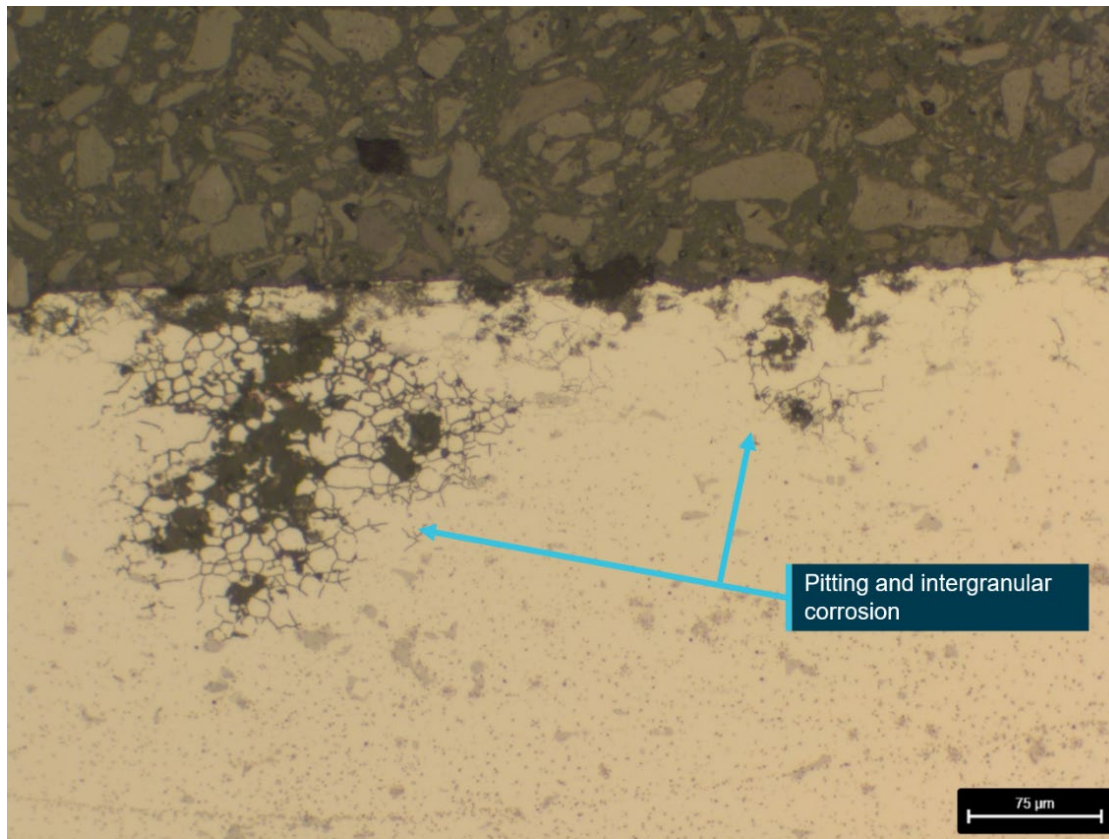
Figure A10: Metallurgical cross-section through a region of pitting damage from the carry-through spar

The corrosion has progressed from the underside surface. Intergranular corrosion has then developed within alloy surrounding the surface pits
