# Collision with terrain, Garlick Helicopters UH-1H, VH-HUE

24 km south-east of Talbingo, New South Wales, on 17 April 2018

Aviation Occurrence Investigation (Systemic)

AO-2018-031

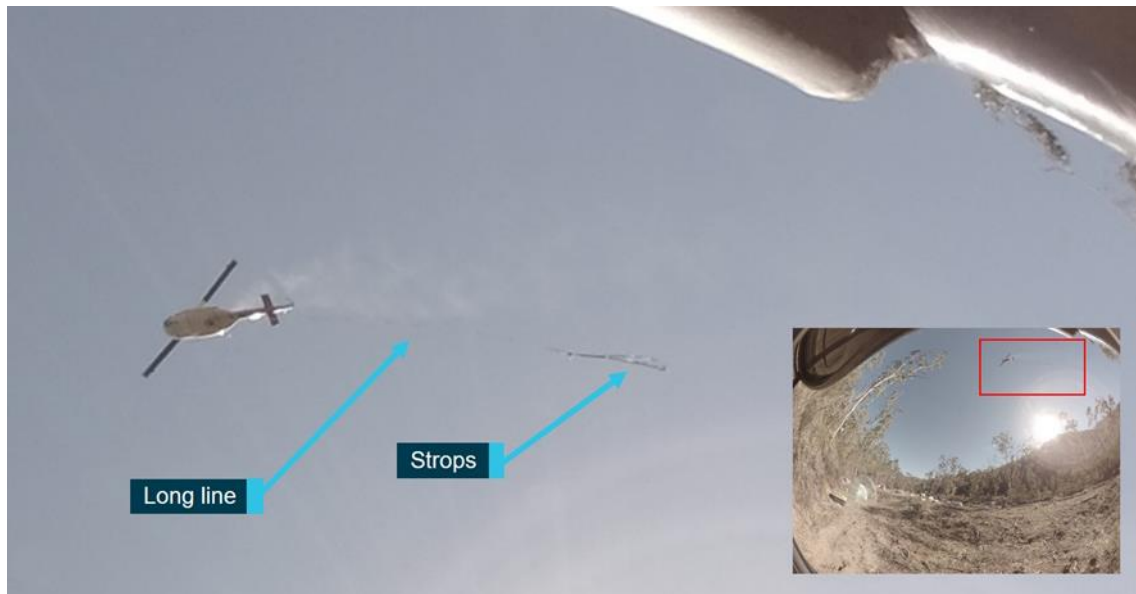
**Figure 3: Light coloured gas or mist from the helicopter above the drill site**

Just prior to the engine failure, HUE was about 200 to 250 ft above ground level, with a forward airspeed of about 20 to 25 kt, based on global positioning system (GPS) data, eye-witness reports, and the pilot reporting flying into a slight headwind. From fuel-burn calculations by the ATSB, the weight of HUE was estimated at 2,900 kg at that time.

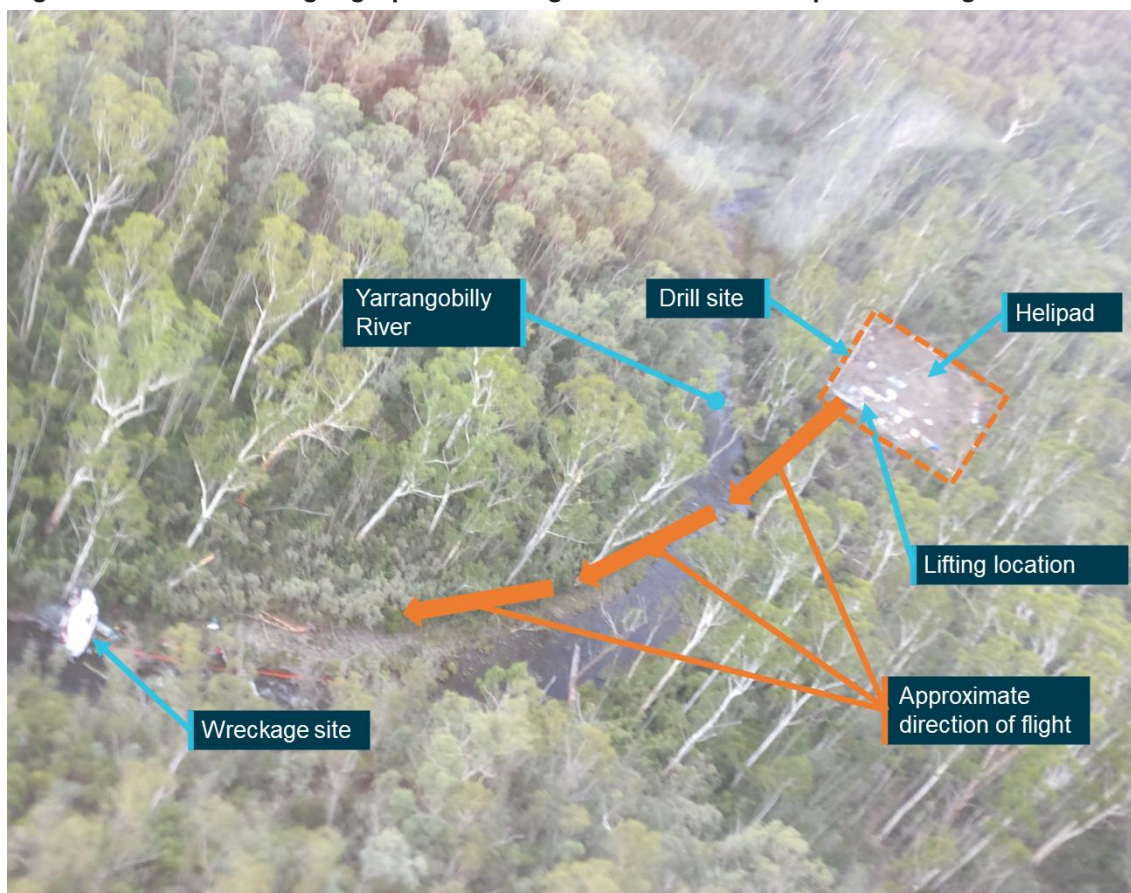
**Figure 4: Forced landing flightpath showing drill site and helicopter wreckage**

The pilot broadcast a ‘Mayday’<sup>3</sup> call and attempted to conduct the forced landing (autorotation) into the Yarrangobilly riverbed, south-west of the lifting area and the ground personnel. The workers observed the helicopter being turned to the south-west, away from the drill site.<sup>4</sup> They described the helicopter as appearing to ‘float’ over the trees, before descending quickly. Around this time, the pilot commanded jettison of the long-line and lifting strops. At interview, the pilot advised that the helicopter was flared prior to the impact with the second tree, but could not recall the remainder of the impact sequence until exiting the helicopter. The helicopter subsequently collided with trees and the riverbed (Figures 4 and 5). Ground personnel from the drill site immediately responded to the accident with fire extinguishers. They extinguished a small fire in the engine bay, removed the pilot from the wreckage, and performed first aid until emergency services arrived at 1520. The pilot sustained serious injuries and the helicopter was destroyed.

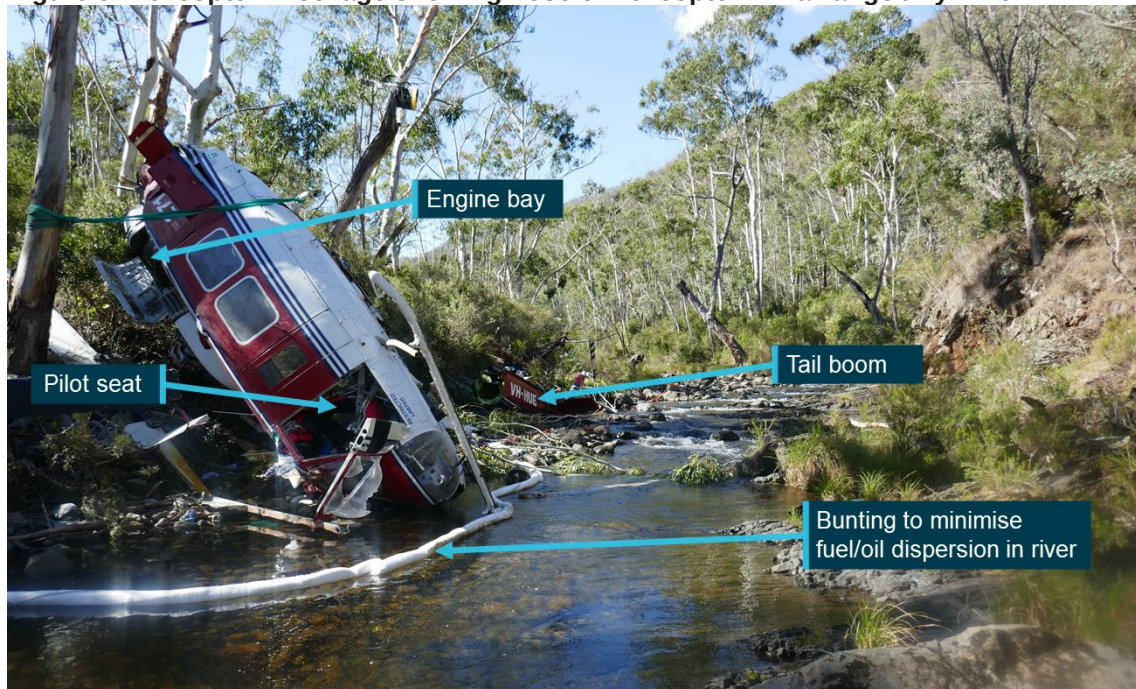
**Figure 5: Helicopter wreckage showing nose of helicopter in Yarrangobilly River**

Examination of the wreckage and ground impact marks indicated that the helicopter had impacted the ground in a nose high, slightly right side down attitude. The tail boom of the helicopter struck the ground during the impact, detaching from the fuselage. The landing gear assembly showed evidence of deflection during the main impact of the fuselage with the ground. The helicopter likely bounced off the skids, leading to the fuselage coming to rest in a nose low, slightly inverted position (Figure 5).

Note: Wreckage of VH-HUE looking upstream toward the drill site, showing the nose of the helicopter and pilot's seat.  
Source: ATSB

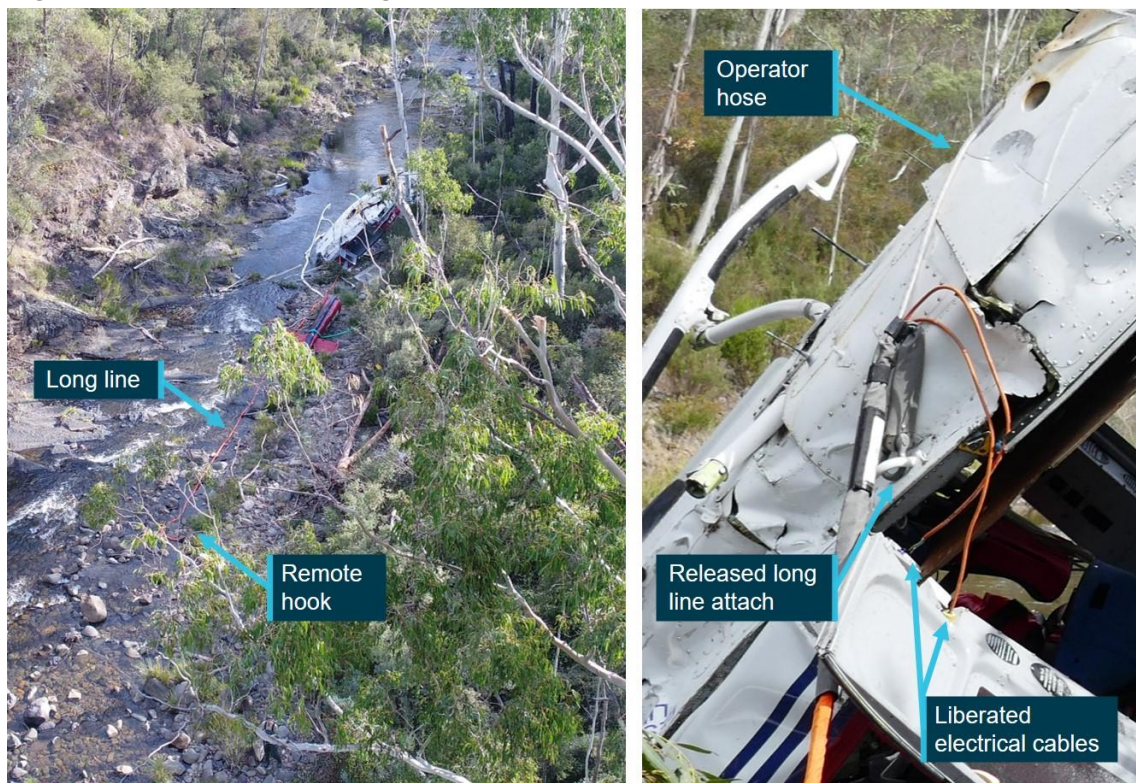
**Figure 6: Failed to detach long line**

For the lifting operations on the day of the accident, a 100 ft/30 m long-line was being used, with lifting strops attached at the remote hook. The site and wreckage examination revealed that, during the accident sequence, the long-line had detached from the belly hook, and the strops had released from the remote hook. This indicated that the long-line and strops were likely jettisoned during the accident sequence, as per emergency procedures. Although the pilot could not recall jettisoning the load, photographs confirmed that both the long-line and strops were attached to these hooks prior to the emergency, and the long-line did not appear to have snagged on any trees during the accident sequence. However, the long-line remained tethered to the fuselage due to the Sacksafoam hose line, which had failed to separate (refer to section titled *Retention of the long-line*) (Figure 6).

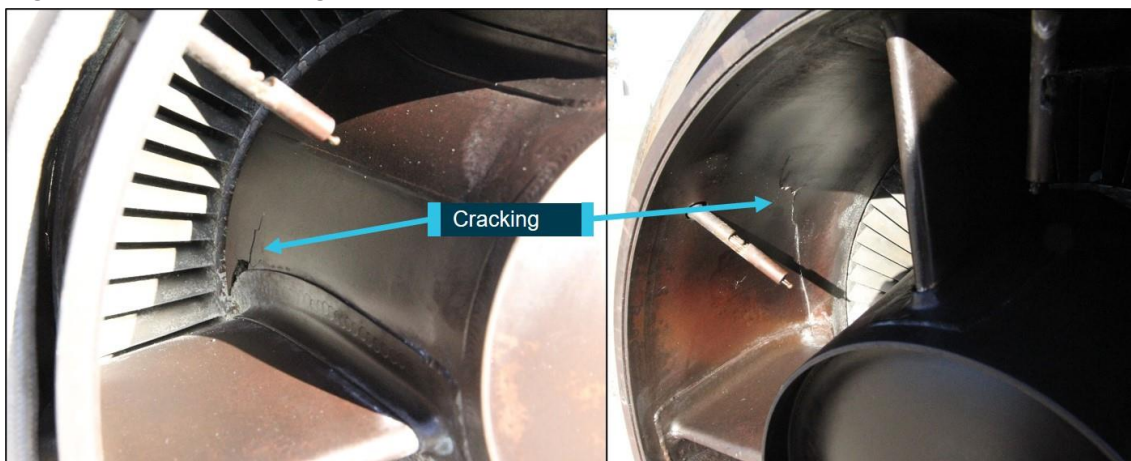
**Figure 7: Visible cracking in the exhaust diffuser area**

During the examination of the wreckage, the ATSB identified cracking and material loss visible in the exhaust diffuser area (Figure 7 and Figure 8). In addition, the exhaust diffuser cover attachment bolt was not lock-wired, as required by the US Army maintenance manual applicable to HUE (Figure 8). Examination of the engine, including the exhaust diffuser assembly is discussed in the next section.

This indicated that cracking and missing material on the inner cone of the exhaust diffuser, as observed by the ATSB after the accident, was likely visible during maintenance inspections prior to the accident. Further, Honeywell stated:

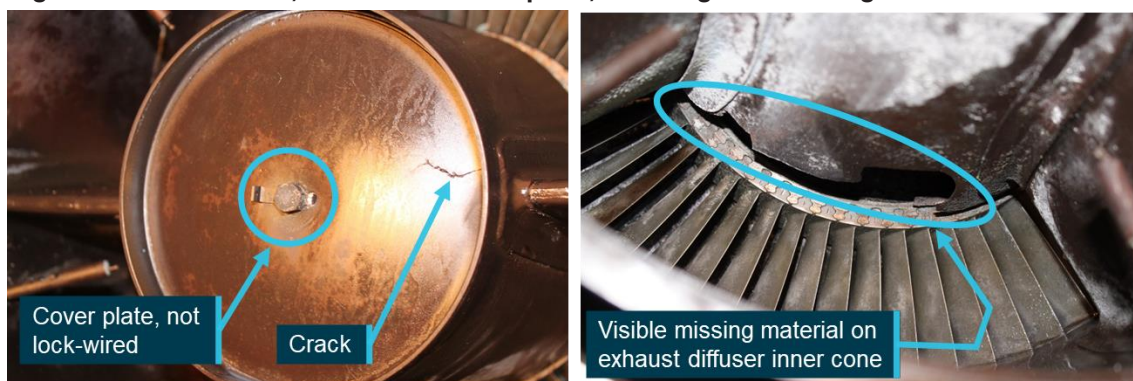
**Figure 8: Diffuser area, unsecured cover plate, cracking and missing material**

Empirical evidence suggests that the cracking develops and propagates over a considerable period of time, i.e. hundreds of operational hours. Therefore, it is believed that the exhaust diffuser cracking and material loss from the inner cone would have been visible during the most recent Phase Inspection performed 20.8 hours before the accident. Visual indications of cracking were likely present during the preceding phase inspection(s) as well. An investigation to assess and rectify the exhaust diffuser cracking would have necessitated the removal from service of the exhaust diffuser.

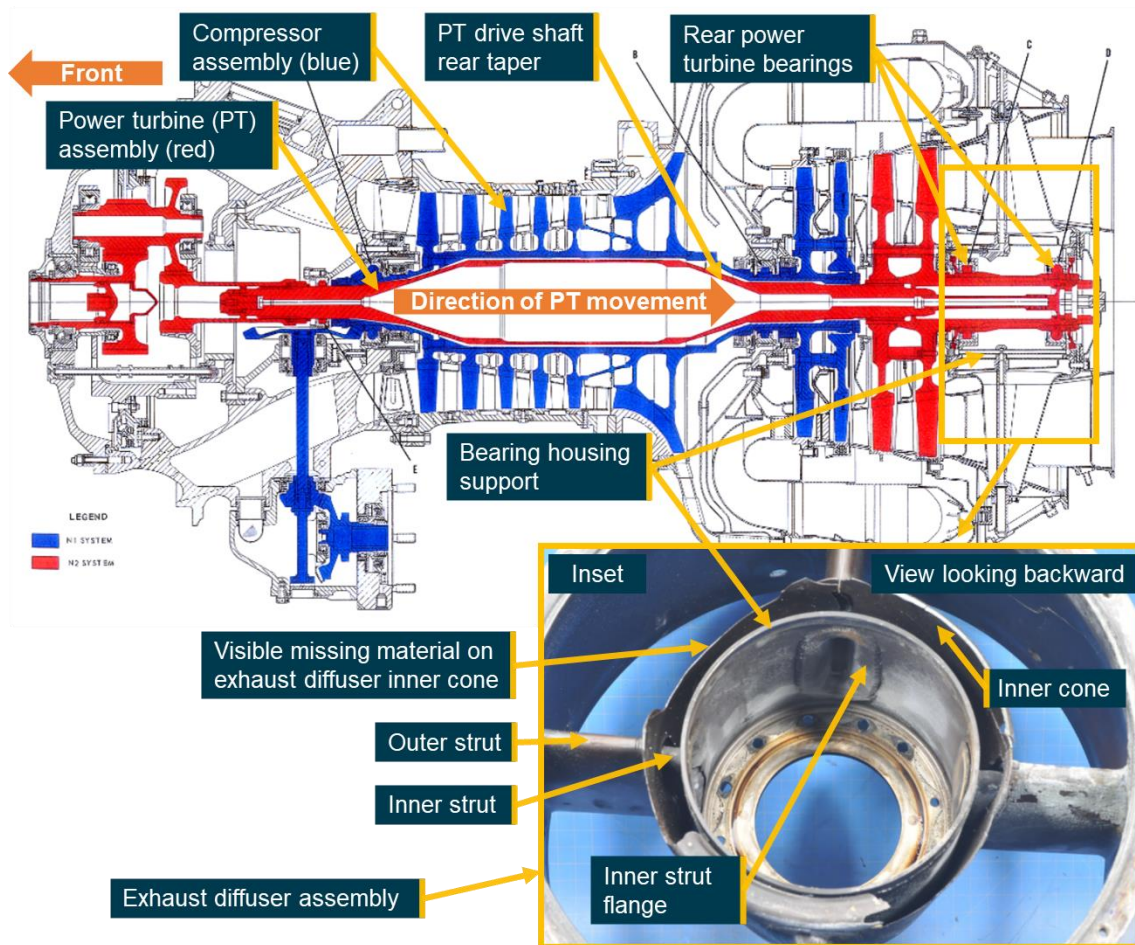
Figure 10: Illustration of T53 engine and exhaust diffuser inner cone (inset)

The Honeywell engine teardown identified extensive fatigue cracking in the exhaust diffuser inner struts (Figure 10 inset). The inner struts were a critical engine component that supported the rear of the power turbine assembly through the number 3 and number 4 bearings (Figure 10). Note for reference that Figure 10 (inset) shows missing material in the exhaust diffuser inner cone also shown in Figure 8. Honeywell identified the location of the cracking for each of the four inner struts:

- two of the four inner struts were separated around the full circumference of the inner strut flange welds
- another strut exhibited cracking around most of the circumference of the inner strut flange welds, although the inner strut remained attached to the inner cone by a small welded section
- one strut was separated through the strut with no visible weld separations.

The analysis by Honeywell determined that the cracking in the inner struts resulted in the complete loss of structural integrity of the four struts. This led to the power turbine assembly moving rearward, indicated by the arrow labelled 'direction of PT movement' in Figure 10. The rearward movement was sufficient for the rear tapered section of the power turbine drive shaft (labelled 'PT drive shaft rear taper') to contact the adjacent rear shaft of the compressor assembly, highlighted in blue. Due to the compressor and turbine assemblies rotating in opposite directions, the contact resulted in considerable friction, and deformation of the rear compressor shaft. This led to the compressor assembly contacting the walls of the engine case.

- the cracking in the strut/inner cone weld joints resulted from high-cycle fatigue emanating from multiple initiation sites along the inner edge of the weld bead, which was likely driven by power turbine vibration
- no material anomalies were observed
- the chemistry of the exhaust diffuser housing was indicative of the manufacturer's specified material
- the measured hardness of the strut, inner cone, and weld bead indicated that the assembly was heat treated subsequent to welding, as specified.

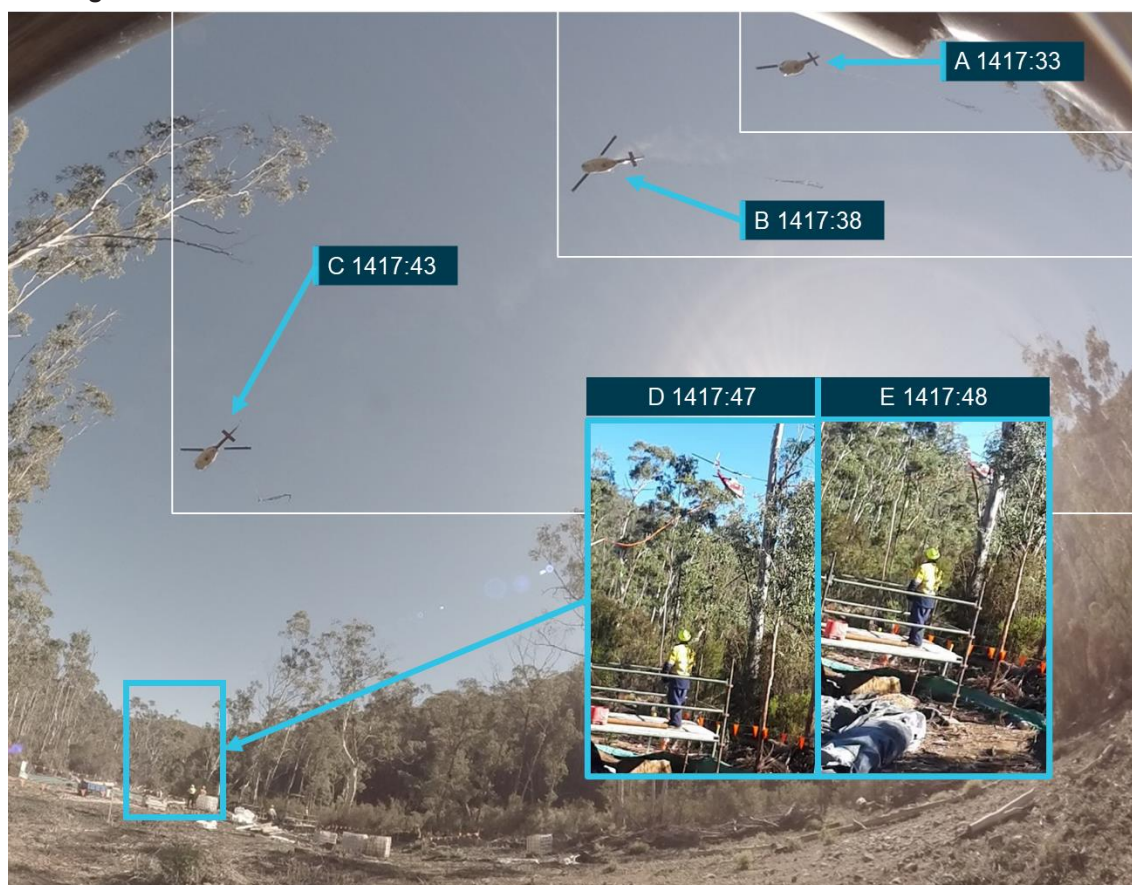
**Figure 13: Time-lapse composite showing helicopter engine failure location and forced landing**

The GPS data, time-lapse images (location shown in Figure 12), supplied camera footage from eyewitnesses and witness statements were evaluated to determine the sequence of events from the engine failure to the collision with terrain. At 1417:33, the helicopter was observed approaching the drill site (indicated by Figure 13 'A'). Following the loss of engine power (Figure 13 'B'), the aircraft started descending and began to accelerate (Figure 13 'C'). As the helicopter approached the line of trees at the end of the clearing, the helicopter had accelerated to about 40 kt and was close to the height of the tree canopy (Figure 13 'D' and 'E'). Around this time, GPS flight data indicated a notable shallowing of the descent profile.

The shallowing descent path was consistent with witness reports describing the helicopter as appearing to ‘float’ over the trees, and that it was not descending quickly until over the trees. Comparison of this glide performance with the published performance charts for HUE revealed this ratio was shallower than the autorotation range performance based on the speed and rate of descent. The pilot reported that, during this time the main rotor speed (RPM) became low. Audio analysis<sup>12</sup> by the ATSB using witness phone footage established that the main rotor speed was about 214 RPM as the helicopter passed over the first line of trees, about two-thirds below the optimal speed of 314 RPM. This suggested that the pilot increased collective pitch of the rotor system to avoid the line of trees prior to reaching the gap in the canopy created by the river below. The pilot stated during interview that the helicopter’s rotor system carried a lot of inertia, and as a result, elected to fly over the trees, knowing that the rotor speed would decay. The pilot’s response was consistent with guidance in the US Army operator’s manual, which stated that a ‘landing in trees should be made when no other landing area is available’. The reduction in rotor speed is a concern during an autorotation as this equates to energy available in the rotor system. As a result, the energy available to arrest the descent rate during landing or to cut through tree branches was reduced.

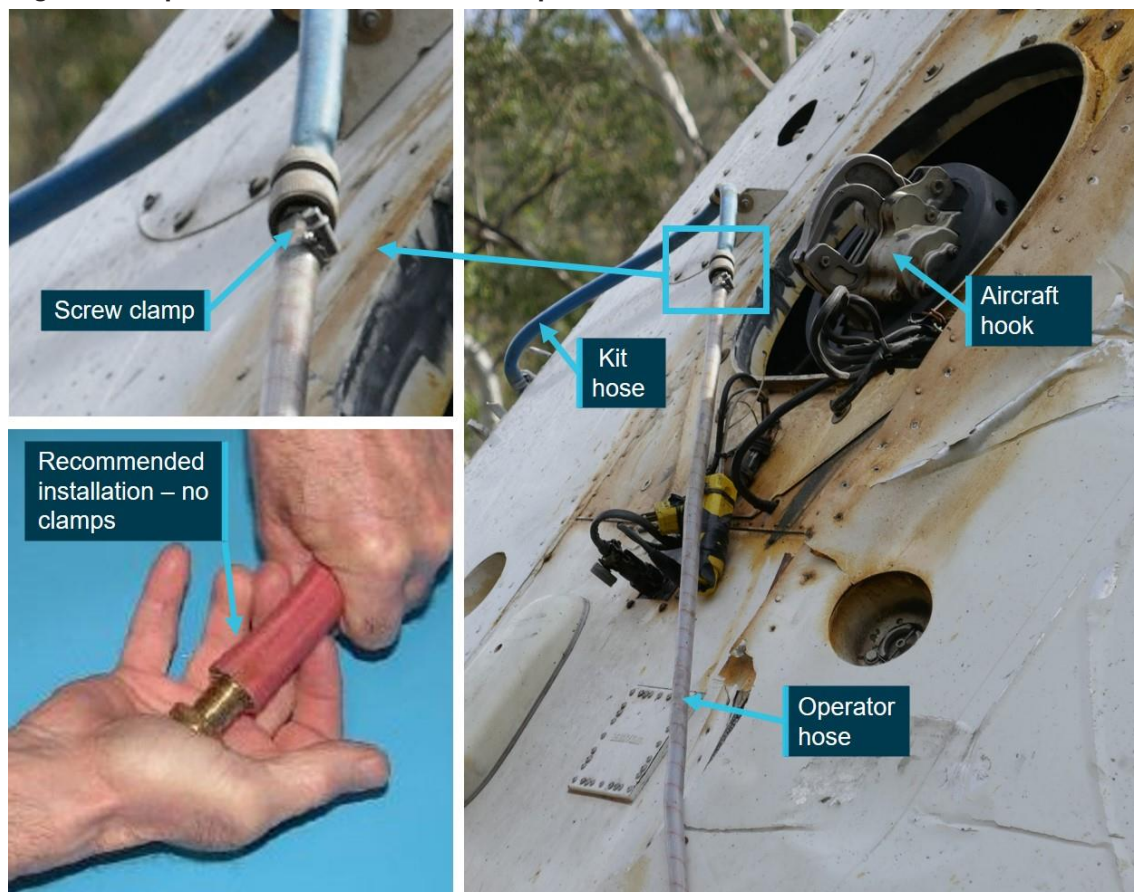
**Figure 14: Operator hose with screw clamp installed**

Although not contributory, the ATSB also found that a screw-clamp was retrofitted to the firefighting retardant delivery hose, which likely prevented the release of the long-line during the forced landing. While this did not influence the outcome of the accident, this had the potential of becoming snagged in trees and increase the severity of the impact.

The pilot reported that the screw-clamp had been fitted (Figure 14), in addition to the barbed fitting, to prevent the hose from 'popping', and leaking corrosive foam from the hose junction.

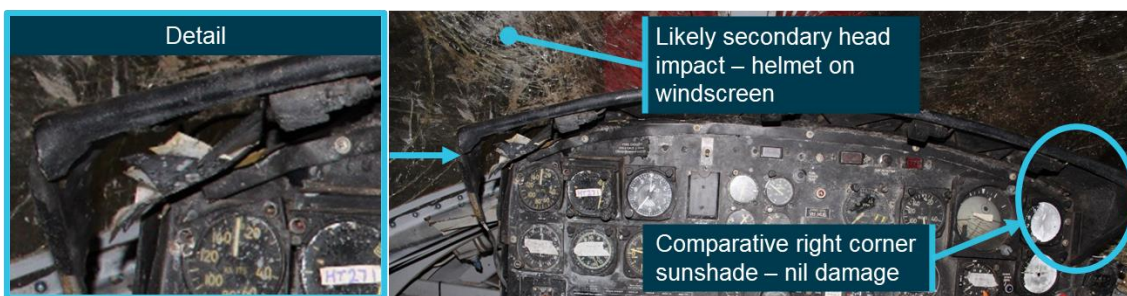
Figure 15: Interior instrument panel sunshade and windscreen damage adjacent to pilot

The left side of the instrument panel and sunshade were damaged, consistent with being pushed forward from within the cabin in front of the pilot's seat (Figure 15). For comparison, the right-side dash panel was undamaged. Although the windscreen exhibited extensive cracking, a localised concentration of damage was present in front of the left pilot seat, the position occupied by the pilot. The damage to the cockpit and injuries sustained were consistent with the pilot's upper torso flailing forward during the accident sequence, sufficient for the pilot's helmet and face to strike the instrument panel sunshade and windscreen.

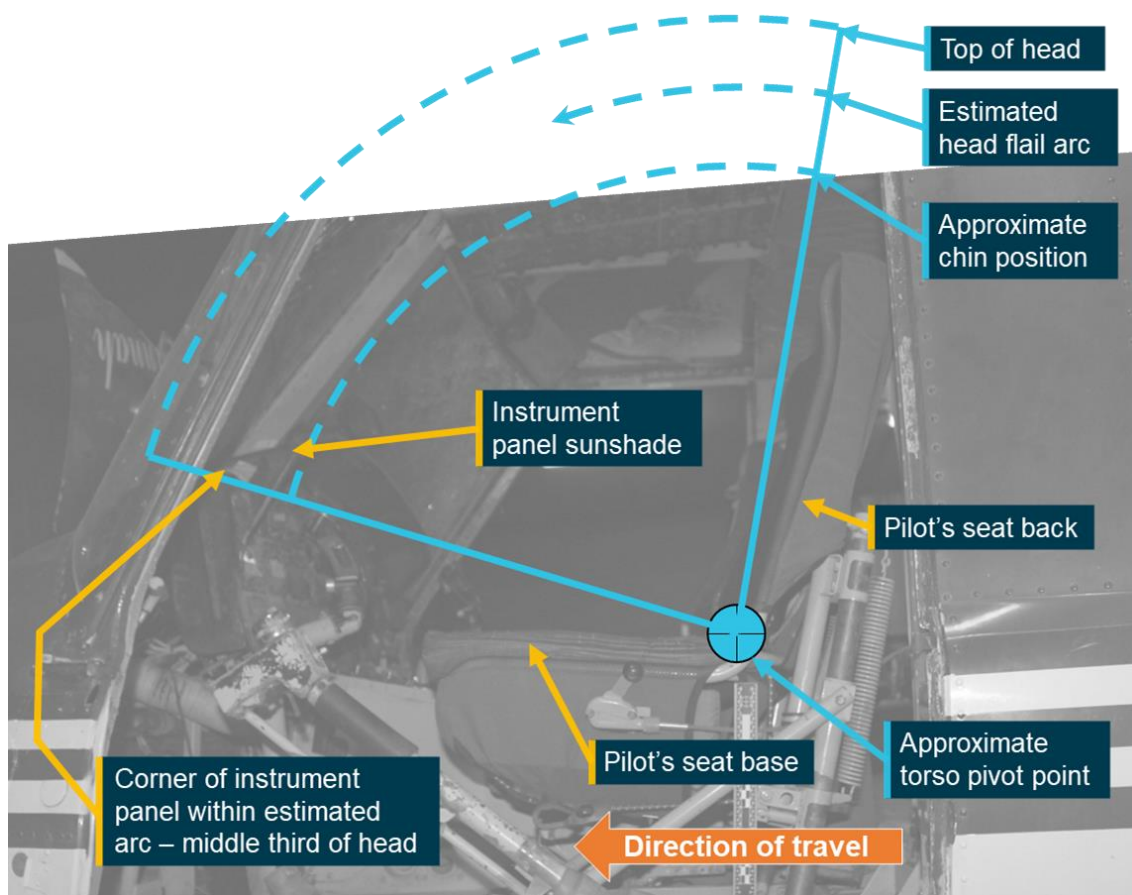
**Figure 16: Pilot seat and cockpit side view with circular arc based on pilot sitting height**

Figure 16 shows a head forward flail circular arc, which indicated that the pilot's head could contact the instrument panel and windscreen if restrained only by the lap-belt. Projections indicated the middle third of the pilot's head aligned with the instrument panel and sunshade.
