# Collision with terrain involving Air Tractor AT-400, VH-ACQ

80 km west-south-west of Moree, New South Wales, on 4 December 2021

## **ATSB Transport Safety Report**

AO-2021-052

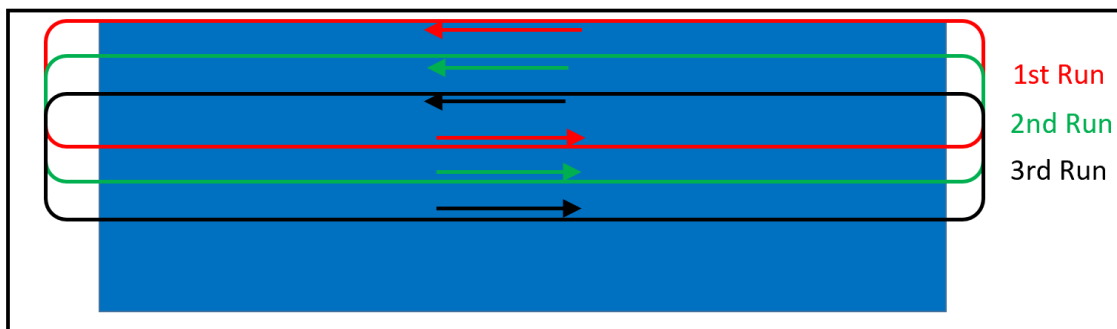
**Figure 1: Racetrack spray pattern**

The GPS tracker onboard the aircraft recorded data at 15-second intervals. The data showed that, commencing at 0632, the pilot conducted 8 spray loads within sight of the loader. For those loads, the pilot sprayed the areas using a racetrack pattern (Figure 1). Each of the 8 loads took about 20 minutes, except the third load, which took 32 minutes as it included clean-up spray runs (across the direction of the pattern) and tracking to the next target area. Each time the aircraft landed at the airstrip, the loader mixed chemical and water totalling 1,200–1,300 L into the hopper and on 2 occasions refuelled the aircraft tanks to full.

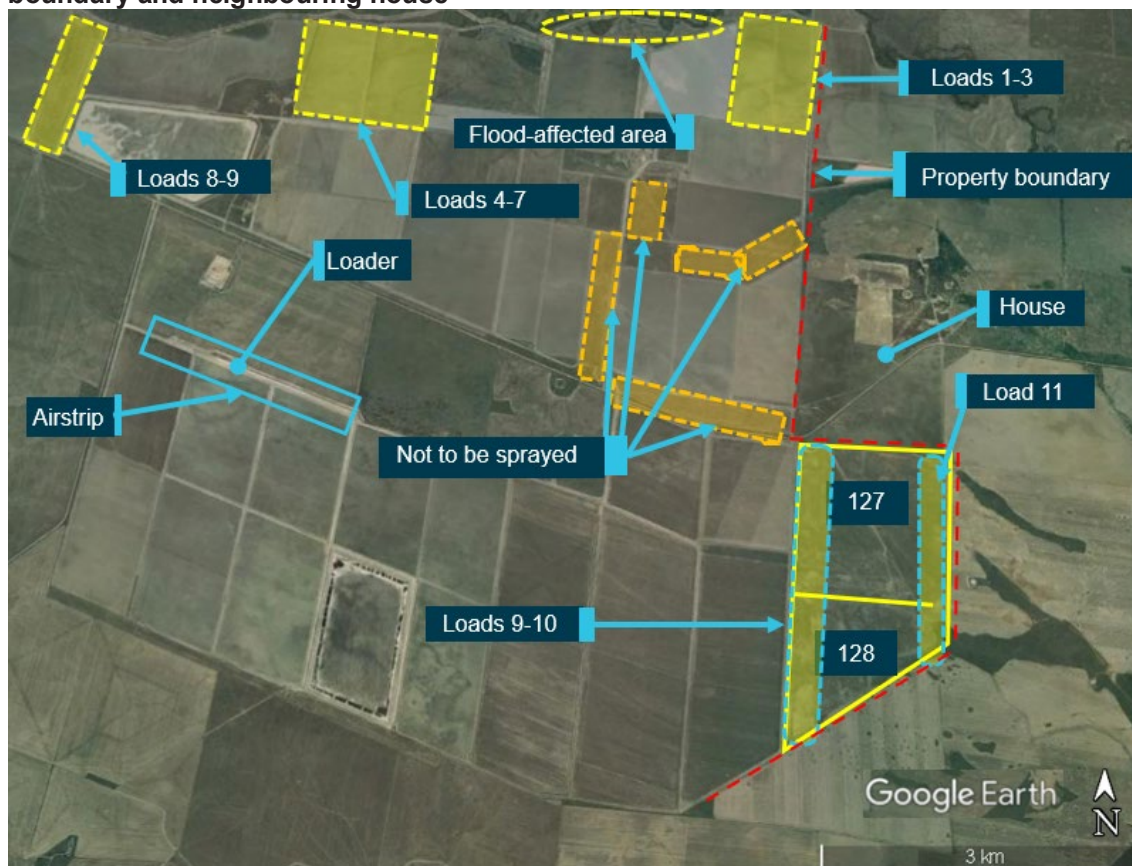
**Figure 2: Operating area including target spray blocks, location of airstrip, property boundary and neighbouring house**

At 0914, while the pilot conducted the seventh load, the operations manager sent the pilot a text message advising that 4 of the target fields marked on the map were no longer to be sprayed (marked in orange in Figure 2). On the next (eighth) load, the pilot overflowed an area marked on the map to be sprayed that day, which was adjacent to a river and under water due to flooding. As a result, the pilot radioed the operations manager to ask whether to spray the water-affected area. The operations manager reported that they contacted the property owner but were subsequently unable to communicate with the pilot via radio to provide a response.

During the ninth load, the pilot completed spraying the last of the target areas north (and within sight) of the airstrip, then flew to the field marked on the pilot's map as blocks '127' and '128' (Figure 2). Recorded GPS data showed that the pilot commenced spraying blocks 127 and 128 from the western side in a north-south racetrack pattern. After completing 4 patterns, the aircraft was returned to the airstrip and the loader transferred chemical into the hopper.

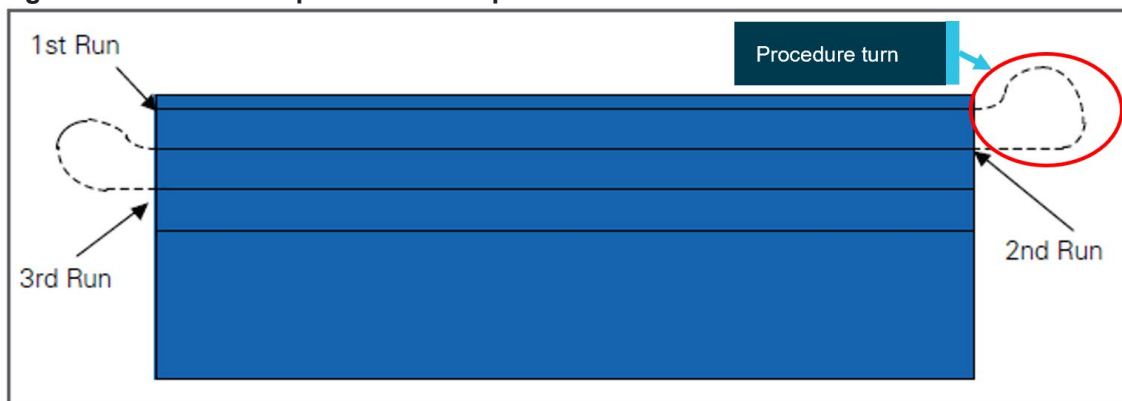
**Figure 3: Back-to-back patterns with a procedure turn**

A witness reported that, on the first run for that load, which was towards the south along the eastern boundary of the block, the pilot used smoke to assess the drift from the wind before commencing spraying on the next run. Instead of a racetrack pattern, the pilot conducted back-to-back spray runs with a procedure turn at each end (Figure 3), to position the aircraft on the reciprocal heading for the next spray run.

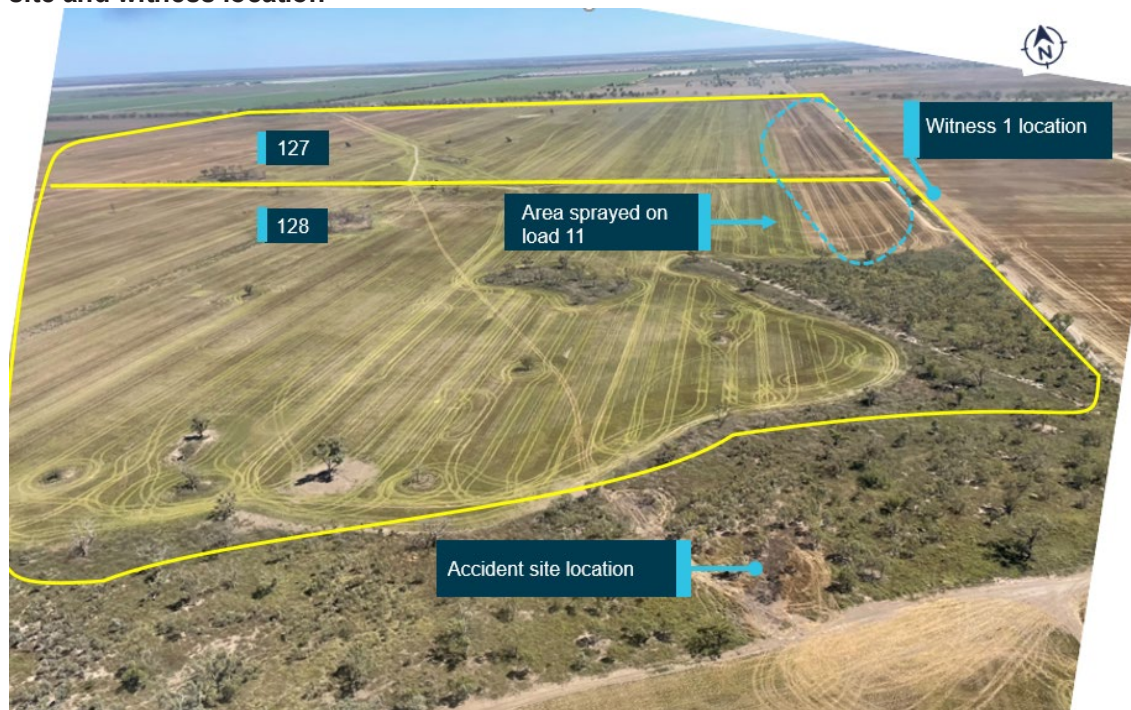
**Figure 4: Aerial photo of target spray area taken 10 December 2021, showing accident site and witness location**

The fourth run (on the eleventh load) to the south commenced at 1145. At the end of the spray run, the aircraft climbed. The last recorded position was at 1145:30 with the aircraft about 170 m beyond the southern end of the field and about 180 ft above the ground. A witness ('Witness 1', Figure 3) located in the neighbouring paddock to the east observed the aircraft enter a right procedure turn above trees. During the turn, the aircraft was observed to descend rapidly, right-wing down and disappear behind the trees (Figure 4). The witness reported seeing a black plume of smoke rise almost immediately afterwards.
