VFR into IMC and controlled flight into terrain involving Pilatus Britten-Norman BN2A, VH-OBL

98 km west-south-west of Hobart Airport, Tasmania, on 8 December 2018

ATSB Transport Safety Report

AO-2018-078

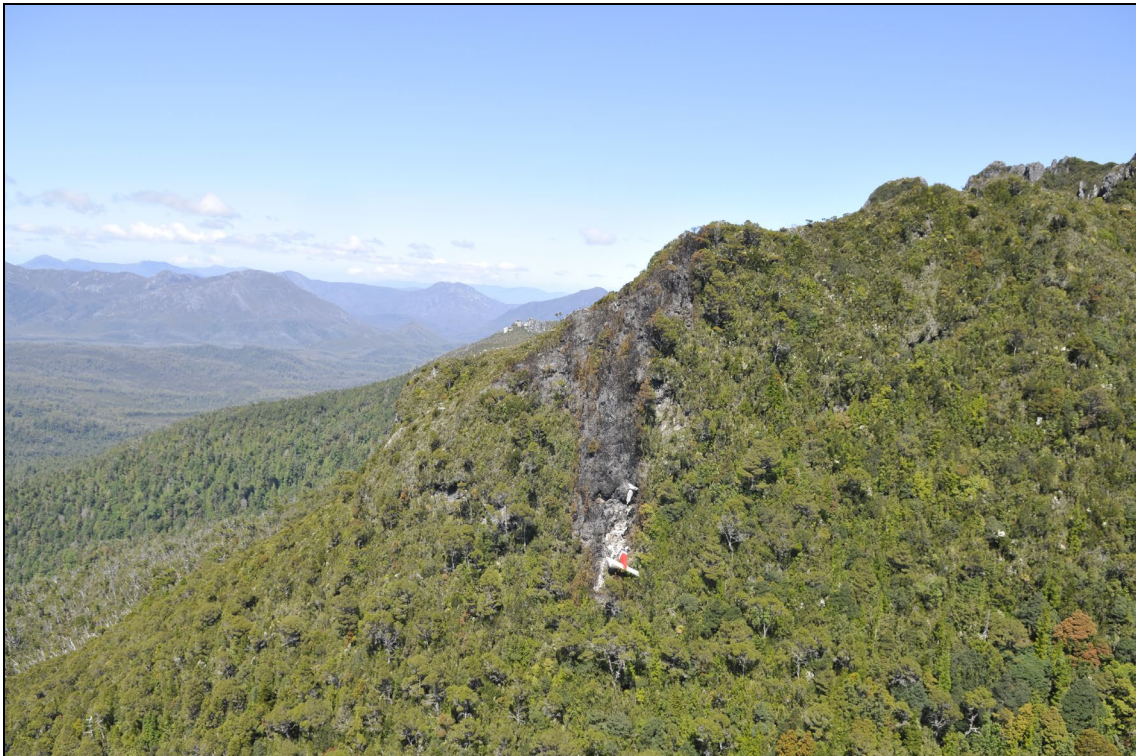
Figure 2: Accident location of VH-OBL in the Western Arthur Range

Multiple attempts were made throughout the day to locate the accident site, however, due to low-level cloud, and fluctuating weather conditions, the search and rescue operation was unable to confirm visual location of the aircraft until about 1900. The aircraft wreckage was found in mountainous terrain of the Western Arthur Range in the Southwest National Park (Figure 2) . The search and rescue crew assessed that the accident was unlikely to have been survivable.

The helicopter crew considered winching personnel to the site, however, due to a number of risks, including potential for cloud reforming, the time of day and lighting, and other hazards associated with the mountainous location, the helicopter departed the area. The aircraft wreckage was accessed the following day, when it was confirmed that the pilot was fatally injured.

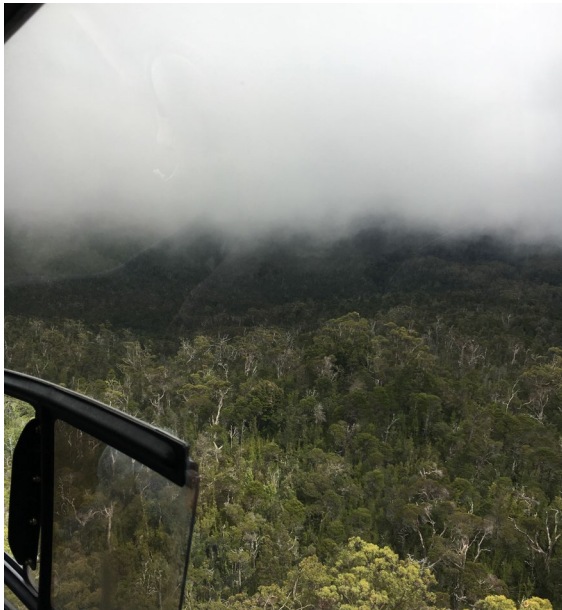
Figure 6: Photograph taken from the company helicopter in the vicinity of the accident location at about 1100

After being notified that one of their aircraft was missing, a helicopter pilot from Airlines of Tasmania flew to the site about 1.5-2 hours after the accident. The pilot reported that, on departure from Cambridge, it was looking like a nice day. However, when they arrived at the Arthur Range, the cloud base was initially down to the tree tops (Figure 6) at the portals and there was nil wind. The pilot reported that, it looked like there was light coming through the cloud and they tried to pass through the portals. However, they only got part way through before they encountered a 'wall of cloud' and had to turn back (Figure 6). The pilot spent over an hour trying to find a different way to enter the area where the emergency locator transmitter signal was detected, however, in each direction they were stopped by low cloud.

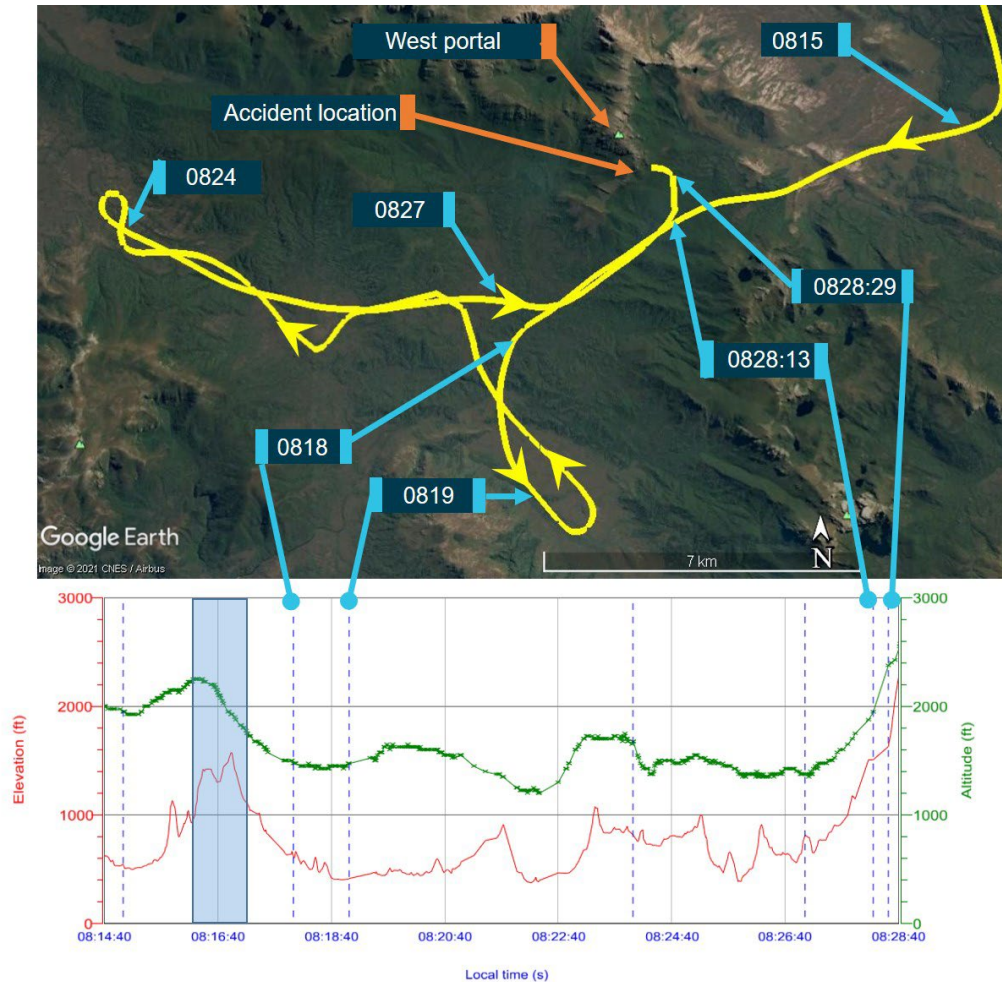
Figure 8: Aircraft track within the valley (yellow track) and height above ground level (lower graph)

- At 0828:29, the aircraft was observed turning toward the ridge of the Western Arthur Range. Over the next 7 seconds, the aircraft climbed about 50 ft at an approximate ground speed of 90 kt.

Note: The yellow line on the Google earth images shows the track of the accident flight. The lower graph shows the aircraft's altitude (green) compared with the elevation of the terrain (red), with the approximate location of the portals shaded blue.
 Source: Google earth, Aireon and GeoScience Australia, annotated by the ATSB

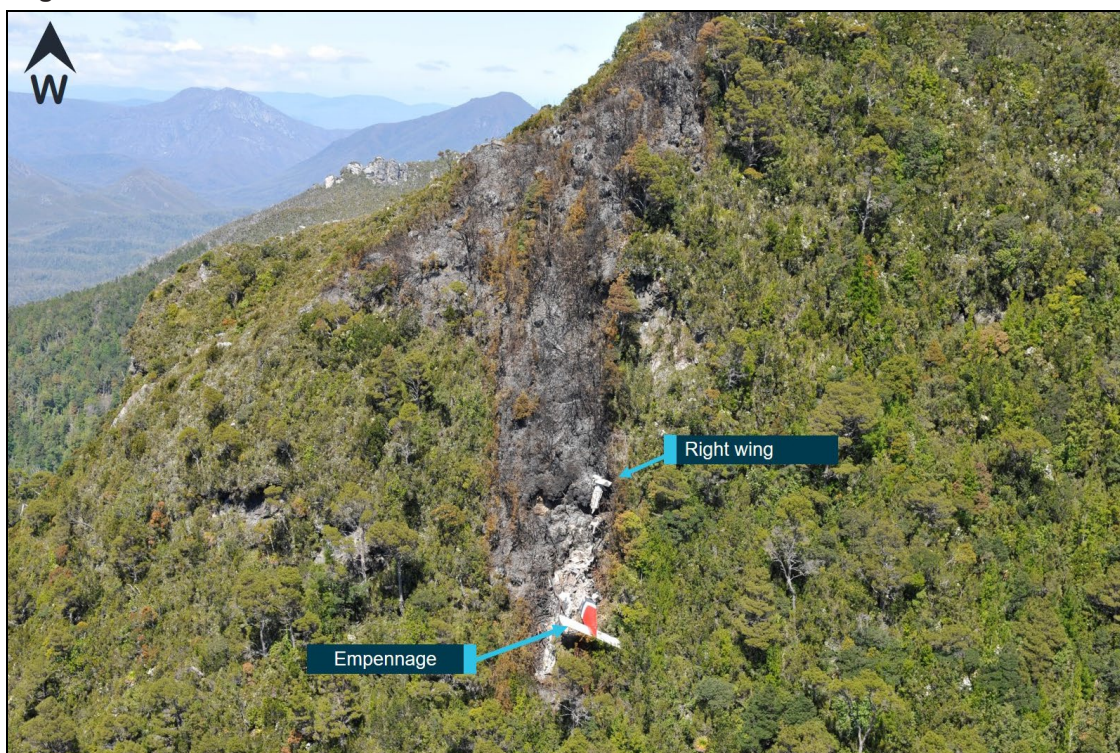
Figure 9: Accident site

The ATSB's review of the accident site photographs and statements by Tasmania Police officers, indicated that the aircraft impacted the terrain while heading in a westerly direction. The location of the wings in the photographs and the narrow line of fire damage indicated that the aircraft impacted the terrain in a relatively steep, left angle of bank. The aircraft was destroyed by the impact and a post-impact fuel-fed fire.

The empennage (tail) section of the aircraft was detached from the main wreckage and came to rest inverted, but appeared mostly intact and not affected by the post-impact fire.

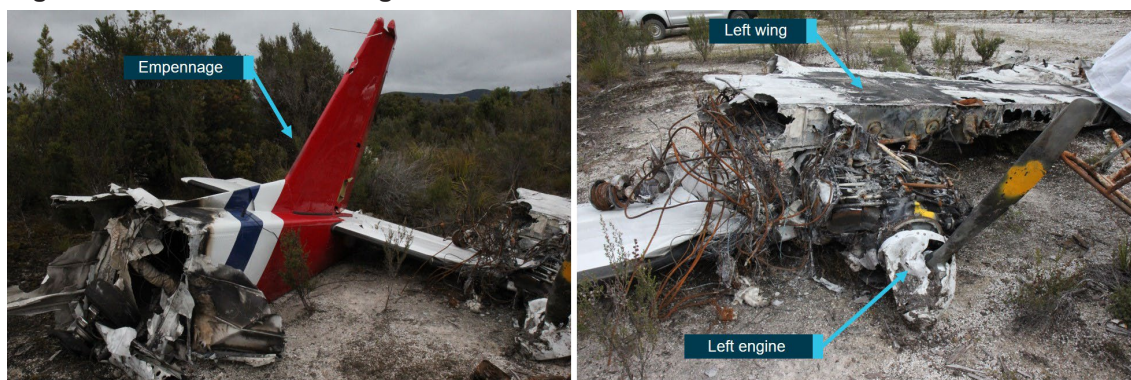
Figure 10: Recovered wreckage

The wreckage was removed from the accident site on 26 February 2019 and re-located to the National Parks and Wildlife depot at Lake Pedder. The ATSB inspected the wreckage on 8-10 March 2019. During the 3-month period between the accident and the ATSB's examination, the wreckage was subjected to the elements with no preservation. This, combined with the post-impact fire, severely degraded the available evidence as fracture surfaces and components were corroded.

Major components recovered from the site included the left and right engines and propellers, the empennage, about two-thirds of the left wing, the forward section of the fuselage, and a large number of small sections of the aircraft and various components (Figure 10).
