Collision with water involving Yakovlev Aircraft Factories Yak-52, VH-PAE

near South Stradbroke Island, Queensland, on 5 June 2019

AO-2019-027

Final – 24 February 2022

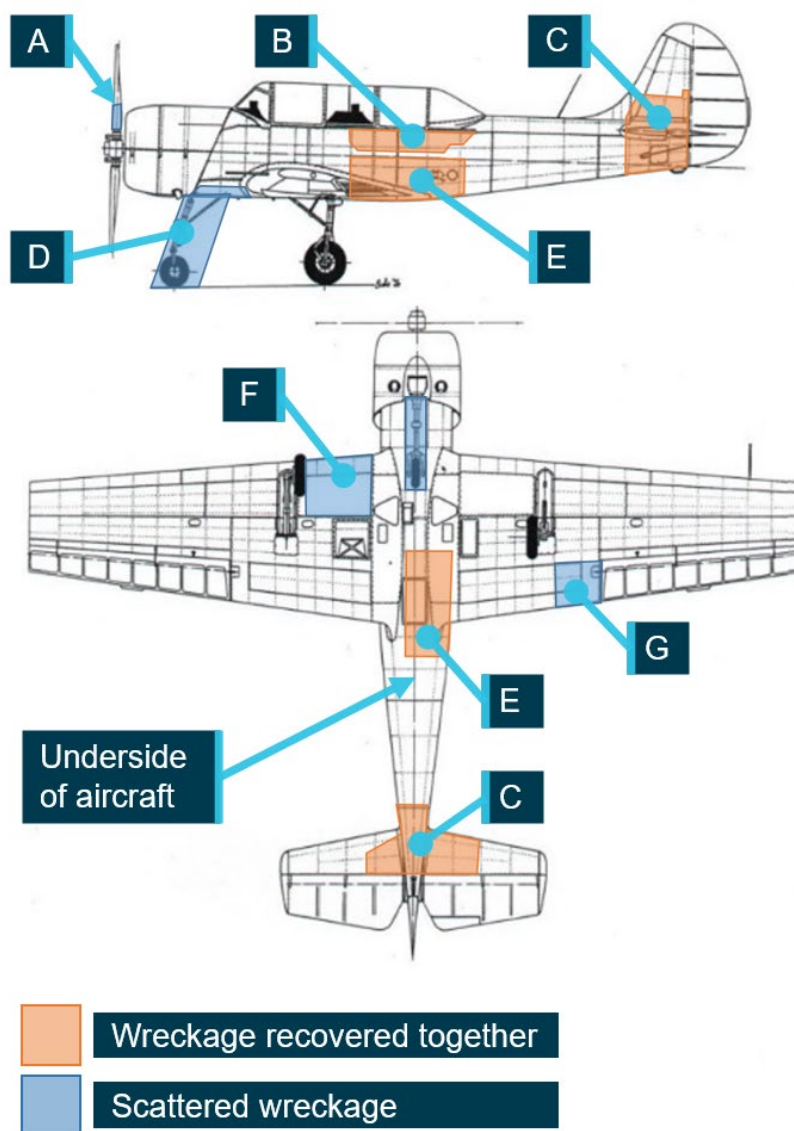
Figure 4: Shaded areas showing the wreckage recovered from VH-PAE

- the fuselage skin and structure from the left side of the rear cockpit (B)
- the tail section consisting of the rear fuselage and the inboard sections of the horizontal and vertical stabilisers (the tail section was found attached to the rear cockpit by the flight control cables) (C)
- the nose landing gear, its associated components and mounting structure (this structure formed the floor of the front cockpit and included the front cockpit rudder pedals) (D)
- a number of components from the front and rear cockpits, with the rear cockpit in place but significantly disrupted (E)
- a section of the right wing inboard leading edge (F)
- a section of the left-wing trailing edge adjacent to the aileron (G).

In addition, a seat cushion base and back, and the pneumatic system main and emergency storage tanks were also recovered.

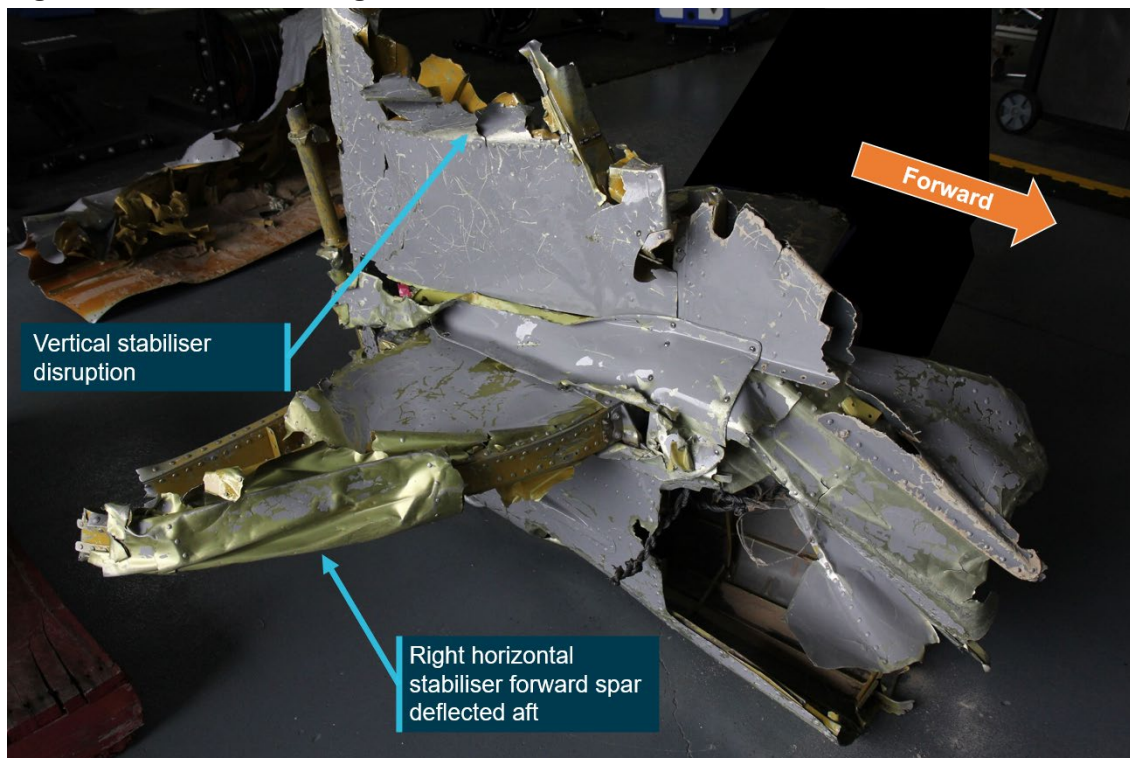
Figure 5: Tail section damage

Examination of the tail section of the aircraft found the right horizontal stabiliser was extensively damaged with its forward and rear spars bent rearwards and stabiliser skin torn away from the structure (Figure 5). The centre hinge for the elevator was bent inboard. The left horizontal stabiliser had tearing mid-span, but otherwise it retained its original form. The vertical stabiliser was extensively damaged with most of its upper section missing. Further, the wreckage examination identified two small cracks on either side of the elevator bellcrank at a change in section (refer to section titled *Bellcrank examination*).

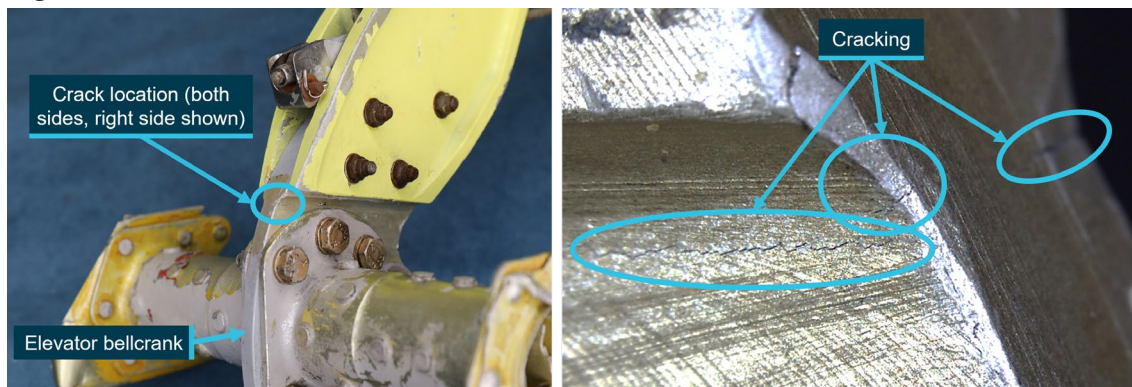
Figure 6: Elevator bellcrank cracks observed on VH-PAE

The elevator bellcrank is primarily loaded in the vertical plane and transmits the forward and rearward pilot inputs on the control column through the cables to control elevator movement. The ATSB's initial examination of the elevator bellcrank identified two small cracks on either side at the location identified in previously published airworthiness directives (refer to section titled *Airworthiness requirements*) (Figure 6). The larger crack on the right side (aft looking forward) was relatively straight and extended about 3 mm across the rear face of the bellcrank and 10 mm along the side. A number of small indents were observed in the region of the crack. Closer examination of the crack on the left side revealed that it was two smaller cracks. One crack was located on the rear face corner, extending about 1 mm each direction, and the other followed the machined radius and extended for about 7.5 mm.

In order to perform further analysis on the cracking, the bellcrank was fractured to examine and categorise the cracks. This examination identified that the smaller cracks on the left (aft looking forward) showed features consistent with fatigue and were likely present prior to the accident. The larger crack's features were predominantly consistent with overstress as a result of the accident.

A chemical analysis of the bellcrank found it had been manufactured from AK-4 aluminium alloy, which may have been an earlier specification due to the age of the aircraft. The most recent design specification was for the bellcranks to be manufactured from AK-6 aluminium alloy. The radius at the change in thickness from the inner to the outer section of the bellcrank was relatively consistent with that specified on the supplied engineering drawings from the manufacturer.

In consideration of the minimal awareness of the service bulletin, the ATSB issued a safety advisory notice ([AO-2019-027-SAN-024](#)) on 25 November 2020. The purpose of the notice was to remind maintainers and operators of the importance of dye penetrant inspections to identify and remove defective bellcranks from service. The notice also noted that Russia, as the aircraft's state

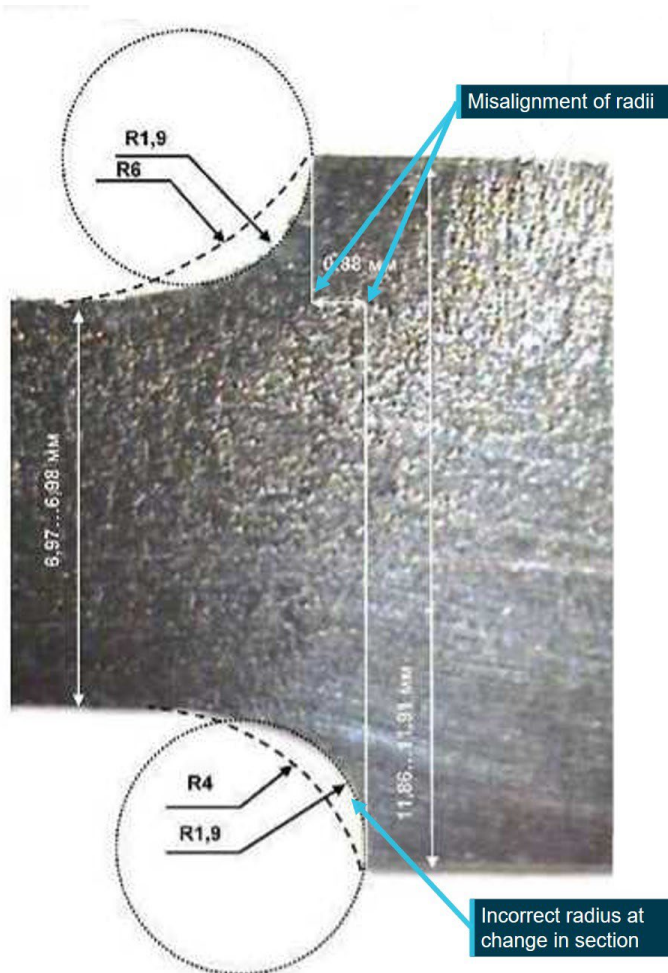
Figure 7: The bellcrank from the Yak-52 involved in the 2010 Yekaterinburg accident showing misalignment of the radii and incorrect radius at the change in section

An examination of the wreckage found that the elevator bellcrank had fractured through the inner section, adjacent to the change in section from the inner to the outer section (see *Appendix - Photographs of the elevator bellcrank from the 2010 accident*). Examination of the fracture surface showed it was consistent with a fatigue failure. The bellcrank was found to have been correctly manufactured from AK-6 aluminium alloy according to the design specification for this aircraft having been manufactured in 1990. The paper concluded that high operational cyclic stresses had influenced the development of the fatigue crack, along with multiple aspects relating to the manufacture of the elevator bellcrank including:

- a radius at the change in section (thickness) on the bellcrank was smaller than that specified in the engineering drawings
- when manufactured, the radii on either side of the bellcrank were incorrectly aligned (Figure 7)
- an unfavourable (lateral) microstructure orientation¹⁸
- rough machining surface at the crack origin.

As a result of the Yekaterinburg fatal accident in 2010, Yakovlev issued a letter in 2011 reiterating the requirement for dye penetrant inspections of the elevator bellcrank every 25 ± 5 flying hours, and for the aluminium alloy bellcranks to be replaced with bellcranks manufactured from 30KhGSA (30XГСА) specification steel.

In 2012, Yakovlev issued service bulletin 121-BD (121-БД), which required all remaining aircraft with aluminium alloy bellcranks to be replaced with steel bellcranks no later than December 2012. The dye penetrant inspection interval of 25 ± 5 flying hours, as specified by amendment 2 of the Yak-52 scheduled maintenance program, remained in place for steel bellcranks.

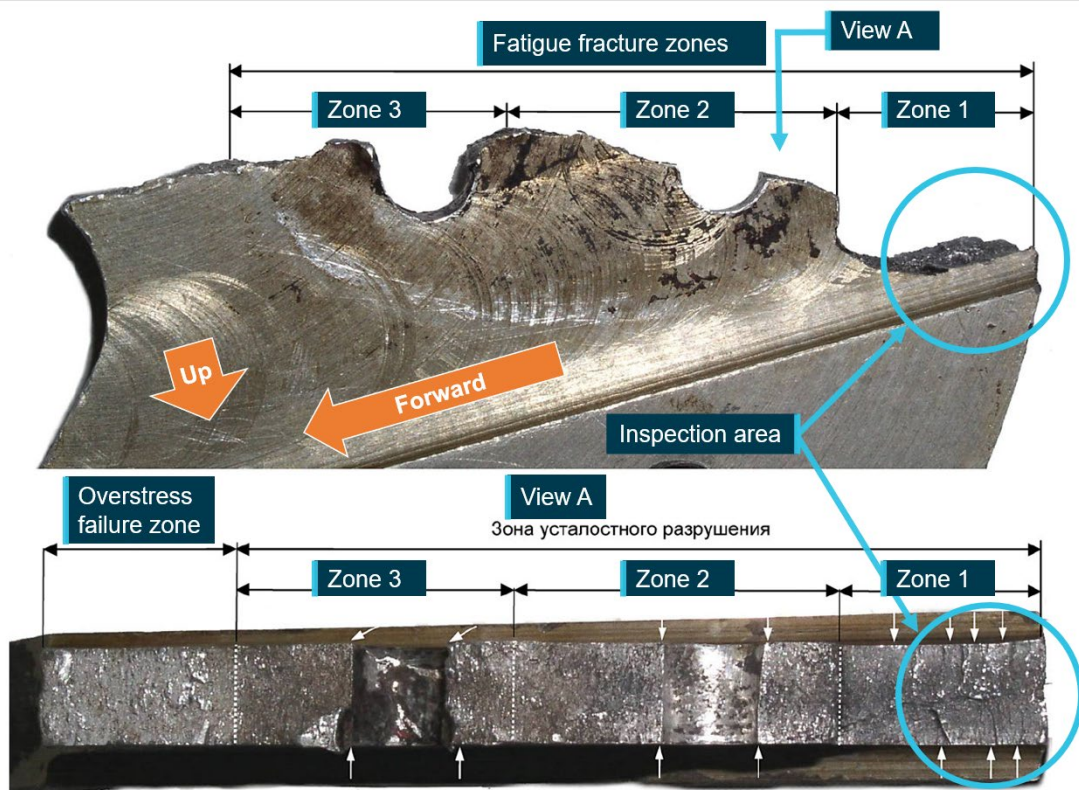
Figure 9: Fatigue fracture zones on the elevator

Note: The various zones indicate the different fatigue fracture characteristics.
