# Loss of control and collision with terrain involving Cessna R172K, registered VH-DLA

Near Sutton, New South Wales, on 13 April 2021

## **ATSB Transport Safety Report**

AO-2021-016

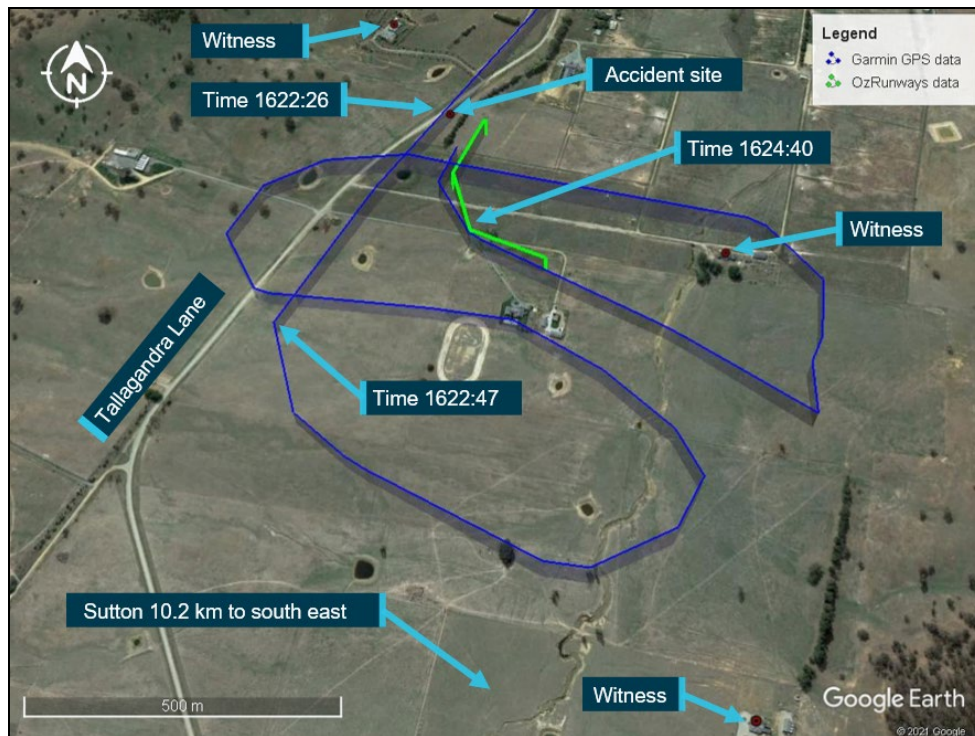
**Figure 1: Recorded flight path data shown relative to the accident site**

Analysis of the final segment of recorded Garmin GPS<sup>2</sup> and OzRunways<sup>3</sup> flight data (see the section titled *Recorded data*) identified that the last Garmin GPS data point at 1624:48 showed the height of the aircraft was about 164 ft above ground level (AGL) about 115 metres from the accident site. The final OzRunways data point, recorded at 1624:50, was about 80 metres from the accident site and indicated that the aircraft was about 80 ft AGL (Figure 1).

*Image description: DLA flight path – Garmin data is primarily referenced due to its higher sample rate and increased vertical accuracy. The final segment of OzRunways data is included as it provided the closest data point to the accident site.*  
 Source: Google, with Garmin GPS and OzRunways data, annotated by the ATSB

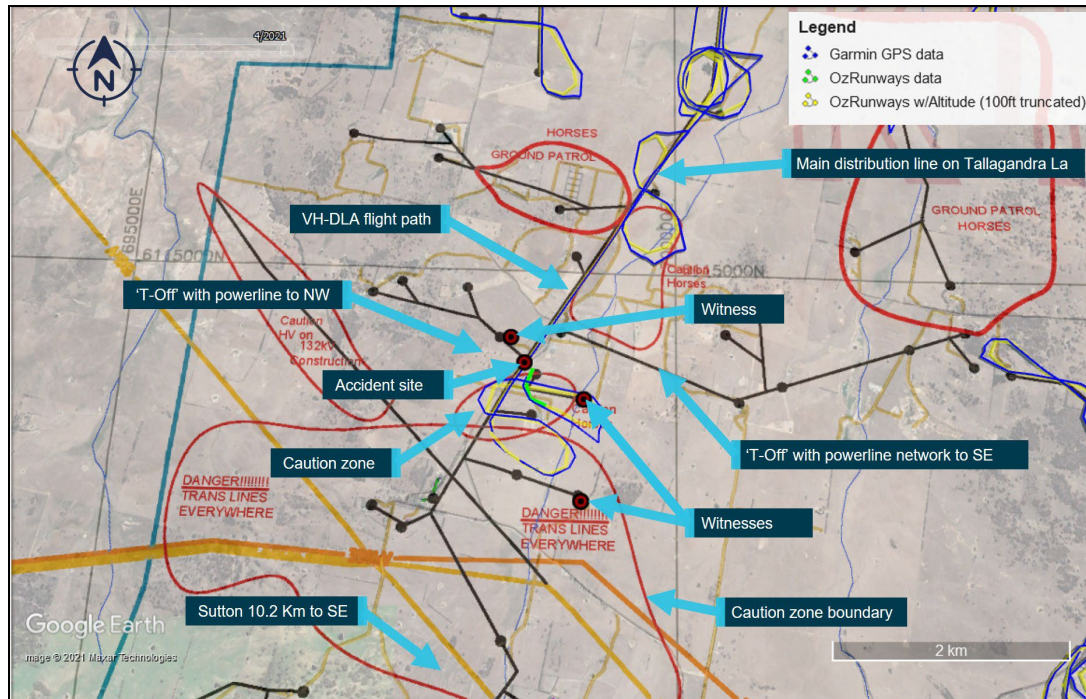
**Figure 2: Aircraft flight path and electrical powerline network in the vicinity of the accident site**

The role of the observer was to coordinate the powerline survey work. The observer monitored the survey's progress on a map depicting the electrical distribution network and directed the pilot to the sections of powerline to be inspected (Figure 2). The map was marked with warnings and cautions associated with network specific features and areas to avoid (no-fly areas) associated with dwellings, livestock and/or hazardous features.

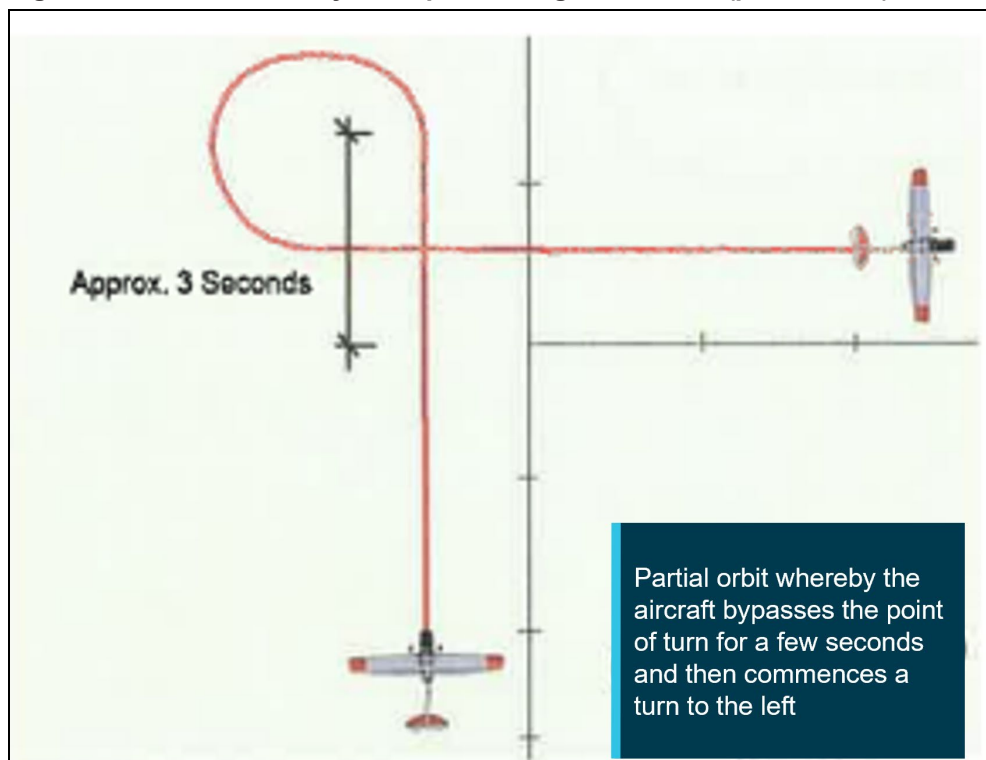
**Figure 3: Powerline survey T-Off positioning manoeuvre (partial orbit)**

The operator's Aircrew Operational Procedures Manual instructed pilots that when surveying T-Offs,<sup>7</sup> from a main distribution line that may require significant manoeuvring, the pilot should initiate a partial orbit of 270° commencing in the opposite direction to the T-Off orientation (Figure 3).

This was a standard re-positioning procedure that would result in a lower bank angle and wing load factor<sup>8</sup> while orientating the aircraft in the direction of the target T-Off.

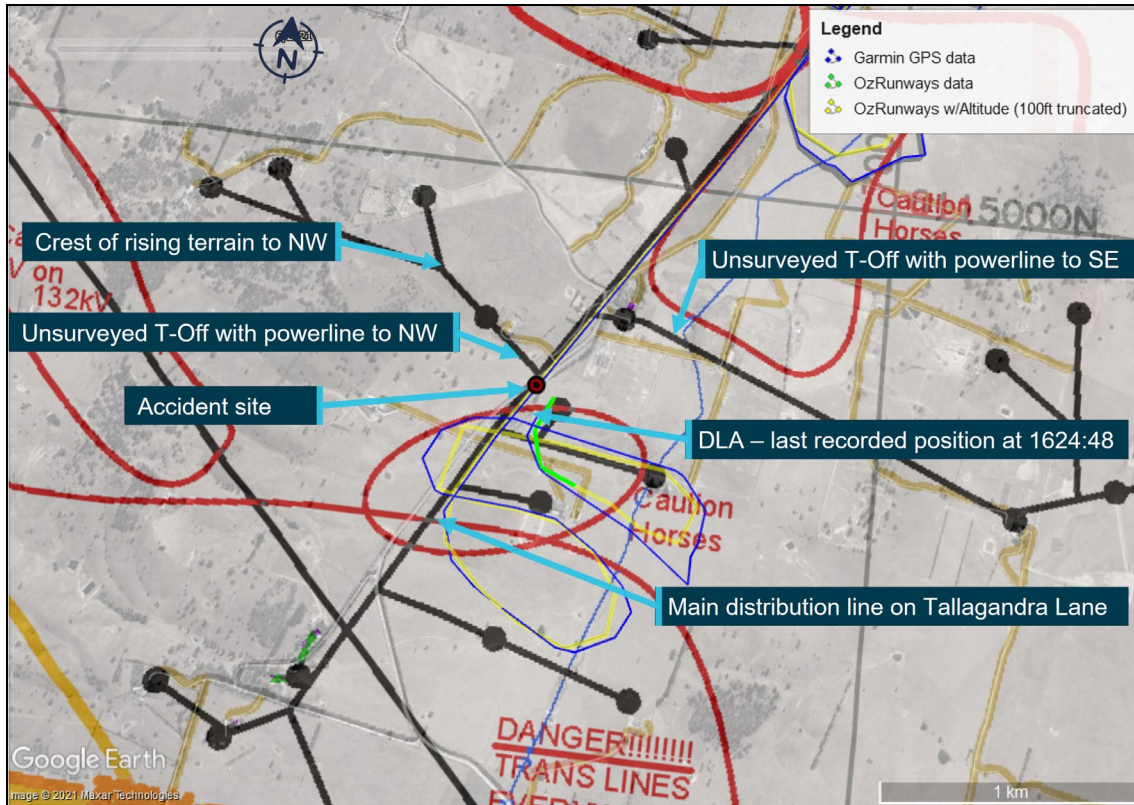
**Figure 4: VH-DLA flight path in the vicinity of the accident site**

On completing the survey work to the east of Tallagandra Lane, the pilot conducted a turn to the north-north-east and momentarily tracked parallel to the main distribution line that ran beside the lane (Figure 4). Based on flight path data and progress notations on the electrical network distribution map, the next powerline to be surveyed was the branch to the north-west which departed the main distribution line near the accident site.

The operator advised the ATSB that the standard procedure to establish the aircraft to survey that branch would have been for the pilot to conduct a partial right orbit through 270° prior to intercepting the powerline. However, the witness accounts indicated that the aircraft banked left towards the branch immediately before the accident. The operator was unable to provide advice as to why the orbit manoeuvre was not performed at this point. Flight path data showed the pilot had performed the 270° partial orbit manoeuvre in similar situations earlier in the flight.
