# Wirestrike and collision with terrain involving Robinson R44, VH-HNF

69 km south-east of Hay Airport (Steam Plains), New South Wales, on 31 July 2020

## **ATSB Transport Safety Report**

AO-2020-040

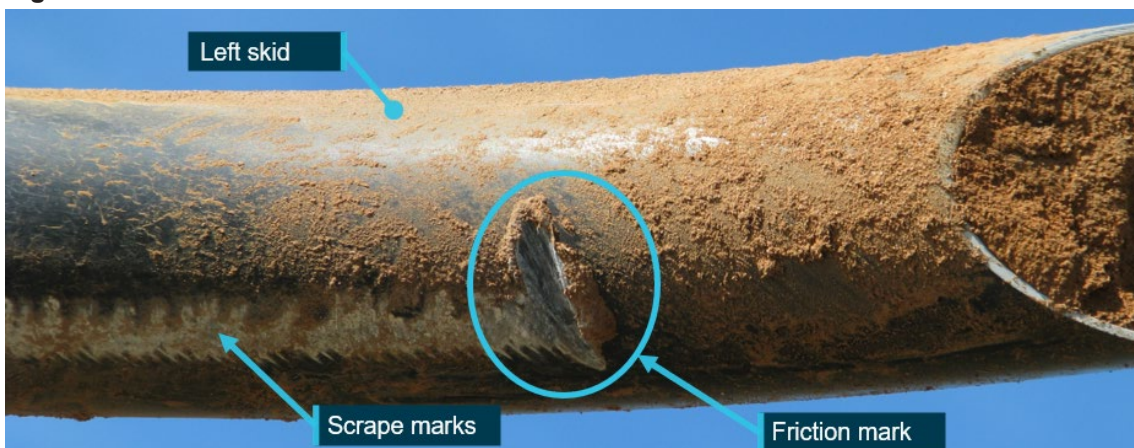
**Figure 3: Wire marks on VH-HNF's left skid**

Examination of the ground scars, damage and distribution of the wreckage indicated:

- the main rotor had impacted the tail boom during the accident sequence, resulting in loss of control of the helicopter
- the helicopter collided with the ground on its left side in a nose-down attitude of about 30°
- the main rotor blade and landing gear dug into the ground, resulting in the helicopter bouncing, rotating about 180°, and coming to rest on the right side.

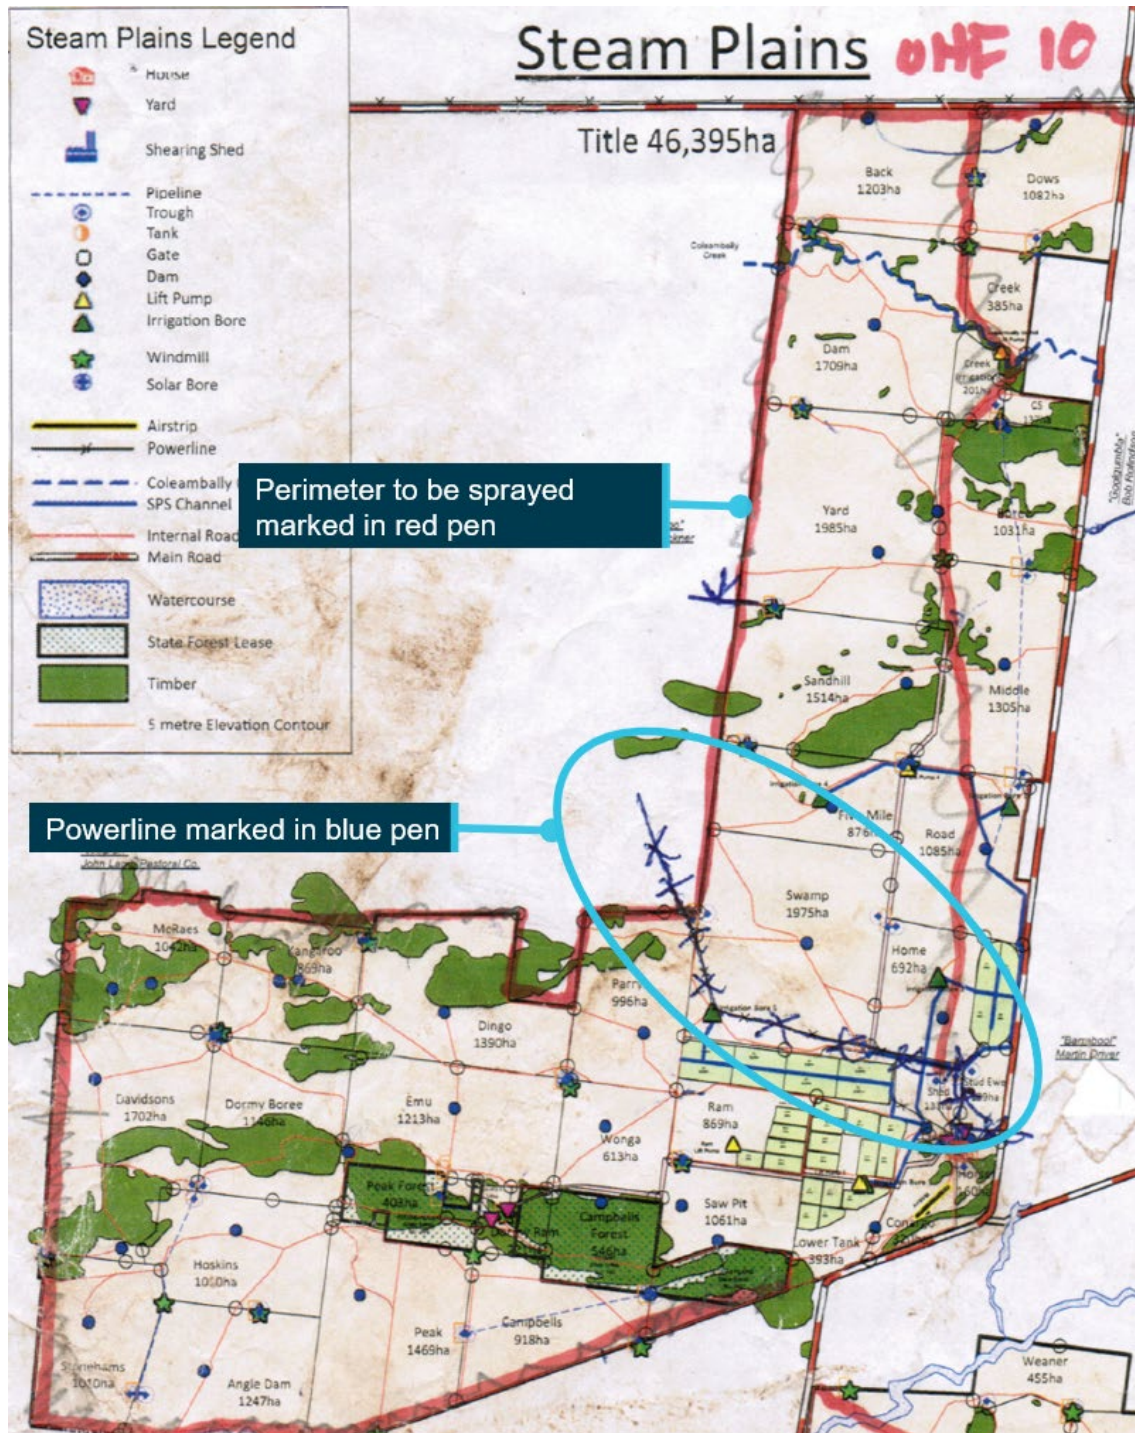
Figure 4: Map of Steam Plains Station showing spray path (red) and powerline (blue)

Prior to the fifth (accident) load, the pilot fuelled the helicopter and discussed with the chief pilot the shape of the boundary fence to be sprayed on the next sortie and the location of the powerline.

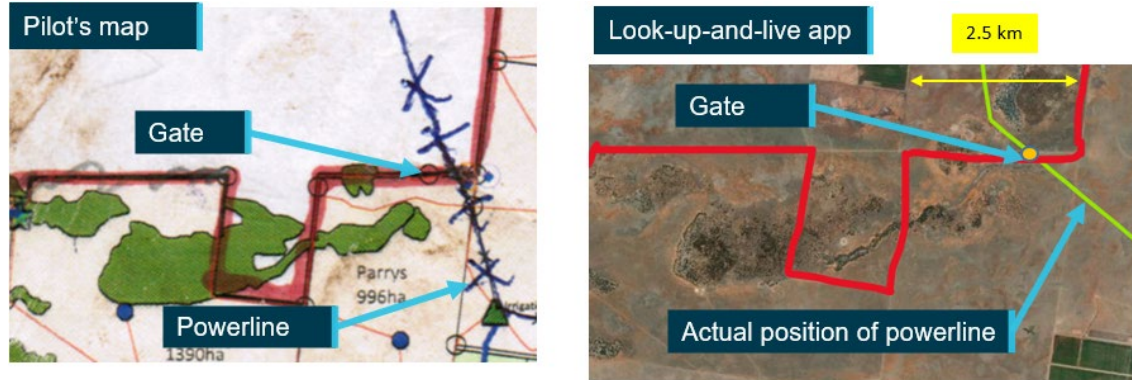
**Figure 5: Map location compared with actual powerline location**

instructor who conducted the pilot's annual flight review and proficiency check in 2019 commented that pilots are trained to expect that planning information may be inaccurate, and reinforced the importance of verifying it by conducting an aerial inspection.

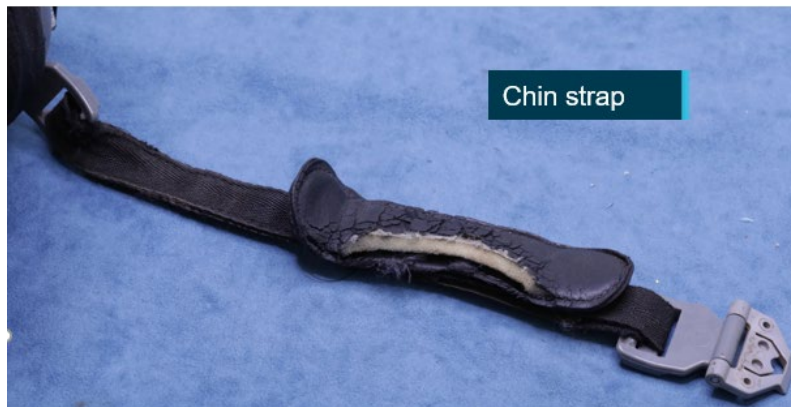
**Figure 9: Helmet chin strap**

The LH250 helmet comes in two shell sizes, which can be personalised with pads to fit the wearer's head. The manufacturer advised that the pads degrade over time and should be replaced to ensure optimum fit. The fit of the helmet was not able to be assessed in this instance. The helmet was fitted with a chin strap and locking buckle, which met US DOI and US Military standards. The chin strap was noted by the ATSB to be worn and frayed (Figure 9). This was indicative of the chin strap being worn securely fastened over a long time.

The chin strap was found intact and attached to the helmet but undone. It could not be determined whether the chin strap came undone during the accident sequence or was not secured at the time. Although the primary impact was on the left side of the helmet, there was also some damage to the right side of the helmet and visor and the chin strap clasp was on the right side. However, there was no visible damage to, or in the vicinity of, the clasp. Although the ATSB found that the clasp could come undone with a direct 'bump' force applied to it, there were no witness marks to indicate the clasp was opened from being caught on something during the impact sequence or directly impacted or bumped. The poor condition of the chin strap may also have resulted in it being uncomfortable to wear secured under the chin. Its poor condition was, however, consistent with the pilot having regularly worn it secured in the past.

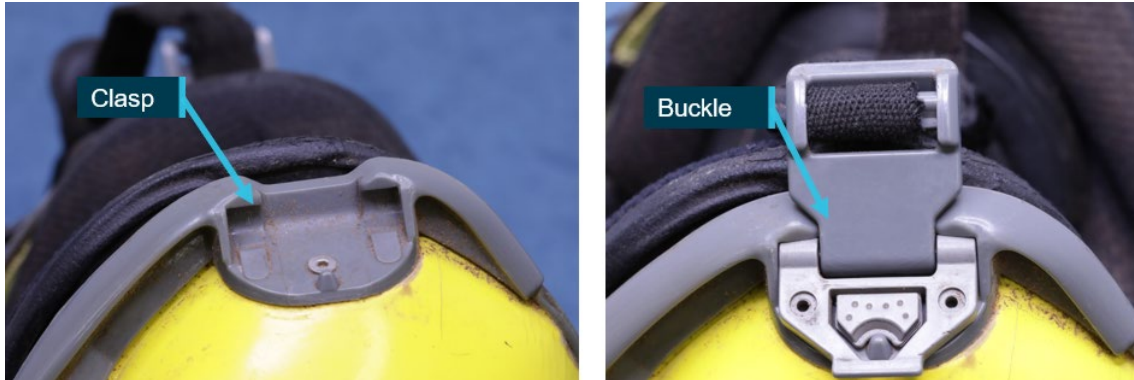
**Figure 10: Helmet clasp and buckle**

The chin strap was found undone with dirt lodged in the clasp. The chin strap fastened on the right-hand side of the helmet (Figure 10). The post-mortem report did not identify chin injuries to indicate that the helmet had been forcibly removed with the chin strap properly adjusted and secured. However, any such injuries may have been obscured by facial hair. Post-accident testing of the helmet by the ATSB found it was possible to undo the clasp with a relatively small 'bump' applied to the clasp. As the clasp was on the right side, this force needed to be applied opposite the (left) side of the initial impact. Although there was no evidence of damage to the clasp or scuff marks near the latch to indicate contact, the damage to the right side of the helmet was consistent

with a secondary impact on that side. There was also no documented history of this latch coming undone in accidents.

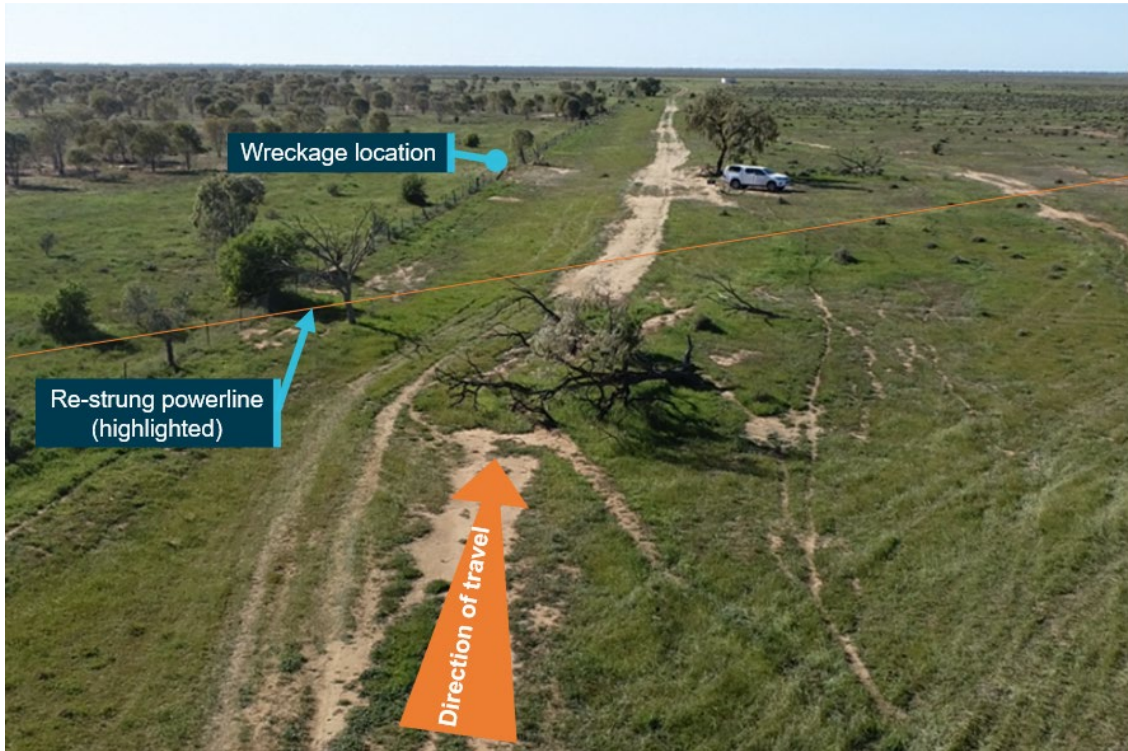
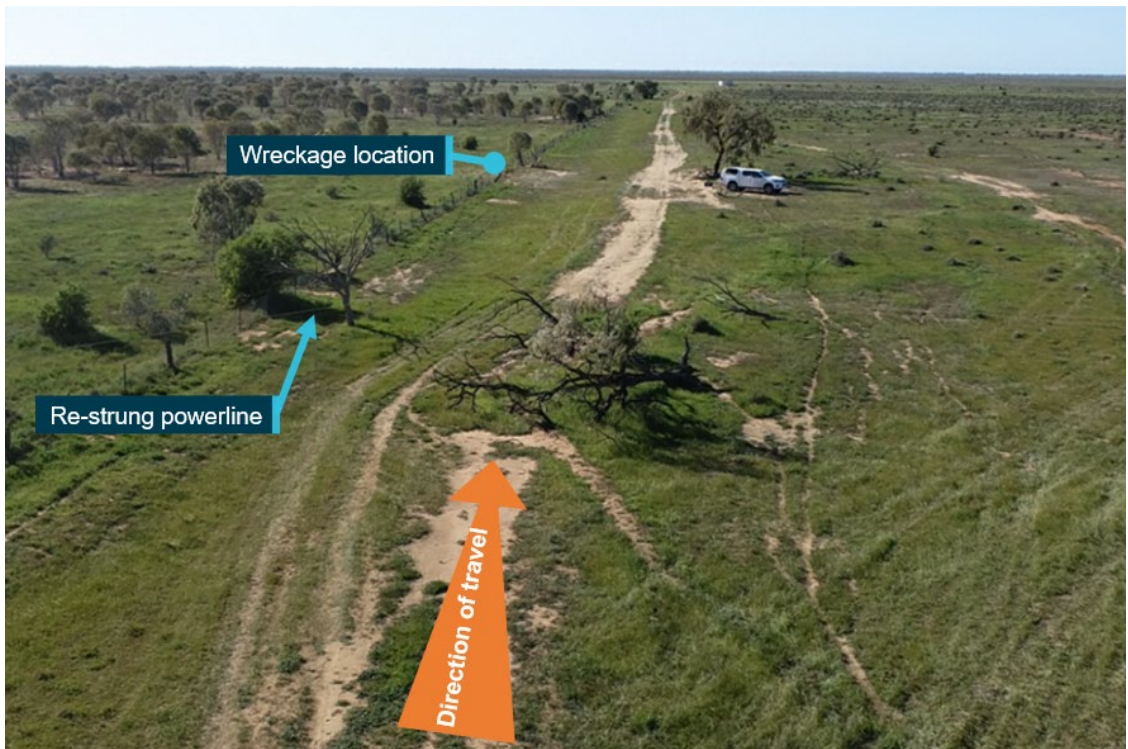
Imagery taken from the ATSB's remotely piloted aircraft (RPA), while following the helicopter's estimated flight path at about the same time on a subsequent day, found that the wire would have been extremely difficult to see (Figure 11 and Figure 12).

**Figure 11: RPA image 50–75 m prior to the powerline showing the accident location, taken at 1028 on 4 August 2020, with powerline highlighted**

**Figure 12: RPA image 50–75 m prior to the powerline showing the accident location, taken at 1028 on 4 August 2020, noting powerline visibility**

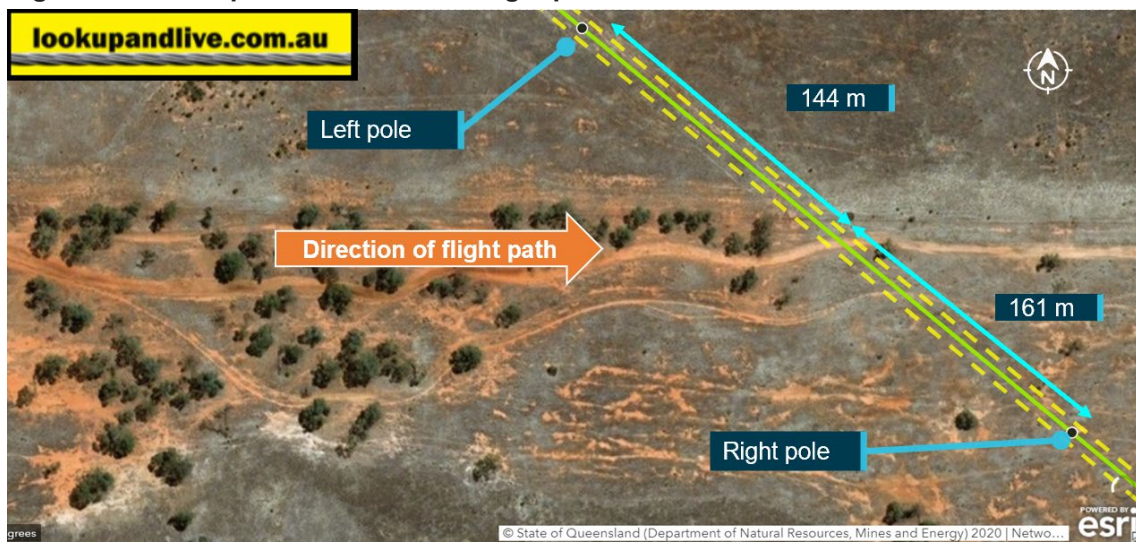
**Figure 13: Power poles either side of flight path**

Figure 13 shows the two closest power poles located either side of the helicopter's flight path. From ATSB RPA footage taken along the estimated flight path, at times, both poles were obscured by trees and lacked contrast and texture variation from their background (Figure 14 and Figure 15). The two power poles should have been visible within the pilot's peripheral vision, however it is likely that the pilot's visual acuity was affected by contrast sensitivity, resulting in the pilot being unable to discriminate the poles from their background. Additionally, based on the powerline's location on the pilot's map, the pilot may not have been looking for cues at that time.
