# Airspeed indication failure on take-off involving Airbus A330, 9M-MTK

Brisbane Airport, Queensland, 18 July 2018

Aviation Occurrence Investigation (Systemic)

AO-2018-053

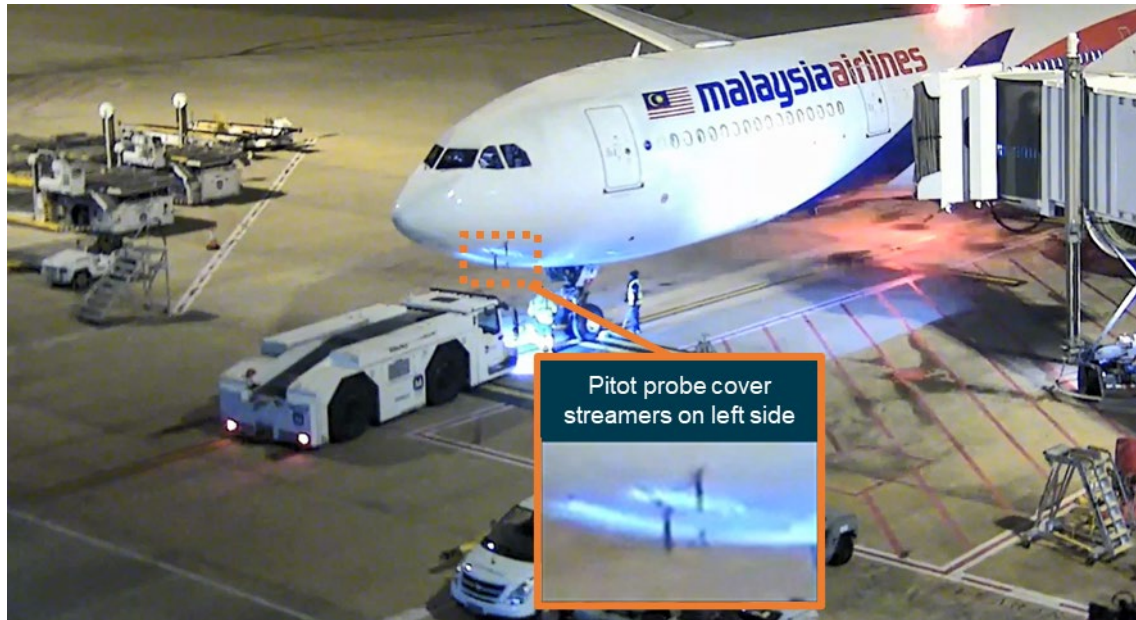
**Figure 1: Aircraft on bay during turnaround about to be pushed back with pitot probe covers in place**

After the aircraft had arrived at the gate following its flight to Brisbane, an engineer placed covers on the aircraft's three pitot probes<sup>1</sup> to prevent them from becoming blocked by wasp nests (a particular hazard at Brisbane Airport—information on this topic is provided in Appendix A). The pitot covers were not removed during the subsequent inspections and other activity throughout the turnaround (Figure 1).

During take-off (commencing at 2331 Eastern Standard Time<sup>2</sup>) and the subsequent flight, the aircraft systems could not calculate and display airspeed correctly due to the pitot probes being covered.

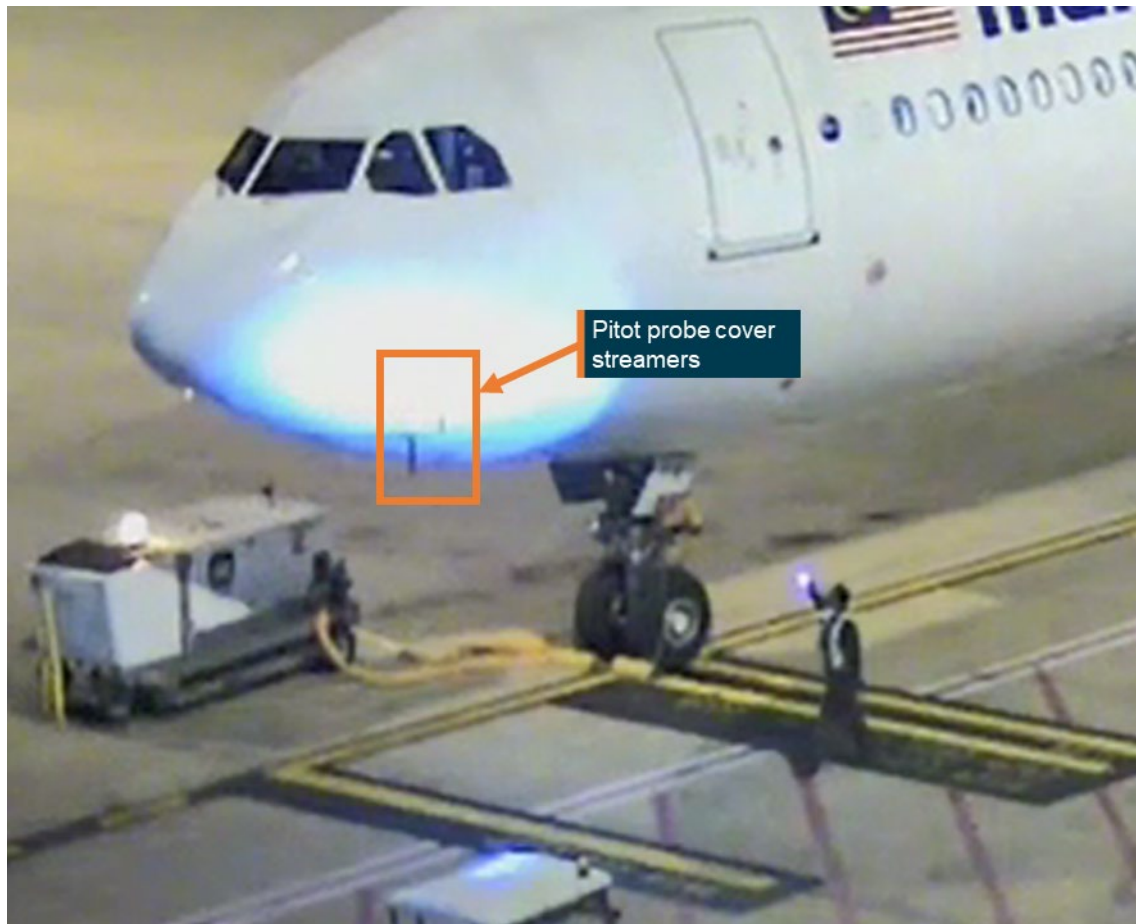
**Figure 2: LAE shining torch on left pitot probes with covers fitted**

The LAE reported noticing the pitot probe covers fitted to the aircraft at the time the nose area was inspected and intended to talk to the support engineer about them. As the support engineer was still absent from the aircraft retrieving supplies, the LAE decided to continue with the engineering maintenance walk-around inspection. The next interaction between the LAE and support engineer was ten minutes later. The LAE, busy with continuing the engineering maintenance walk-around inspection through that period, forgot about the pitot probe covers.

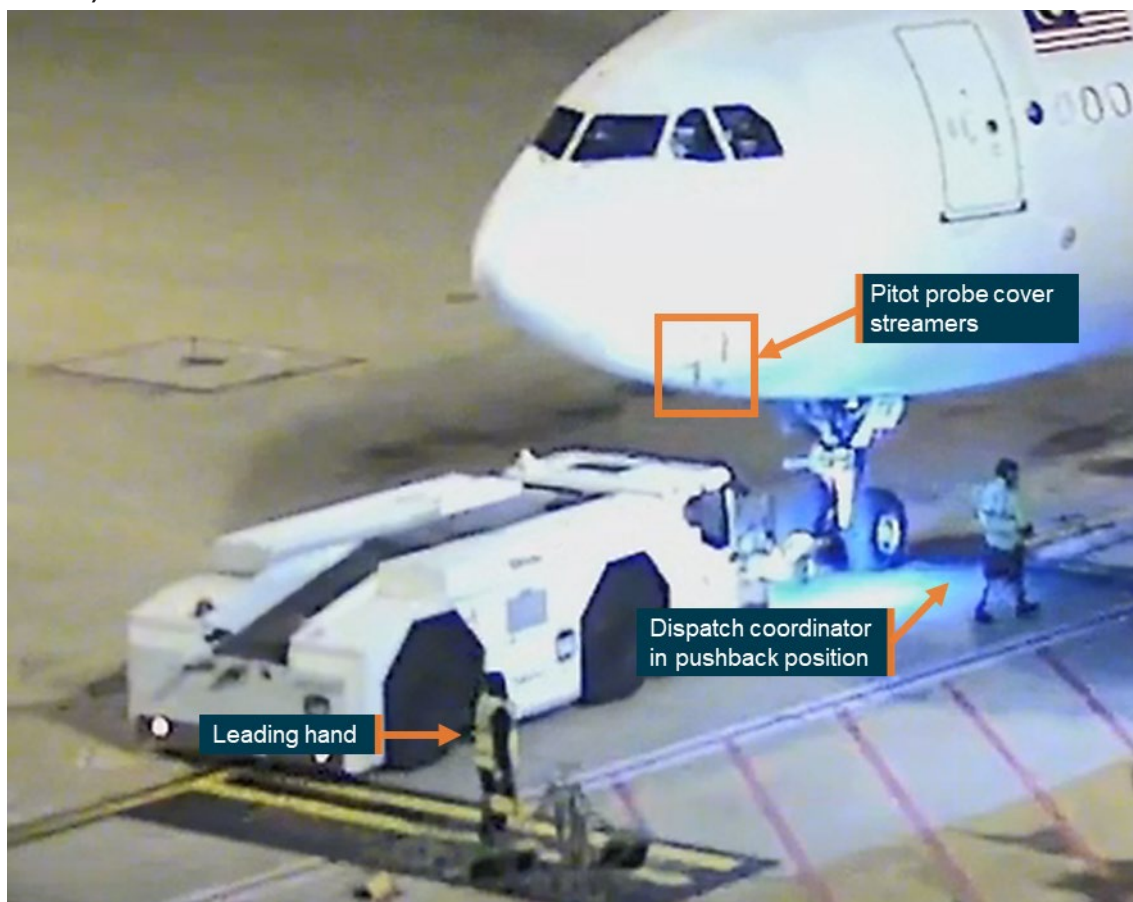
**Figure 5: Aircraft about to be pushed back with pitot probe covers in place (two of three visible)**

The dispatch coordinator walked alongside the nose gear until the tug driver stopped pushing the aircraft back. During this period, the dispatch coordinator was likely checking for sufficient obstacle clearance behind and to the sides of the aircraft and would not have had a need to look behind and above towards the area of the pitot probes.

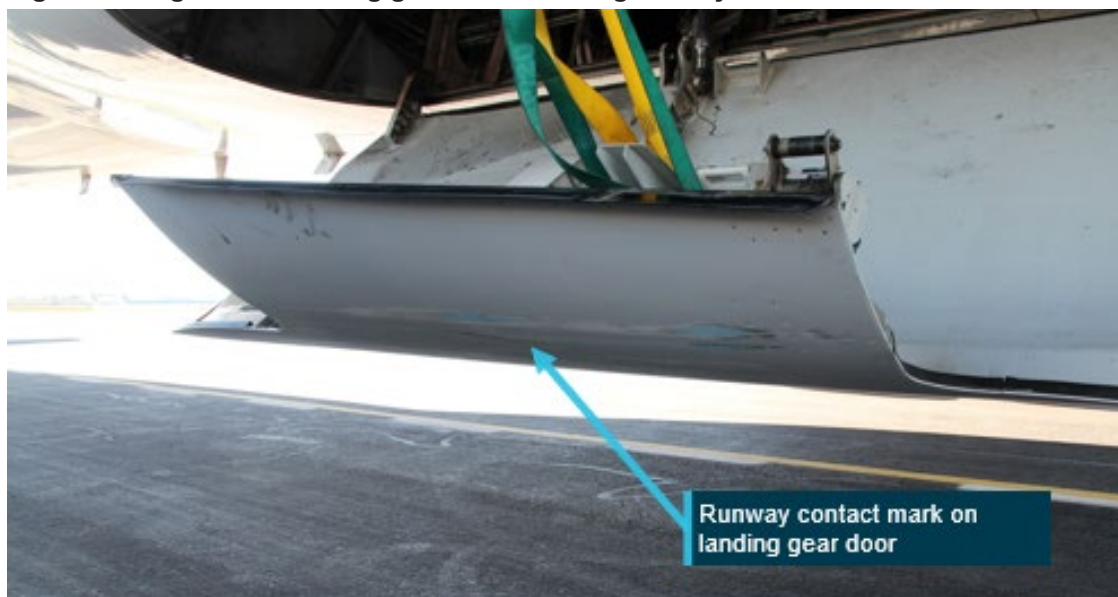
**Figure 10: Right main landing gear door showing runway contact mark**

The inoperative air data systems meant that normal landing gear extension was not available, so the flight crew had carried out a gravity landing gear extension. Because of this, the main landing gear doors did not retract and were slightly damaged on landing. Also, nose wheel steering was not available and the aircraft remained on the runway for a short period before being towed to the gate.

The main landing gear doors had minor abrasion damage where they contacted the runway surface on landing. If the main landing gear doors are opened on the ground, such as for maintenance activity, they typically remain clear of the ground. However, compression of the main

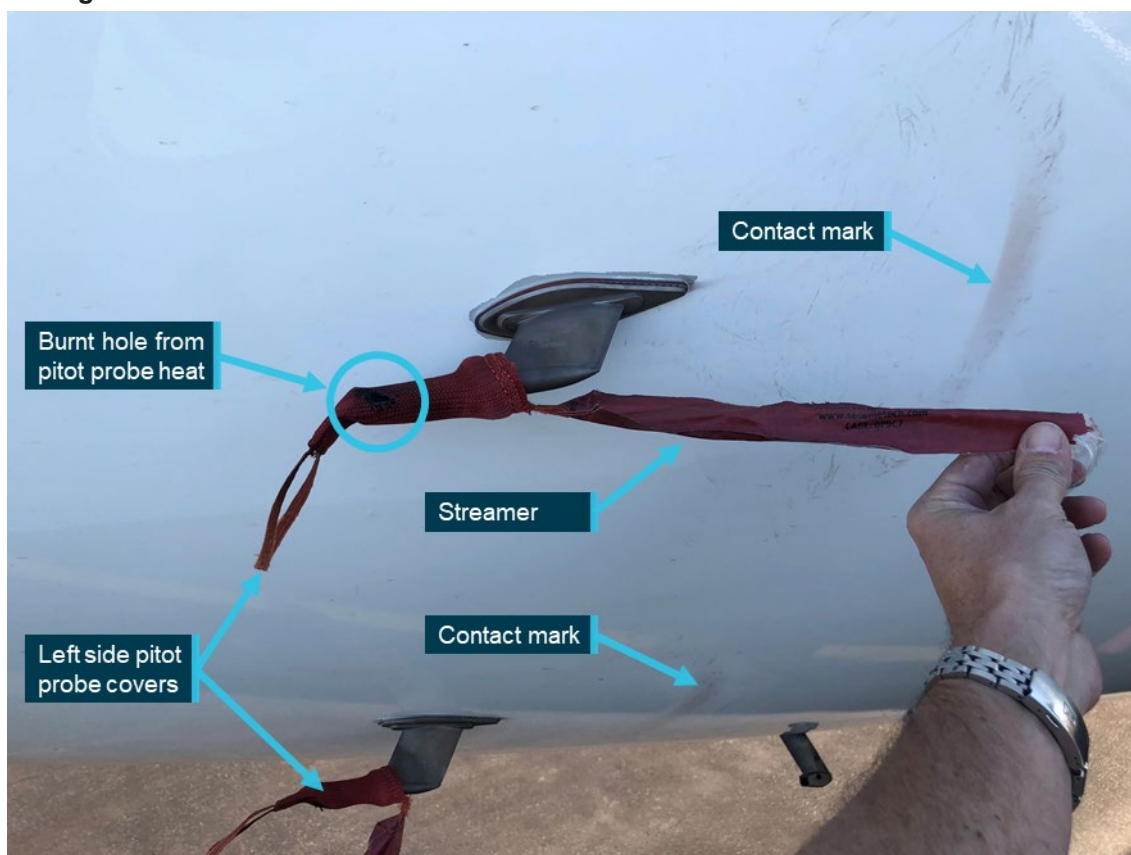
**Figure 11: Reconstruction of pitot probe covers on 9M-MTK, showing pitot probe cover damage and contact marks on aircraft skin from the streamer**

The pitot probe streamers were damaged by airflow and left red marks on the fuselage skin where they rubbed during the flight (Figure 12). The sheaths were partially burned where they folded over the heated pitot probes in the airflow.

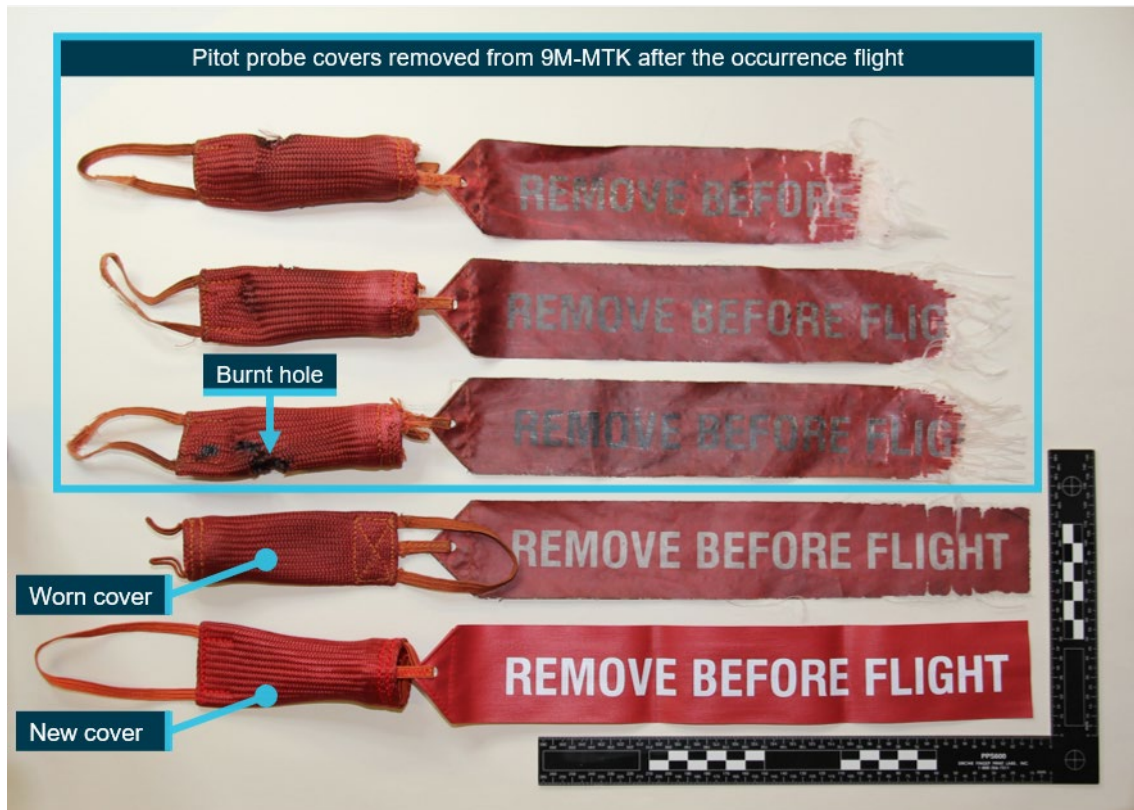
**Figure 34: Pitot probe covers removed from 9M-MTK after the occurrence flight, and exemplar covers of the same type**

<sup>11</sup> The pitot probe covers used were different to the type approved by the aircraft manufacturer. See *Pitot probe covers* for further information. See *Airport information* for further information about the mud wasp hazard at Brisbane.

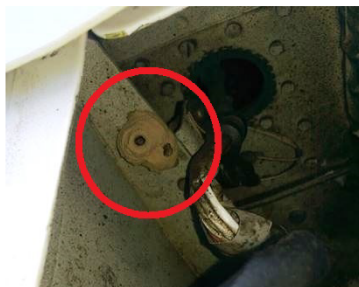
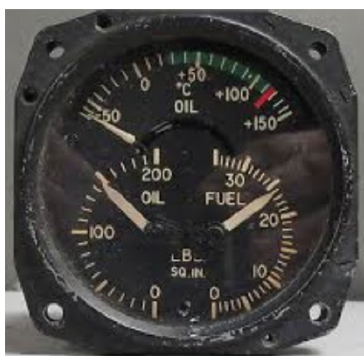
Figure 5.b.

There was also one large wasp nest entirely suspended on the flight control cables in the rear fuselage.

During visual inspection on the left and right elevator actuator/hinge area, a small mud wasp nest was found on the left side adjacent to the actuator (Figure 5.b.).

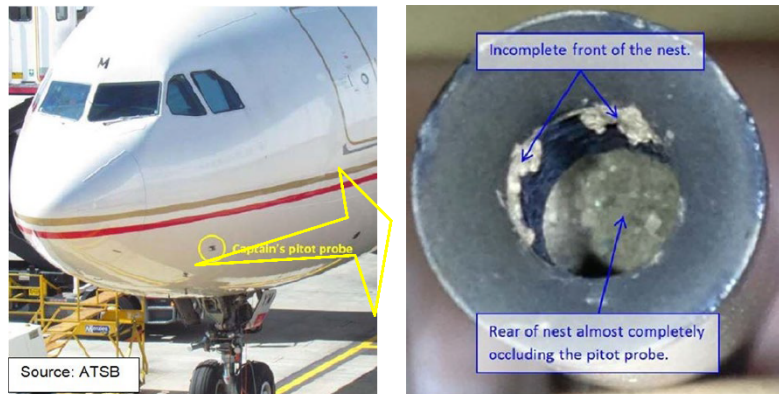
**Figure 7.** Airbus A330 Wasp Nest Partial Blockage of Captain's Pitot Probe

A typical example occurred in 2013 when an Airbus A330 suffered a rejected take-off in Brisbane, due to an airspeed indication failure which was only detected during the take-off roll. Through the subsequent inspection, it was found that the Captain's pitot probe (Figure 7) was almost totally obstructed by an insect nest, consistent with mud-dauber wasp nest residue (Figure 5).

Regardless of whether the aircraft has only a short turn-around time or remains on the flight line, approved protective covers should be used. It is important to use the manufacturers approved probe cover which are a part of the flight kit for each aircraft. Other manufacturers' covers may not fit correctly nor offer complete protection.
