Airspeed indication failure on take-off involving Airbus A330, 9M-MTK

Brisbane Airport, Queensland, 18 July 2018

ATSB Transport Safety Report

AO-2018-053

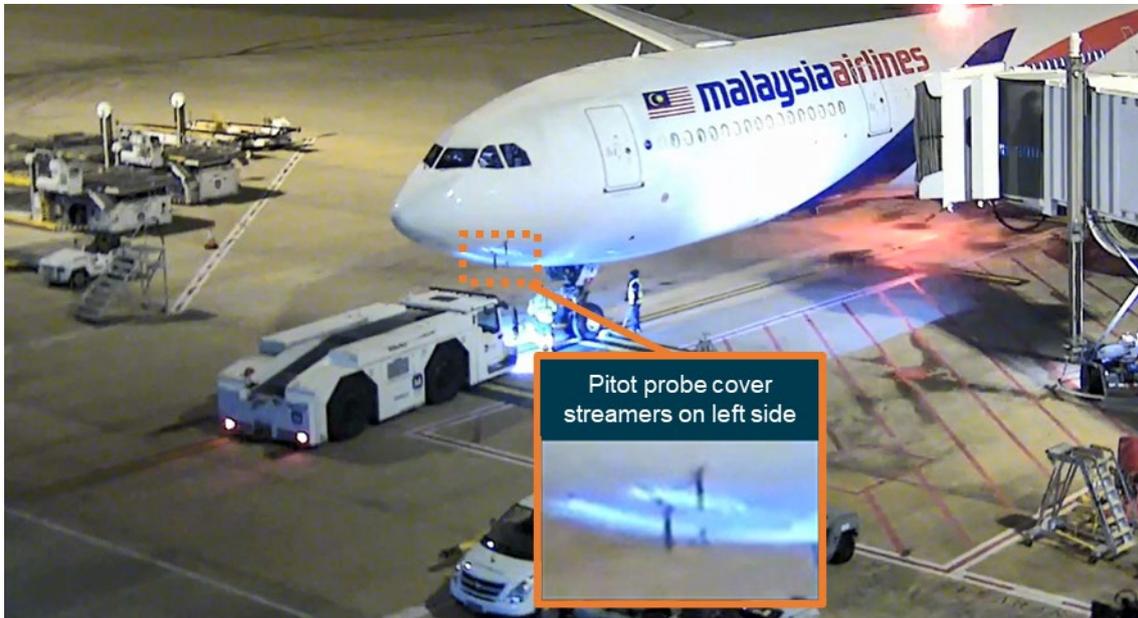
After the aircraft had arrived at the gate following its flight to Brisbane, an engineer placed covers on the aircraft's three pitot probes¹ to prevent them from becoming blocked by wasp nests (a particular hazard at Brisbane Airport—information on this topic is provided in Appendix A). The pitot covers were not removed during the subsequent inspections and other activity throughout the turnaround (Figure 1).

Figure 1: Aircraft on bay during turnaround about to be pushed back with pitot probe covers in place

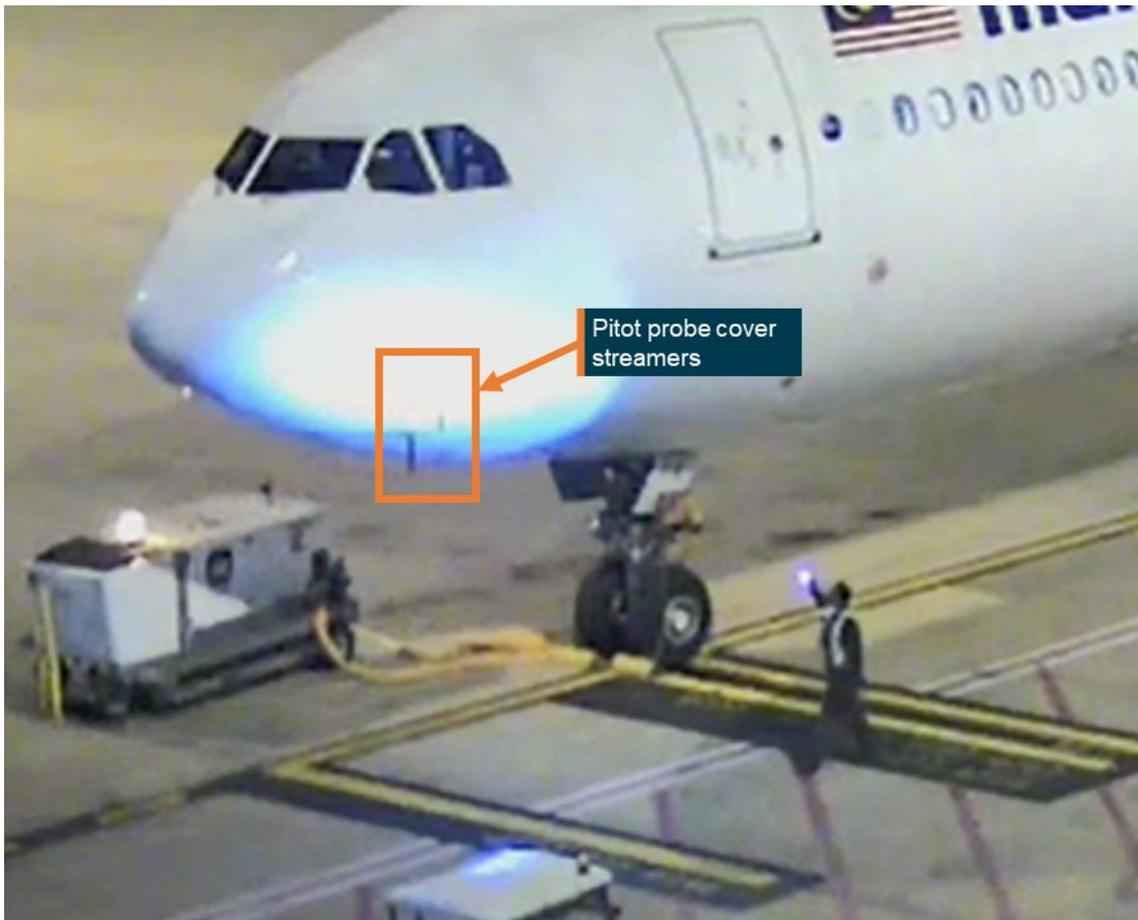
Figure 2: LAE shining torch on left pitot probes with covers fitted

The LAE reported noticing the pitot probe covers fitted to the aircraft at the time the nose area was inspected and intended to talk to the support engineer about them. As the support engineer was still absent from the aircraft retrieving supplies, the LAE decided to continue with the engineering maintenance walk-around inspection. The next interaction between the LAE and support engineer was ten minutes later. The LAE, busy with continuing the engineering maintenance walk-around inspection through that period, forgot about the pitot probe covers.

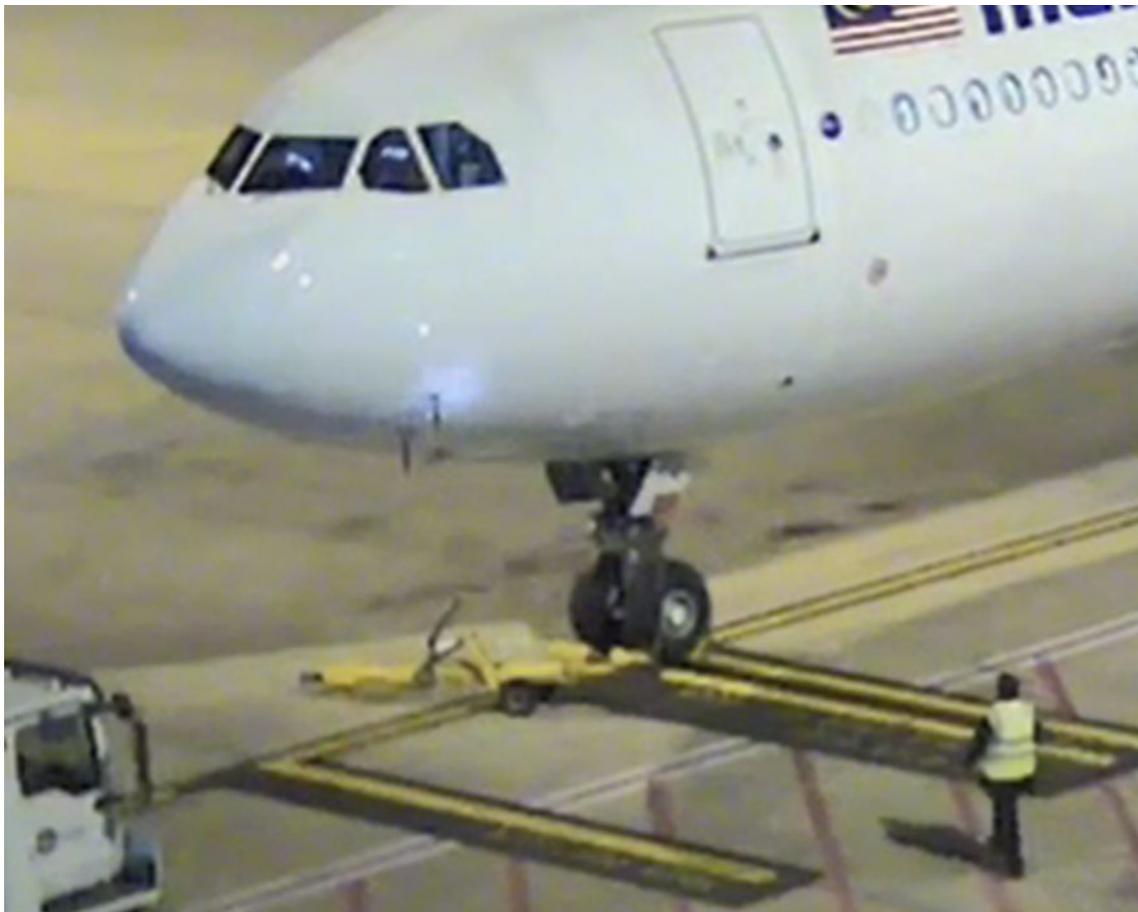
Figure 4: Captain briefly shining torch on left side pitot probe area

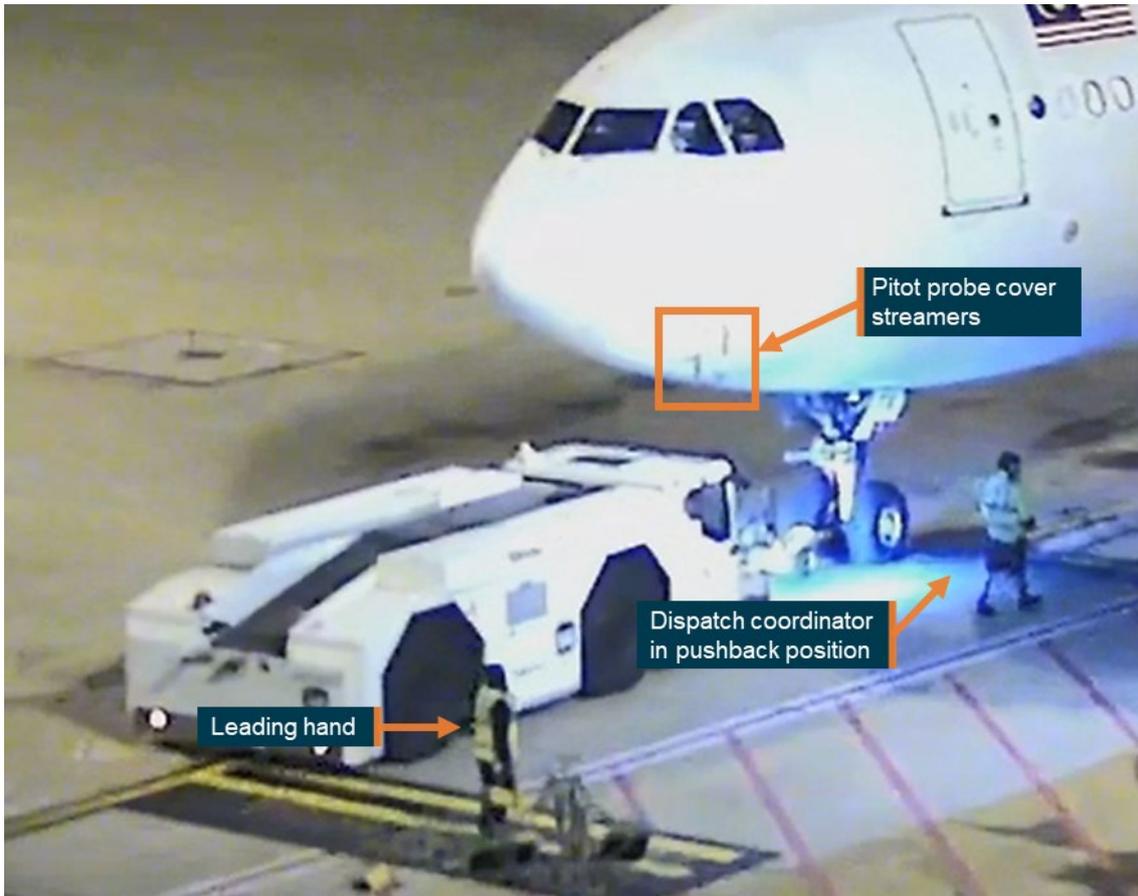
Figure 5: Aircraft about to be pushed back with pitot probe covers in place (two of three visible)

The dispatch coordinator walked alongside the nose gear until the tug driver stopped pushing the aircraft back. During this period, the dispatch coordinator was likely checking for sufficient obstacle clearance behind and to the sides of the aircraft and would not have had a need to look behind and above towards the area of the pitot probes.

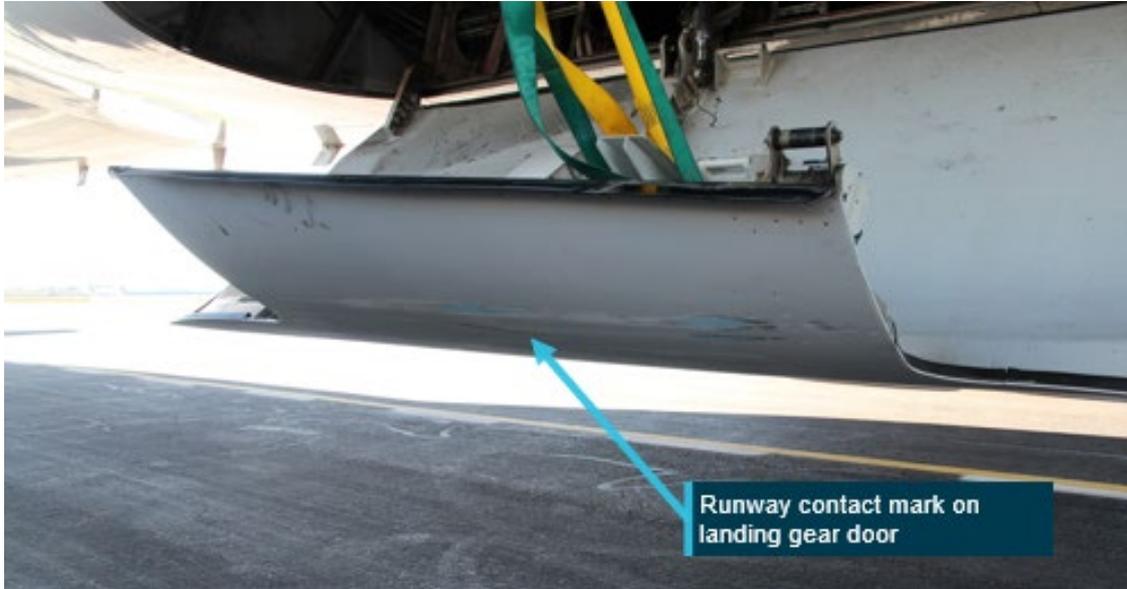
The main landing gear doors had minor abrasion damage where they contacted the runway surface on landing. If the main landing gear doors are opened on the ground, such as for maintenance activity, they typically remain clear of the ground. However, compression of the main

Figure 10: Right main landing gear door showing runway contact mark

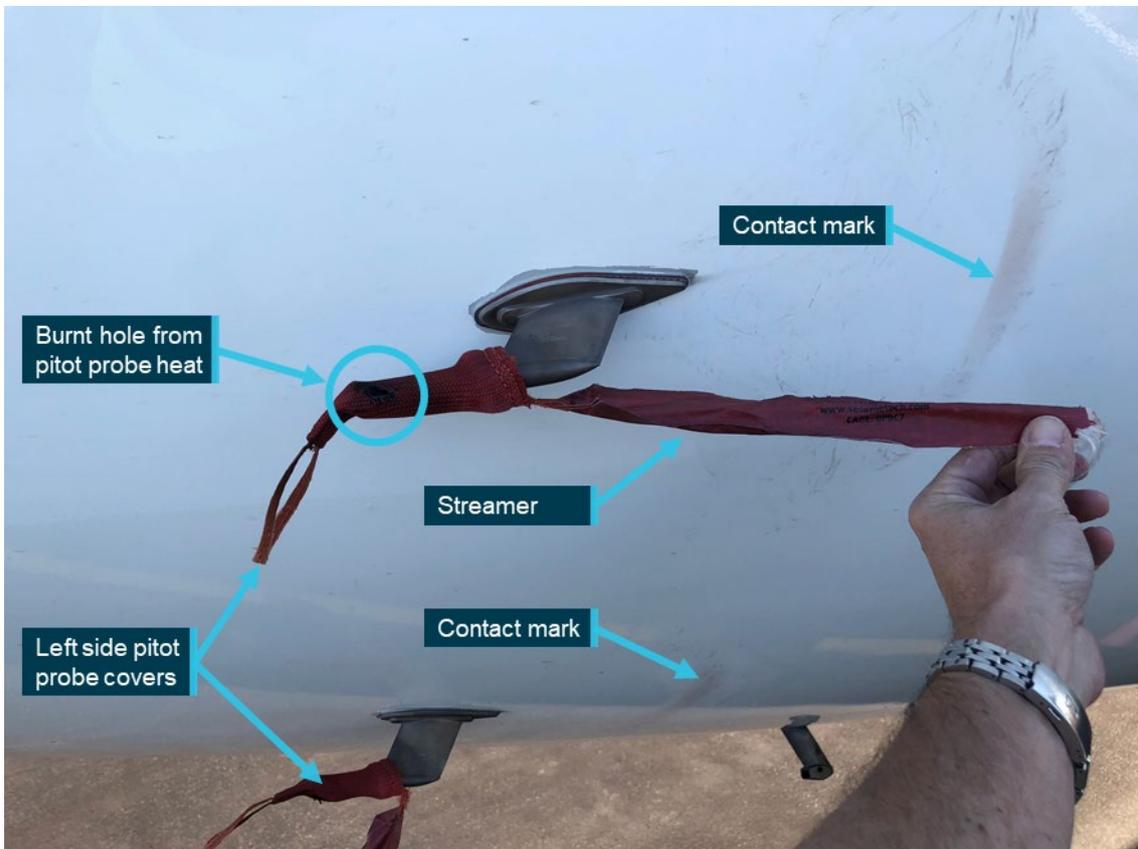
The pitot probe streamers were damaged by airflow and left red marks on the fuselage skin where they rubbed during the flight (Figure 12). The sheaths were partially burned where they folded over the heated pitot probes in the airflow.

Figure 11: Reconstruction of pitot probe covers on 9M-MTK, showing pitot probe cover damage and contact marks on aircraft skin from the streamer

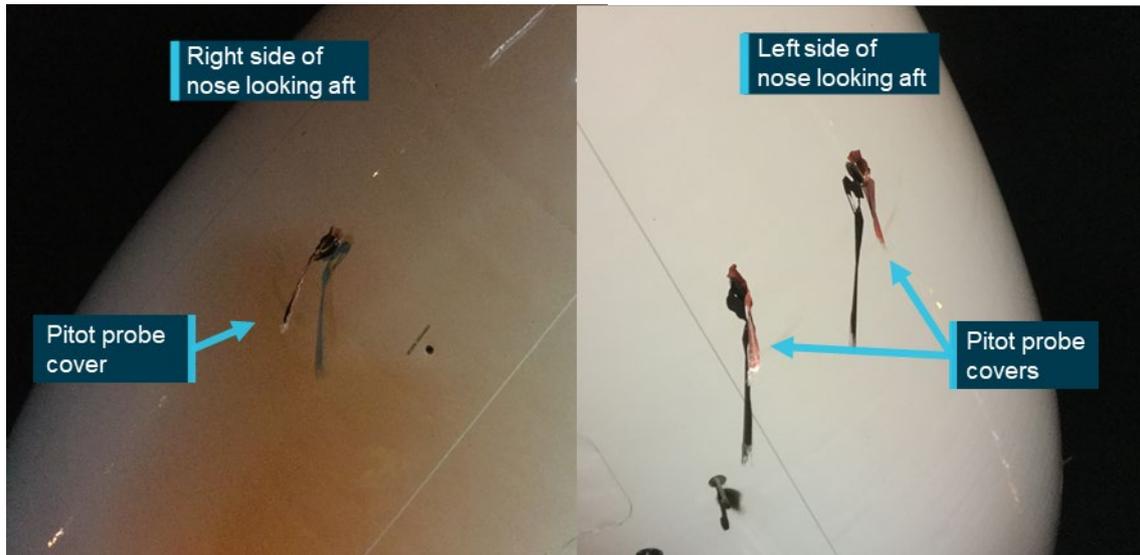
Figure 12: The right and left sides of the aircraft’s nose shortly after landing, showing pitot probe covers installed

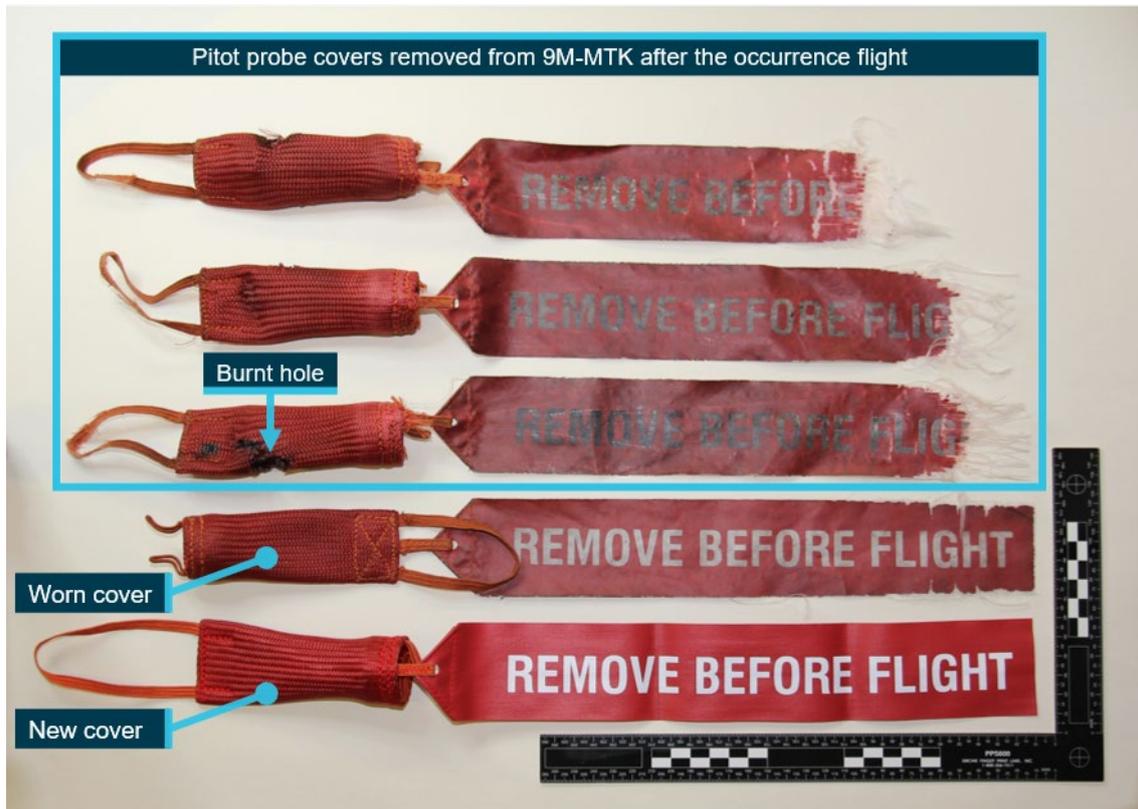
Figure 34: Pitot probe covers removed from 9M-MTK after the occurrence flight, and exemplar covers of the same type

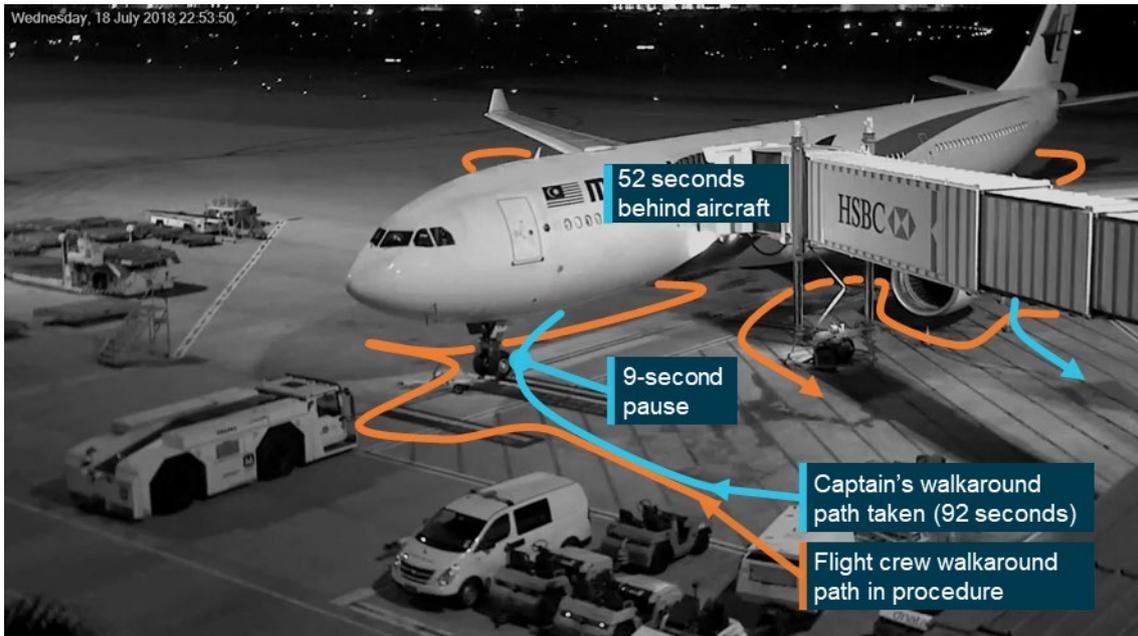
Figure 43: CCTV still image of 9M-MTK overlaid with the required flight crew walk-around path and the captain’s visible walk-around path.

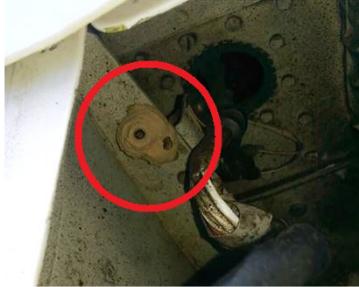
There was also one large wasp nest entirely suspended on the flight control cables in the rear fuselage.

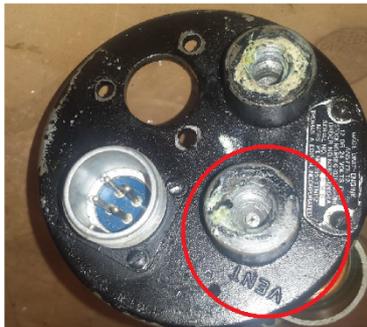
Figure 6.a.

Triplex fuel gauge in an Aerocommander 500s had a blockage in the external fuel vent line. The fuel pressure indication has a capsule which is ported overboard via this vent line. The vent line is common to both indications and because of the blockage both gauges indicated zero (Figure 6.a.).

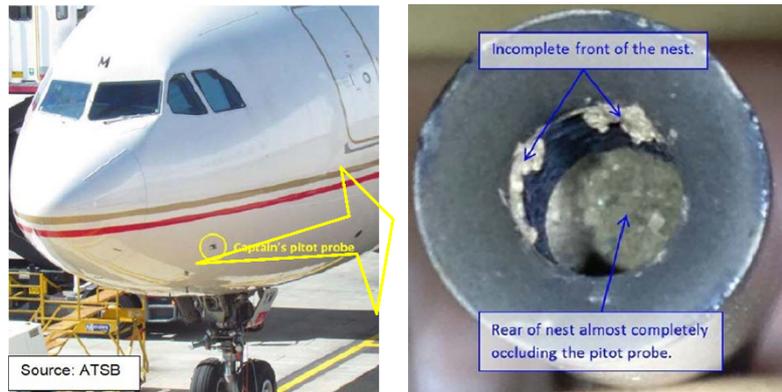
A typical example occurred in 2013 when an Airbus A330 suffered a rejected take-off in Brisbane, due to an airspeed indication failure which was only detected during the take-off roll. Through the subsequent inspection, it was found that the Captain's pitot probe (Figure 7) was almost totally obstructed by an insect nest, consistent with mud-dauber wasp nest residue (Figure 5).

Figure 7. Airbus A330 Wasp Nest Partial Blockage of Captain's Pitot Probe

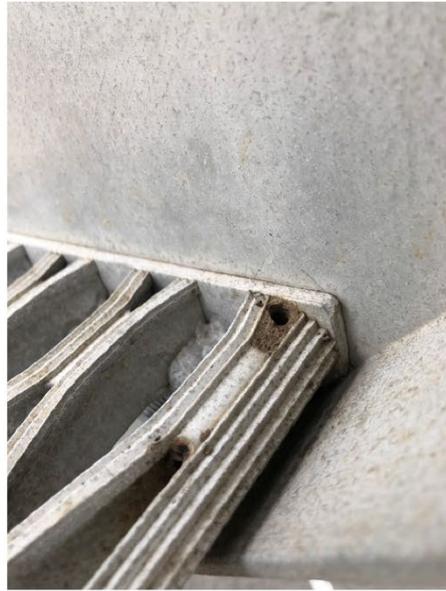
Figure 9. Wasp nest found in stairs

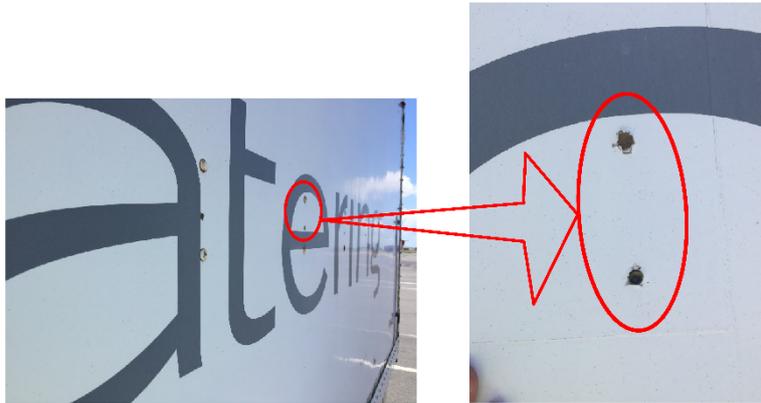
Figure 11. Wasp nest in catering truck panel holes
