Wirestrike and collision with terrain involving Robinson R22, VH-KLY

75 km west-north-west of Hay, New South Wales on 26 May 2021

ATSB Transport Safety Report

AO-2021-020

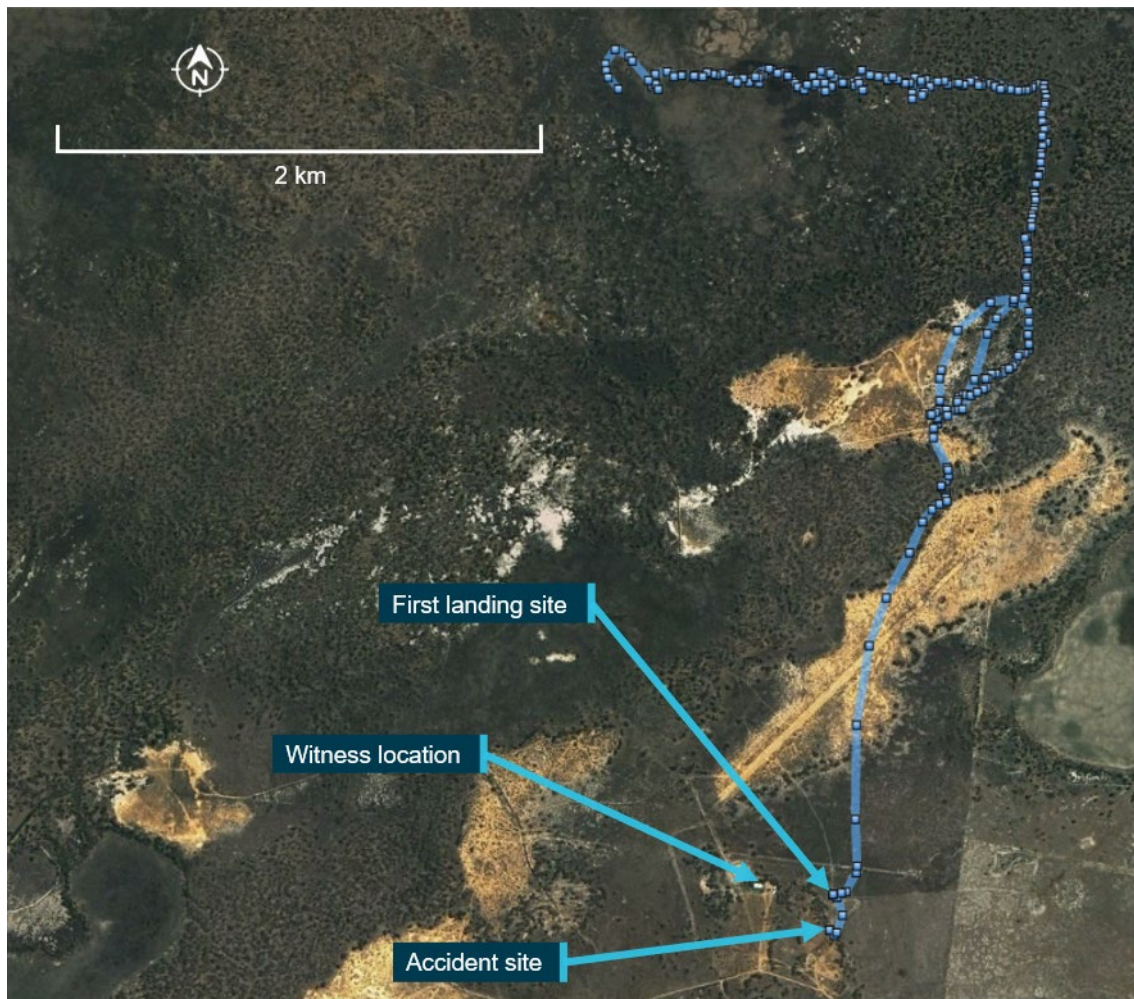
Figure 2: Last section of flight from recorded GPS data

Analysis of the recorded flight data indicated KLY took off from the first gate at the yards and flew in a southerly direction, towards the second gate, at between 16–33 ft (5–10 m) above ground level (AGL) (Figure 3). The recorded groundspeed was about 22 kt, slowing to 15 kt⁴ as the helicopter turned towards a closed gate adjacent to the accident site. This gate was required to be opened to allow the cattle access to the yards.

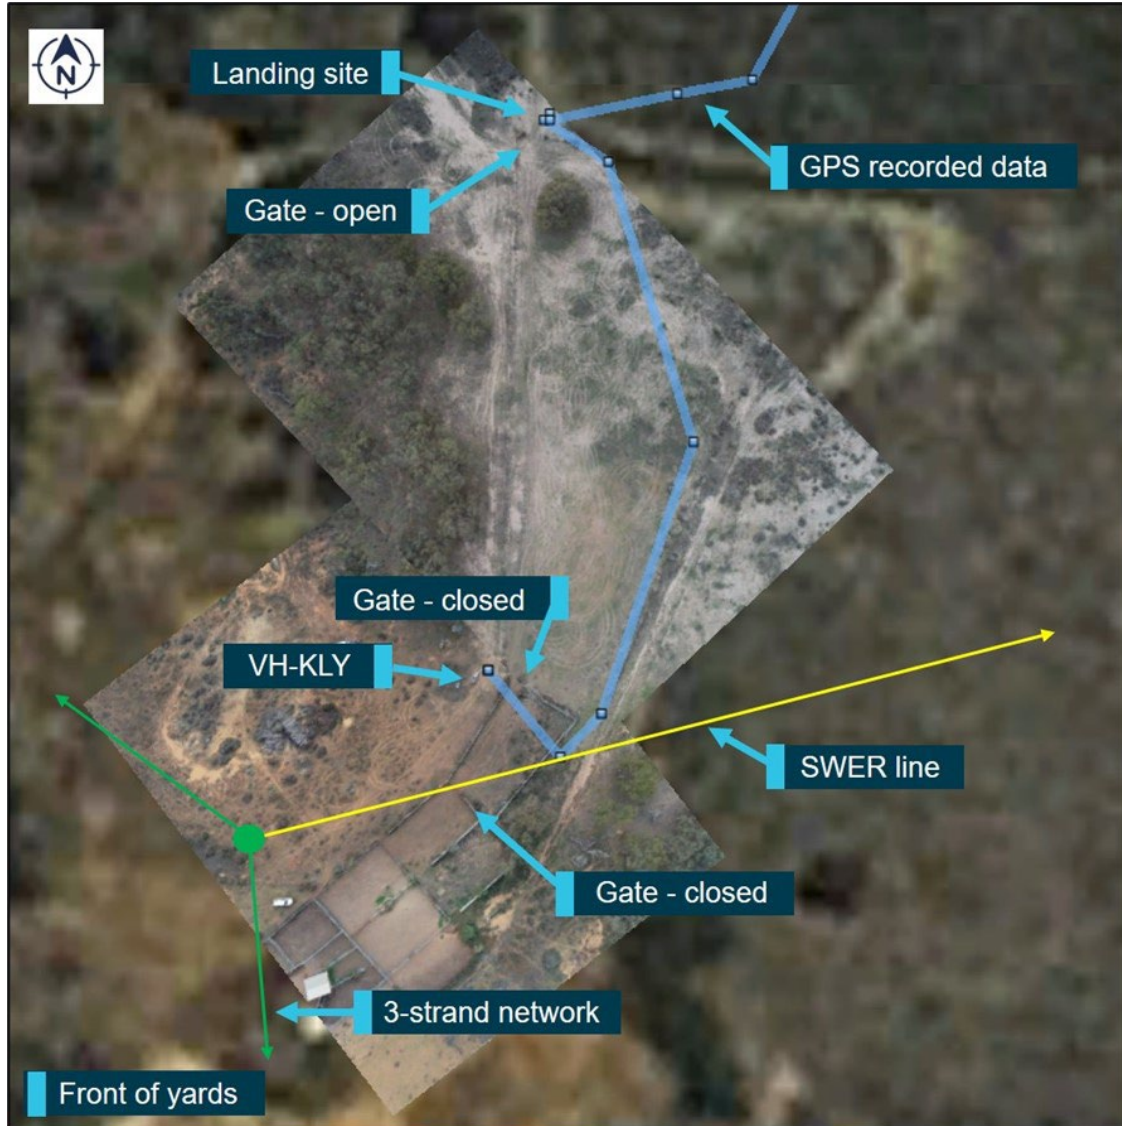
Figure 3: Flight track and powerline

A power pole (green dot in Figure 3) was located about 75 m west-south-west of the accident site. It had one network consisting of 3-strands, which ran along the front of the yards. Above this, a SWER network ran across the northern side of the yards. The single strand was attached at the top of the pole at 10.48 m (34.4 ft) above the ground.

A SWER line is a single line of intertwined narrow-gauge steel wires. It spanned approximately 351 m to the next pole in the network. The minimum ground clearance of the SWER line was 7.23 m (23.7 ft). There were no markers or other devices installed on the powerline to enhance its visibility, nor was there a requirement to install such devices.

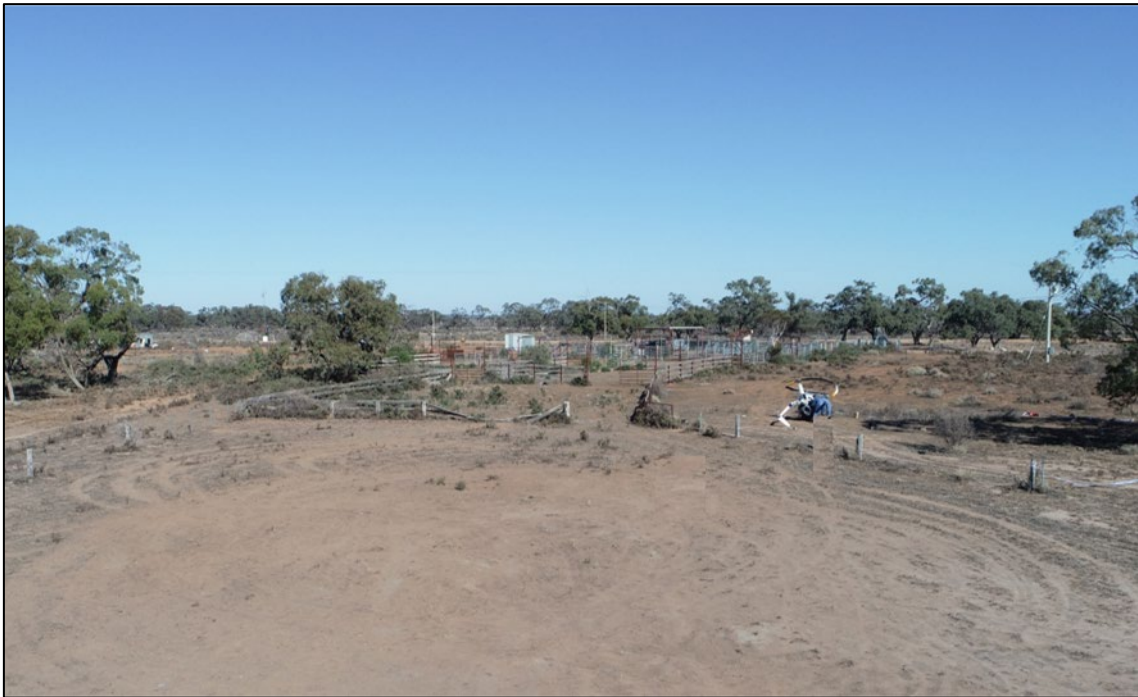
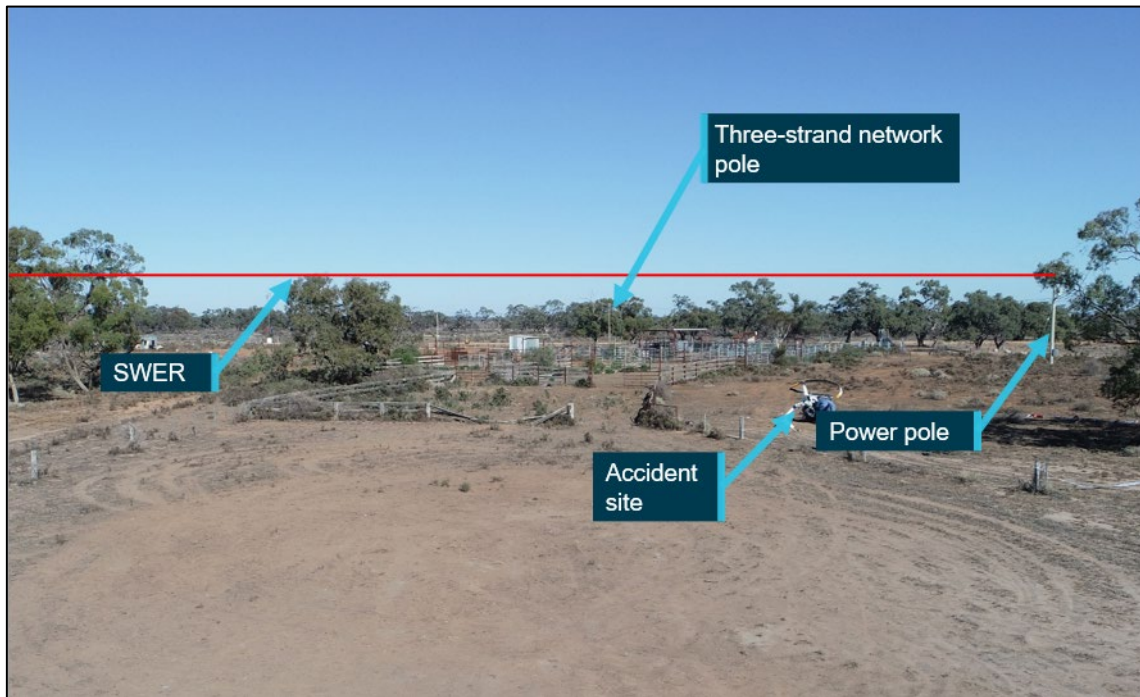
Figure 4: Image taken by RPAS along approximate helicopter flight path

Using a remotely piloted aircraft system (RPAS), the ATSB recreated the approximate flight path of the helicopter at about the time of day the accident occurred. The RPAS was flown at a similar speed and height above the ground to provide an appreciation of the pilot's perspective (Figure 4).

On the accident flight, the pilot flew in a southerly direction from the entrance of the yards, most likely with the intention of landing and opening a second gate to allow cattle to enter the yard. The SWER line, which crossed the yard, was very difficult to detect due to the:

- lack of contrast to the background
- next power pole in the SWER network being outside the pilot's normal field of view in the direction of flight
- absence of markers on the SWER line to increase the line's visibility.

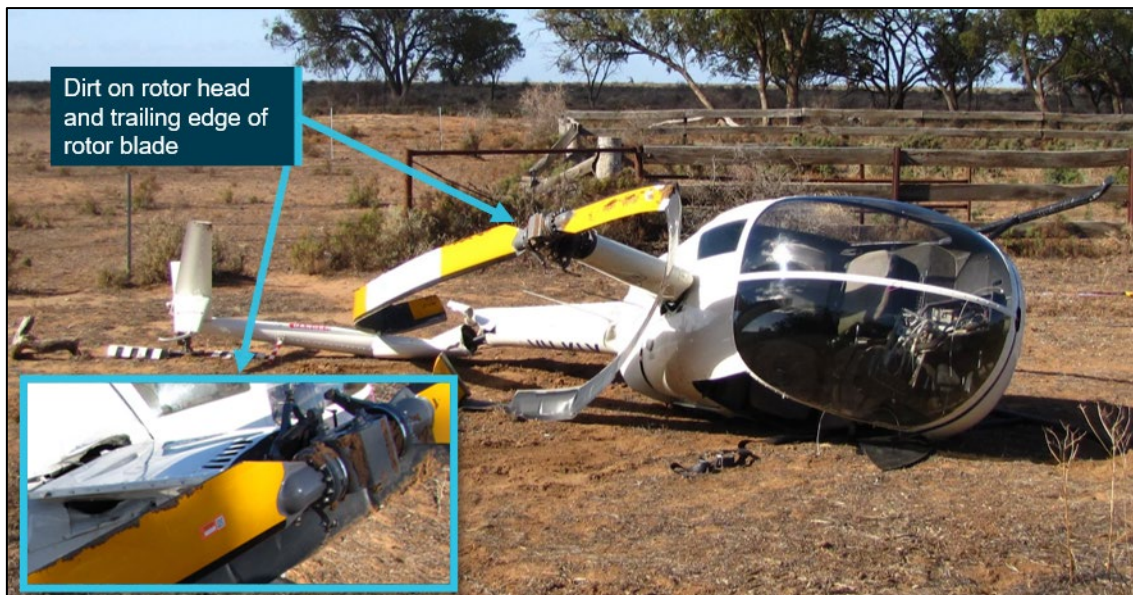
Figure 6: VH-KLY

All components of the helicopter were identified at the accident site. Examination of the site and wreckage indicated the helicopter collided with terrain largely inverted. Damage to the right side of the landing gear was consistent with a significant secondary impact, right side low and slightly nose up, before the helicopter came to rest on its right side, about 6 m from the initial impact point. The wreckage was located about 17 m from the SWER line.

The survivable space within the helicopter cabin was maintained throughout the accident sequence (Figure 6). The right (pilot) seat displayed minor creasing on the right side. The storage under the right seat was filled to the volumetric capacity,⁹ however, as the helicopter was inverted when it collided with terrain, this was not considered to have contributed to the pilot's injuries.

After contacting the wire, the helicopter collided with terrain in an inverted position. It then rolled over with the front of the right skid collapsing under the fuselage while coming to a rest on its right side.

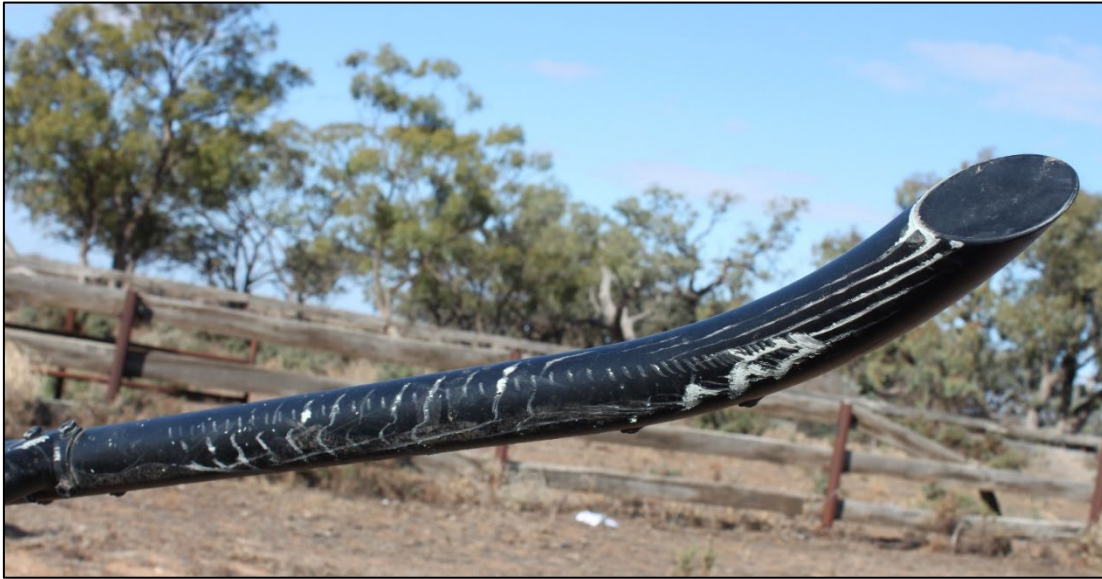
Figure 7: Landing gear front left skid

- dirt embedded in the main rotor head assembly, the top and leading edge of one blade and the trailing edge of the second blade, along with ground scars consistent with the main rotor head and blades
- the main rotor pitch links had failed in overstress
- main rotor blade strike to the tail cone
- no pre-existing defects with the rotors, drivetrain or flight controls that would have prevented normal flight
- several indicators that the engine was providing power at the point of impact
- the left skid, forward of the crosstube, had marks consistent with a wirestrike.⁸ The marks indicated that the relative contact had been both towards, and away from, the front crosstube (Figure 7)
- the right skid had collapsed under the fuselage.

The direction of the marks on the left skid indicate that the left skid contacted the SWER line on an oblique angle. The marks indicated the wire had rubbed along the skid toward the front crosstube, and then away from the tube. This, and the relatively low forward airspeed, likely contributed to the SWER line not being severed. It could not be determined if the pilot had observed the wire prior to contact and was trying to avoid it, or if they reacted as the wirestrike occurred.

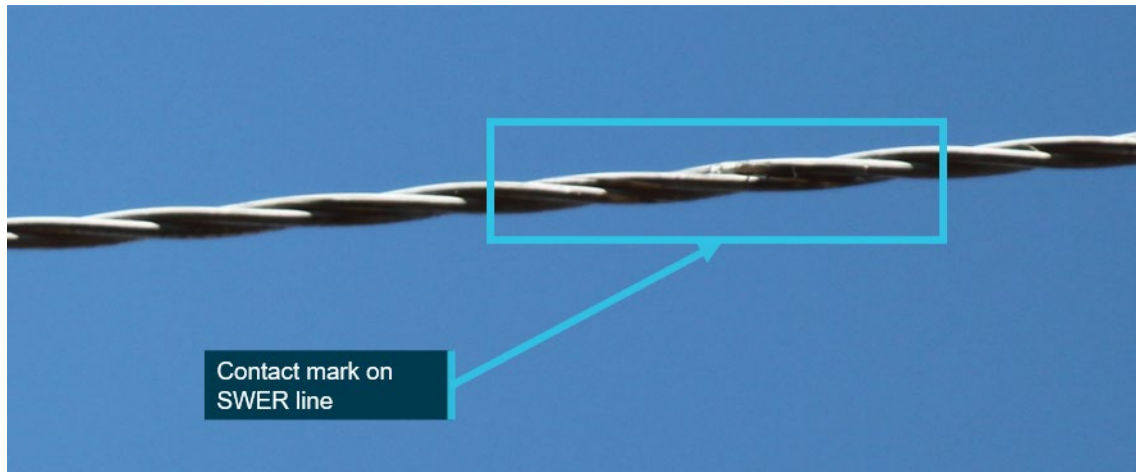
Figure 8: Contact mark on SWER line

The SWER line was found intact and the insulators on the power poles at either end of the span were undamaged. A polished area was observed on the SWER line in the approximate location of the flight path, consistent with it being contacted (Figure 8). Equipment available to the ATSB during the initial site visit was not sufficient to enable a close inspection of the wire. This mark was not visible when the ATSB returned to the accident site approximately 4 weeks later.
