Signal DP29 passed at danger involving suburban passenger train DW17 and near collision with another suburban passenger train

Park Road Station, Queensland, on 25 March 2019

ATSB Transport Safety Report

RO-2019-009

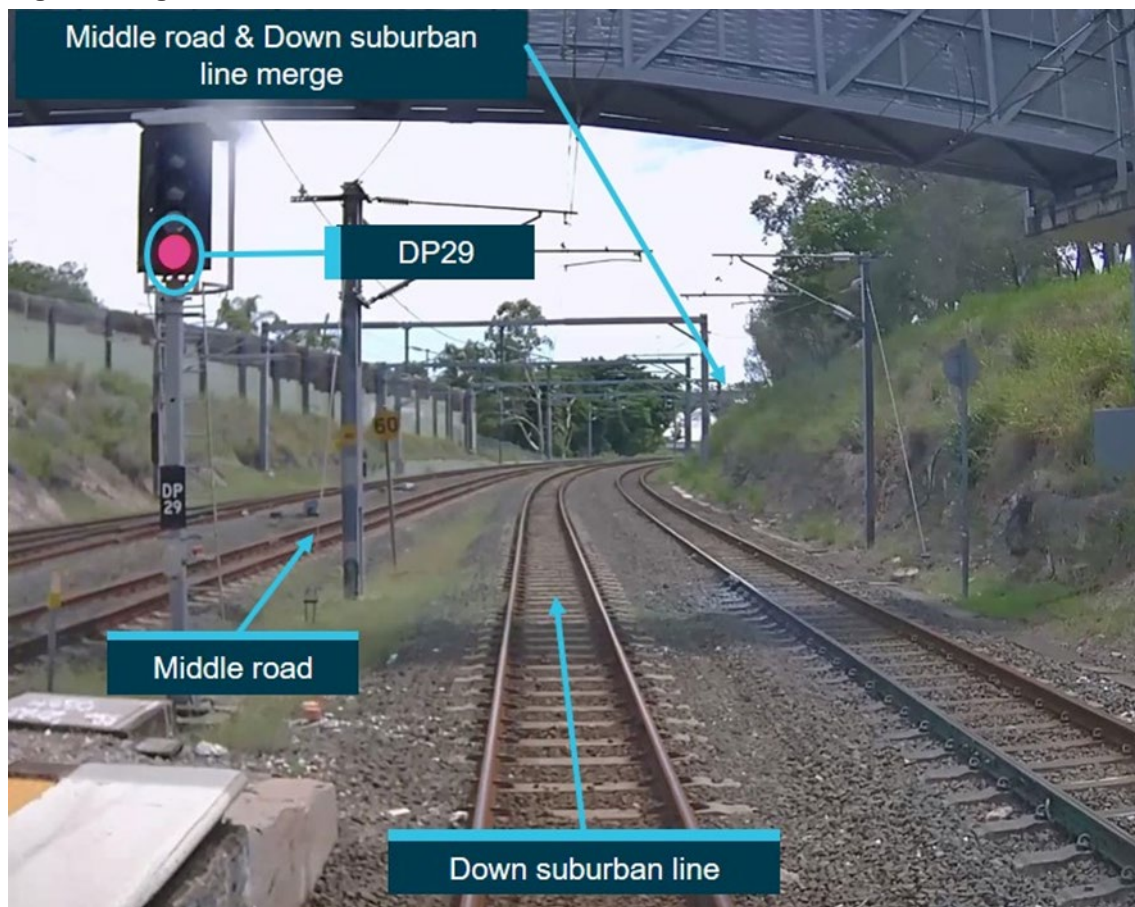
Figure 2: Signal DP29, the middle road and the down suburban line at Park Road Station

Signal DP29 was displaying a stop indication because the NCO had planned to briefly delay DW17 at the platform. This was to allow another suburban passenger train (1E65), which was running late, to proceed in advance of DW17 and pass through the middle road (platform 3) to connect with the down suburban line (Figure 2).

The image was taken from the forward-facing camera of DW17 on the day of the occurrence. It shows the down suburban line, which DW17 was traversing, and the red aspect in signal DP29. The middle road was set for the path of 1E65 to run in advance of DW17. Source: QR, modified by the ATSB

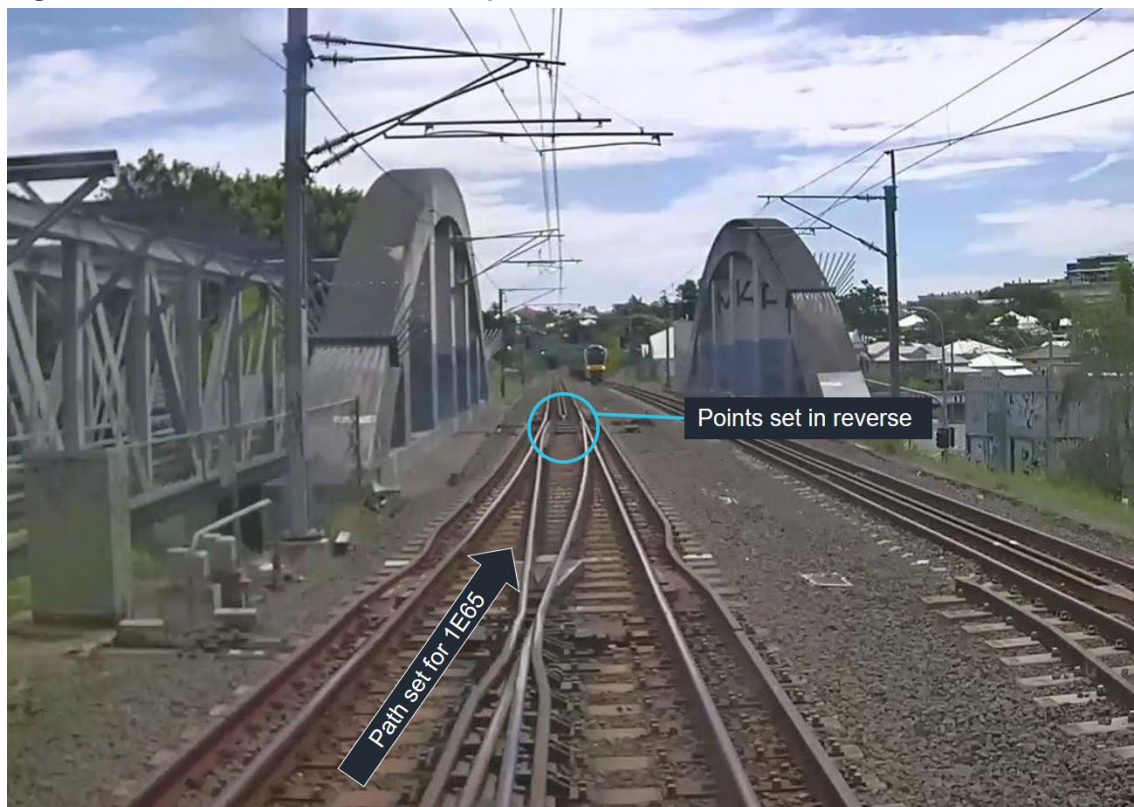
Figure 3: Points set in reverse for the path of 1E65

Initially, the driver of DW17 thought the emergency command was for another train, but then noticed the points ahead were set in reverse for the train on the middle road (that is, 1E65) (Figure 3). The driver then recognised that the emergency stop command related to their train, and that they had exceeded their limit of authority by passing signal DP29. At 1215:56, while travelling at 54 km/h, the driver applied the brakes, and the train came to a stop at 1216:08.

The image was taken from the forward-facing camera of DW17 immediately prior to the train running through the points that were set for 1E65.

The SPAD occurrence resulted in no injuries and only minor damage to rail infrastructure. The damage was due to DW17 running through the points, which were set in reverse to facilitate the movement of 1E65 from the middle road to the down suburban line at Park Road.

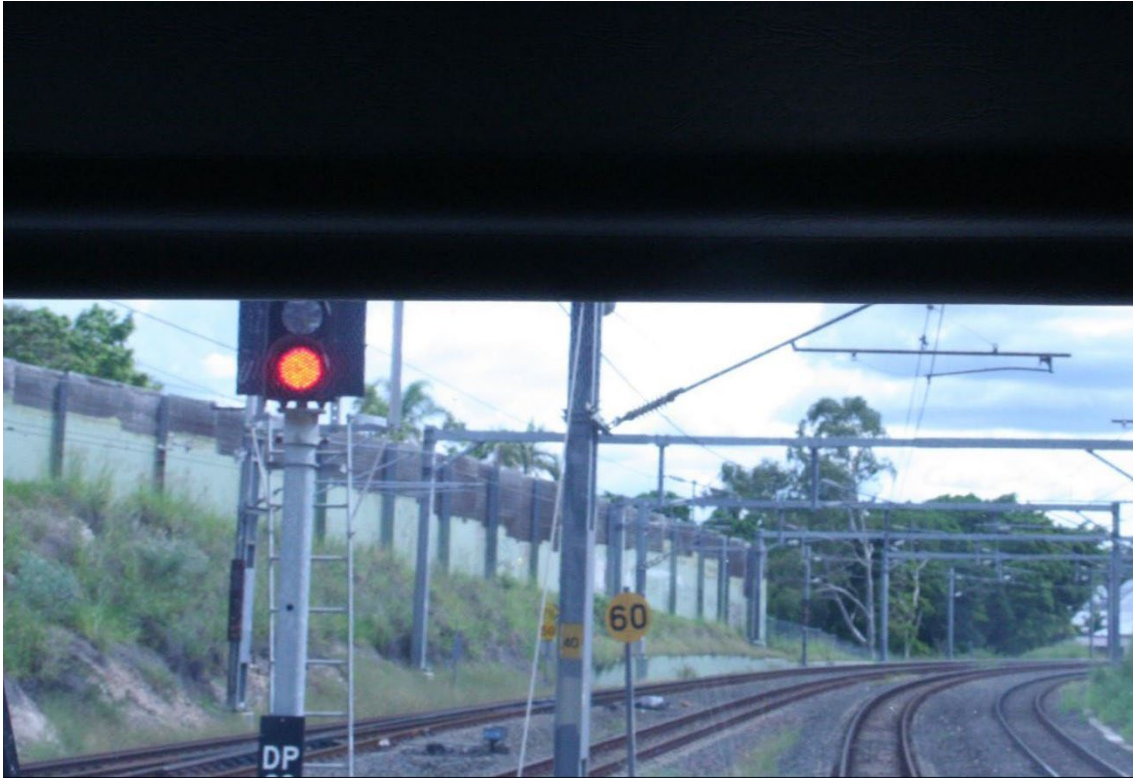
Figure 6: A view of signal DP29 from the driver's seat of an NGR service stopped at the 6-car stopping mark at platform 2 Park Road

The photo, taken from the driver's seat of an NGR service, shows the red aspect in signal DP29 with the front blind almost fully drawn.
Source: ATSB

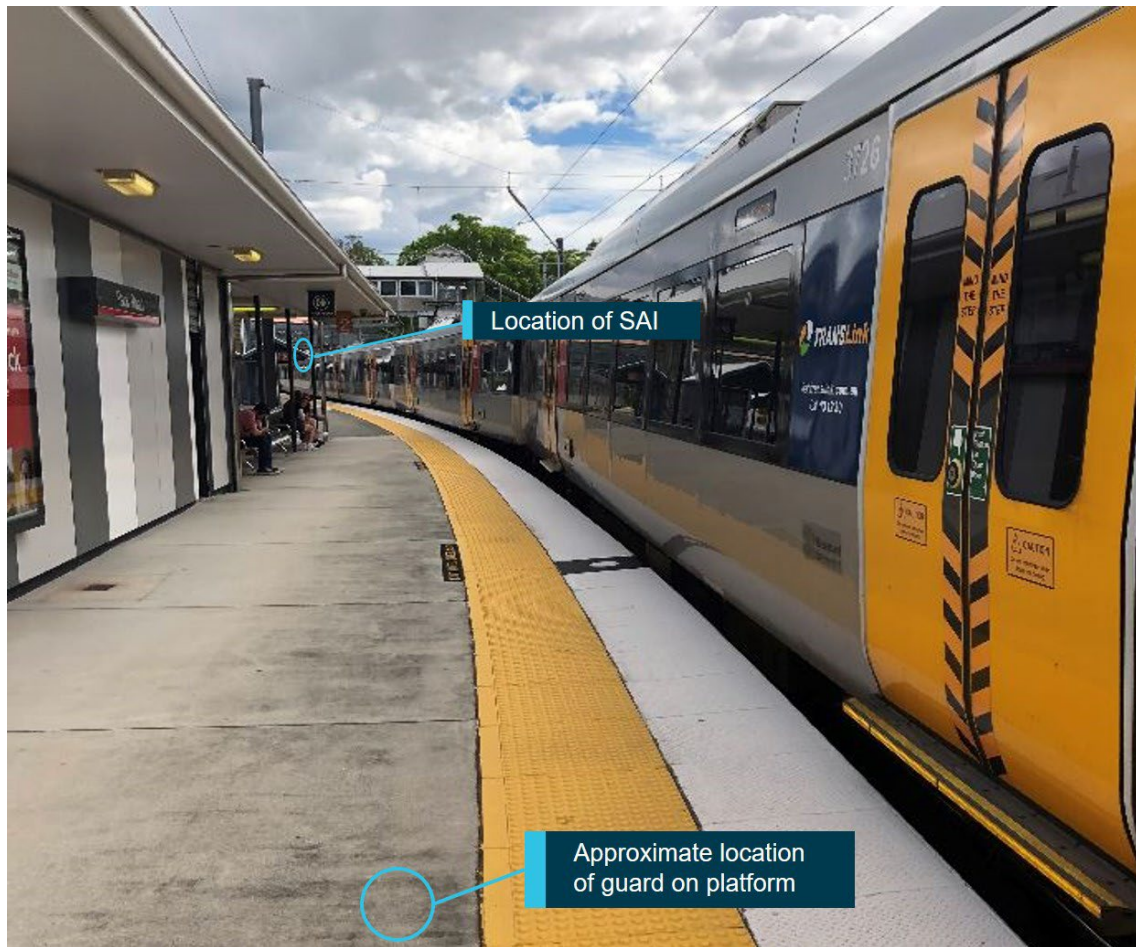
Figure 8: Location of the SAI relative to the location of the guard at Park Road platform 2

ATSB investigators visited Park Road Station to observe the SAI indicator on platform 2. They noted that, when the SAI was illuminated, the white light was reasonably distinct from its background. However, when not illuminated (as shown in Figure 8), the SAI was not distinct from its background as the black indicator face had little contrast with the awning on the platform shelter. In addition, depending on exactly where the train stopped, some thin building posts could partially obstruct the sighting of the SAI. It could also be obstructed by passengers on the platform.

The image shows the location of the SAI at platform 2 Park Road Station. Its location on the platform limited the viewing of the indicator from a guard's perspective, particularly when the indicator was not illuminated (as in this image).
Source: ATSB

The guard of DW17 stated that when illuminated, the LED lamps of SAIs were quite bright and distinct. They also said that the SAI at Park Road platform 2 was hard to see. As noted in *The occurrence*, the guard stated that they checked the SAI and noted that it was illuminated
