Mid-air collision involving Piper PA-44-180 Seminole, VH-JQF and Beech D95A Travel Air, VH-AEM

8 km south of Mangalore Airport, Victoria on 19 February 2020

ATSB Transport Safety Report

AO-2020-012

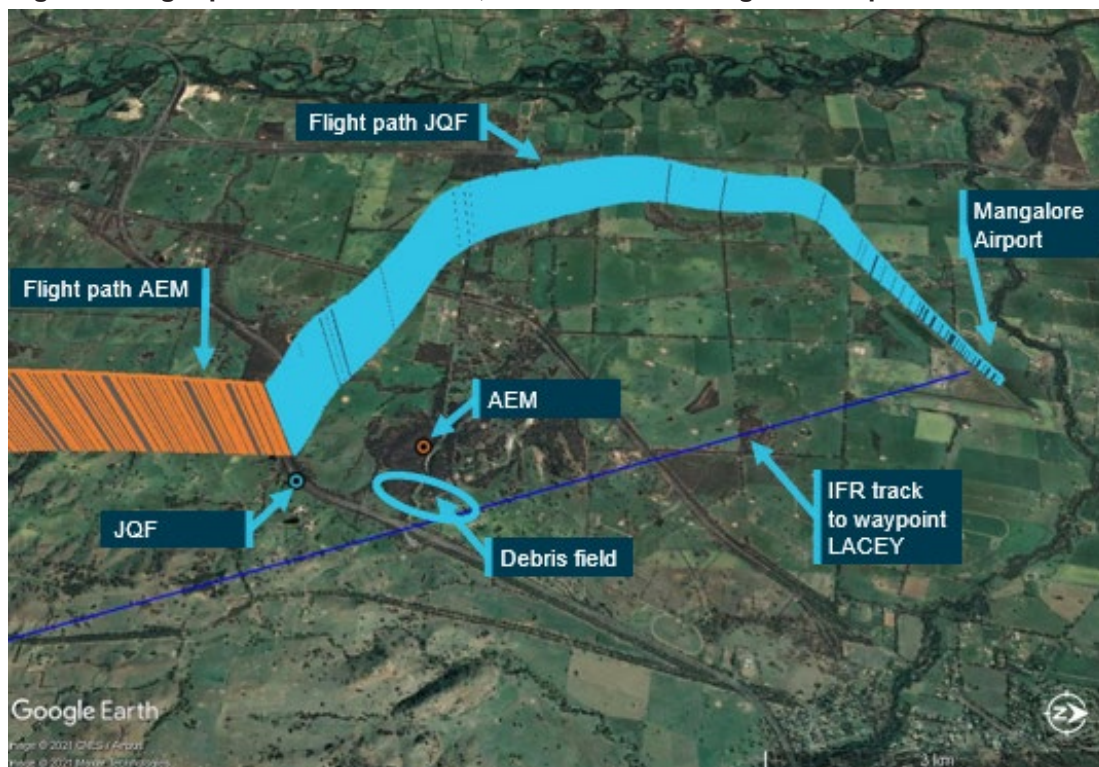
Figure 2: Flight path of AEM and JQF, and location of the ground impact of both aircraft

The two aircraft impacted the ground about 1.3 km apart (Figure 2). Some lighter debris from each aircraft was located at a third location downwind from the collision point. All four pilots were fatally injured in the accident, and both aircraft were destroyed.

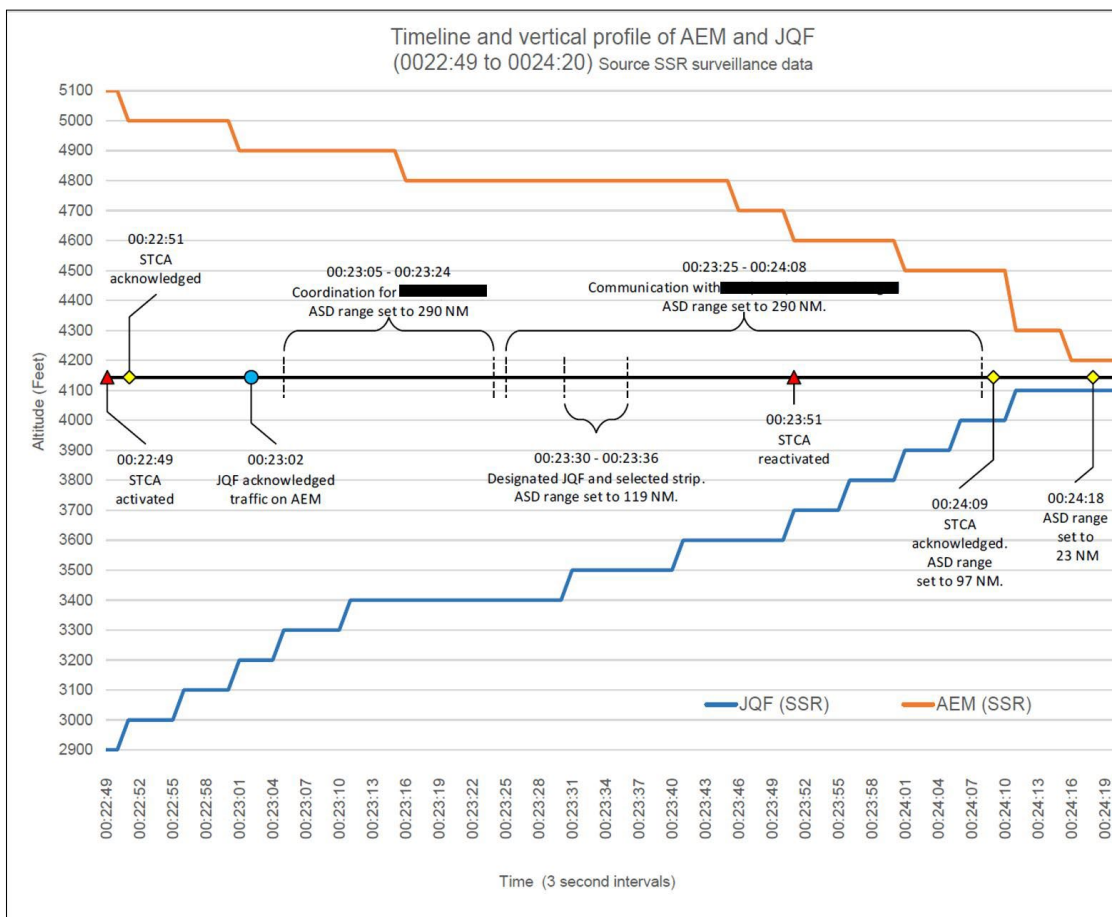
Figure 12: STCA activation and vertical profiles of AEM and JQF

In the time between JQF taking off and the collision, there were three STCA alerts generated (Figure 12).

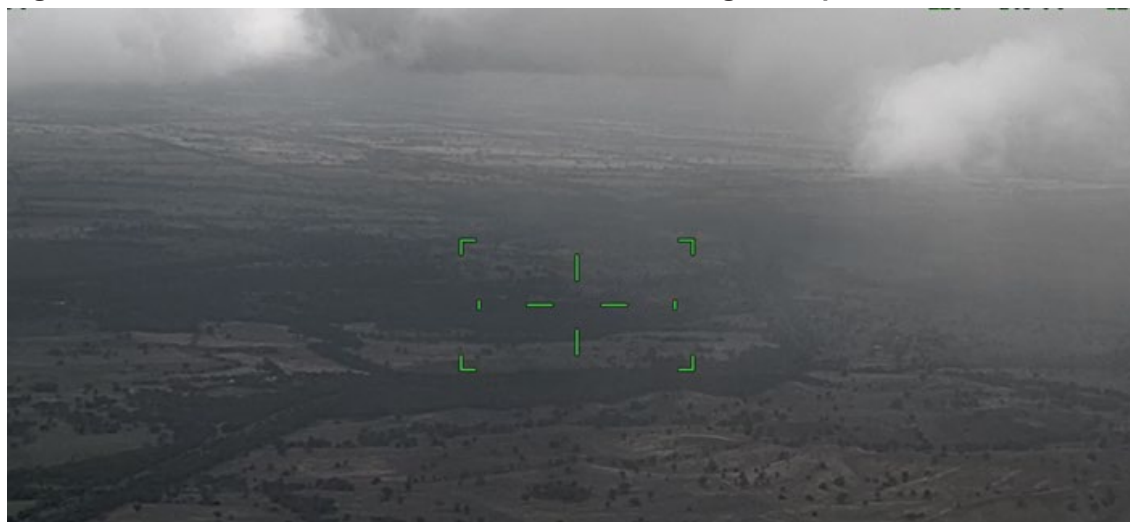
Figure 19: View of cloud from the Victoria Police Air Wing helicopter

Video imagery recorded by the Victoria Police Air Wing (Figure 19) near the accident site at 1240, 1 hour and 16 minutes after the accident showed a broken layer of cloud at approximately 4,050 ft AMSL with some lower patches of cloud also present. This is just below the approximate height of the collision (4,100 ft)

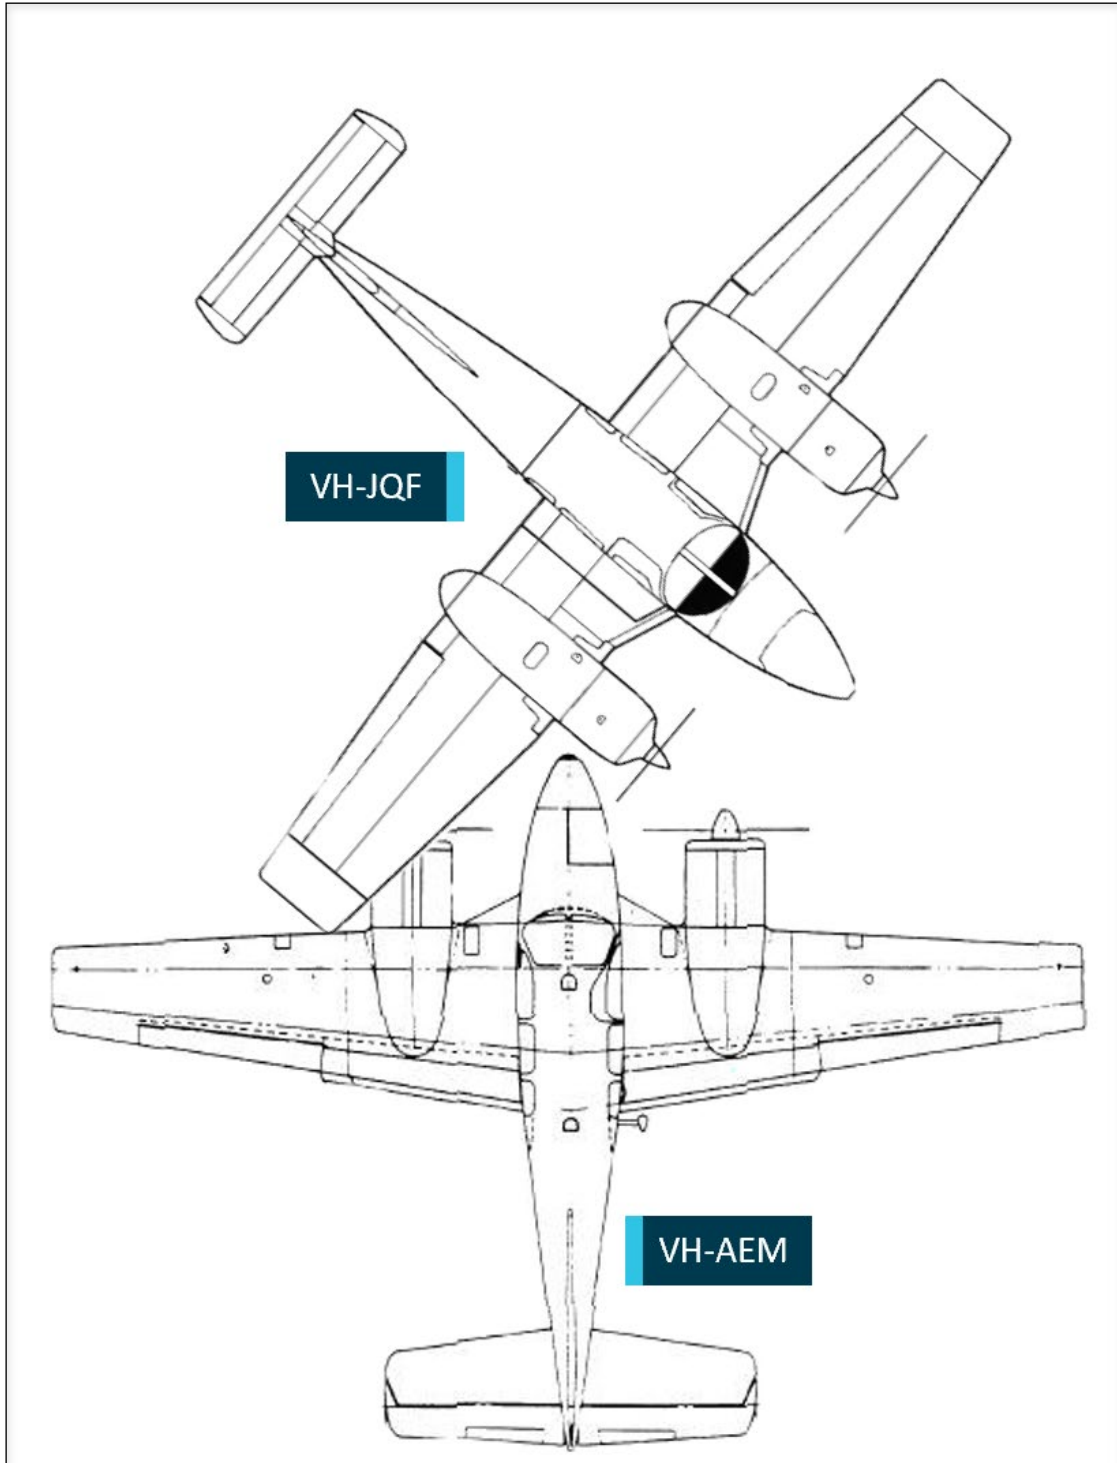
Figure 24: Estimated collision aspect based on ADS-B data and wreckage assessment

Analysis of the wreckage from each aircraft indicated that the two aircraft came together at an obtuse relative angle with JQF crossing over the top of the AEM (Figure 24).
