# Collision between coal trains MB526 and AH378

Kooragang, New South Wales, on 29 July 2020

**ATSB Transport Safety Report**  
Rail Occurrence Investigation (Short)  
RO-2020-013  
Final – 4 April 2022

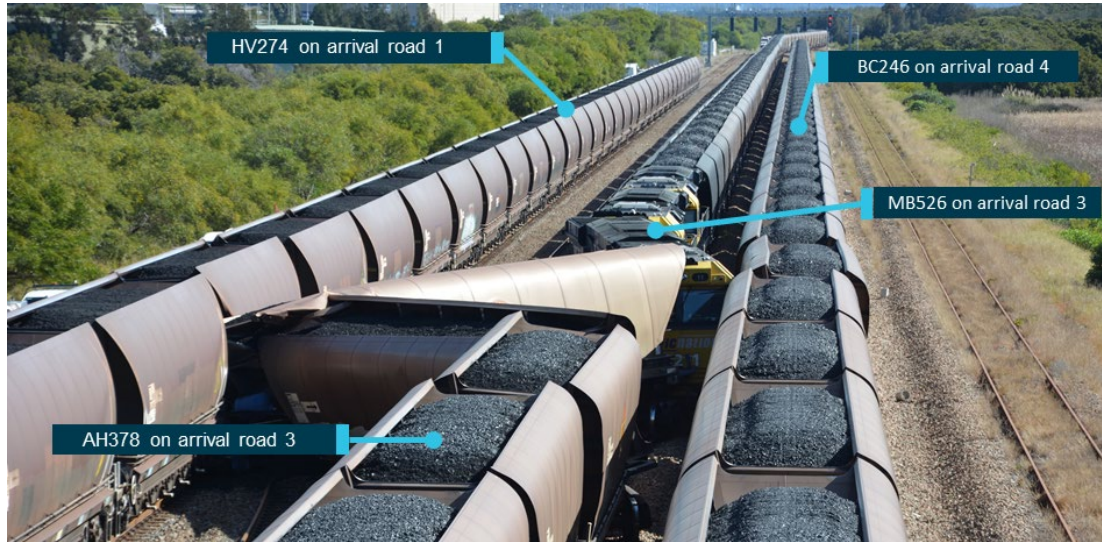
Figure 3: Collision site

As a result of the collision, MB526's lead locomotive (9211) derailed to the left, impacting and derailing a wagon of ORA coal train BC246 on arrival road 4. The wagon (PHWH0214S) remained upright and coupled to the remainder of BC246. AH378's rear two wagons (PHEH01514D and PHEH01513R), derailed to the right and struck PN coal train HV274, derailing a wagon (NHRH50410Q), this wagon remained upright and coupled to HV274 (Figure 3).

The incident also resulted in damage to approximately 70 m of rail and concrete sleepers on number 2 and 3 arrival roads.

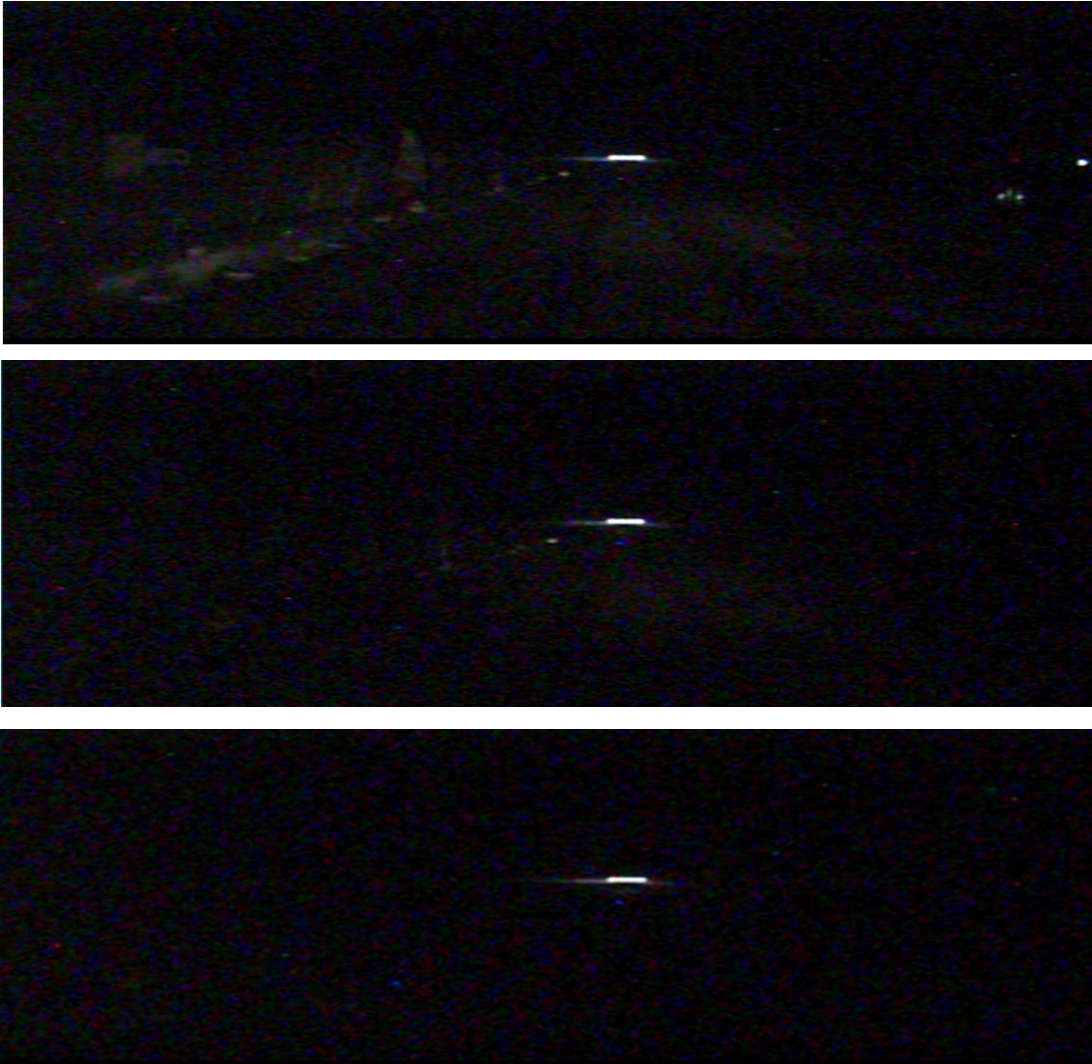
**Figure 4: Video onboard MB526 three seconds apart, showing outside visibility with headlights on Bright mode (upper), Dim mode (middle) and off (lower)**

MB526 was equipped with a front-facing video camera and the ATSB reviewed footage of the approach along arrival road 3. The video (as captured in Figure 4) showed that conditions were dark, and that after the train drivers extinguished the headlights, nothing was visible outside apart from distant artificial lighting.

The front-facing video from MB526 showed the driver turned the headlights to Dim mode before turning the headlights off after passing HV274. When the headlights were turned to Dim mode, visibility ahead of the train was significantly reduced.

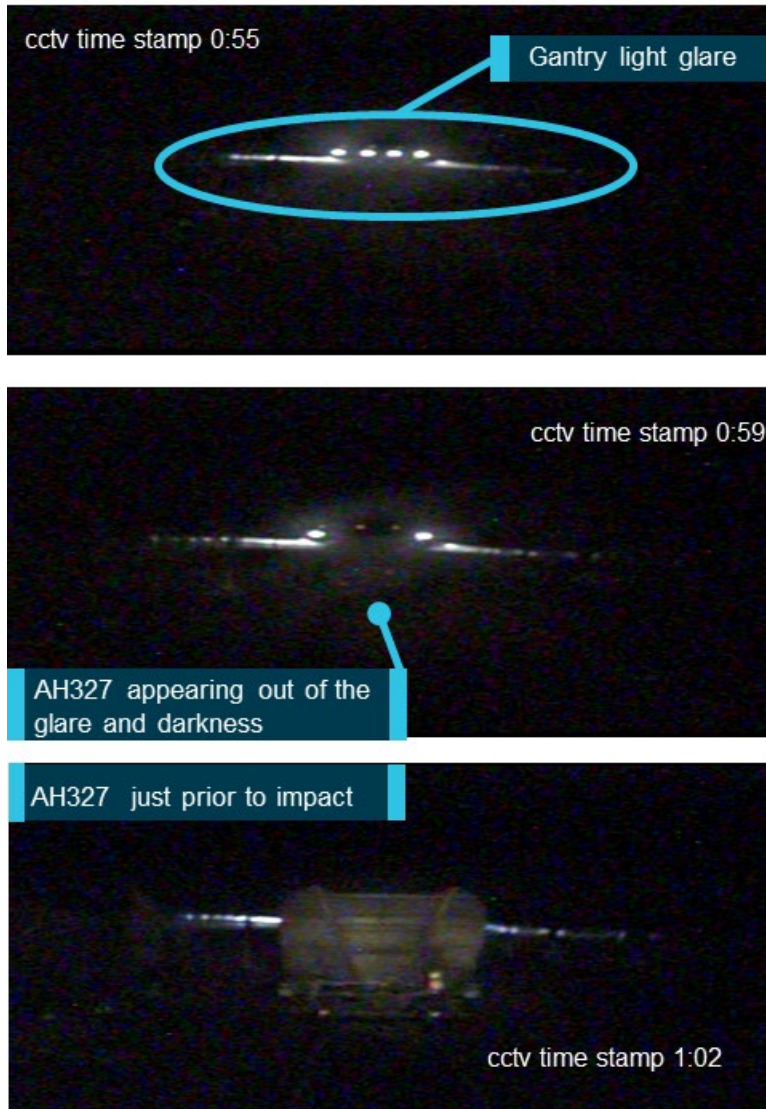
Figure 5: MB526 front of train CCTV frames over 7 seconds

The rear of train AH378 was 110 m before the overhead gantry signal K31, in MB526's direction of travel. Video footage from MB526 showed that as the train approached the gantry, the gantry lights appeared to produce a halo of light which occluded the surrounding area. The rear of train AH378 only became visible in the video footage a few seconds prior to impact. The drivers of train MB526 did not mention any problems associated with the overhead gantry but did recall that AH378 appeared to "come out of nowhere" (Figure 5).

Ahead of train MB526 was train AH378, immediately ahead of the overhead gantry displaying signal K31. Bright lights can sometimes cause visual problems due to extra light being scattered within the eye onto the retina, thereby reducing contrast of the retinal image.<sup>7</sup> Where this causes some loss of visual capability, this is described as ‘disability glare’. Footage from the forward-facing video recorded from MB526 showed that the gantry lights appeared very bright, which may have caused disability glare for the drivers and impaired their vision of the track (and train) ahead.

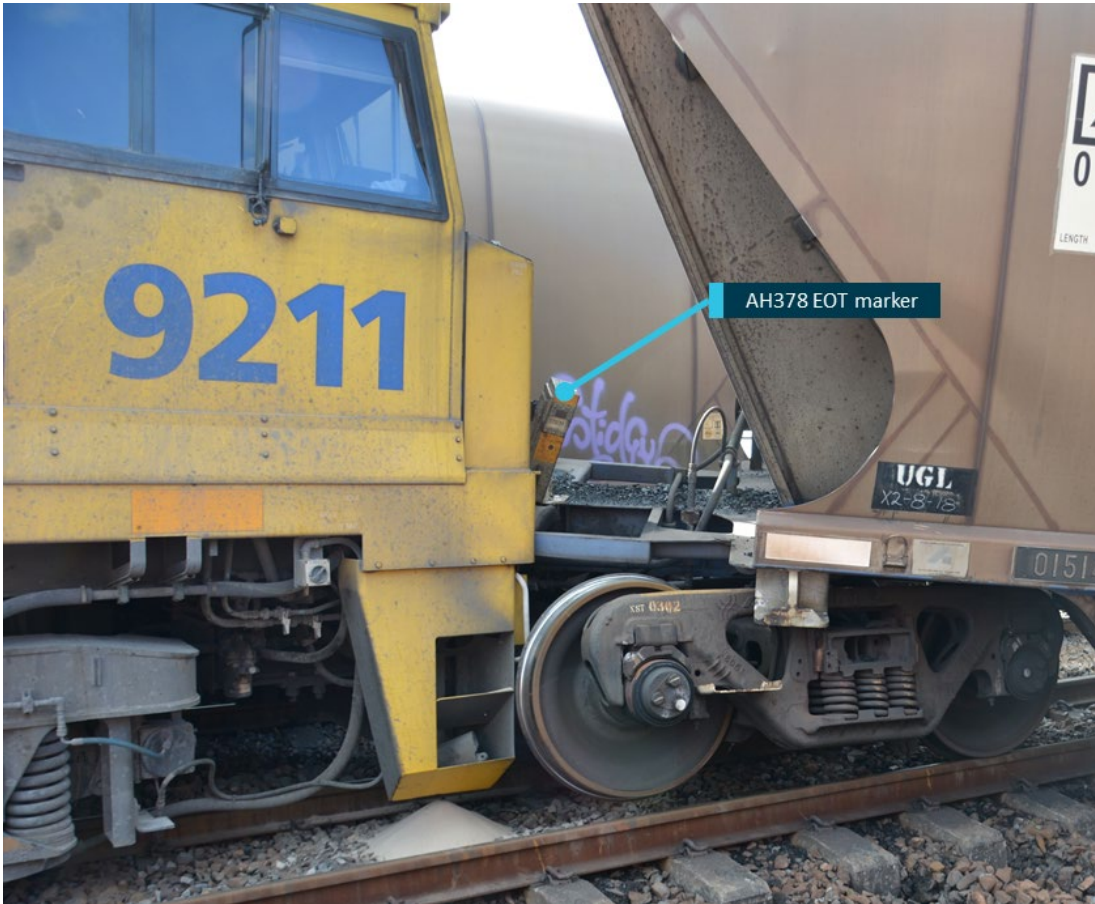
Figure 6: EOT marker light and impact point

The ECP cable also provides power to the train EOT light (Figure 6), if the ECP fails or is turned off, the EOT light extinguishes. The EOT light on the rear wagon of AH378 was extinguished at the time of the accident. The last wagon on AH378 also had reflective discs to assist with visibility in lowlight conditions.

ORA instigated a review of their asset management plan to include programmed monitoring of EOT lights. On 28 August 2020, ORA also circulated safety information (Notice to Drivers -HV-0046) to all their drivers. This notice reminded drivers of the requirement to communicate with network control all conditions affecting the network. The notice also informed train crew that when ECP is ended the EOT light extinguishes. ORA provided copies of network rules *ANGE232 Responsibilities of Rail Traffic Crews and ARTC Network Rule ANTR416 Disabled Trains* with the notice to drivers.

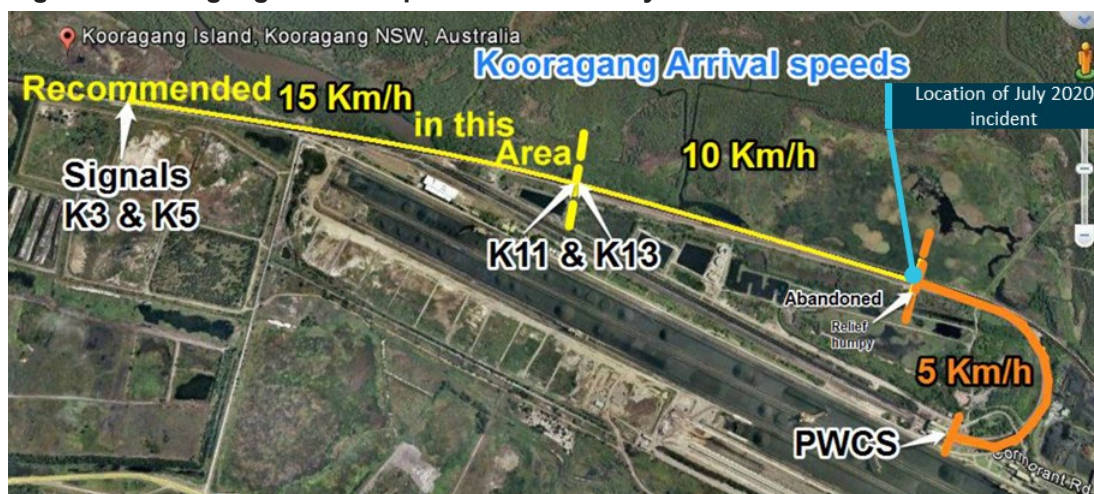
**Figure 8: Kooragang reduced speed limit issued by PN in 2012**

On 26 September 2012, PN issued a Divisional Safety Notice (DSN 15/12) which superseded the Local Safety Notice. DSN 15/12 imposed a speed limit of 10 km/h on PN trains from signal K13 (174.180 km) until they reached a brick building (adjacent to the position of the July 2020 collision location at 176.160 km). From the point adjacent to the brick building to the dump stations a speed of 5 km/h was imposed (Figure 8). This speed limit was less than the posted 25 km/h ARTC limit.

The PN self-imposed speed limit was discontinued before the time of the July 2020 accident.

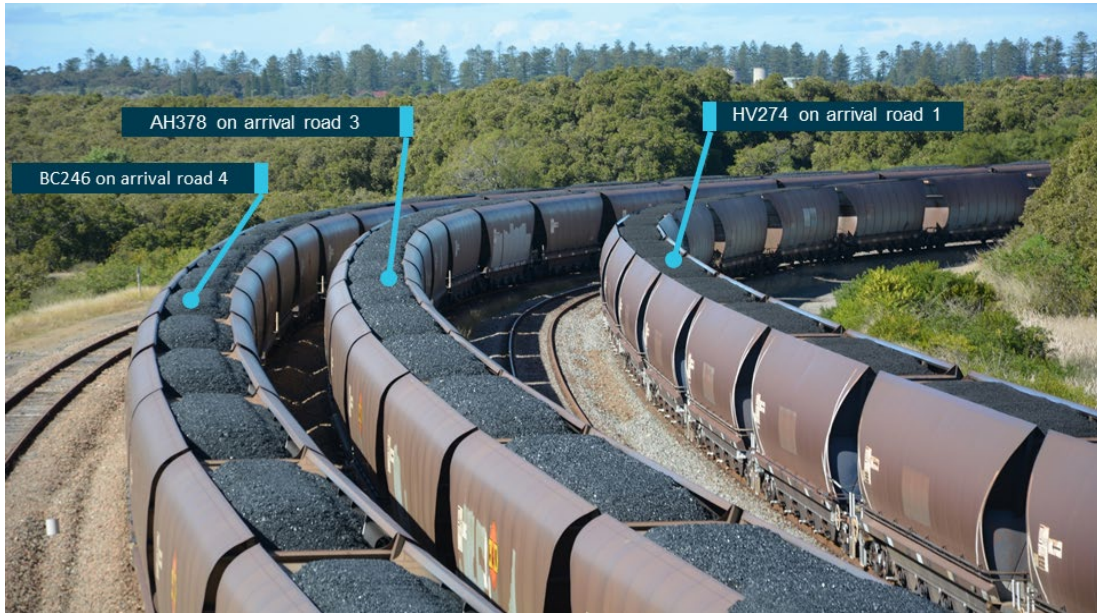
**Figure 9: Bend in Kooragang arrival roads**

When interviewed the crew said, that confirming the location of the train with the unlit EOT (HV274) that they had been warned about and the absence of any EOT light in front led them to relax, as the situation appeared as they expected. The driver expected the train ahead was around the corner and was preparing to slow MB526 as they passed the next signal before they reached the turn (Figure 11).
