Collision with terrain involving amateur-built Osprey 2 amphibian aircraft, registered VH-WID

Near Maitland Airport, New South Wales on 17 May 2020

AO-2020-028

Final – 4 April 2022

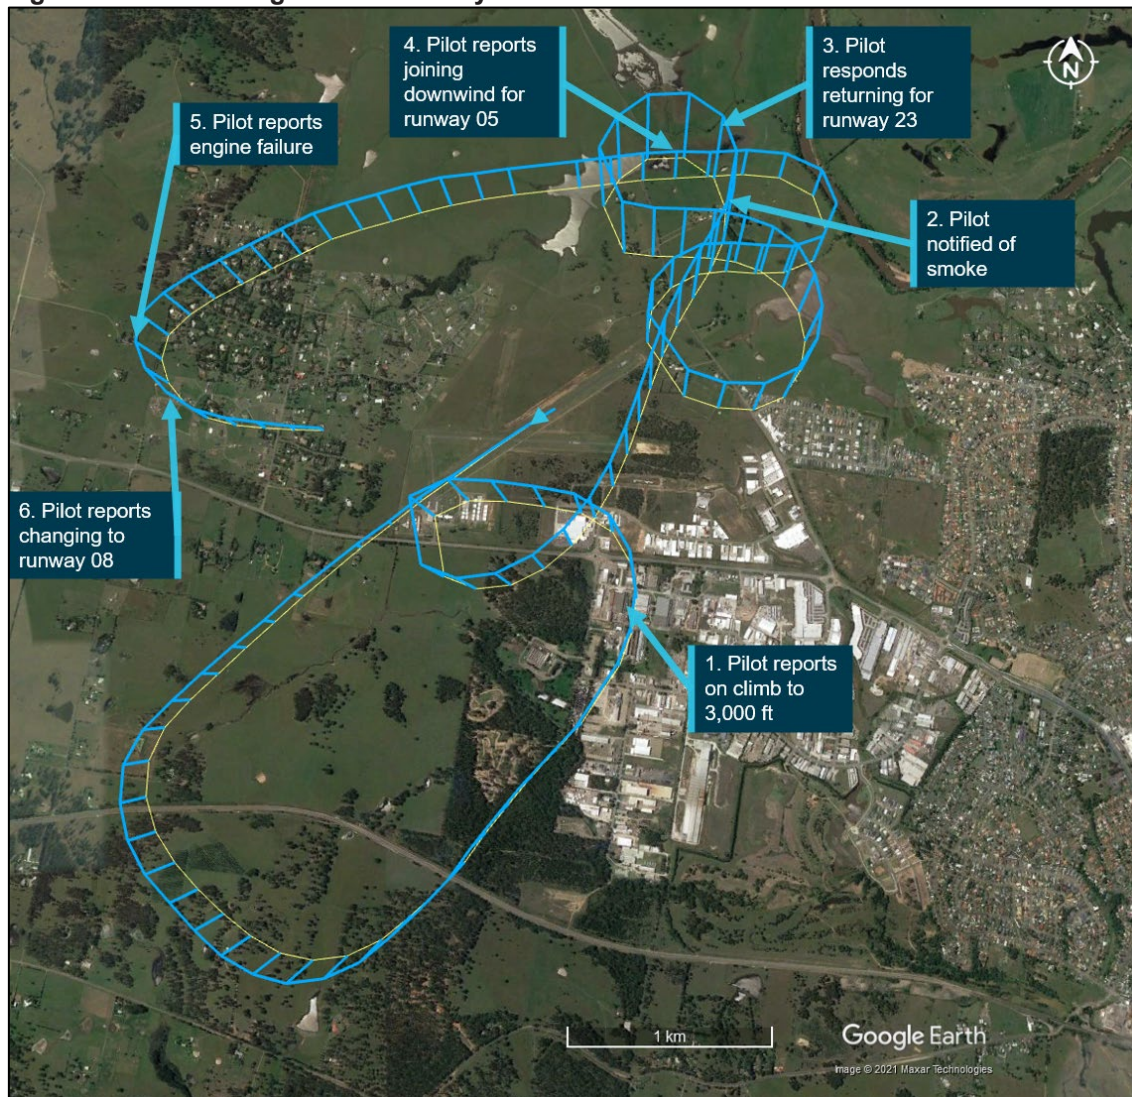
Figure 1: Accident flight track and key events

The pilot of WID commenced a descending left orbit to the north of the airport. However, instead of continuing the descent to land on the previously-advised runway 23, they stopped the descent at about 1,000 ft AGL and conducted a turn in the opposite direction. They then turned to join the circuit for runway 05, advising on the CTAF they were joining downwind (Number 4 in Figure 1). The pilot subsequently increased the engine power and climbed to maintain between 1,100 and 1,200 ft AGL on a widening downwind leg.

As the aircraft turned base for runway 05, (about 5 minutes after the pilot was advised of smoke from the aircraft) the engine stopped. The pilot made a broadcast to advise they had a 'complete engine failure' and they were conducting a glide approach to runway 05, which they quickly changed to runway 08 (Numbers 5 and 6 in Figure 1).

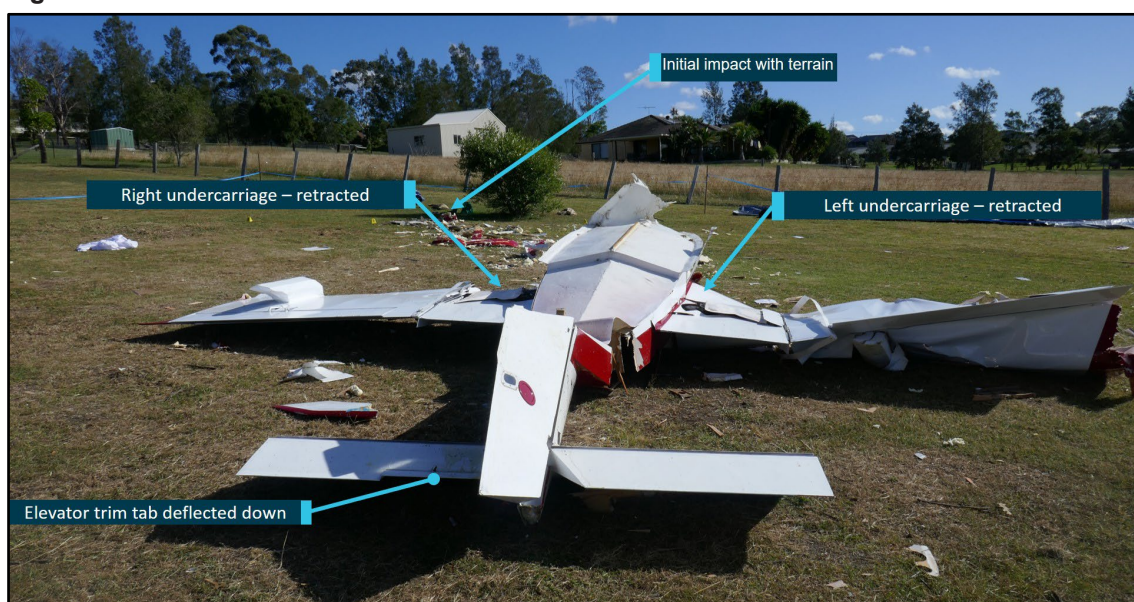
Figure 3: Accident site

The distance from the first impact point to the last item of wreckage was about 27 m, with the engine and fuselage coming to rest about 11 m from the initial impact point. This, along with the angle at which the impact occurred, suggested a low forward speed. There was no post-impact fire.

All the major aircraft components were accounted for at the site. The inspection also identified that:

- the flight control system was intact, with no defects identified that may have contributed to the accident
- while the main landing gear was found retracted, video evidence indicated that the gear was extended for the duration of the flight, as such retraction likely occurred during the accident sequence
- one of the propeller blades was significantly fragmented while the other remained intact
- the oil supply line from the engine to the oil cooler was disconnected (Figure 4)
- the engine cowl, rear fuselage, and empennage were heavily coated with engine oil, with streams forming as the oil migrated on the surfaces (Figure 5)
- there was no oil in the engine
- the oil gauge/filler tube was broken at the base where it attached to the engine lower crankcase assembly (Figure 4)
- the crankcase below the no. 1 cylinder was perforated (see the section titled *Engine inspection*).

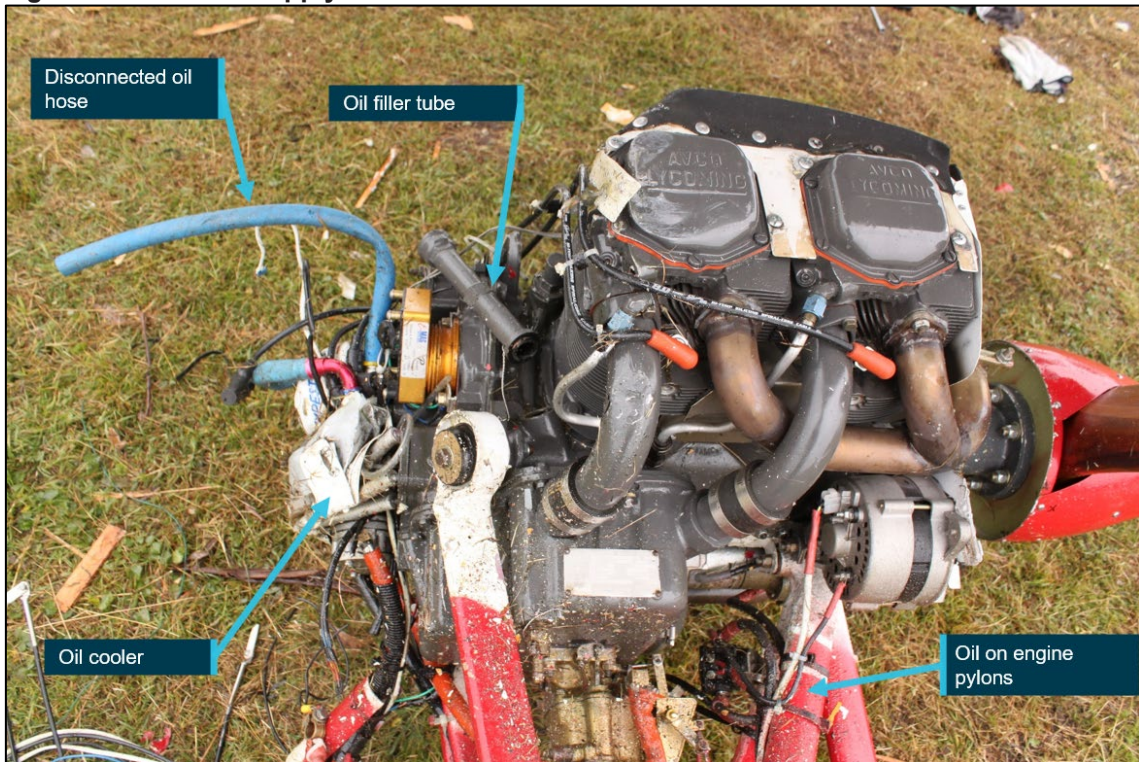
Figure 4: Oil cooler supply hose disconnected

An oil cooler removes surplus heat from an internal combustion engine. The oil pump transfers the oil from the sump through a supply hose to the oil cooler. The return hose passes the oil through an oil filter and then on to lubricate and cool the engine. The supply hose to the oil cooler was found disconnected at the accident site (Figure 8).

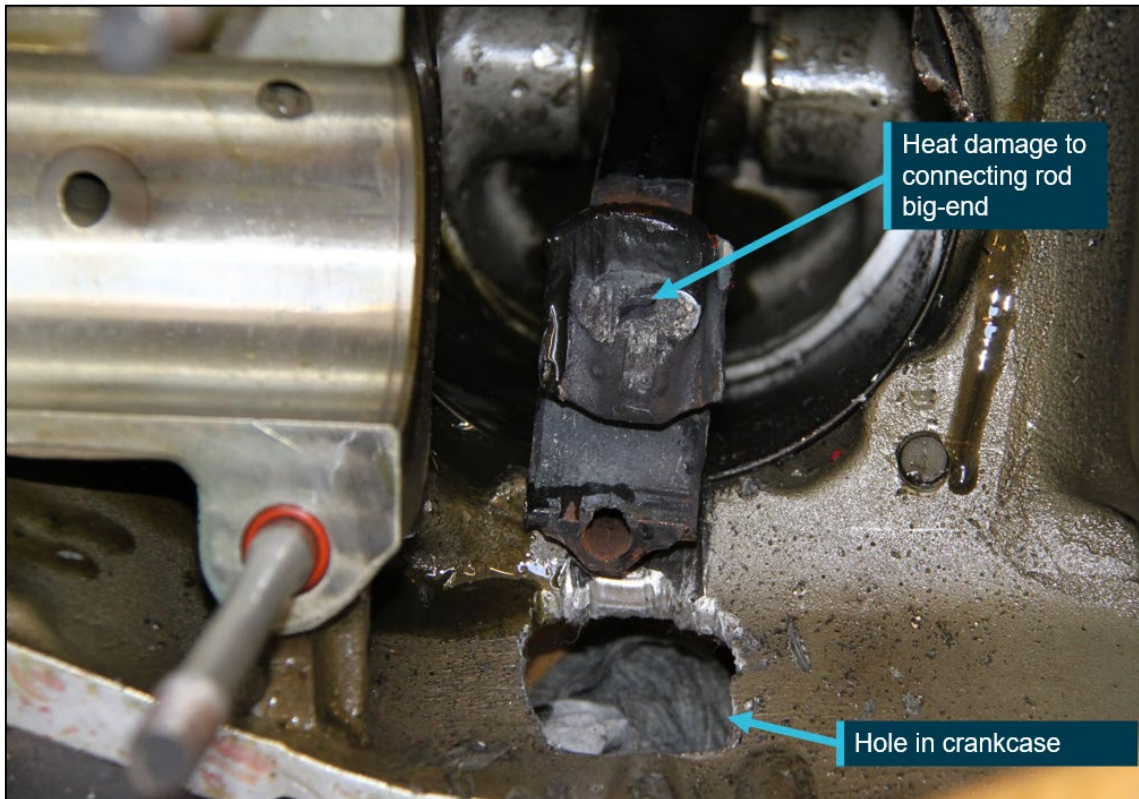
Figure 6: Number one cylinder damage

The engine was inspected at an independent CASA-approved engine overhaul facility. The inspection found signs of internal damage indicative of an engine that had been starved of lubricating oil. The inspection also found that:

- the connecting rod in the no. 1 cylinder had separated at the big-end (Figure 6), most likely resulting in the observed hole in the crankcase (Figure 6 and Figure 7)
- the crankshaft journals¹¹ exhibited various levels of heat damage (Figure 7)
- within the no. 3 cylinder, corrosion was observed on the bolts on the connecting rod and the bearings were heavily distressed with copper discolouration and deformed on one side
- within the no. 4 cylinder, while oil was observed in the connecting rod bearing, it was discoloured black
- all oil galleries were clear of obstructions.

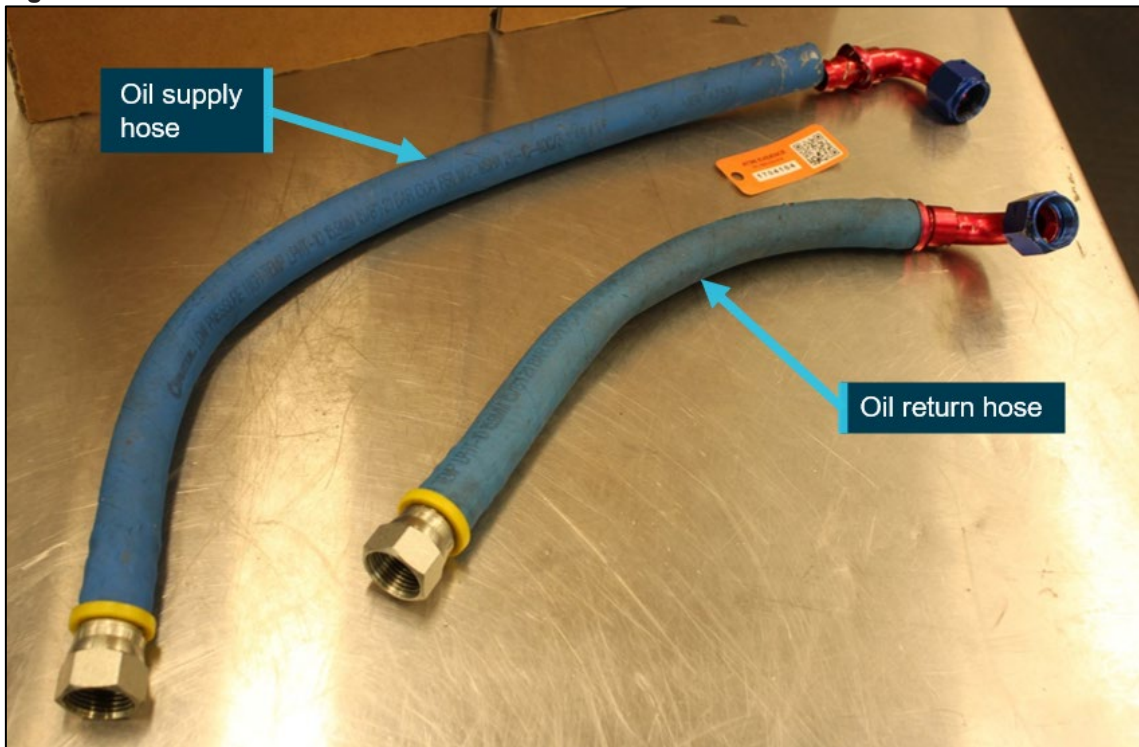
Figure 9: Oil hose assemblies

The hose assembly at the top of the image is the oil cooler supply hose which was found disconnected at the accident site. The lower hose is the oil cooler return hose. The lighting in this photo resulted in the silver coloured fittings appearing brass coloured.

The two hose assemblies were similar in construction but of different lengths. It was reported that the hoses were most likely cut from the same length of hose (Figure 9) however, they were different shades of blue. The hoses had a polyester textile outer braid with an internal textile reinforcement. They were designed to be used in low pressure, high temperature applications to carry petroleum-based products including lubricating fluids, hydraulic and transmission oils. Crazeing was found on the outer surface of both hoses but was more significant on the detached oil cooler supply hose (Figure 10).

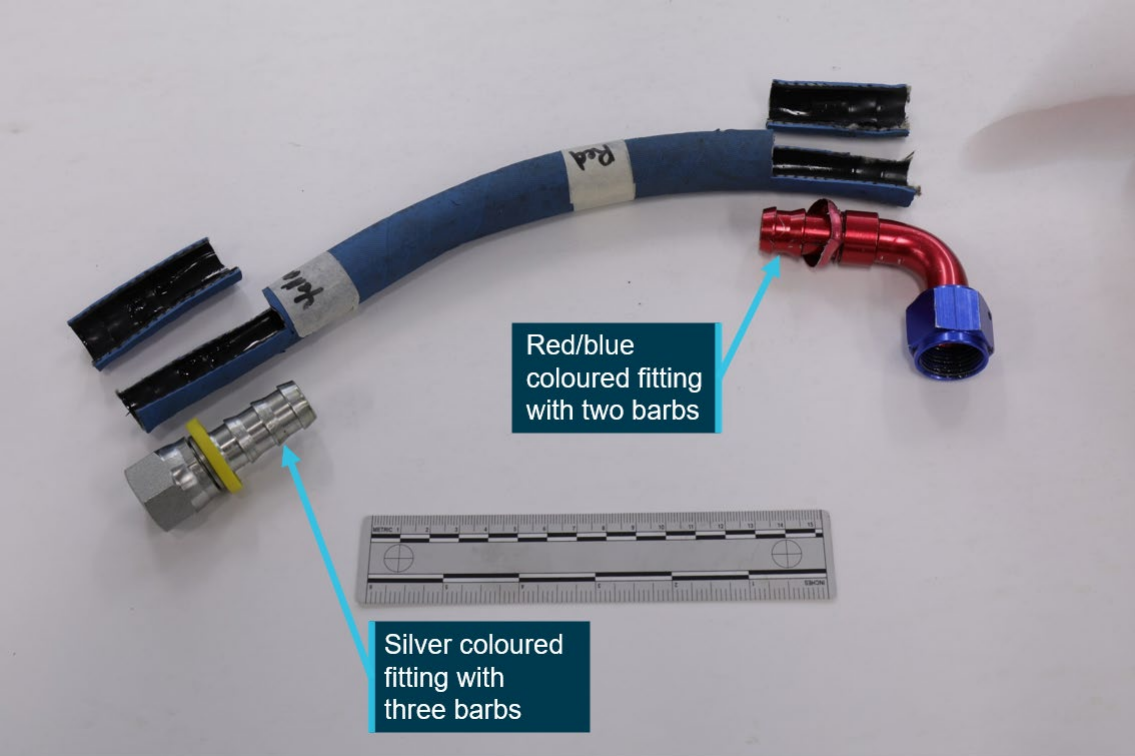
Figure 11: Hose and fittings

On each hose assembly, the end connected to the engine had a straight, silver colour plated mild-steel fitting, with three barbs and a yellow collar. The end connected to the oil cooler had a 90° curved, red and blue aluminium alloy fitting, with two barbs (Figure 11–Figure 13). Table 1 lists the differences between the two fittings.

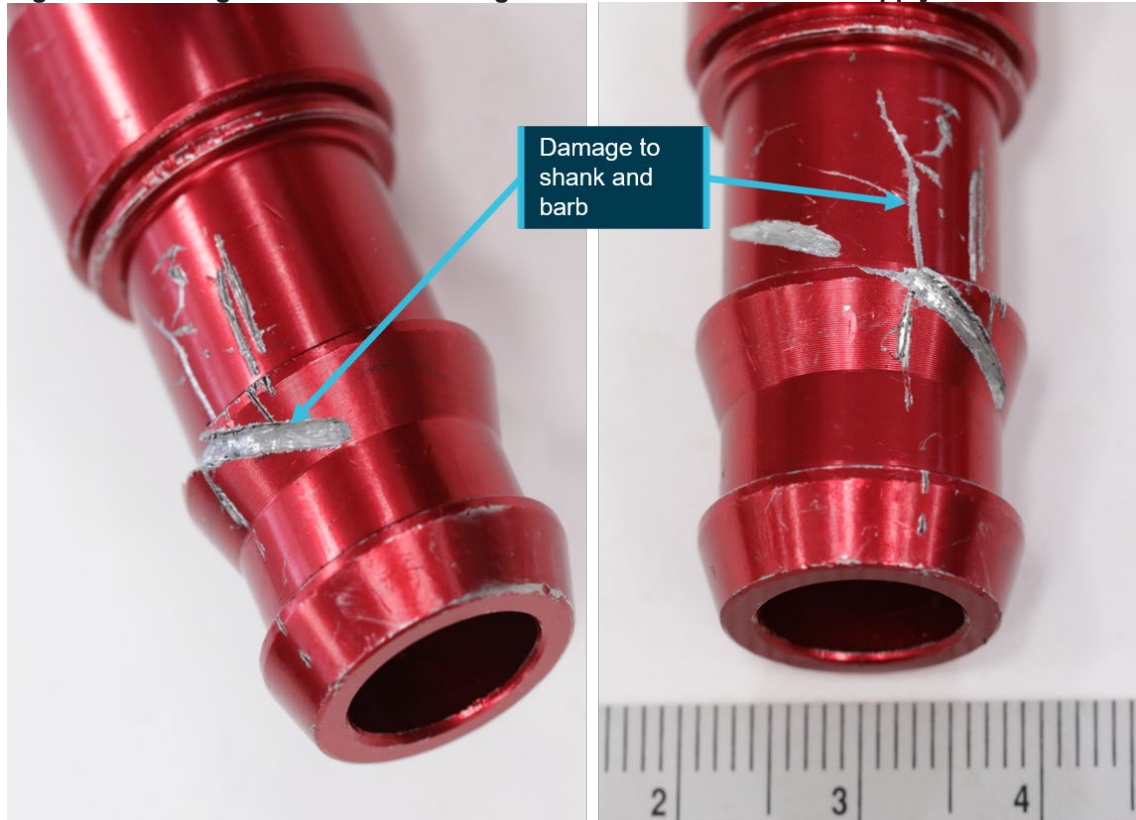
Figure 12: Damage to two barbed fitting of the detached oil cooler supply hose

The two-barb fitting from the detached oil cooler supply hose, showed signs of mechanical damage consistent with tooling marks which could not have been sustained during the accident sequence (Figure 12).

Examination of the engine identified a number of significant deficiencies with the oil supply hose and fitting connected to the oil cooler. Firstly, a damaged fitting was used to connect the oil supply hose to the oil cooler. This damage would likely have allowed oil to leak past the fitting's barbs. Secondly, the external condition of the supply hose indicated that it had reached the end of its effective lifespan. Its aged condition probably reduced the ability of the hose to mechanically grip the barbs and ensure the integrity of the connection.

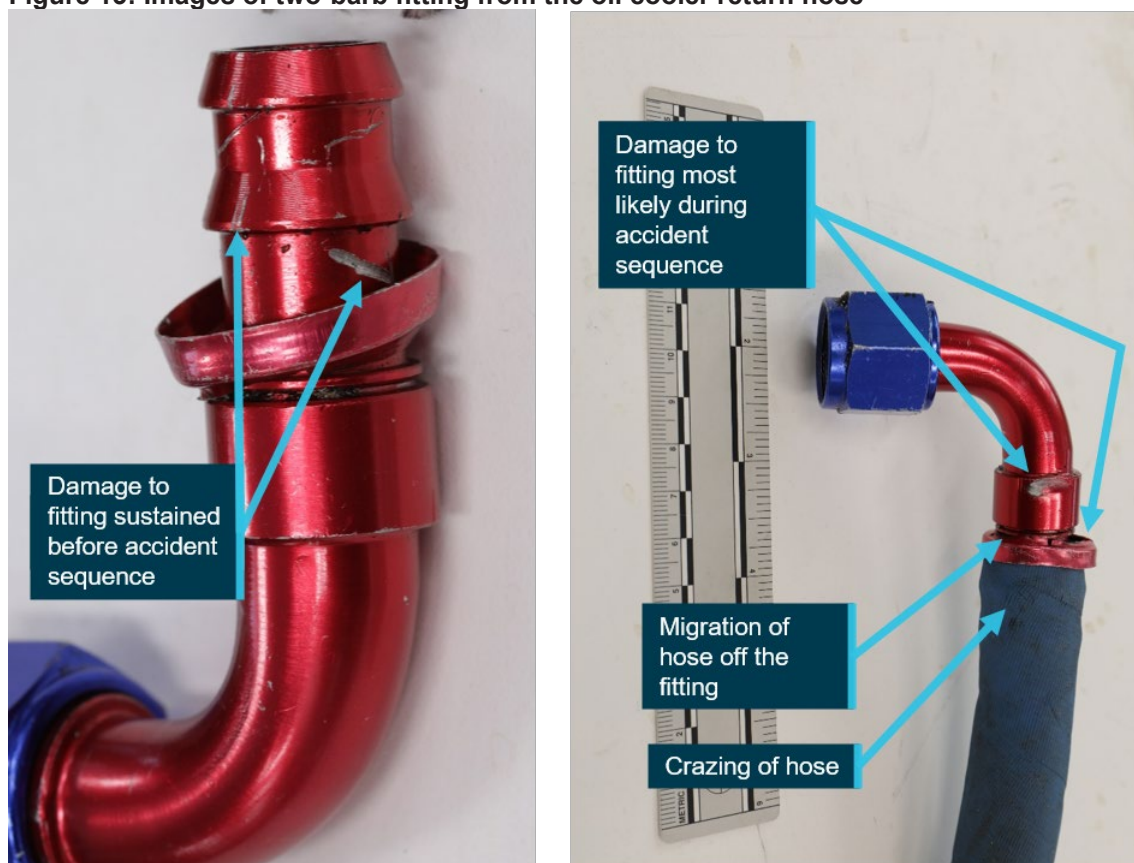
Figure 13: Images of two-barb fitting from the oil cooler return hose

The two-barb fitting on the oil cooler return hose, which did not detach, also had some mechanical damage, though this was less severe, with no significant damage to the barb (Figure 13). This connection also showed signs of the hose migrating off the fitting. However, as there was impact damage on the fitting collar, it could not be established if the migration of the hose occurred prior to, or during, the accident sequence.

The image on the left shows mechanical damage to the fitting, the image on the right shows damage to the fitting and migration of hose from fitting.
