Level crossing collision between freight train 2C74 and road-train truck

Yarri Road, Parkeston, Western Australia, on 22 February 2021

ATSB Transport Safety Report

RO-2021-003

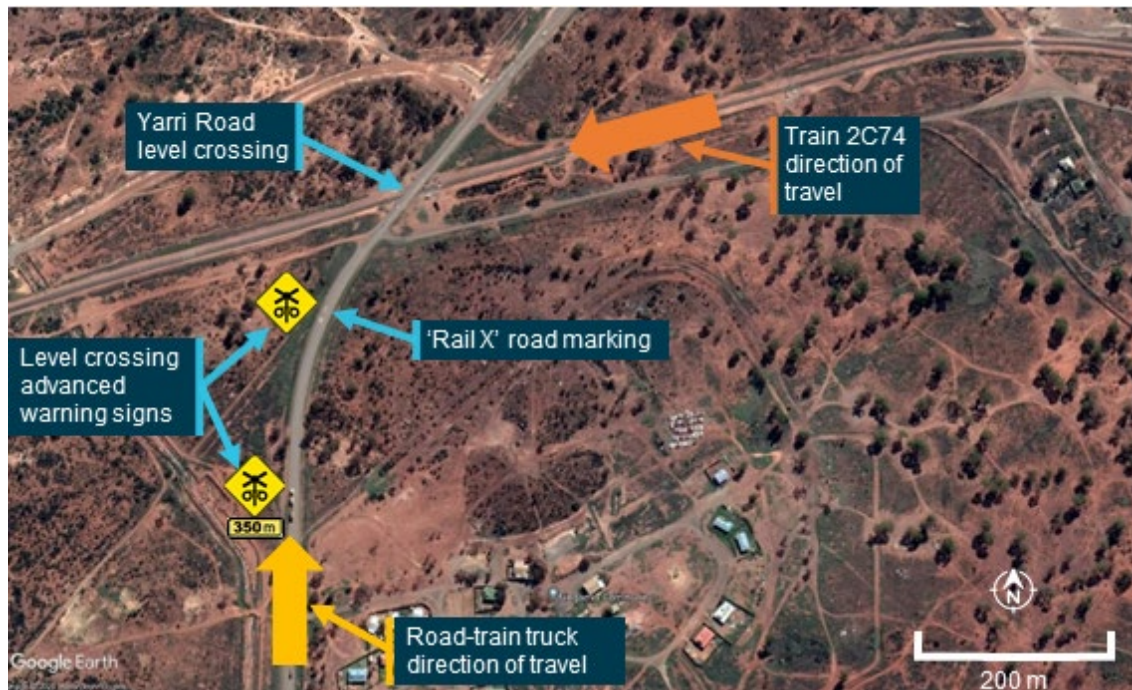
Figure 1: Aerial view of the level crossing approach and road alignment

The northbound road approach to the Yarri Road level crossing consisted of a sweeping right curve leading up to the crossing (Figure 1). Two passive level crossing advanced warning signs provided advice to approaching road traffic of a crossing ahead, one located at the beginning of the curve and the other about half distance through the curve. At about the location of the second sign were 'Rail X' road markings. At about the location of the second

The road-train truck was travelling north along a sweeping right curve on Yarri Road before approaching the railway crossing. The train was travelling west.

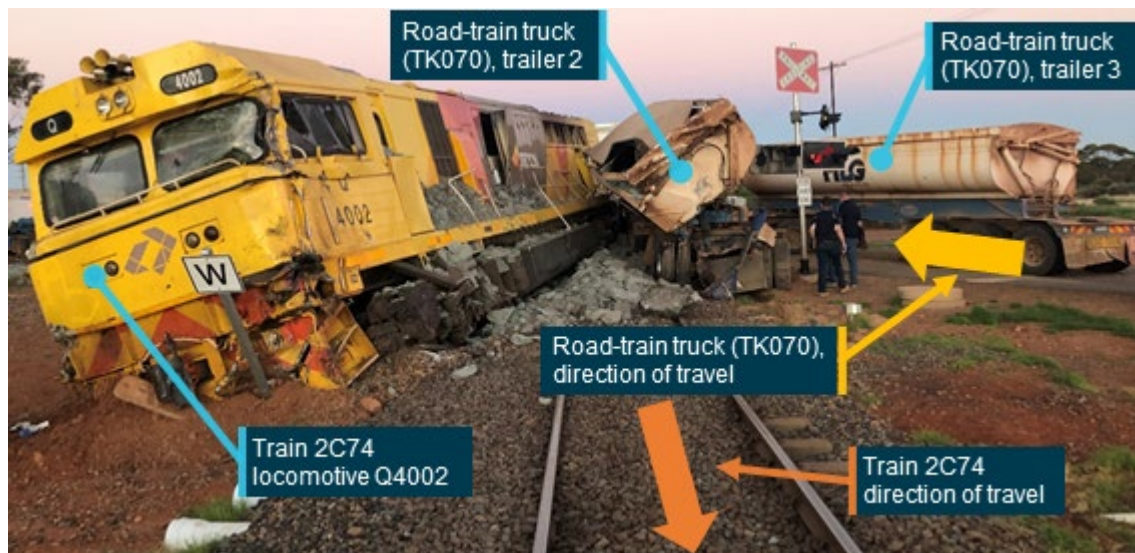
Figure 2: Locomotive, post-collision

Image taken towards the east of the locomotive post-collision. Also visible are the rear 2 trailers of the road-train truck TK070.
Source: Aurizon, annotated by the ATSB

The truck's prime mover uncoupled from its trailers, left the road and came to a stop about 50 m after the crossing. The truck's first trailer came to rest between the prime mover and locomotive on

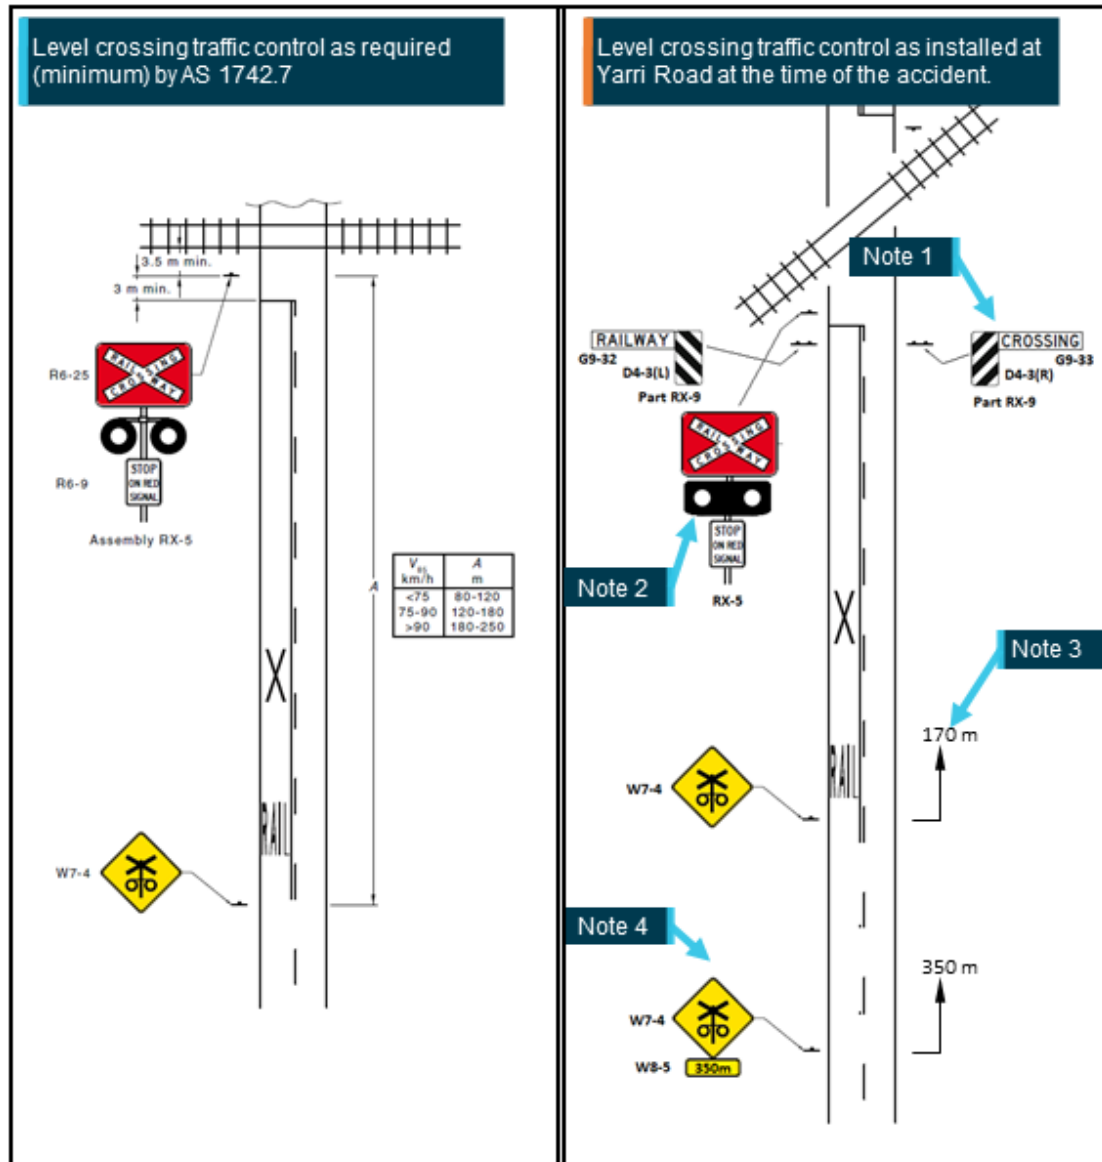
Figure 5: Comparison of traffic control required by AS 1742.7 (left) with the controls installed at Yarri Road level crossing on 22 February 2021 (right)

Consequently, the ATSB examined the Yarri Road approach with respect to the straight road approach treatment specified in the standard. Figure 5 (left) shows the minimum treatment as specified in AS 1742.7. An examination of road markings and signage at the Yarri Road level crossing identified slight variations from the requirements specified in the standard. Figure 5 (right) shows the configuration installed at the Yarri Road level crossing on 22 February 2021.

Note that the illustration shows the road for a straight road approach, whereas the Yarri Road approach consisted of a sweeping right curve.

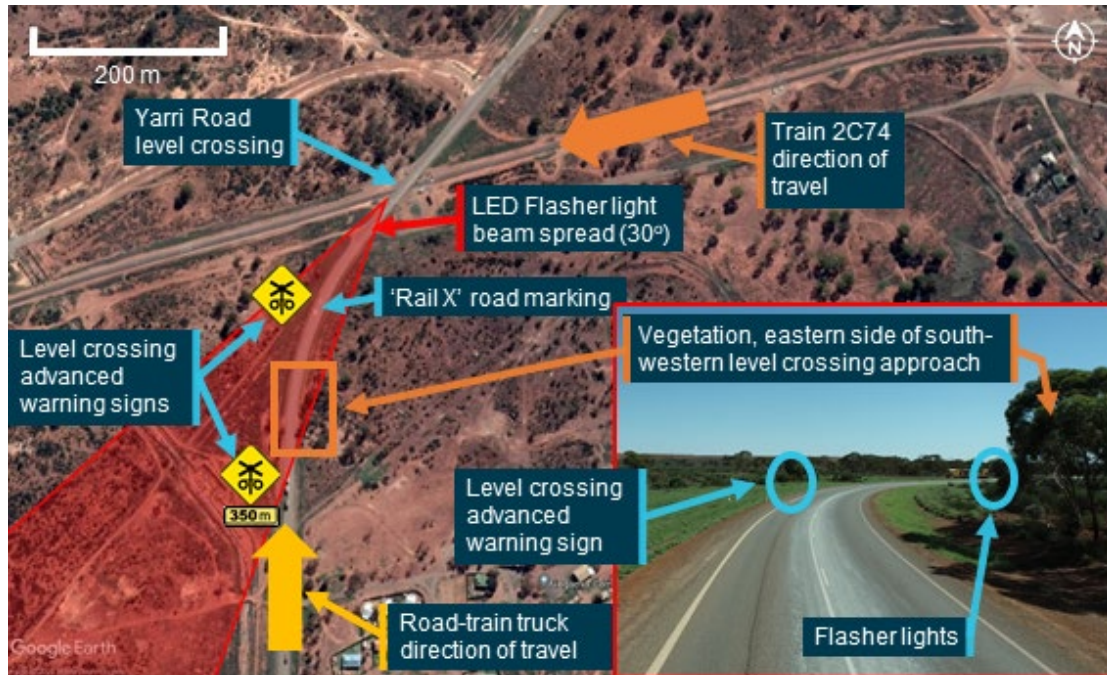
Figure 6: LED light beam spread and vegetation affecting sighting distance on northbound approach to Yarri Road level crossing

¹² The sighting distance was to the flashing lights. Prior to 220 m, the sighting was limited by trees and/or vegetation. Following the accident, a MRWA site survey undertaken on Yarri Road level crossing in April 2021 measured a sighting distance of 260 m.

Image shows the LED light beam spread for the northbound approach to Yarri Road level crossing, as well as the vegetation on the eastern side of the road. Note that the light spread encompasses the entire area from when the warning lights come into view after passing vegetation on the eastern side of road.

The road owner, City of Kalgoorlie-Boulder has removed vegetation to improve sighting at the level crossing. Main Roads Western Australia are currently reviewing the speed zones along Yarri Road, with discussions held with the City of Kalgoorlie-Boulder to consider extending the 60 km/h zone to incorporate the level crossing. Additionally, a feasibility study is planned to determine if active advance warning assemblies can be installed on the approaches to the level crossing.

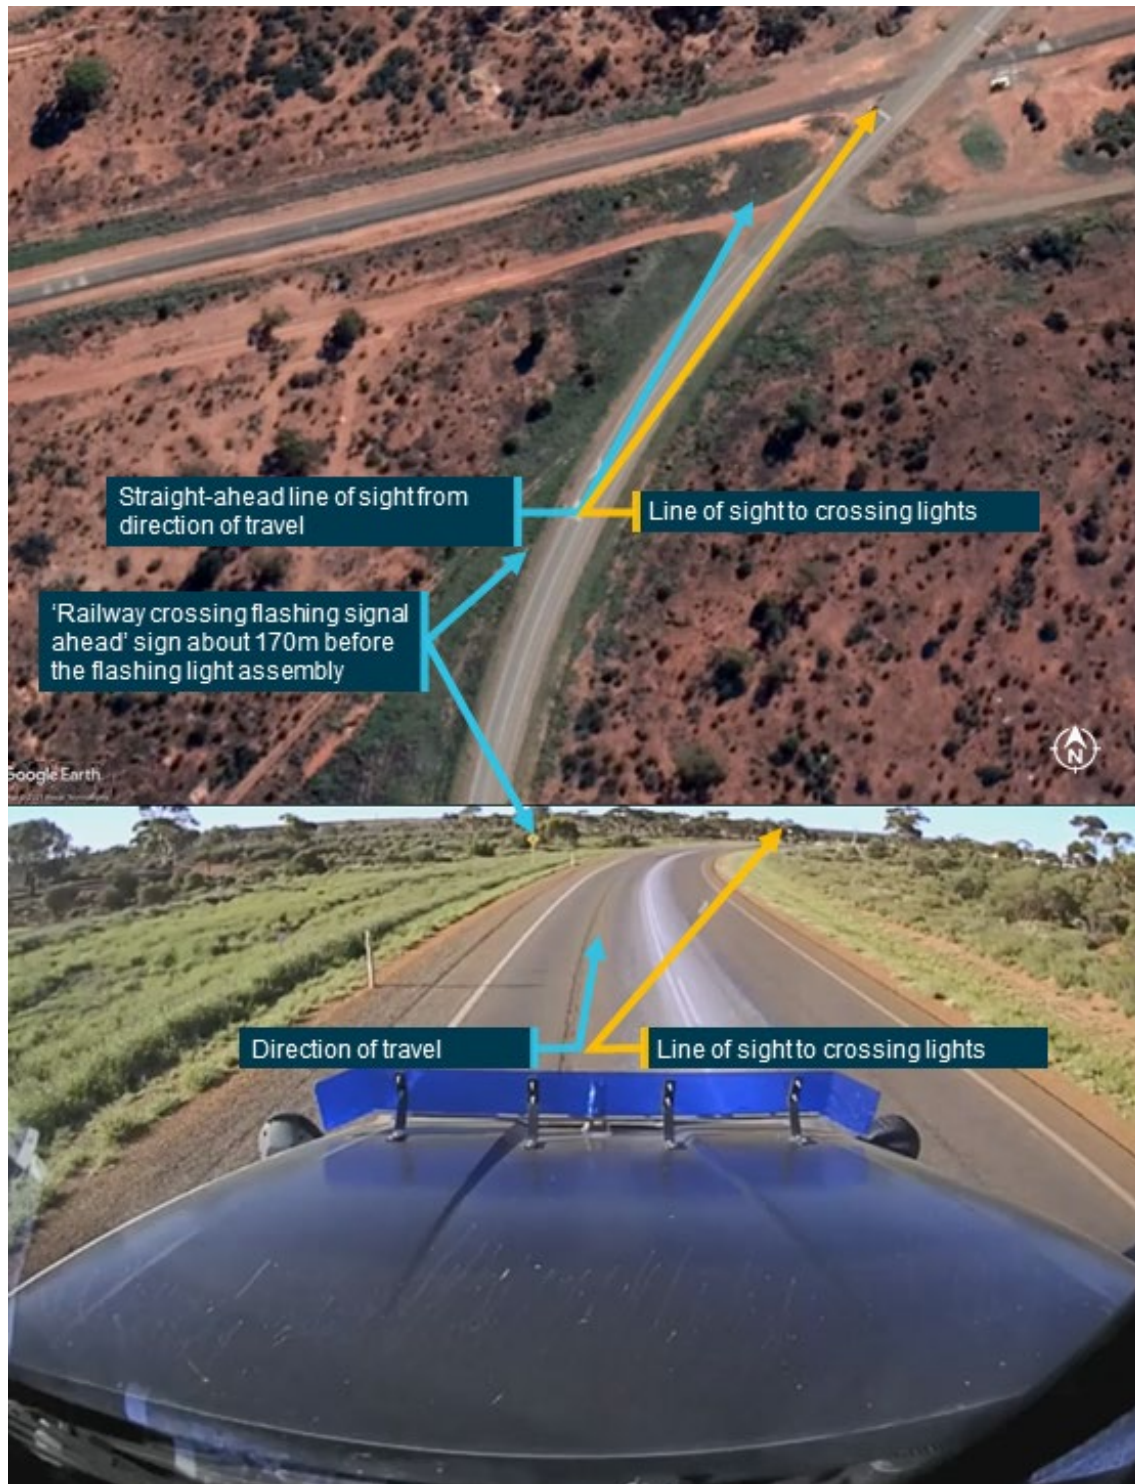
Figure 7: Curved road approach to the level crossing

The southern (northbound) approach to Yarri Road level crossing consisted of a sweeping right curve, before straightening about 70 m prior to the crossing. For this approach configuration, a road vehicle driver's line of sight would need to look through the curve, across vegetation on the inside of the curve, to be capable of sighting the flashing lights (Figure 7). It is not until the vehicle is much closer to the crossing that a driver's vision along the road would also coincide with line of sight to the crossing. By this time, it would be unlikely that a large multi-trailer truck, travelling at the speed limit, would be able to stop before the level crossing. It is for this reason that a driver must continuously scan the road ahead, so action can be taken to avoid hazards. In this case, scanning includes looking through the curve, identifying the flashing lights and bringing the vehicle to a stop in a controlled manner.

Note that the 2 images show the curved road approach from about 180 m from the level crossing. The top image shows the approach overhead with an indication of the road-train truck driver's line of sight. The bottom image shows a screen capture from the forward-facing video camera on road-train truck TK070 with the driver's sight lines to the road and the level crossing ahead.
 Source: MLG Oz and Google Earth, annotated by the ATSB
