In-flight break-up involving Robinson R44 Raven I, VH-HGU

31 km east of Goulburn Airport, New South Wales, on 2 December 2020

ATSB Transport Safety Report

AO-2020-061

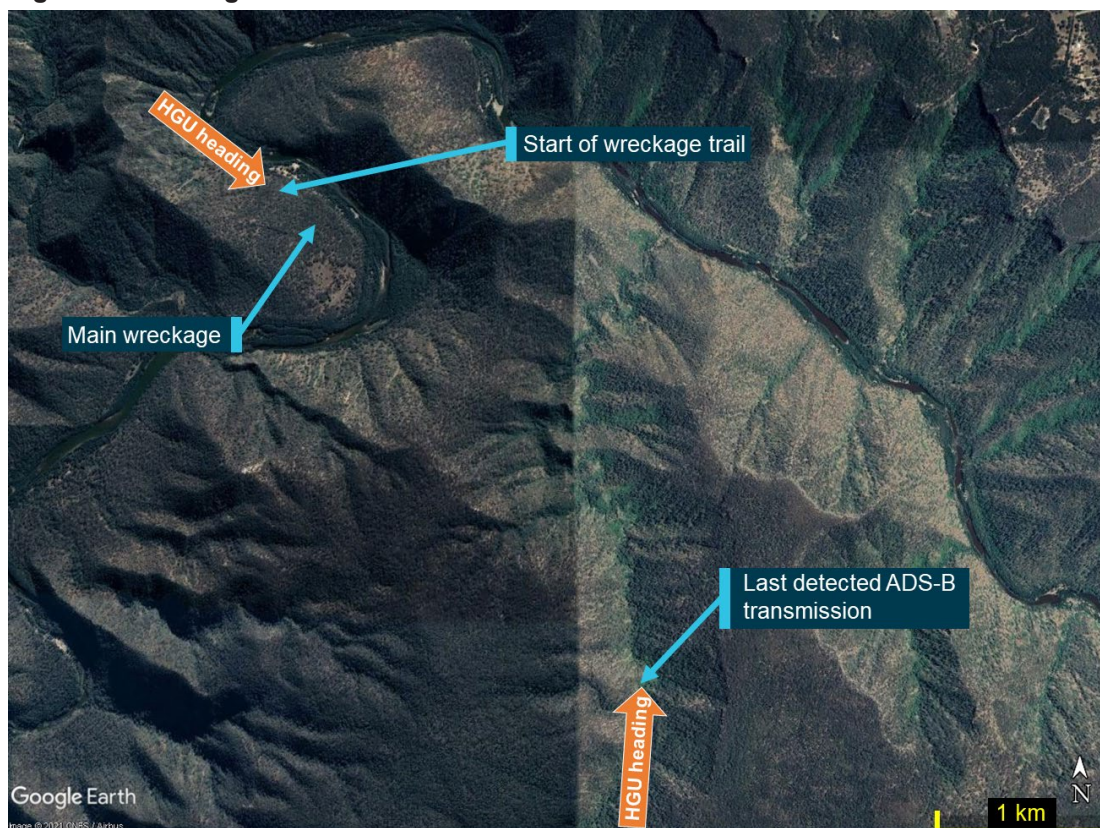
Figure 3: Wreckage trail and final ADS-B transmission from VH-HGU

The wreckage trail was approximately 275 m long on a south-easterly heading, parallel to the river. Figure 3 shows the location of the wreckage and calculated direction of flight prior to impact, as well as the helicopter's last detected ADS-B transmission.

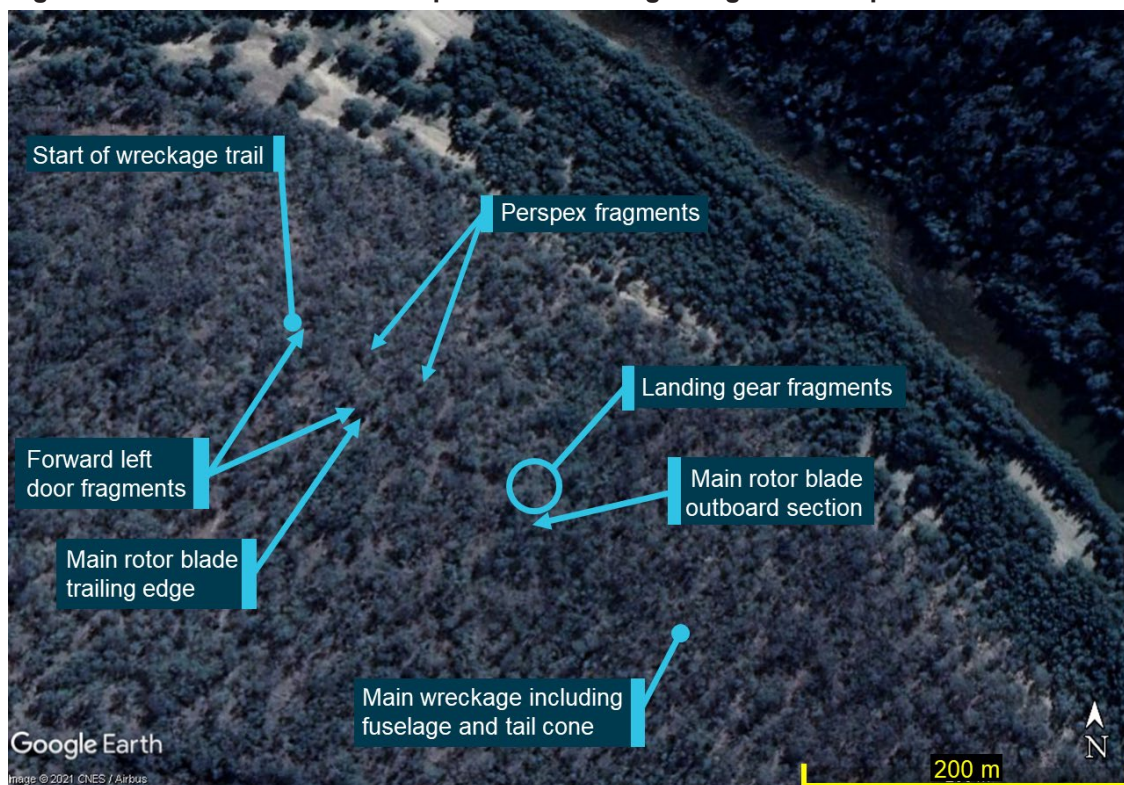
Figure 4: Location of aircraft components following in-flight break-up

Figure 4 shows the locations of some of the components identified in the wreckage trail. An outboard section of one main rotor blade was located about halfway along the debris trail, along with liberated pieces of landing gear skids and struts. Damage to vegetation commenced about 20 m prior to the impact zone and was consistent with a relatively shallow descent profile. Impact forces likely ruptured the crash-resistant fuel tanks and an intense fire ensued, destroying the fuselage, engine and main gearbox. The fire zone was about 10 m in diameter. The tail cone assembly was situated a few metres to the west of the fire zone, and was unaffected by the fire. All extremities of the helicopter were identified.

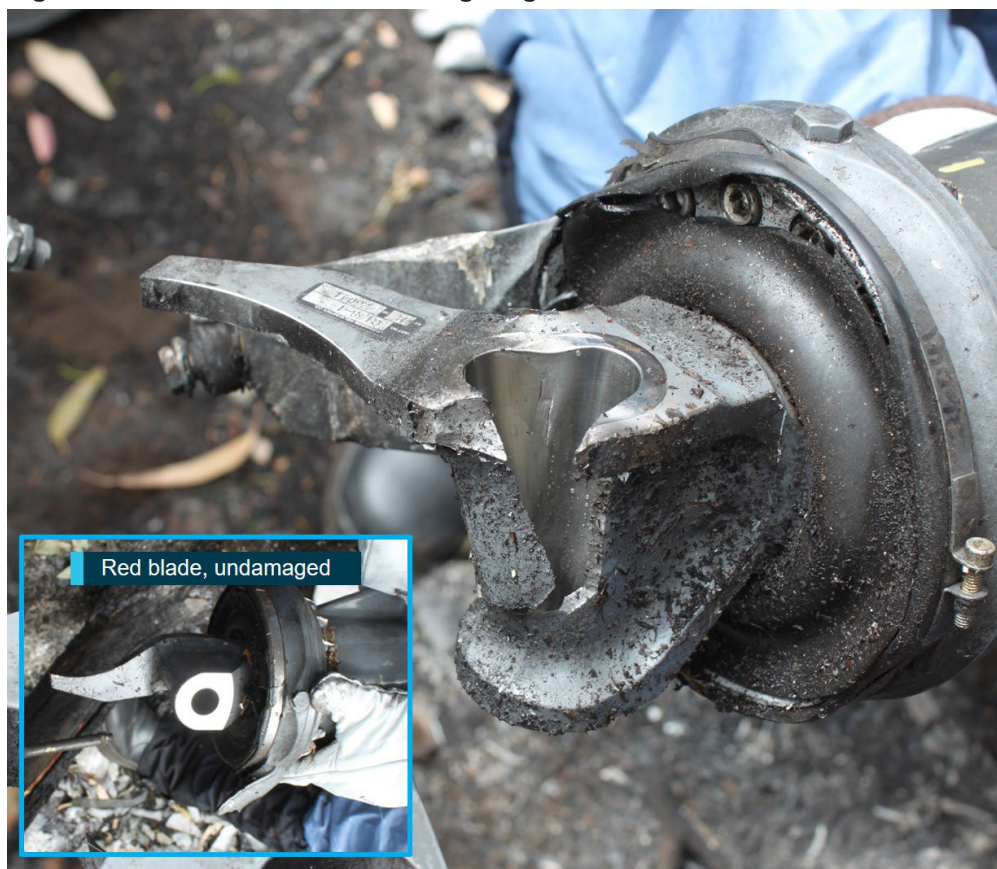
Figure 5: Blue blade tusk and coning hinge bolt bore

The coning hinge bolts were removed to allow removal of the spindles and remains of the main rotor blades (designated red and blue) from the main rotor hub (MRH). While the MRH attachment point on the red rotor blade was undamaged, the blue rotor blade tusk had been severely deformed (bent downwards nearly 90°), and the coning hinge bolt bore was split open as a result. This damage is shown in Figure 5, with the undamaged tusk from the red rotor blade for comparison. Following removal of the MRH, the teeter stops were seen to exhibit damage consistent with severe impact from the blade spindles, shown in Figure 6.

The broken teeter stops, failed pitch links, bent tusk and blade impact damage were consistent with the low-G mast bumping scenario described by the Robinson Helicopter Company (RHC). The damage was also similar to many other in-flight break-up incidents that were the result of extreme teetering after entering a low-G condition.

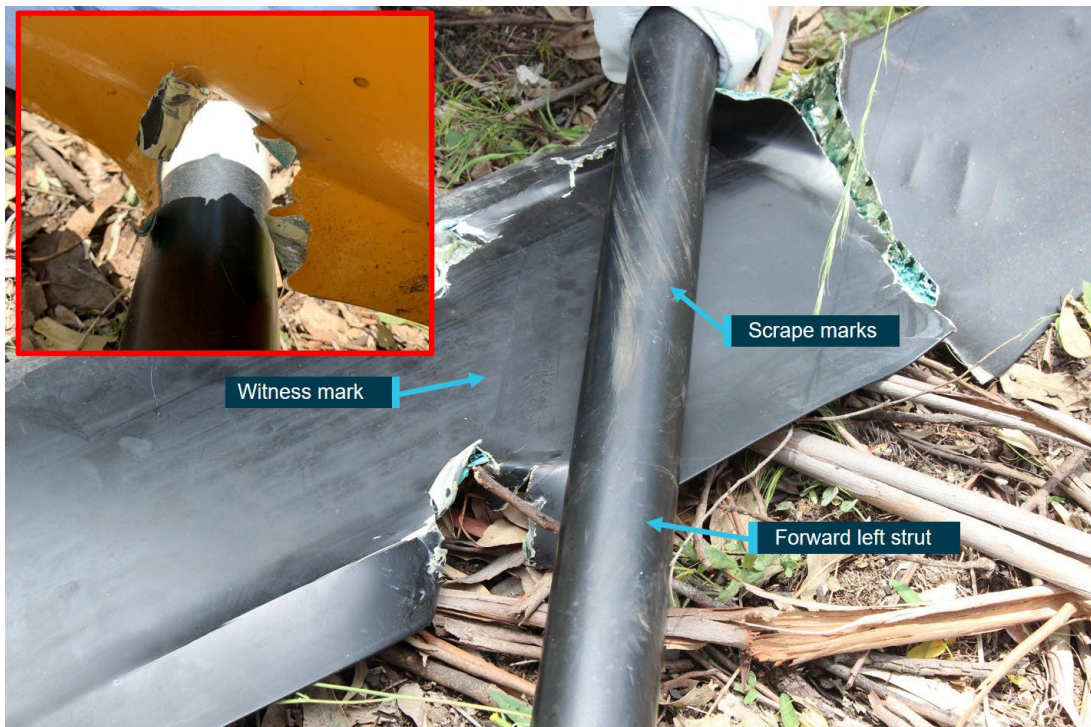
Figure 7: Damage to the blue main rotor blade and the forward left landing strut

The underside of the blue main rotor blade exhibited impact damage and a witness mark consistent with the dimensions of a landing gear strut. In addition, the forward left landing strut showed some scrapes and scuff marks. The location of the damage on the blade was consistent with the measured distance of the left forward strut from the main rotor hub. Some yellow paint transfer was noted on the forward section of the left skid, consistent with a main rotor strike.

Distribution of the wreckage, damage to the main rotor system, and damage to the fuselage and skids are all consistent with a main rotor blade striking the left forward fuselage at the commencement of an in-flight break-up.
