# Collision with terrain involving Robinson R44, VH-IDW

King River, Northern Territory, on 28 February 2022

**ATSB Transport Safety Report**

AO-2022-009

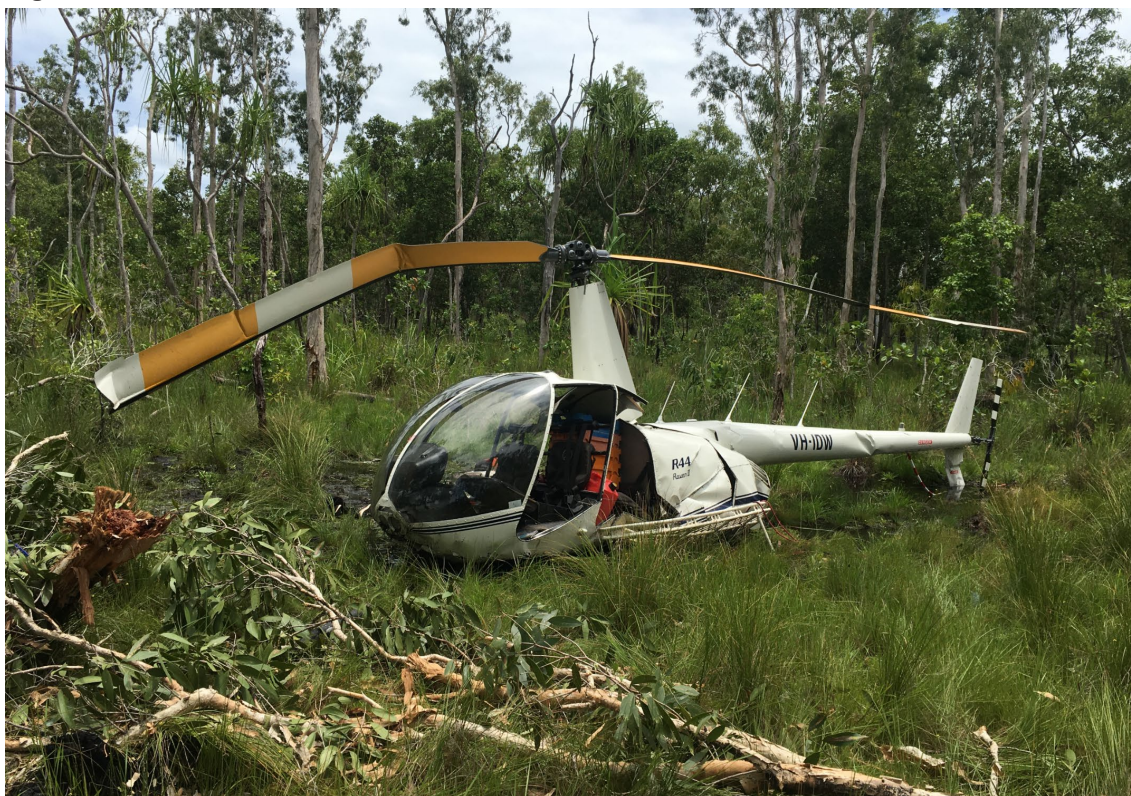
**Figure 2: VH-IDW accident site**

The helicopter's main rotor blade had struck and cut through the trunk of at least one tree at multiple points before the helicopter collided with terrain upright, facing north-east (Figure 2). The helicopter's skids had splayed and fractured, and the base of the pilot's seat had crushed as designed to absorb impact forces.

Initial assessment indicated that the engine was stopped when the helicopter collided with the ground. There was no visible damage to the tail rotor blades and continuity of the drive system and flight controls was established.

The two fuel bladder tanks were intact despite breaches of the surrounding metal tanks and there was no fire. However, the fuel system was compromised in the accident and it was possible fuel escaped into the creek that flowed beneath the wreckage. After initial assessment, the helicopter wreckage was retrieved from the site. ATSB investigators subsequently drained about 250 ml of blue fuel from the main tank's bladder.
