Collision with terrain involving Garlick Helicopters UH-1H VH-UHX

36 km north of Launceston, Tasmania on 14 February 2022

ATSB Transport Safety Report

AO-2022-006

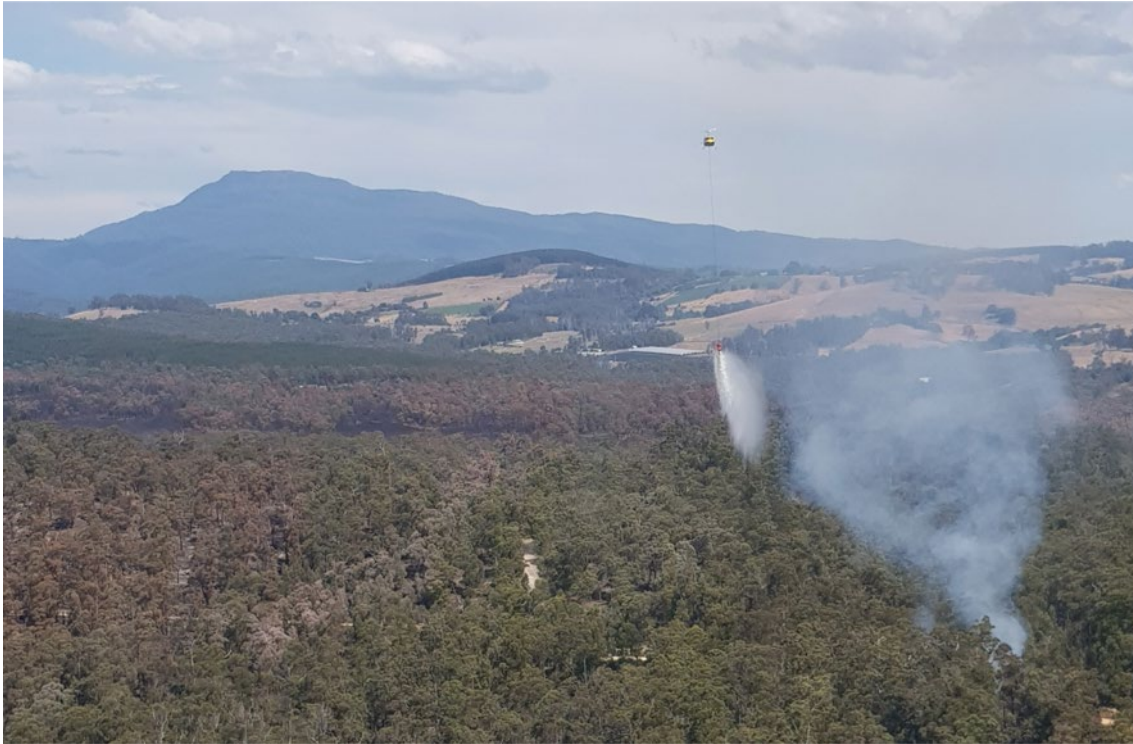
Those onboard Firebird 460 observed VH-UHX approach the identified fire hot-spot and witnessed the release of the water load from the underslung bucket. The pilot of Firebird 460 recounted that the drop was unusual because the water missed the target (Figure 1). VH-UHX was then observed by those onboard Firebird 460 to commence a gradual left turn and track away from the staging area. Suspecting the pilot of VH-UHX was encountering an in-flight difficulty, and wanting to avoid any potential conflict with the approaching helicopter, the pilot of Firebird 460 initiated a climbing 360° turn away from VH-UHX.

Figure 1: VH-UHX photographed by a witness onboard Firebird 460 completing the aerial water drop away from the identified hot-spot

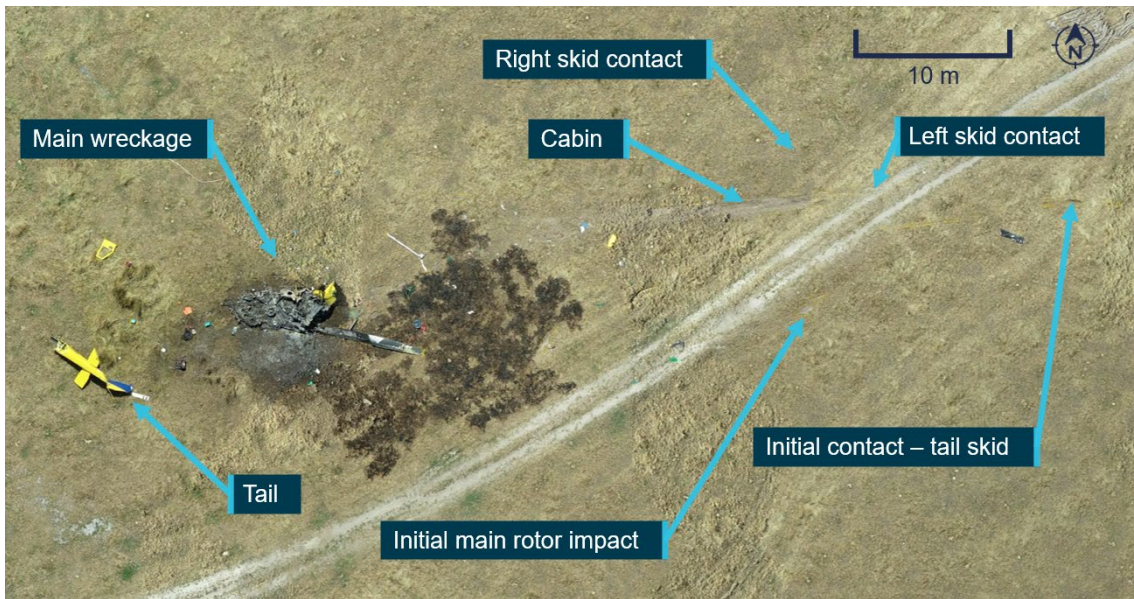
Figure 2: Accident site

The helicopter wreckage was located in an open paddock near Pipers Brook road, about 2.6 km north of the TFS staging area. It had been destroyed from exposure to ground impact forces and the subsequent fuel-fed fire. A survey of the accident site showed that the helicopter had impacted the ground along a westerly flight track. Ground scars at the site showed that the tail section made first contact with the ground, followed by the skids, main rotor blades and the cabin (Figure 2).

Almost the entire tail section, including the tail rotor gearbox, separated from the fuselage, and had come to rest a short distance from the main wreckage. Other items that separated from the helicopter included both main rotor blades, the battery and the landing skids. The furthest item from the accident site was the underslung bucket that remained attached to its long line. The bucket and line had been released from the helicopter prior to the ground impact and were positioned approximately 300 m from the wreckage.

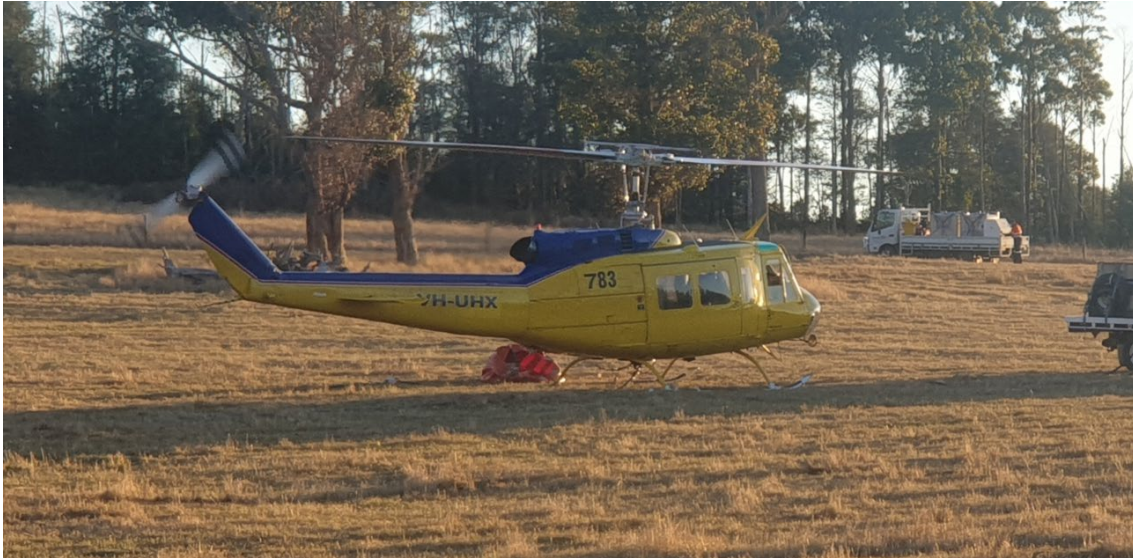
Figure 3: VH-UHX at the Tasmania Fire Service staging area

The accident helicopter was manufactured as a UH-1H by Bell Helicopters in November 1965 for the United States (US) military and was converted by Garlic Helicopters for civilian application in November 2007 (Figure 3). The helicopter had a two-blade main rotor and two-blade tail rotor and was powered by a Honeywell Aerospace (formally Lycoming Engines) T53-L-703 turboshaft engine.
