Collision with terrain involving Cessna A150M, VH-CYO

5 km west-south-west of Peachester, Queensland, on 23 June 2021

ATSB Transport Safety Report

AO-2021-025

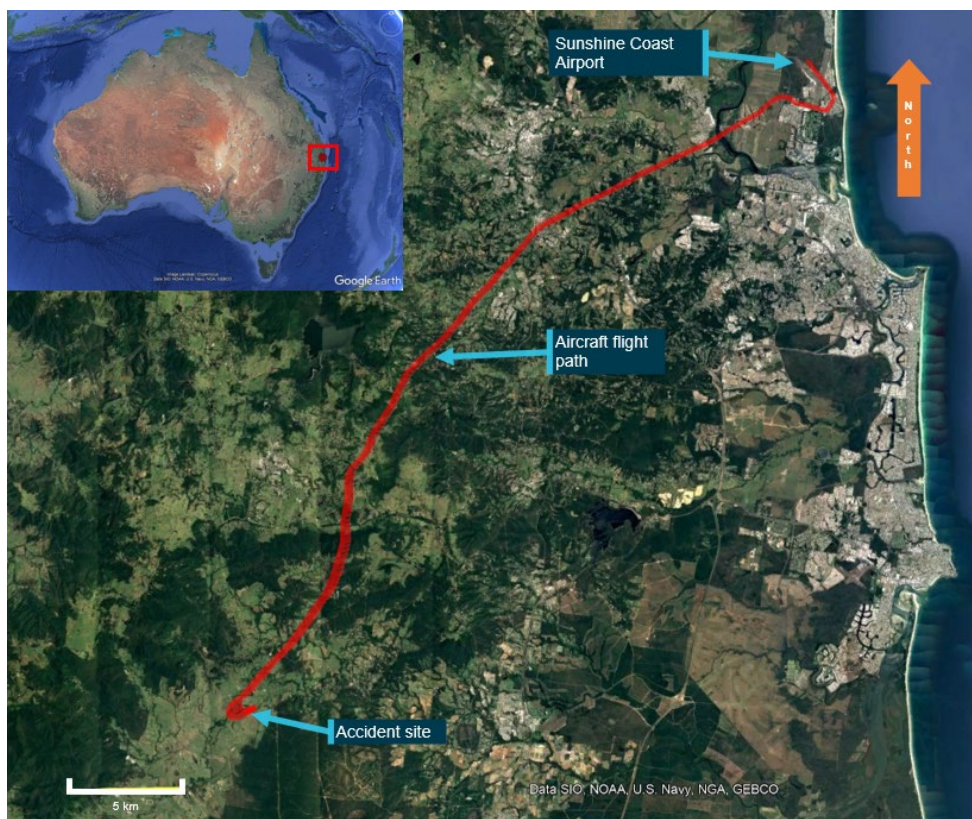
The aircraft departed to the south-west and climbed to about 6,000 ft above mean sea level (AMSL) (Figure 1). It arrived at the area intended to conduct aerobatics about 20 minutes after departure.

Figure 1: VH-CYO flight track radar data showing take-off point and accident site

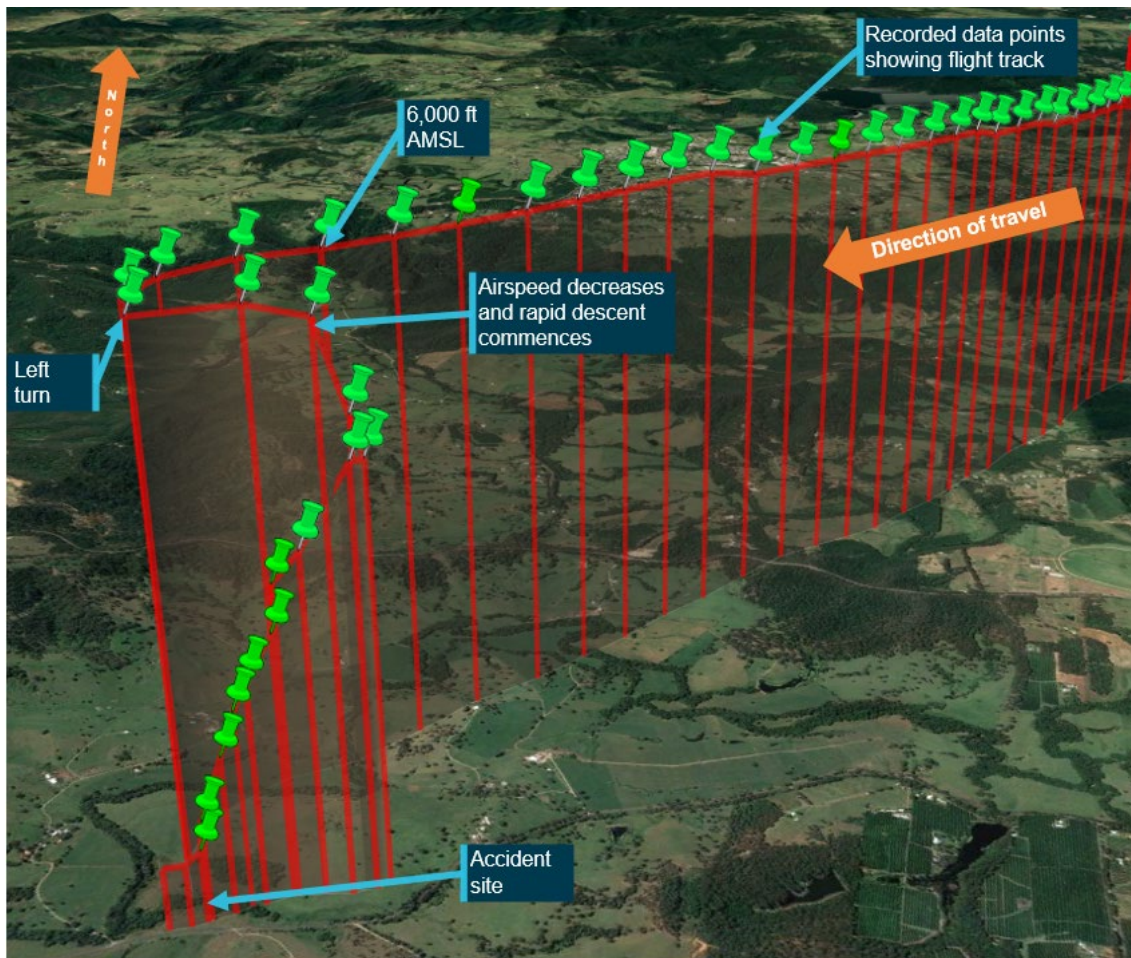
Figure 2 shows recorded radar data for the last 3 minutes of the flight. It indicates that, within the last 90 seconds, the aircraft turned left, decelerated while maintaining altitude, and then descended rapidly. Shortly after, at about 1122, the aircraft impacted terrain. The aircraft was destroyed and the two occupants were fatally injured.

Figure 2: VH-CYO last 3 minutes of recorded flight data viewed from the left and above

Radar positions (depicted by green pins) were recorded every 5 seconds. The last two points depicted without pins were predictive in nature and were not considered to be accurate.
 Source: Google Earth, annotated by the ATSB

Each of the green pins in Figure 2 depicts a recorded radar position. The recording stopped at about 1,200 ft AMSL, most likely due to the aircraft descending below radar coverage.

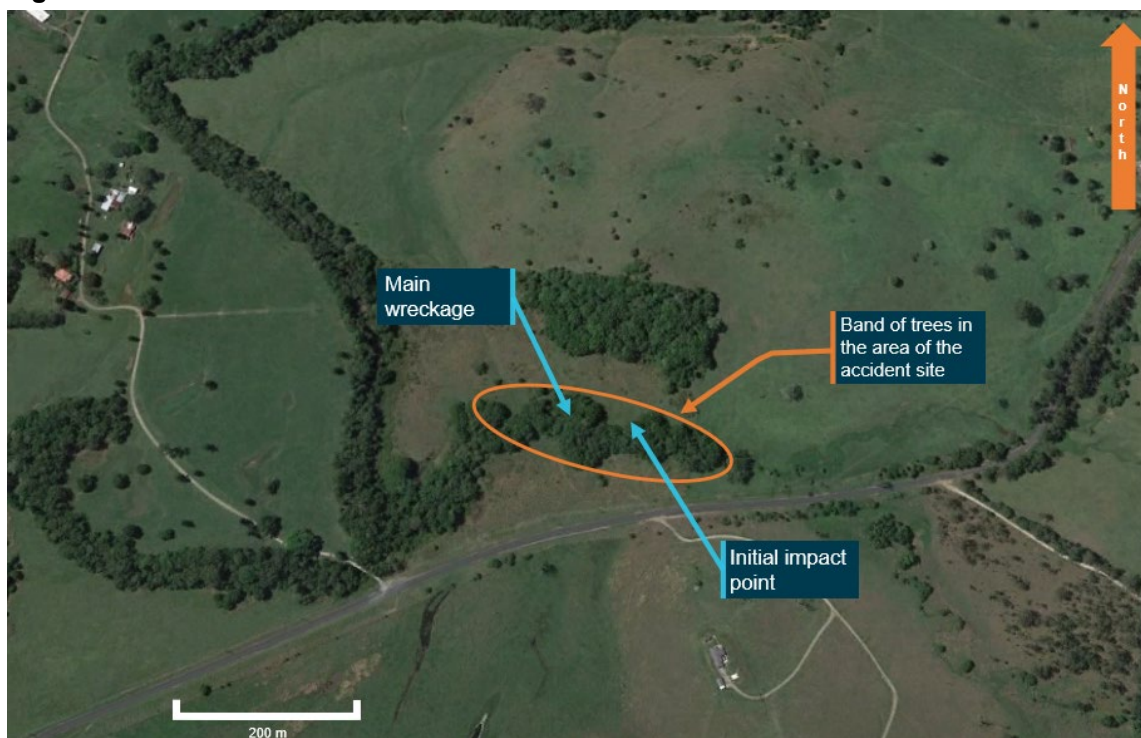
The accident site was located in a dense stand of trees, about 400 ft AMSL. The trees stood about 15–20 m high and straddled a creek line in a band about 50 m wide, with open areas of farmland on either side (Figure 3).

Figure 3: Area of accident site

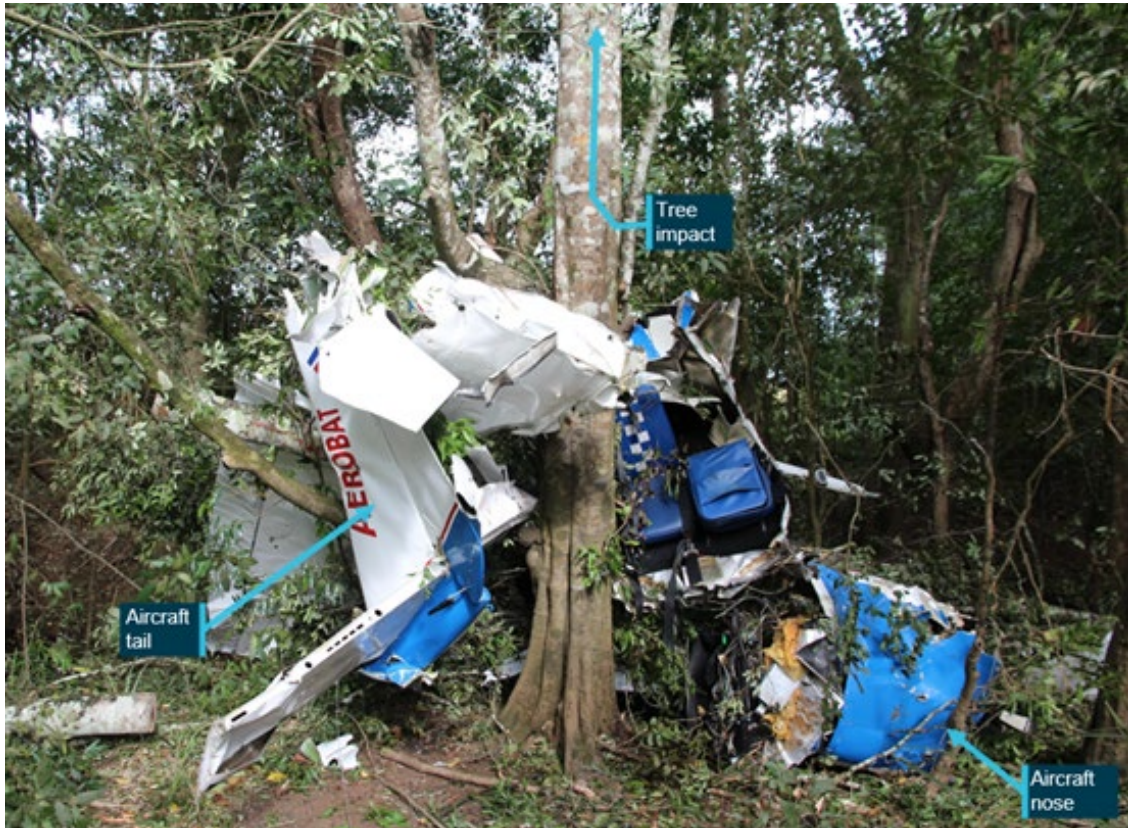
The wreckage trail extended about 50 m from the initial tree impact point, until the final piece of wreckage, oriented in an east-west direction. There were several notable tree impact points, including trees that had been broken in half or completely felled by the impact forces.

Calculations of the tree impact damage heights indicated the final flight path angle was a descent of about 13°. The main wreckage came to rest at the base of a tree that was struck at a height of about 10 m.

The aircraft structure was significantly disrupted as a result of impacting several trees (Figure 4).

Figure 4: Aircraft main wreckage at the base of a large tree that was struck

- the disruption to the aircraft and foliage, coupled with the length of the wreckage trail, indicated that the aircraft had significant forward speed at impact
- the flaps were in the retracted position
- the aircraft had no evident pre-impact defects with the flight controls or aircraft structure
- the aircraft was intact prior to impact with terrain
- the engine had no obvious defects upon external examination
- the throttle setting was captured at an idle position during the accident sequence
- the propeller rotational damage signatures were minimal, indicating a low power setting.
