# Landing on closed runway involving Cessna 510, VH-MSU

Temora Aerodrome, New South Wales, on 21 October 2021

## **ATSB Transport Safety Report**

AO-2021-045

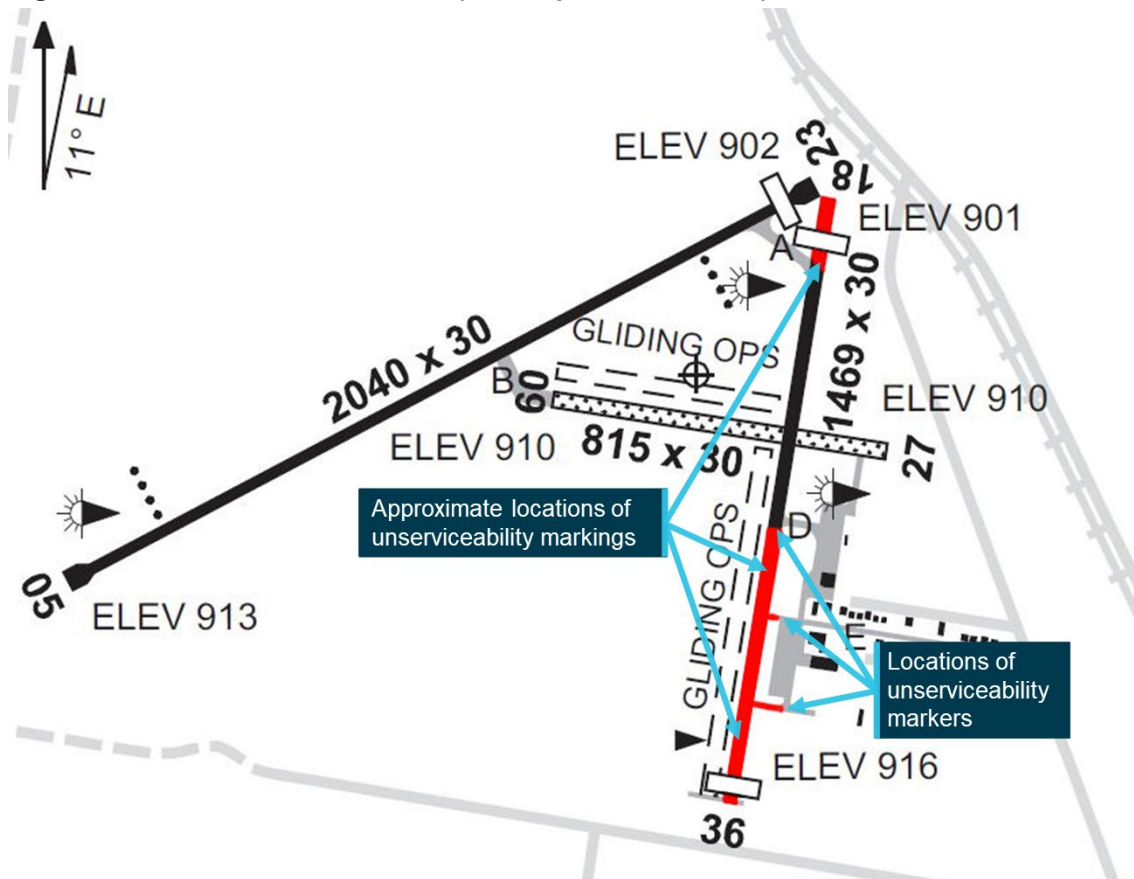
Figure 1: Temora Aerodrome chart (closed pavement in red)

A combination of unserviceability markers (cones) and markings (crosses) had been placed on the aerodrome as annotated in Figure 1.

Unserviceability markers, consisting of 50cm high white cones with a red band, were placed at the end of taxiways E and F entering runway 18/36, and across runway 18/36 south of taxiway 'D', to prevent aircraft taxiing into the works area.

Three unserviceability markings, constructed with 6-metre-long white lines laid as a cross, were placed on the runway:

- 116 metres north of the threshold of runway 36
- halfway between taxiways D and E, and
- 42 metres south of the runway 18 threshold, between the numbers and 'piano-keys'.

The distances between these markings were 431 and 750 metres.

At the time of the incident, the unserviceability markings, were not located in positions that were clearly visible when landing or taxiing on runway 18, and were not of the required size. These factors likely contributed to the pilot not seeing the unserviceability markers during landing or taxi.

Additional 9 metre markings have been purchased for use on both runways.

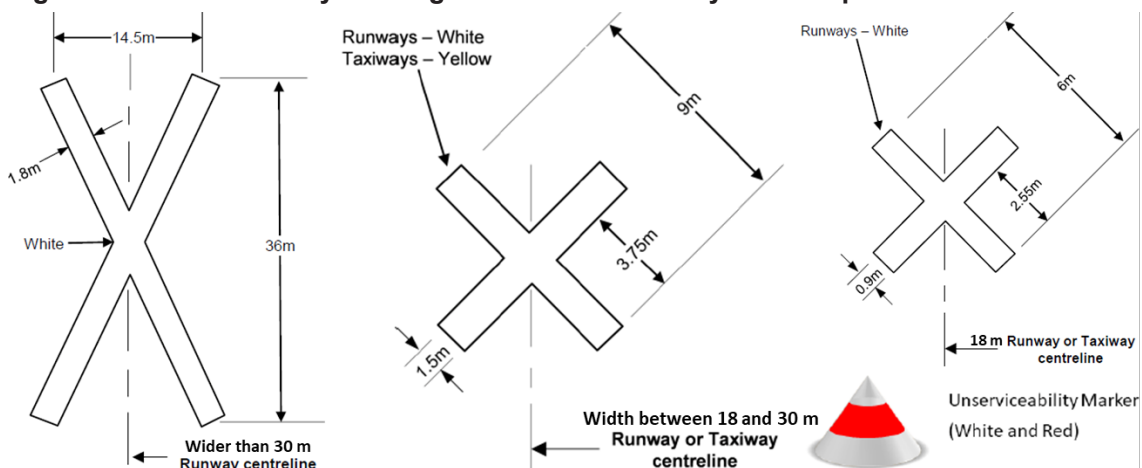
The size of the markings for unserviceable runways was determined by the width of the runway (Figure 2):

- for runway widths greater than 30 m – a 36-metre-long by 14.5-metre-wide cross
- for runway widths from 18 m up to 30 m – a cross with 9-metre-long lines
- for runway widths less than or equal to 18 m – a cross with 6-metre-long lines.

**Figure 2: Unserviceability markings and unserviceability marker specifications**

As defined by the MOS, unserviceability markers were to be a 50 cm tall white cone with a 25 cm wide horizontal red stripe (Figure 2). These markers had to be placed at the entrance to, and across, any part of the movement area of an aerodrome (including runways) that are not to be

As well as the active NOTAM at the time of the incident, Temora Aerodrome had a total of three unserviceability markings, crosses with 6-metre-long lines, along runway 18/36. The Civil Aviation Safety Regulations Part 139 Manual of Standards (MOS) required these markings to be 9 metre markings for a 30 m wide runway, and be placed no more than 300 m apart. This would mean that at least 5 markings were required for the 1,469-metre runway. As the length of runway being used as a taxiway exceeded 300 metres, temporary taxiway markings would also be required to separate unserviceability markings from the taxi route.
