Collision with terrain involving Airbus Helicopters EC130 T2, VH-XWD

near Mount Disappointment, Victoria, on 31 March 2022

ATSB Transport Safety Report
Aviation Occurrence Investigation
AO-2022-016
Preliminary – 12 May 2022

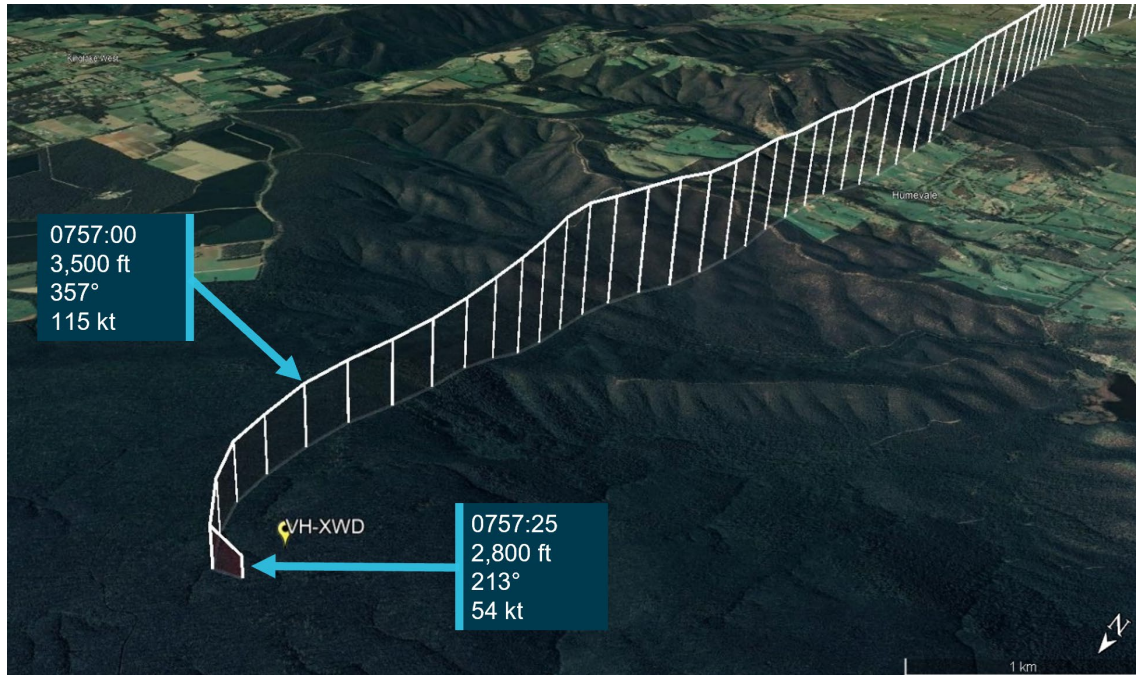
Figure 3: VH-XWD flight track and accident site

At 0757:15, the pilot of WVV found a clearing through cloud and turned back northbound at 3,957 ft, with a clearance from air traffic control to climb to not above 5,000 ft. At the same time, the flight data for XWD indicated a track of 333° at 3,300 ft and 100 kt. At 0757:20, XWD was on a track of 297° at about 3,100 ft and 91 kt. The last recorded data point was at 0757:25, at which time XWD had a track of 213° at about 2,800 ft and 54 kt (Figure 3). XWD collided with terrain about 250 m south of the last recorded data point. The elevation of the main wreckage site was about 2,359 ft (719 m). The 5 occupants were fatally injured, and the helicopter was destroyed.

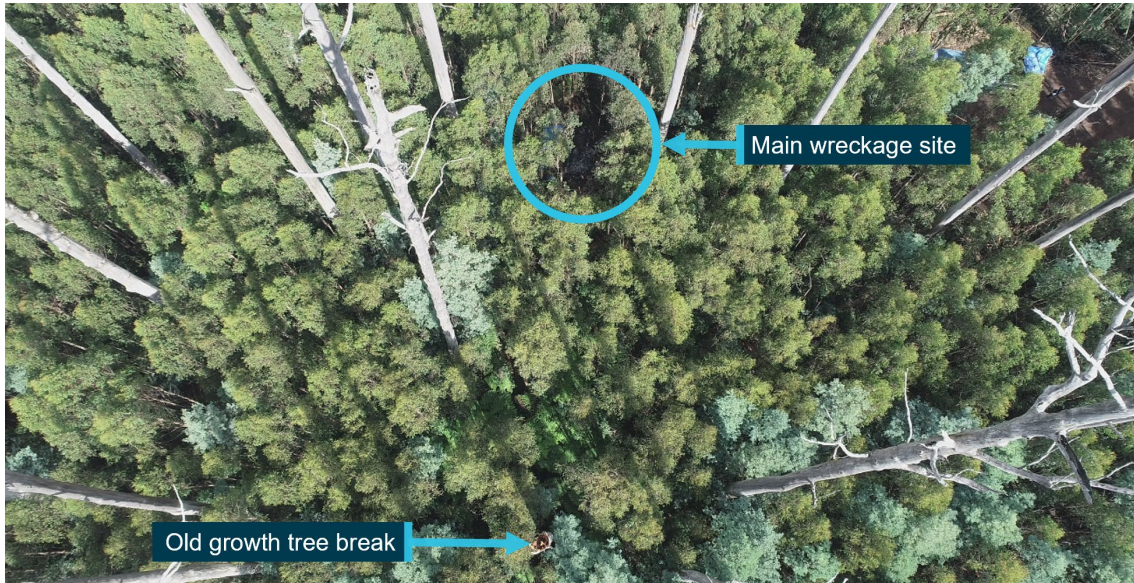
Figure 4: Overhead view of old growth tree break and main wreckage site

The ATSB's site survey established that XWD had impacted a large old growth tree (Figure 4), which broke the upper tree trunk and severely disrupted the cabin. The helicopter then descended on a southerly trajectory at an angle of about 45° to ground impact. The vegetation surrounding the accident site was comprised of 2 distinct levels of growth. A new growth canopy that had an average height of 24 m, and old growth trees that had an average height of about 70 m. The old growth tree break was about 41 m above ground level (elevation of 759 m). The elevation of the base of this tree was 718 m, which indicated that the elevation of the top of the tree was likely

about 2,585 ft (788 m). Therefore, the tree impact very likely occurred between 2,490–2,585 ft (759–788 m).

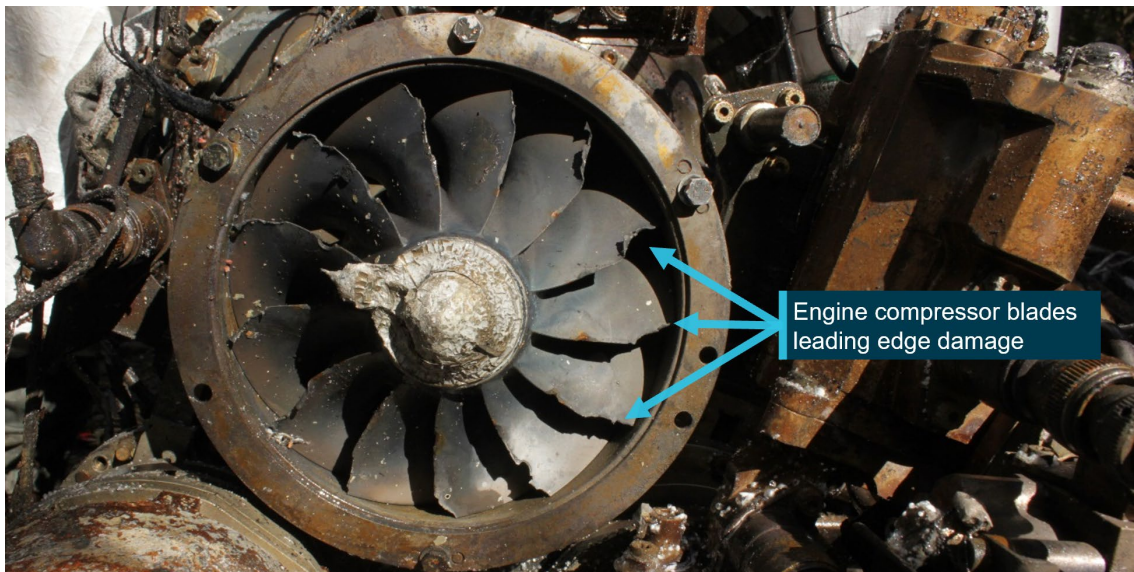
Figure 5: Damage to the engine compressor blades

The helicopter was subject to a post-impact fire, resulting in the destruction of some components. However, from the components available there was no evidence to indicate any pre-existing defect that would have prevented normal operation. The engine had disconnected from both the main rotor and Fenestron driveshafts. The Fenestron driveshaft exhibited significant scoring damage, which indicated it was rotating at high speed during the accident sequence. Damage to the leading edges of the engine compressor blades was also characteristic of high-speed rotation (Figure 5). In addition, the power turbine exhibited blade shedding.
