Airborne collision alert involving AgustaWestland AW139, VH-YXH and Piper PA-44-180, VH-HMQ

Mangalore Airport, Victoria on 6 June 2021

ATSB Transport Safety Report

AO-2021-023

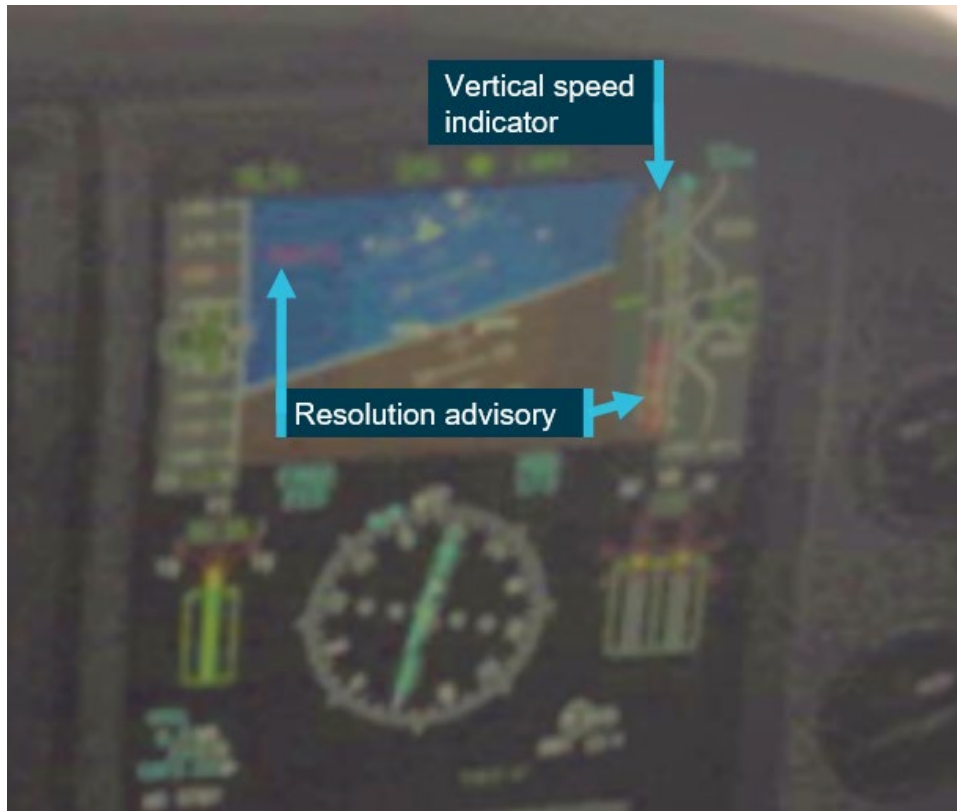
Figure 3: Video capture of the resolution advisory indications during the occurrence

At 1556:39 the TCAS presented a resolution advisory alert to the pilot. The resolution advisory (RA) provided an aural alert 'monitor vertical speed' and presented a red 'avoid' indication on the vertical speed indicator (VSI) for descents of 500 ft per minute or greater (Figure 3).

The pilot incorrectly perceived the RA as a descent instruction. At that time, the helicopter's climb rate was increasing to 600 feet per minute and the pilot believed that transitioning to a descent could startle those onboard. The pilot also believed that following TCAS instructions could lead to a collision with terrain and therefore did not want to descend below the lowest safe altitude. Hence, the pilot attempted to increase separation by commencing a right turn away from the Seminole. By the completion of the turn, the climb rate had reduced to zero. The helicopter reached a maximum altitude during the event of 3,180 ft.

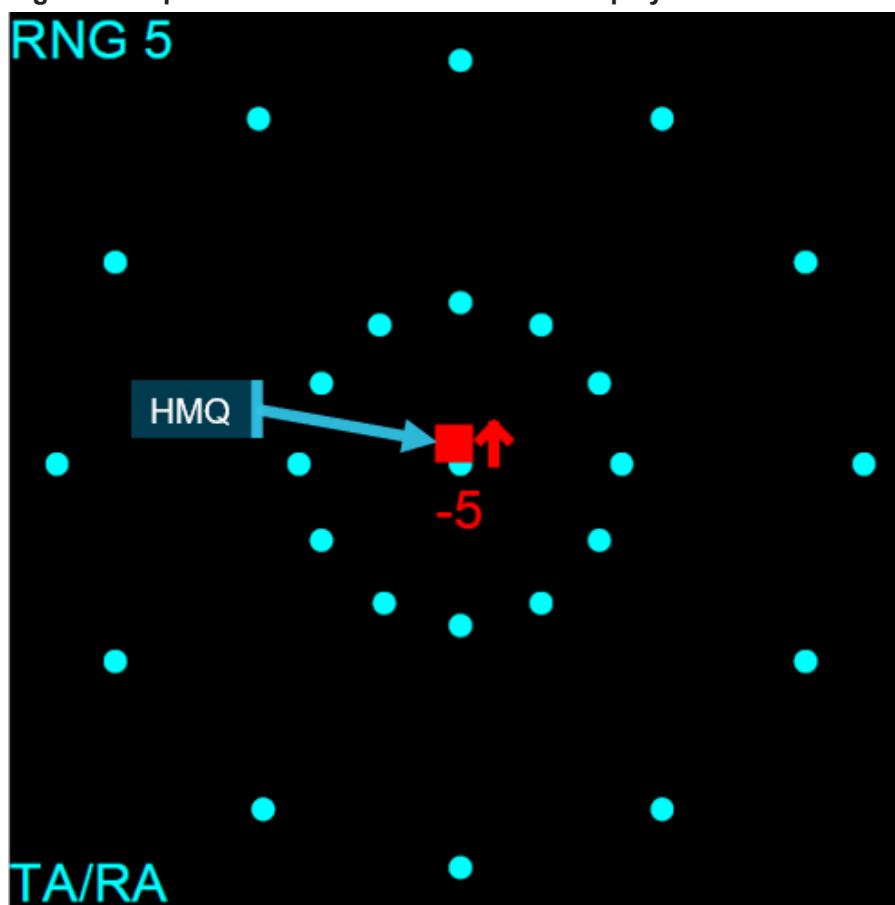
Figure 6: Representation of the TCAS traffic display at the time of the RA

Note: The information generated for the Seminole shows it as an RA (red square) that is 500 ft below the helicopter (-5 below the red square) and climbing at more than 500 feet per minute (up arrow).

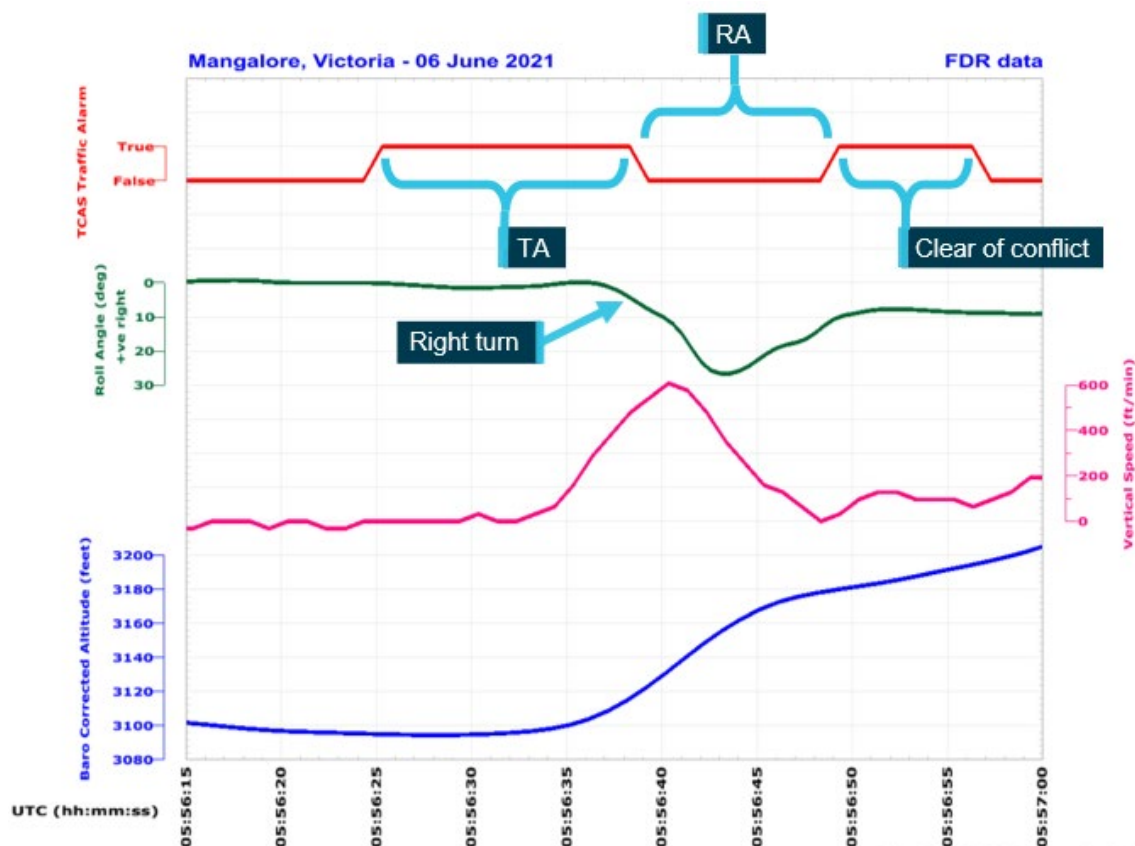
Figure 7: Graphical representation of flight data

The flight data showed activation of the TA at 15:56:25. At 15:56:33, the helicopter commenced climbing and, at 15:56:38, commenced a right turn. Two seconds after the turn commenced, the climb rate peaked at 608 feet per minute before reducing to zero 10 seconds after the turn had commenced. The helicopter climbed 84 feet during the conflict.

Note: The resolution advisory was not captured as a 'Traffic Alarm' by the flight recorder and is therefore presented as 'False' in the graphical representation of the flight data.
Source: ATSB

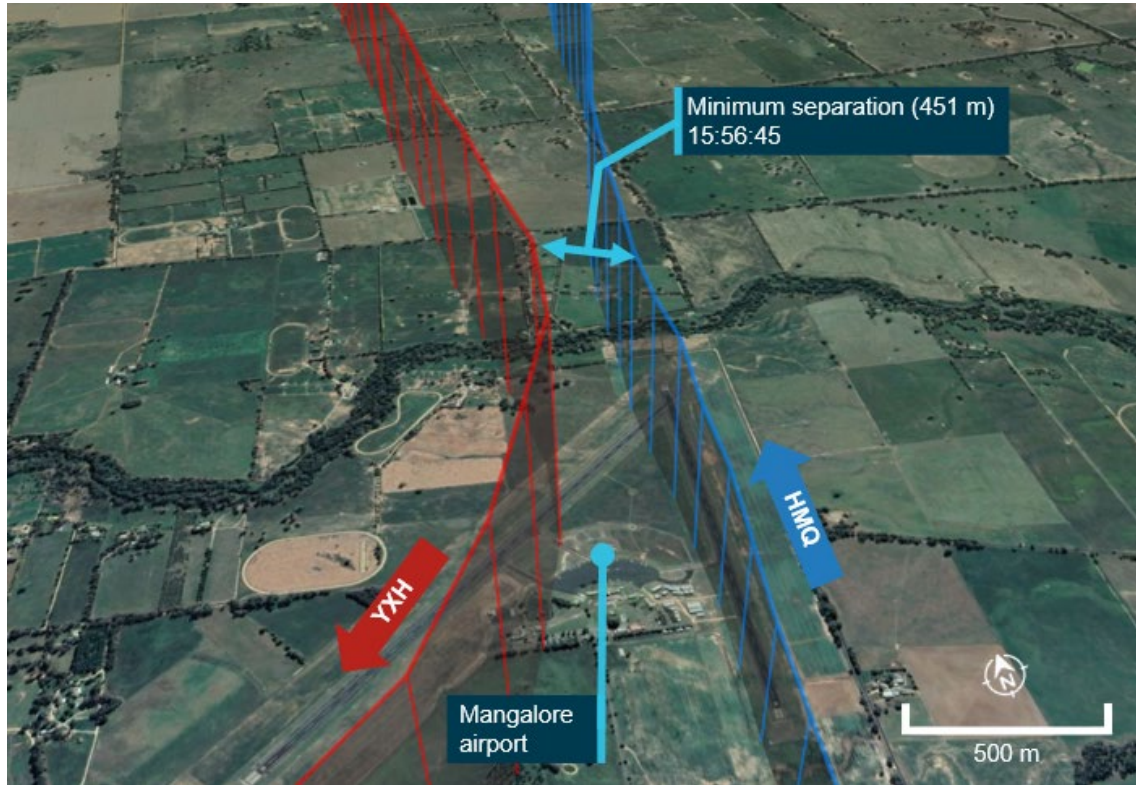
Figure 8: Representation of recorded surveillance data

At 1556:45, six seconds after the RA, the two aircraft passed with a minimum vertical separation of 543 ft and a minimum horizontal separation of 333 m (451 m in a straight line).

Airservices provided surveillance data relating to the flight paths of the Seminole and the helicopter. The data captured both flights including the incident (Figure 8).
