Airspeed management event involving a Fokker F28-0100, VH-UQN

Rockhampton Airport, Queensland, on 10 November 2019

AO-2019-063

Final – 7 June 2022

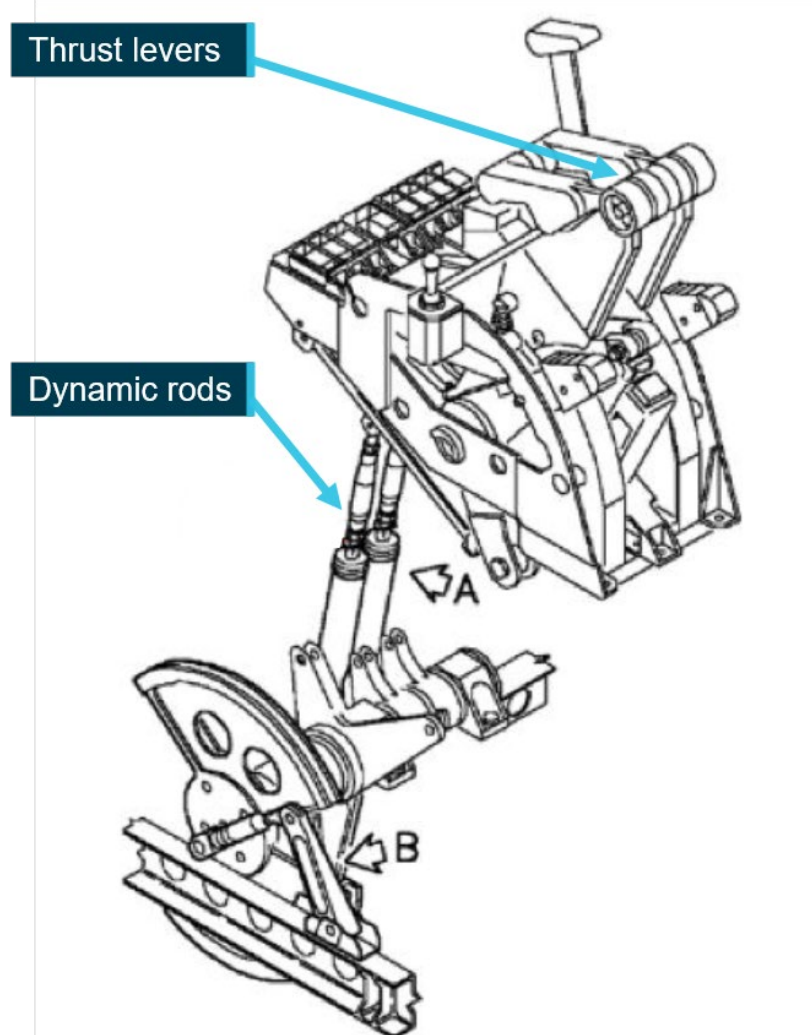
Figure 3: Dynamic rods schematic

The dynamic rod behaviour under alpha mode was specific to the operator's F100 fleet. The Fokker F28 Mk070 (F70) series, also operated by the operator, was also fitted with alpha mode but did not have the dynamic rod feature. A modification was available to remove the dynamic rod behaviour in the F100; however, this had not been incorporated into any of the operator's F100 fleet at the time of the incident. The operator reported that it had considered incorporating the modification across the Fokker fleet, but this was not achievable due to part availability and cost.

The force override switches are de-activated during alpha mode operation and if, at this moment, the pilot attempts to manually advance the thrust levers to speed up engine response, he experiences heavy override forces which may give the impression that the thrust levers are blocked. Although not recommended, ATS can be overridden by holding the ATS disconnect buttons [on the thrust levers] depressed and advancing the thrust levers until the speed is above V_{MA} and the alpha mode is deactivated.

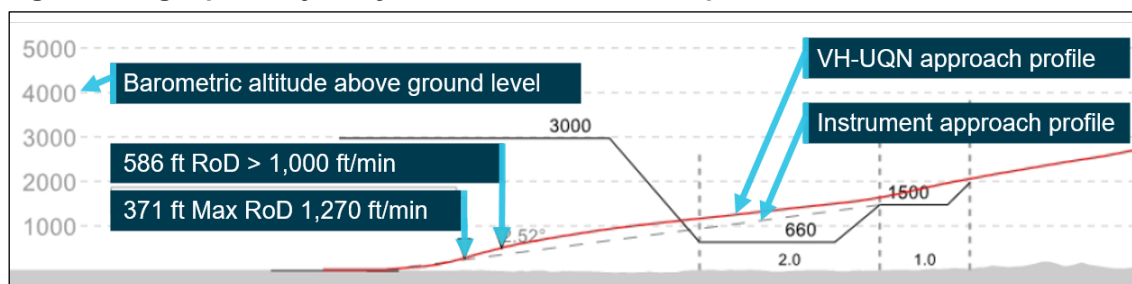
Figure 4: Flight path trajectory for VH-UQN at Rockhampton

The operator's flight data analysis software triggered 2 high RoD events during the approach at 586 ft and the second at 371 ft (Figure 4).

Data for the initial stages of the approach indicated that the aircraft was relatively stable until about 600 ft, when the aircraft's rate of descent began to increase past 1,000 ft/min. At about 370 ft, a maximum descent rate of 1,270 ft/min was recorded as the airspeed reduced to 135 kt. This added instability to the approach, however, the descent rate was not sustained above 1,200 ft/min for greater than 6 seconds. The flight crew did not consider the momentary increases in RoD as leading to an unstable approach requiring a go-around.

The aircraft's flight data noted 2 high rate of descent events when below 600 ft on approach, with a maximum rate of about 1,200 ft/min for a short period of time. This exceeded the operator's stable approach criteria, which required a rate of less than 1,000 ft/min. The identification of the high descent rate may not have been as immediate as the data suggested, as the flight crew were in the higher workload phase of landing in challenging conditions. Granularity of the vertical speed indicator increments, abbreviated vertical speed readout and display layout most likely affected the flight crew's ability to readily identify the increased rate of descent above 1,000 ft/min. This required greater attentional resources to identify, correct and monitor the rate than the flight crew

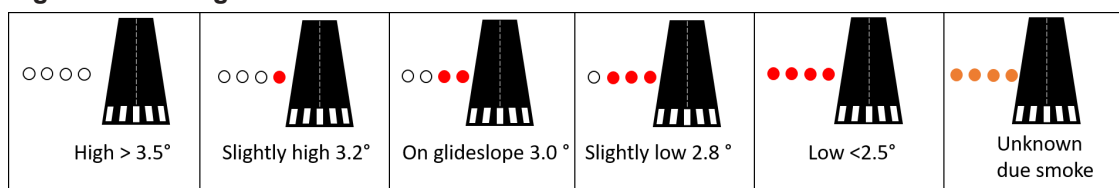
Figure 5: PAPI light indications

The PAPI light display is susceptible to the line-of-sight limitations of distance and visibility. The presence of smoke is likely to discolour the light array and make distinguishing colour from red to white difficult (Aeronautical Research Laboratories, 1981).

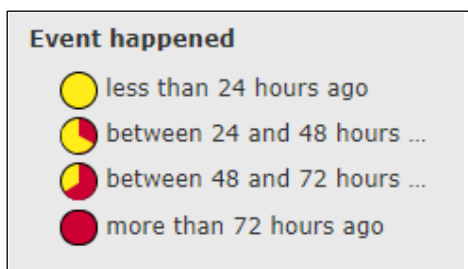
Figure 6: Safety management reporting system 72-hour countdown timer

The timer initially appeared yellow and then progressively changed to red indicating the time remaining for the submission of the written report to the ATSB. Once completely red, the report was overdue to the ATSB. The countdown timer offered a dashboard review screen where multiple occurrences could be reviewed in a date-based order.

When a report had been submitted to the ATSB, the timer was removed. However, for reports that did not require notification to the ATSB, the timer remained and appeared red until it had been validated. The operator indicated that these reports could potentially take several days to validate. As such, multiple reports with red timers would be visible on the dashboard. However, if a report was submitted late, as was the case for this incident, the report would appear in the list below other reports that had already been processed. With this setup, there was no obvious indication that a late report had not been submitted and was outstanding for ATSB reporting.
