Loss of control during taxi, involving RF Designs Mephisto, remotely piloted aircraft

Bruhl Airfield, 2 km south-west of Tara, Queensland on 19 June 2020

ATSB Transport Safety Report

AO-2020-035

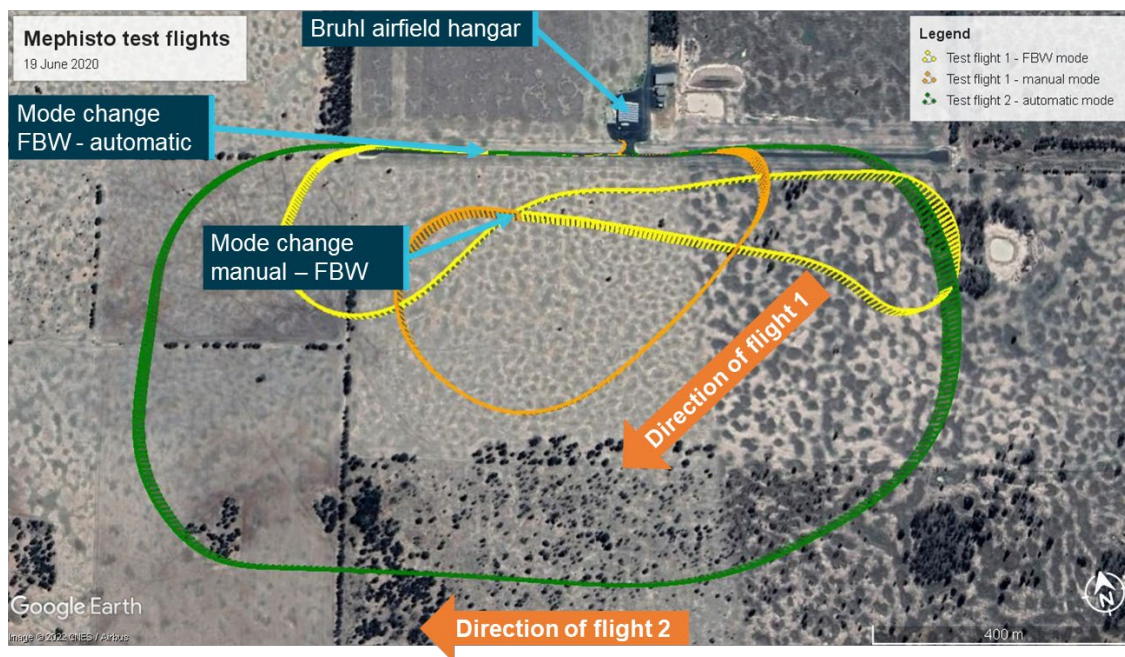
Figure 2: Mephisto test flights 19 June 2020

At 1242 Eastern Standard Time,¹ HP001 was launched, with both flights completed without incident. Figure 2 shows the Global Positioning System (GPS) tracks of the aircraft during the first and second flights with the track colour indicating the aircraft's mode. Figure 3 shows the

transition between the flights and the completion of the second flight, the initial taxi, loss of control and the recovery.

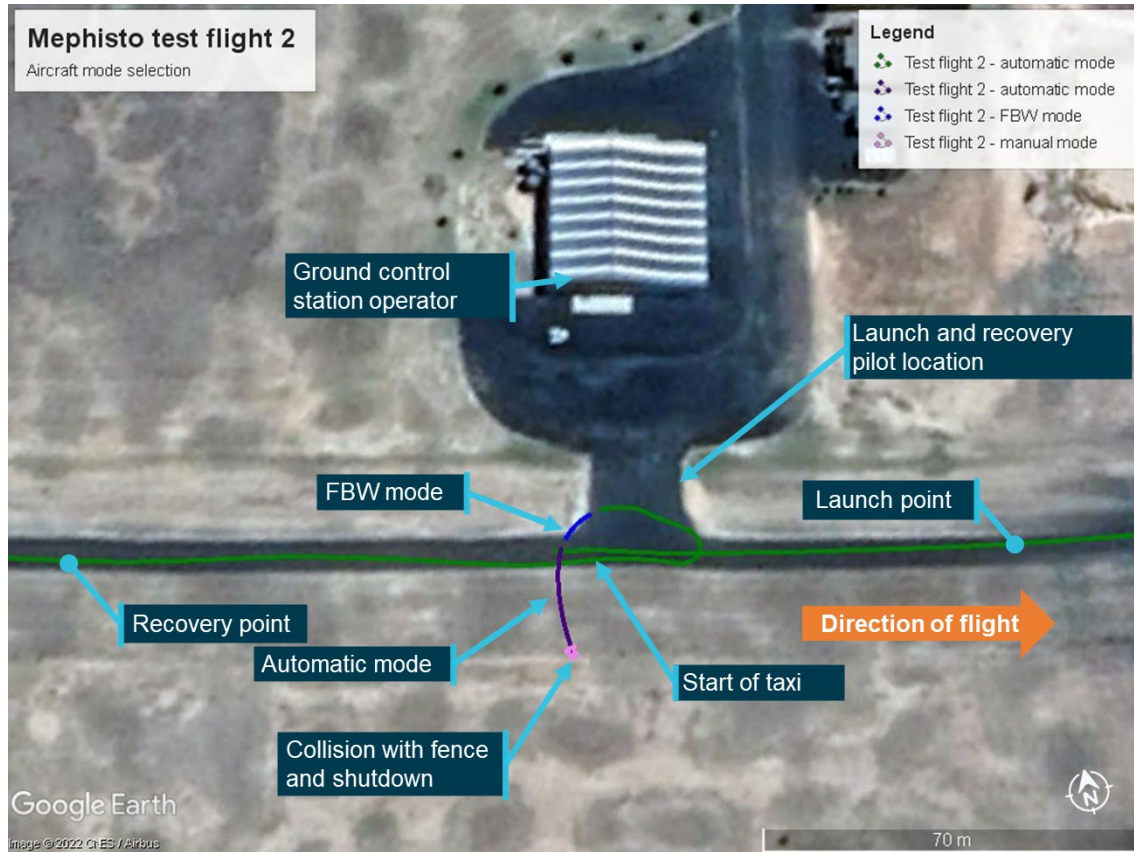
Figure 3: Mephisto test flight 2 - occurrence flight

Following the autonomous recovery at the conclusion of the second test flight, the pilot attempted to transition the aircraft out of the autonomous mode and back into manual mode for taxi to the hangar. The pilot toggled the automatic mode switch and increased the throttle setting to provide thrust to taxi the aircraft. Once the aircraft had sufficient momentum to allow for the taxi the pilot attempted to reduce the throttle setting. However, the aircraft did not respond to the pilot's commands and the turbine engine continued to accelerate.

The aircraft was now in relatively close proximity to the pilot and moving towards other personnel who had been observing from nearby. The pilot considered arresting the aircraft by hand but, due to the aircraft's speed and momentum, they determined that was not practical. The pilot re-toggled the automatic mode switch, allowing them to regain control. With the aircraft back under control, the pilot directed the aircraft across the runway to the southern side of the airfield away from the hangar and personnel. The aircraft was arrested, at low speed, by the airfield boundary fence.

The aircraft was then attended by the pilot and several other personnel who conducted a normal shutdown before pushing it back to the hangar for inspection. The inspection determined that the aircraft only had minor damage to the skin due to the impact with the fence.

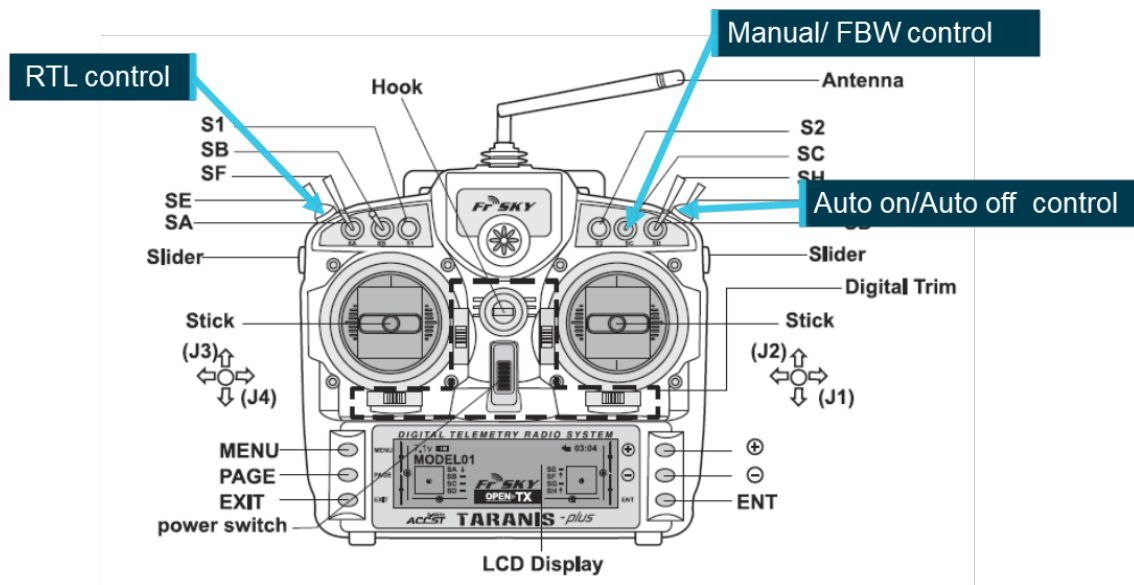
Figure 6: TARANIS X9D Plus with key controls identified

For this operation, to ensure redundancy, the 2 position switches activated the 'return to launch'³(RTL) function. This meant that 3 position switches were used to control the aircraft's modes. To reduce risk of the automatic mode being inadvertently deactivated the modes were switched separately. One switch controlled the automatic mode (on and off) and the other selected manual or FBW. The control hierarchy placed the automatic mode switch above the manual or FBW switch so an inadvertent movement of the manual or FBW switch would not disengage the automatic mode.

Figure 6 shows the location of these switches. The operation of any of these switches required a defined movement and the pilot described that changing between positions made an audible 'click'.

The automatic mode switch was configured with 2 'auto on' and 1 'auto off' position, which was the top position. This configuration had recently been updated from 1 'auto on' and 2 'auto off' positions. This change was due to a risk to the aircraft associated with inadvertent deactivation of the automatic mode during flight, particularly when the aircraft was BVLOS. To ensure that the switch was in the correct position it was normal for pilots to drive the switch to an end point of the control to ensure that the desired mode had been selected.

- 3-position mode switches were replaced with 2-position mode selection switches to eliminate issues with incomplete deactivation of the automatic mode.
- All launch and recovery pilot controllers had a 'kill switch' added that overwrites the aircraft's mode to manual and drives the throttle immediately to zero thrust. This switch is gated to enable easy to operation when necessary, but is also difficult to inadvertently activate.
- Taxi procedure has been changed/formalised to require that all aircraft are shutdown on the runway and pushed back to the hangar by hand rather than under their own power.
- The operational timeline has been extended from 7 to 10 days, with additional time to setup and prepare the aircraft and a break before operations commenced.

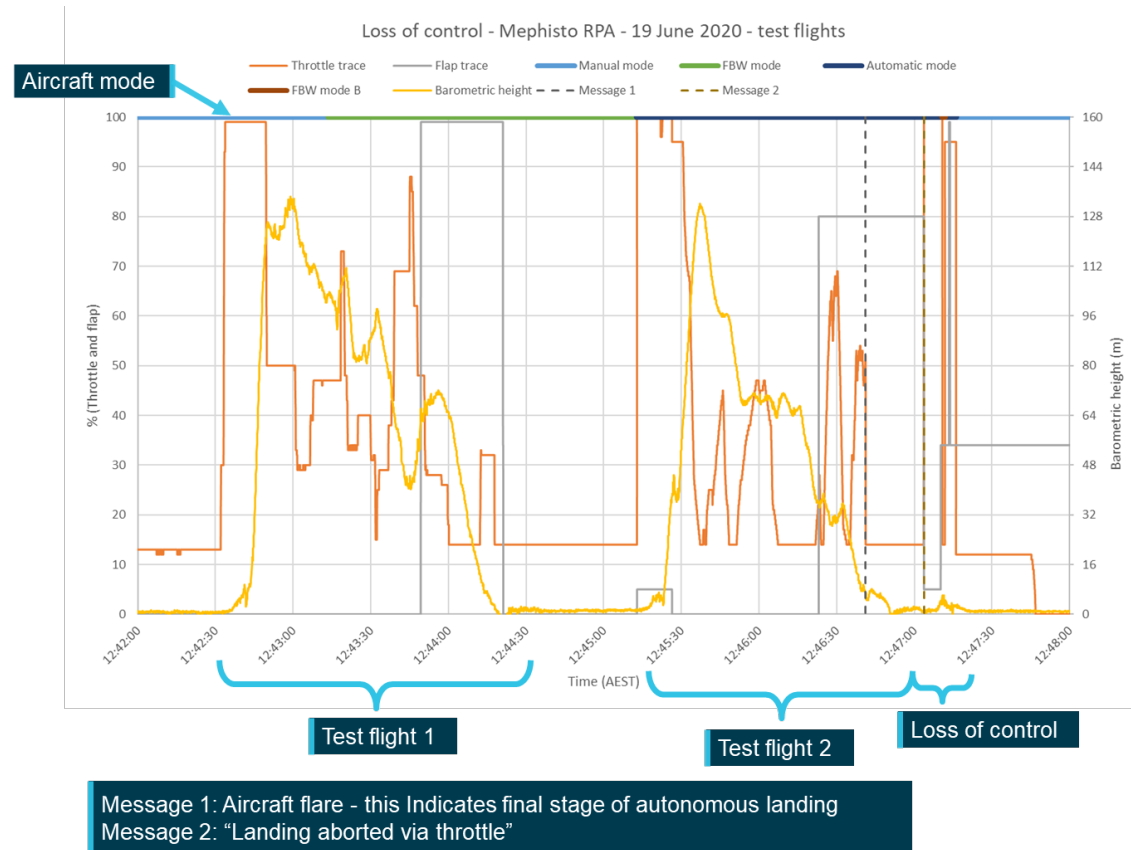
Figure 7: Flight data showing 19 June test flights

The data for the two test flights, was downloaded by the operator and the data and relevant software for interpreting it were provided to the ATSB. Figure 7 shows data from these flights with throttle, flap and altitude traces. Additionally, the active aircraft mode is shown and some of the recorded aircraft status messages.

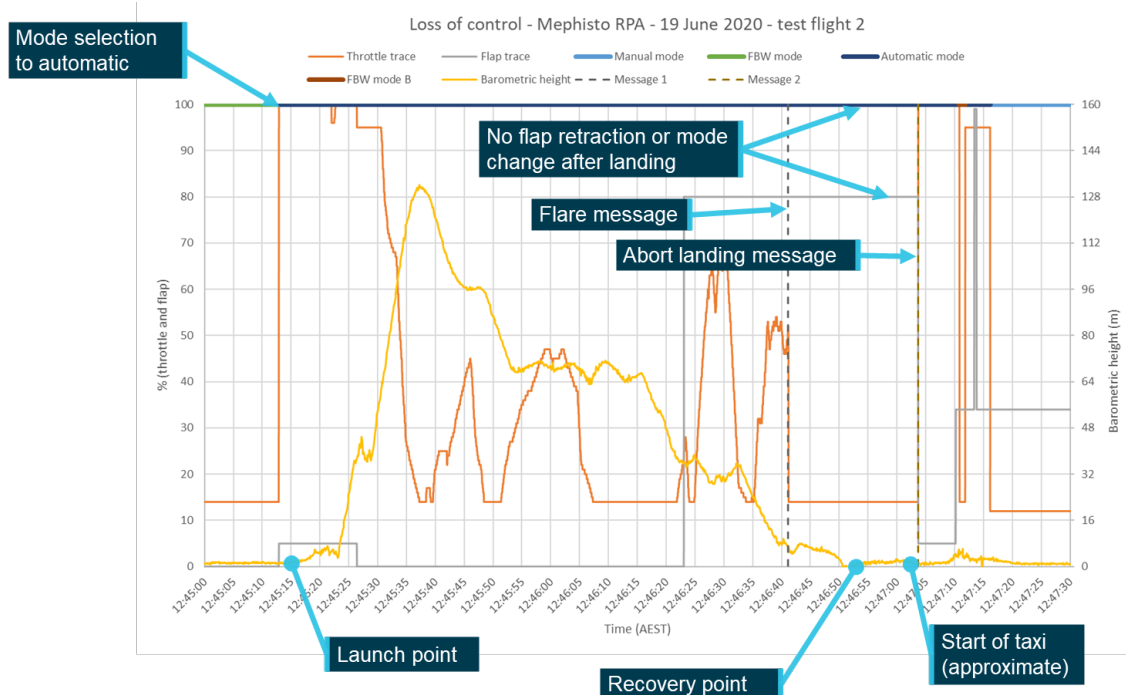
Figure 8: Flight Data - Mephisto test flight 2 - 19 June

Figure 8 shows data from the second flight with the transition into automatic mode and the aircraft then launching conducting a circuit and being recovered. Following the landing there were a number of mode changes and an aircraft status message that corresponded with the 'abort landing' function being activated, the pilot toggling the mode switch to disengage this function and directing the aircraft away from personnel on the flight line.

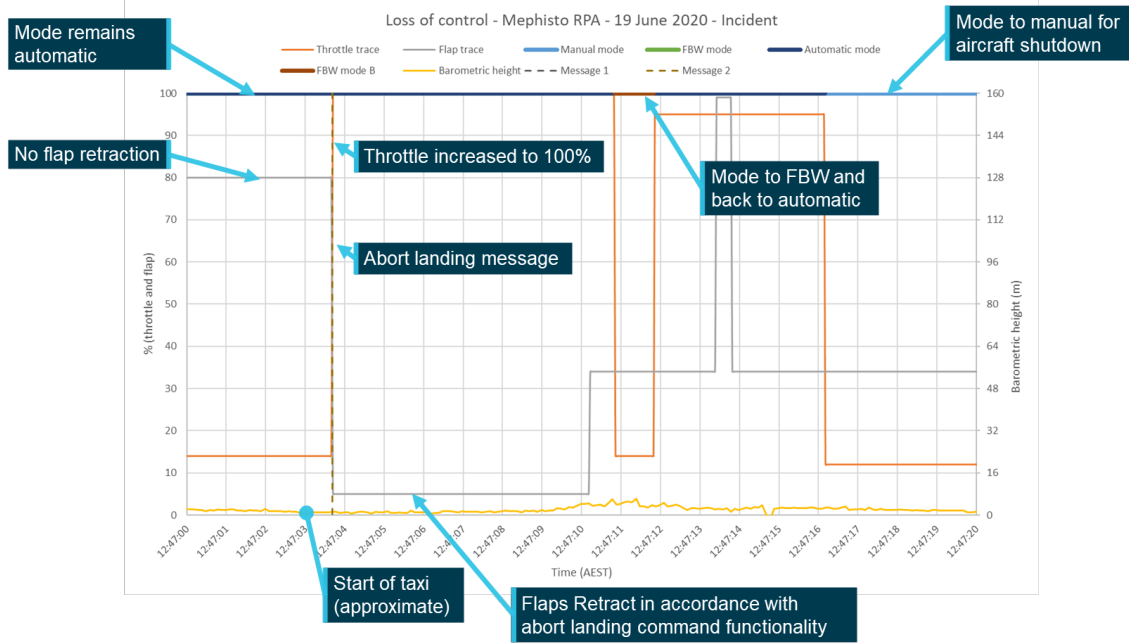
Figure 9: Flight Data - Incident - 19 June

Figure 9 shows greater detail of the incident over the period of 20 seconds from 12:47:00 to 12:47:20, during which the aircraft was under the control of the LRP. This time covers the aircraft on the ground preparing to taxi, the throttle being advanced, and the 'abort landing' function being activated, as identified by aircraft status message 2. It shows the mode selections by the pilot as they disengaged the abort landing function and toggled into manual mode as the aircraft was directed towards the airfield fence.

The data showed the pilot toggling the automatic mode switch to off, and back on, to overwrite the 'abort landing' function. It shows the throttle trace as the pilot directed the aircraft away from the flight line and across the runway towards the fence, and finally the re-engagement of the manual mode for the aircraft to be shutdown.
