Australian Transport Safety Bureau

# Safety Advisory Notice

Number: AO-2022-006-SAN-001

## UH-1H helicopter main drive shaft failure

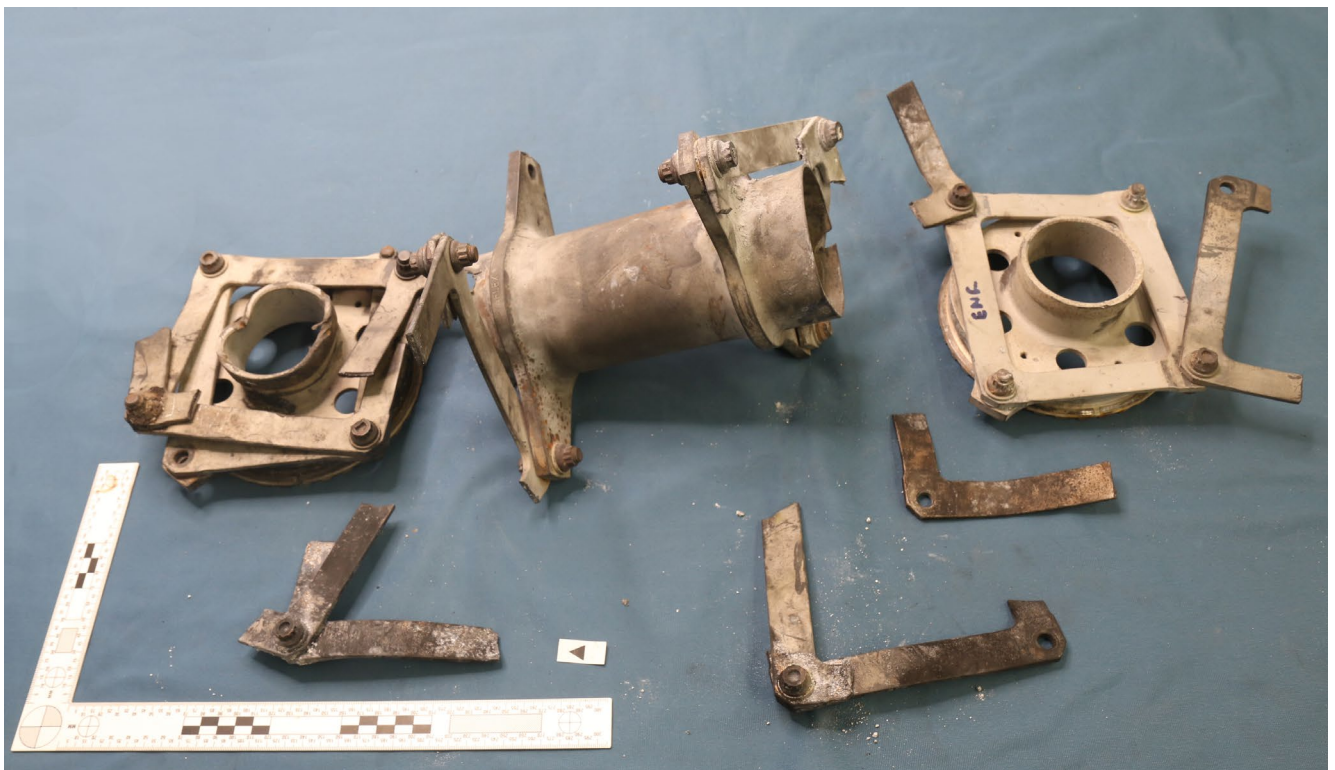
The ATSB's on-site examination of the wreckage found anomalies with the helicopter's main drive shaft, identified as a KAflex and manufactured in the United States by Kamatics Corporation (Kamatics), that transmits engine power to the transmission. The shaft was found to have fragmented during the accident sequence, with 4 of the flex-frame attaching hardware (nuts, bolts, and their washers) and portions of the flexible frame elements unable to be accounted at the accident site. The ATSB subsequently commenced a detailed technical examination of the KAflex shaft assembly and importantly, severe frictional and wear damage was identified to have occurred to one portion of the shaft. The results of that work was presented to Kamatics and the Civil Aviation Safety Authority (CASA).

While the ATSB's investigation of this accident and further technical examination of the KAflex shaft remain ongoing, the manufacturer advised that the presence of the frictional damage was evidence that the shaft had entered fail-safe mode during operation. The frictional damage was consistent with other KAflex shafts that had entered fail-safe mode following the release of flex-frame attaching hardware, or, when one of the flexible frame elements had fractured during operation.

Fragmented KAflex from the accident helicopter, source ATSB

The ATSB advises operators of UH-1H helicopters to note the preliminary details of this accident, the content of AD 2021-26-16 and CASA Airworthiness Bulletin AWB 63-004, and to look for the presence of:

- corrosion
- fretting
- frame cracking
- missing or damaged flex-frame attaching hardware

during all inspections of the KAflex drive shaft. Any identified defects should be notified to the Civil Aviation Safety Authority and the ATSB.
