Collision with terrain involving Piper PA-25, VH-SEH

Seaview, Victoria, on 23 February 2022

ATSB Transport Safety Report

AO-2022-008

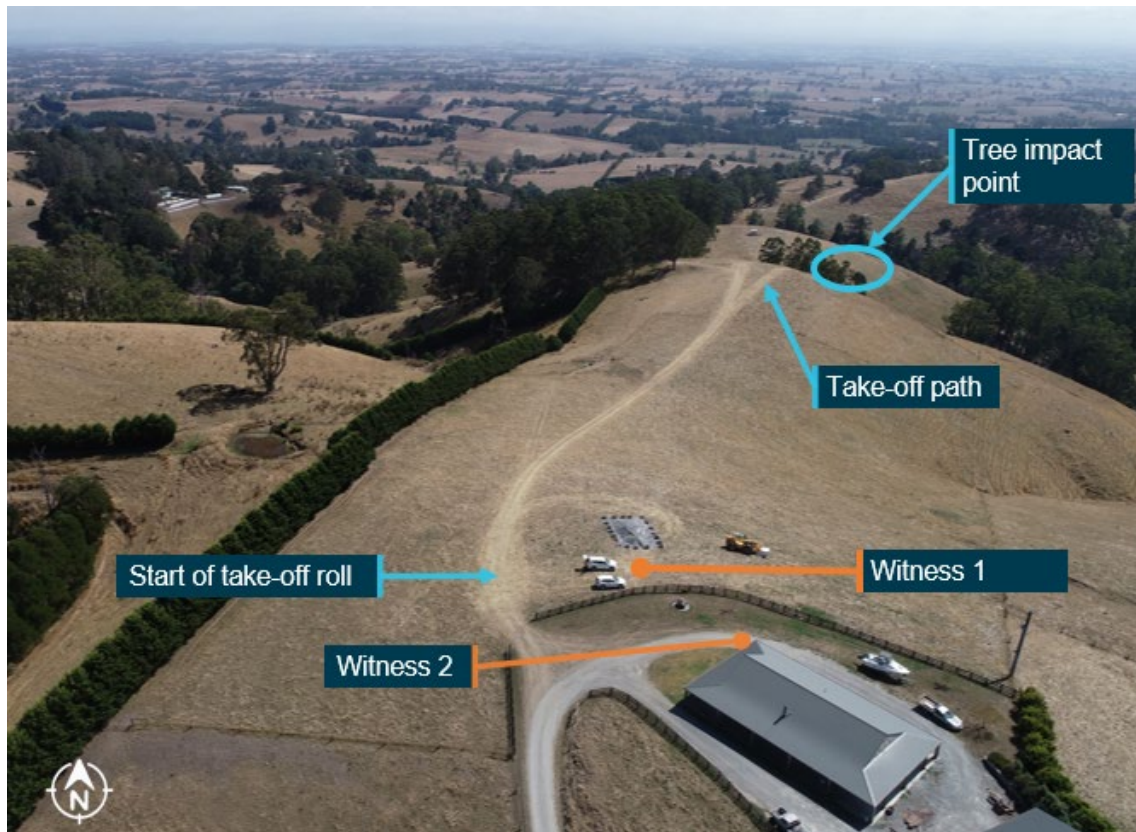
Figure 1: Landing area overview

Data from an onboard GPS showed that the pilot commenced the take-off on the prepared runway strip at about 0711 (Figure 1). According to witnesses and the recorded video, the aircraft accelerated along the prepared strip and traversed the right section where the strip split into 2 directions. The aircraft briefly became airborne at a point at the end of the strip, where the terrain dropped away, before the outboard section of the aircraft's left wing impacted trees. The aircraft rolled to the left, pitched down, and collided with terrain about 30 m north of the trees (Figure 2). The pilot was fatally injured and the aircraft was destroyed.

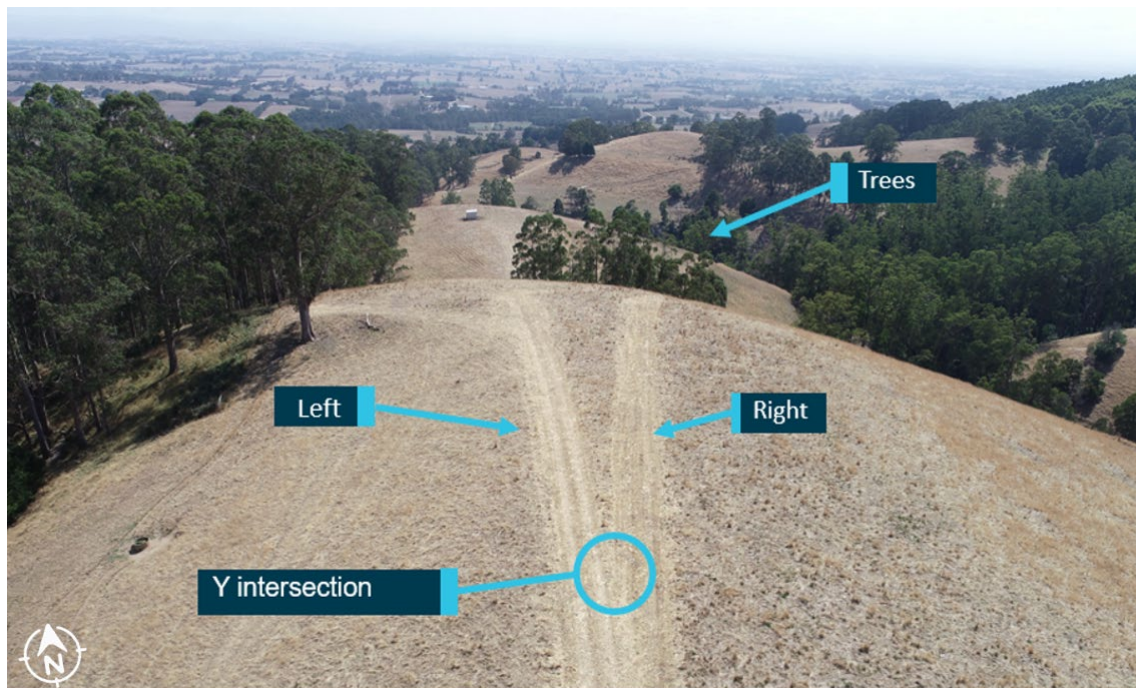
Figure 4: Runway strip Y intersection showing the left and right take-off options with the trees at the runway's end

The prepared strip had been mowed into a 'Y' configuration by the pilot in the days before the accident. It consisted of mowed grass and the surface was rough from previous cattle movement in wet soil. The strip was about 360 m in length and followed the natural terrain, with a downwards then upwards slope before the terrain dropped steeply towards a stand of trees about 60 m from the northernmost end of the strip. The left of the 'Y' was oriented to the left of the trees and the right of the 'Y' was oriented directly towards the trees (Figure 4).

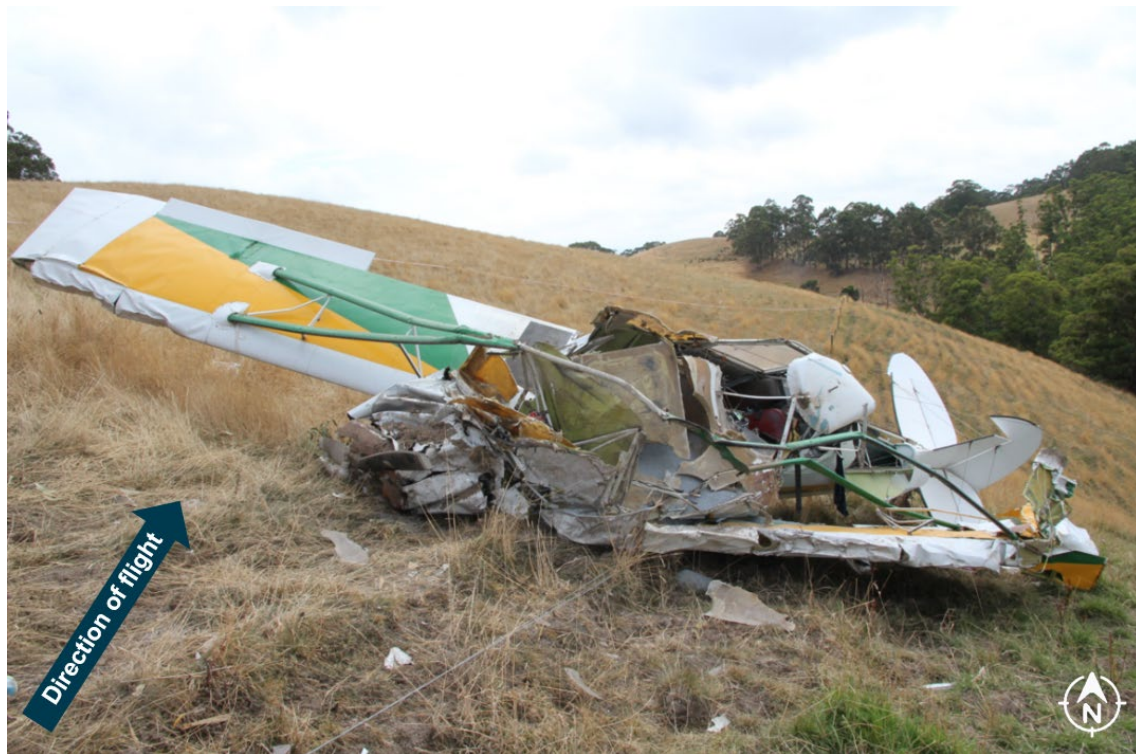
Figure 5: Wreckage of VH-SEH

The ATSB conducted an on-site examination of the aircraft wreckage (Figure 5). The aircraft impacted the ground inverted with an angle of entry of about 50°. There were no evident pre-impact defects with the flight controls or aircraft structure, and external examination of the engine did not identify any obvious defects. The propeller damage was indicative of the engine driving the propeller with significant power at impact. Preliminary audio analysis of the witness video indicated that the engine was at or close to its maximum rotational speed throughout the take-off.
