# Collision with water involving EC135 P2+ helicopter, VH-ZGA

37 km north-north-west of Port Hedland, Western Australia, on 14 March 2018

## **ATSB Transport Safety Report**

AO-2018-022

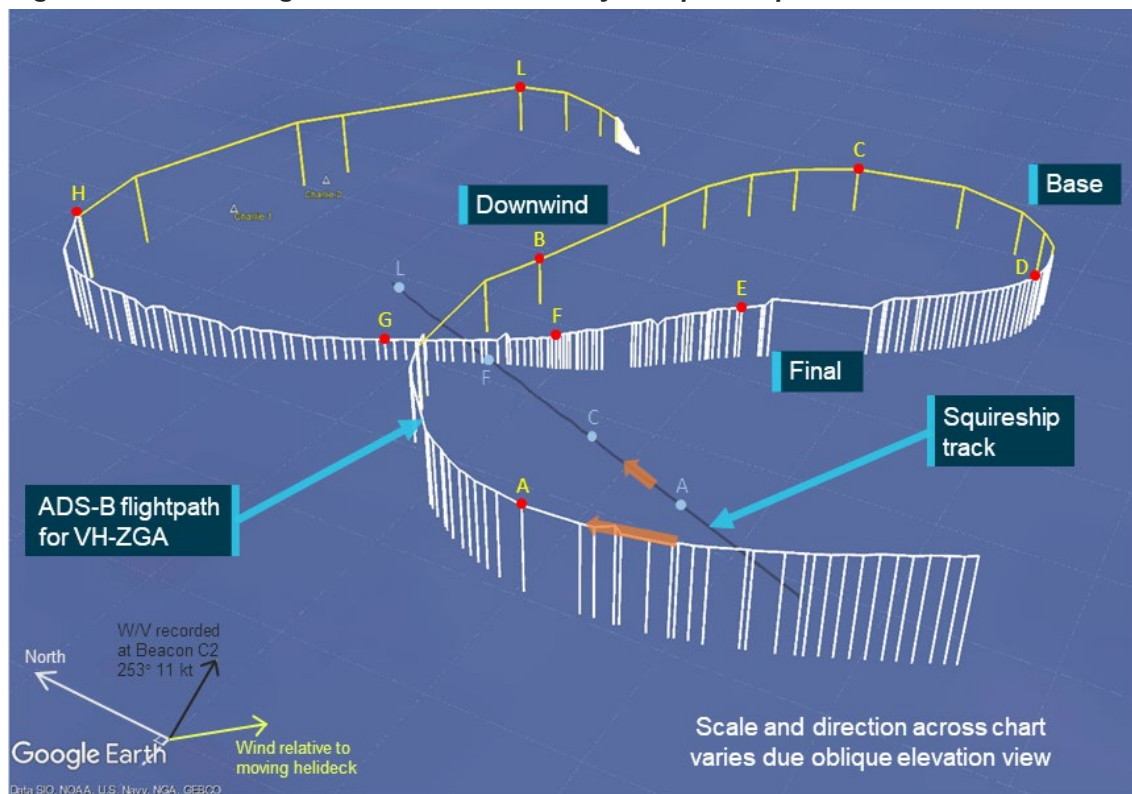
**Figure 2: Manoeuvring of VH-ZGA in the vicinity of *Squireship***

This figure shows a representation of the flight path derived from ADS-B data recorded while VH-ZGA was being operated in the vicinity of Squireship. The white helicopter track is derived from positions recorded by Aircservices Australia ADS-B receivers. Where that data was not available, positions recorded by the FlightRadar24 internet server were utilised and represented as the yellow flight path.<sup>10</sup> Data relevant to the annotated labels A to L is presented in Table 1 and marked as labelled index points in Figure 3. The light blue dots represent the AIS position of the bulk carrier recorded by the Australian Maritime Safety Authority receiver at corresponding times during the approaches of VH-ZGA. The bulk carrier was 288 m in length, with the AIS position 248 m from the vessel's bow.

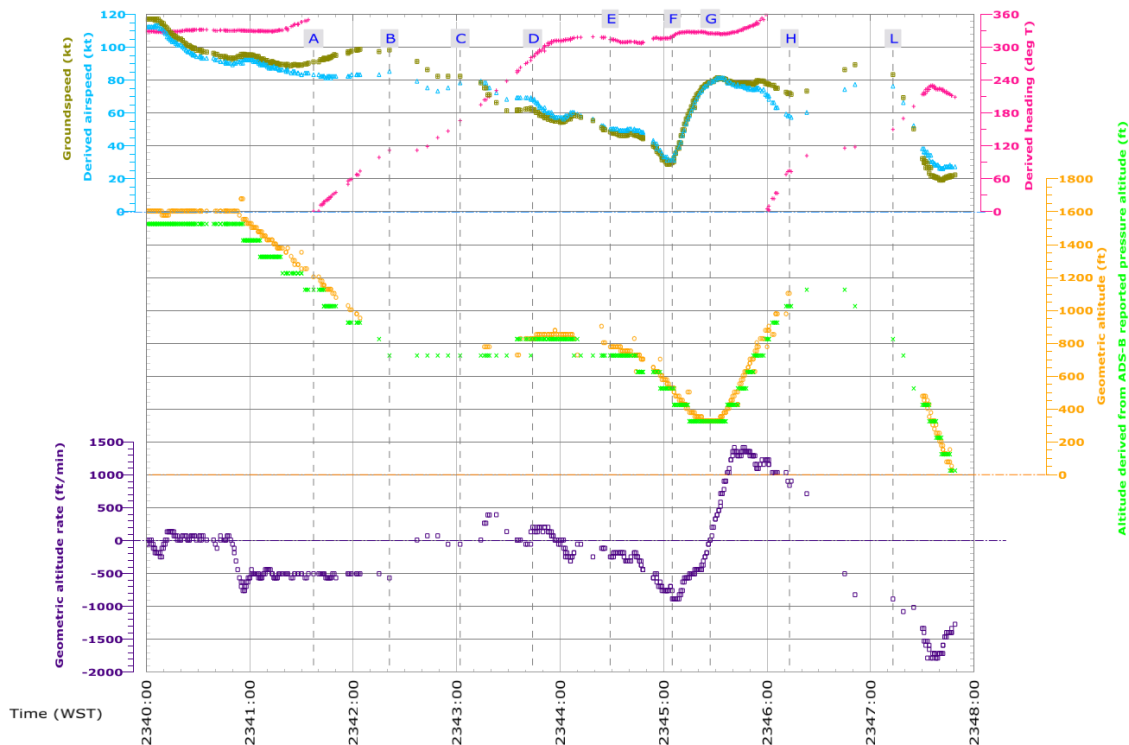
**Figure 3: VH-ZGA derived airspeed, altitude and geometric altitude rate of change in vicinity of C1/C2**

Graphical summary of aggregated ADS-B and derived data, while VH-ZGA was in the vicinity of the bulk carrier during the accident flight. The airspeed of the helicopter is derived from the ADS-B groundspeed and ground track using the wind velocity and atmospheric pressure recorded by meteorological equipment at a nearby channel marker and corrected for temperature. The helicopter altitude is derived from the ADS-B geometric altitude and the independently measured pressure altitude, adjusted for surface pressure. The geometric altitude is reported in 25 ft increments, the pressure altitude is reported in 100 ft increments. The geometric altitude rate of change was broadcast by the helicopter's ADS-B equipment, in increments of 6.25 ft/min. Breaks in the continuity of the data indicate periods where ADS-B broadcasts were not being received. The labelled time markings correspond with the positions depicted in Figure 2 and Table 1.

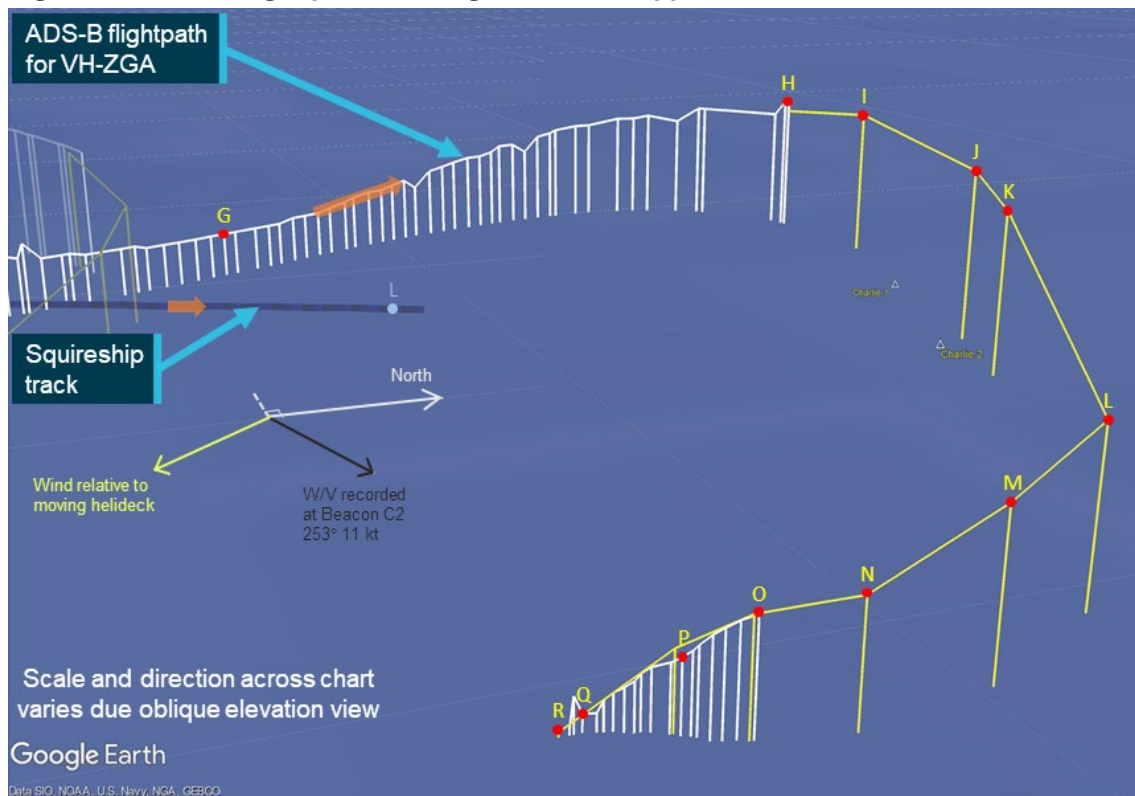
**Figure 4: VH-ZGA flight profile during the second approach**

This figure shows a representation of the flight path derived from ADS-B data recorded while VH-ZGA was being operated in the vicinity of Squireship. The white helicopter track is derived from positions recorded by Airservices Australia ADS-B receivers. Where that data was not available, positions recorded by the FlightRadar24 internet server were utilised and represented as the yellow flight path. Data relevant to the annotated labels H to R is presented in Table 2 and marked as labelled index points in Figure 5.  
Source: ATSB

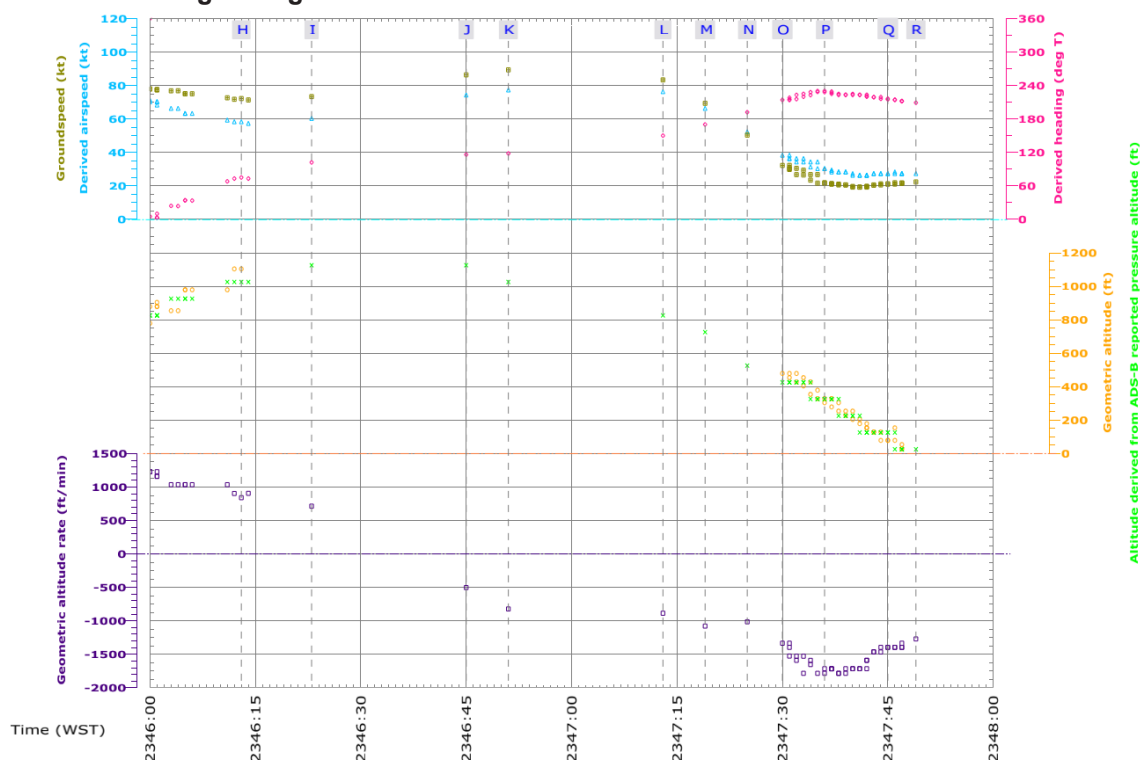
**Figure 5: VH-ZGA derived airspeed, altitude, geometric altitude rate of change and derived heading during second circuit**

Graphical summary of aggregated ADS-B recorded data and parameters derived from that dataset, during the second circuit of the bulk carrier and during the final descent. The airspeed of the helicopter is derived from the ADS-B groundspeed and ground track using the wind velocity and atmospheric pressure recorded by meteorological equipment at a nearby channel marker and corrected for temperature. The helicopter altitude cross-references the ADS-B geometric altitude and the independently measured pressure altitude, adjusted for surface pressure. The geometric altitude is reported in 25 ft increments, the pressure altitude is reported in 100 ft increments. The geometric altitude rate of change was broadcast by the helicopter's ADS-B equipment, in increments of 6.25 ft/min. Breaks in the continuity of the data indicate periods where ADS-B broadcasts were not being received. The labelled time markings correspond with the positions depicted for the helicopter in Figure 4 and Table 2.

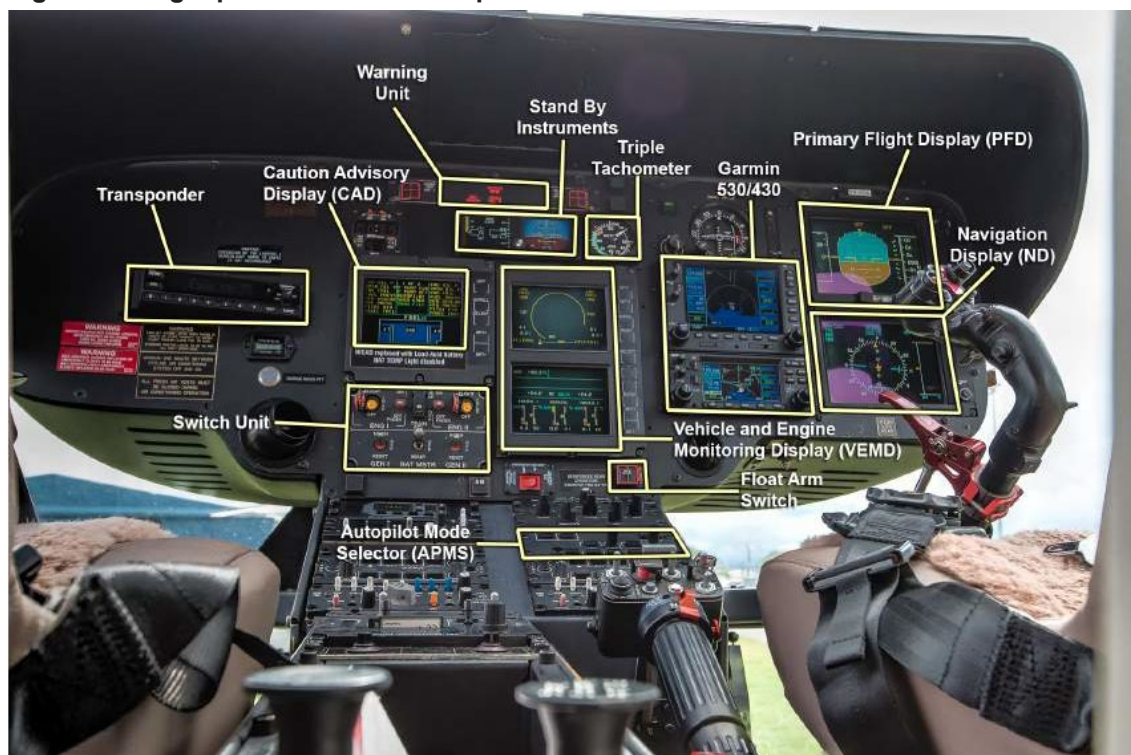
**Figure 7: Single-pilot IFR instrument panel fitted to VH-ZGA**

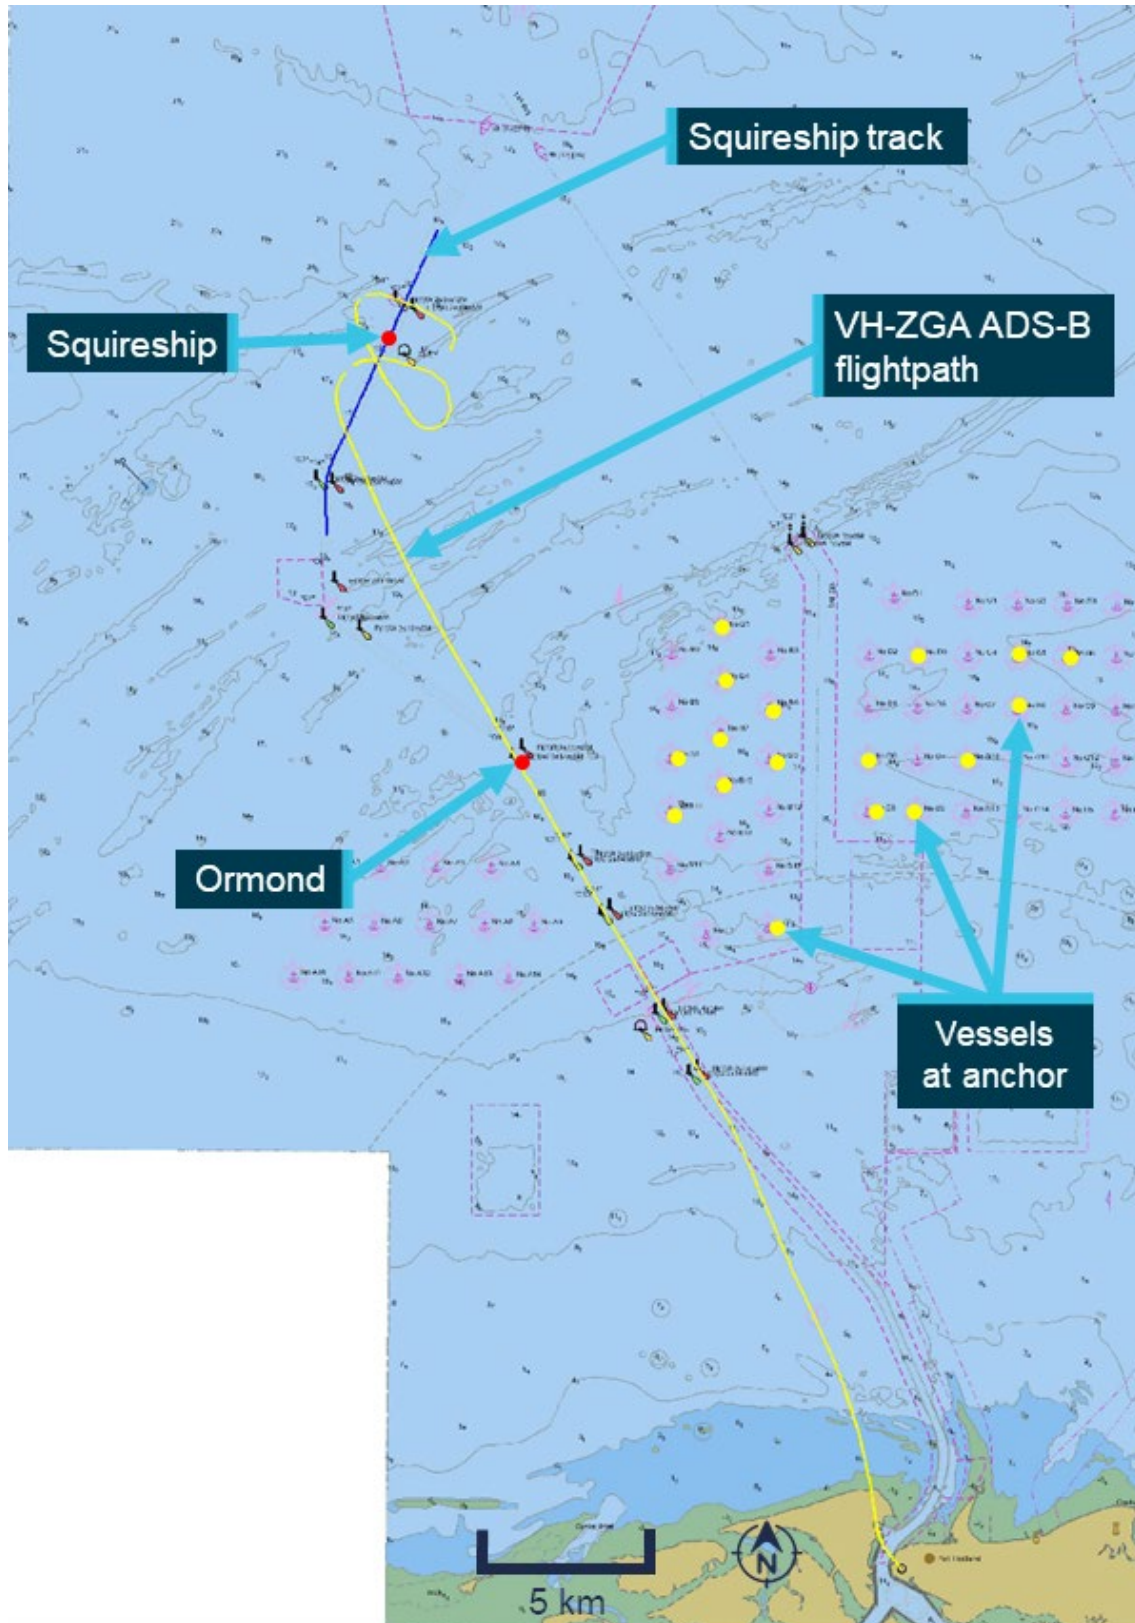
**Figure 13: ADS-B flight path for VH-ZGA, including relative position of Port Hedland, vessels at anchor and vessels underway at the time of the accident**

*This image shows the helicopter flight path during the accident flight and the surface track of the departing bulk carrier in vicinity of C1/C2. Also shown is the position of the bulk carrier, Ormond underway along the shipping channel at the time of the accident, together with the vessels at anchor.*

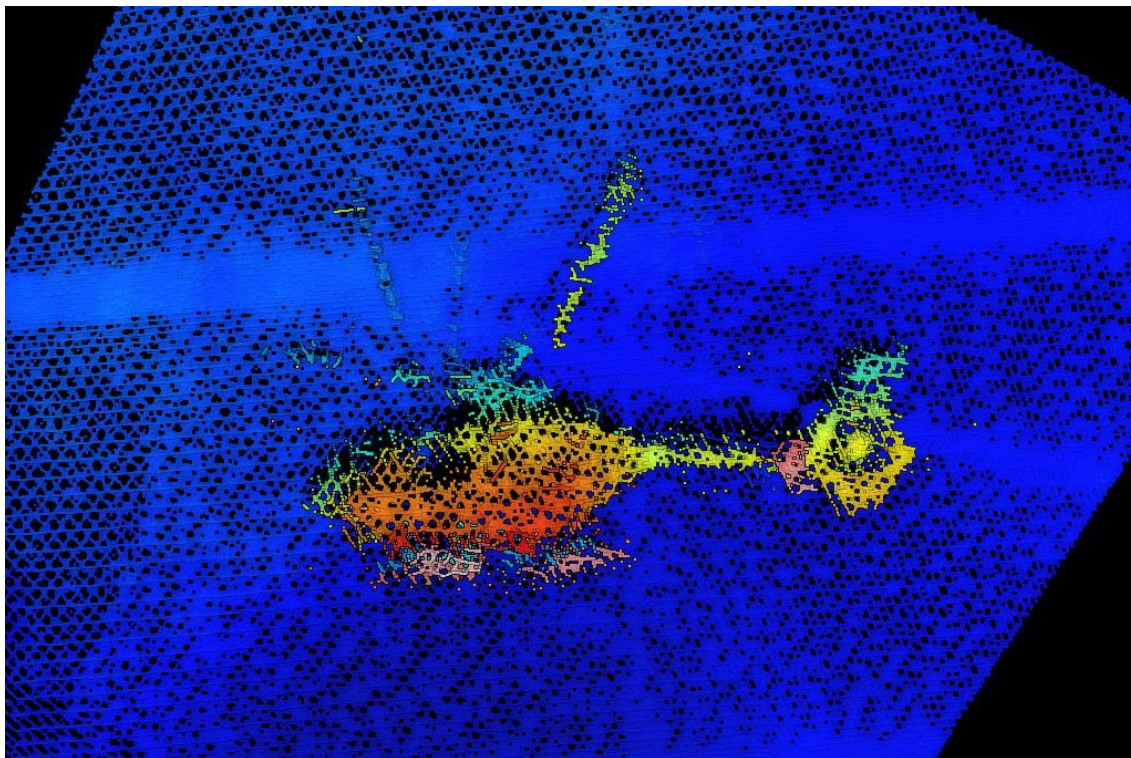
**Figure 14: Sonar image of helicopter resting on its right side**

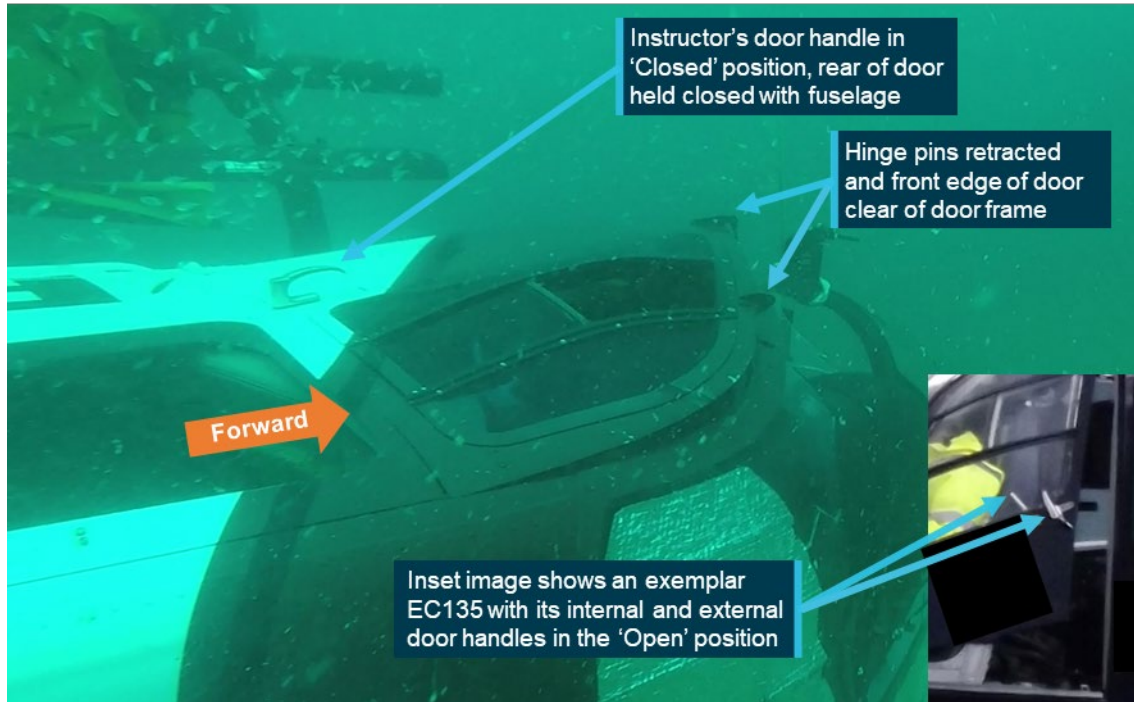
**Figure 15: Image of instructor's cockpit door captured from police dive video, showing deployment of the door's emergency jettison system and a partial door release**

*This image shows the helicopter as found on the seabed, on the right side of its fuselage. The instructor's cockpit door (left) is shown with the forward hinge pins retracted and the door's front edge slightly ajar from the fuselage. The door operating handle used for normal door operation is still in the closed position and the latching mechanism is holding the rear edge of the door closed.*  
 Source: Western Australia Police Force dive video, annotated by the ATSB

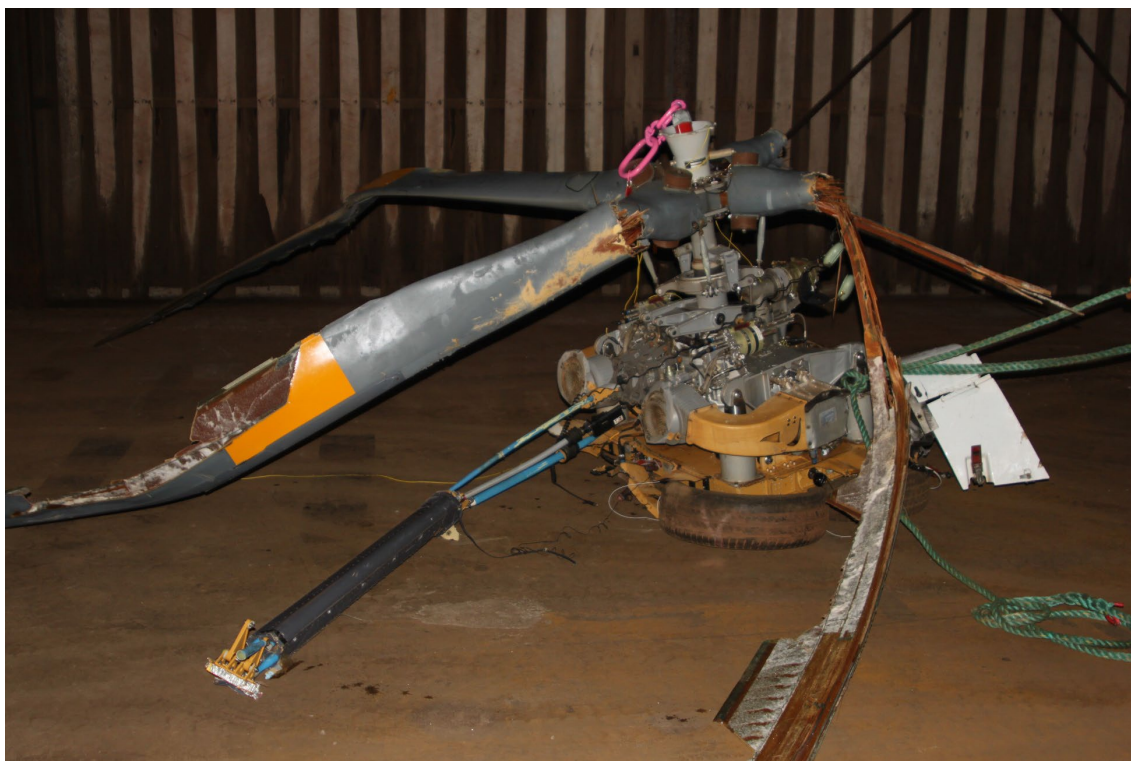
**Figure 17: Main rotor blades and main transmission, showing damage in vicinity of the blade roots**

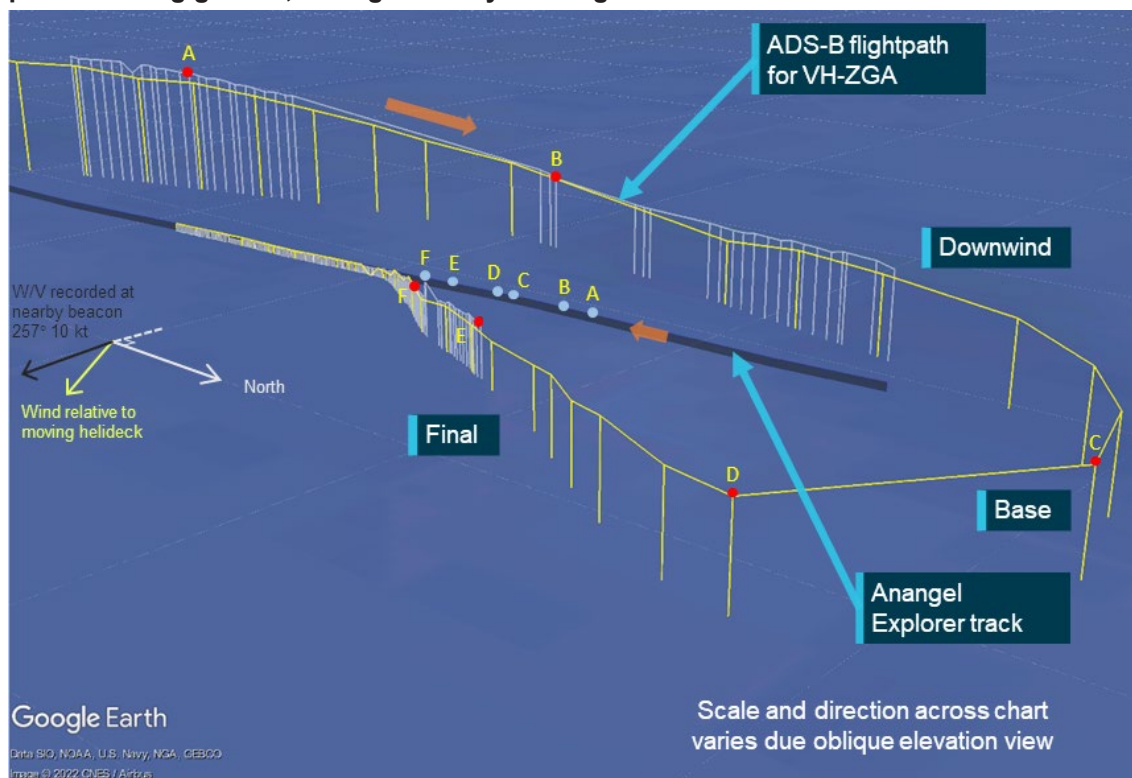
**Figure 21: ADS-B data for VH-ZGA, during a night approach to *Anangel Explorer* at the pilot boarding ground, during the early evening of 14 March 2018**

Representation of recorded track data during the first night flight, to transfer a marine pilot to *Anangel Explorer* at the pilot boarding ground. This flight was conducted at night, under night VFR procedures. The white track is positions of VH-ZGA recorded by the ASA ADS-B receivers, the yellow track is positions recorded on the FlightRadar24 internet server. The annotated labels A to F correspond to the ADS-B helicopter position relative to the bulk carrier's landing hatch, as derived from shipping data recorded by the Australian Maritime Safety Authority. Data relevant to the annotated labels for VH-ZGA is presented in Table 13 and marked as labelled index points in Figure 22. The bulk carrier was 289 m in length.

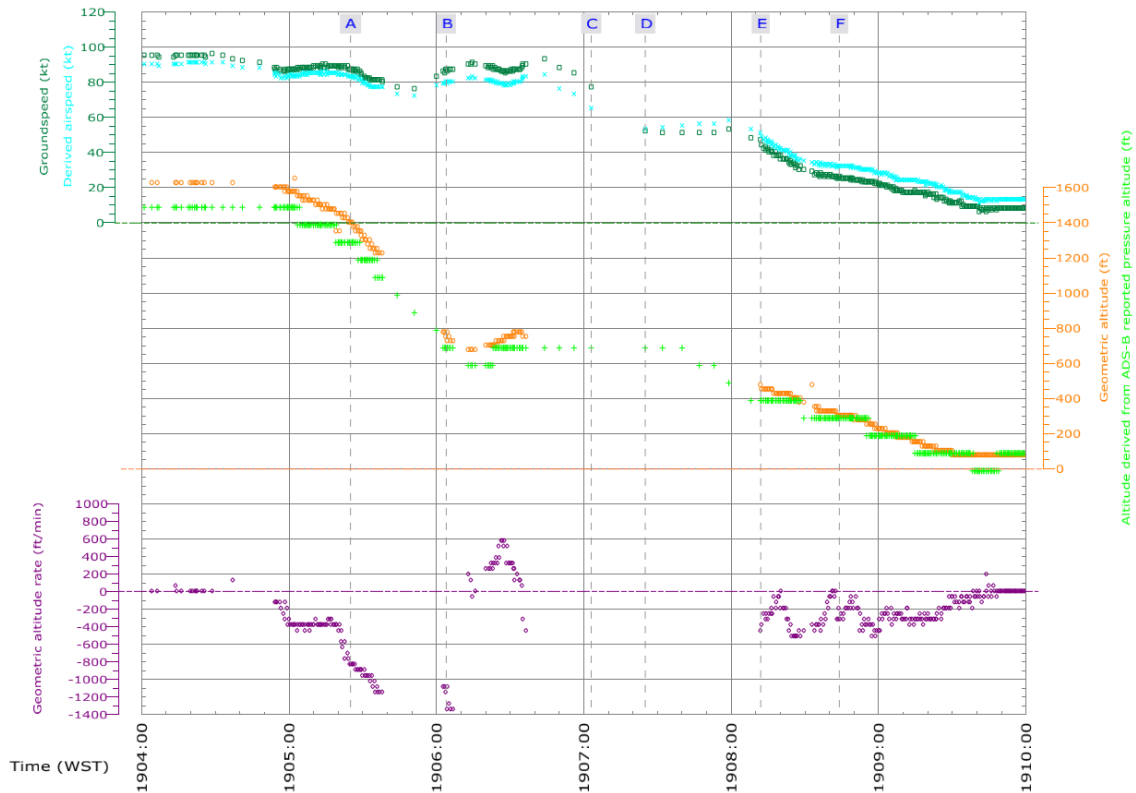
**Figure 22: VH-ZGA derived airspeed, ADS-B reported altitudes and geometric altitude rate of change during the first night approach at the pilot boarding ground**

Graphical summary of aggregated ADS-B and derived data during the evening of the accident, while VH-ZGA was being operated in vicinity of Anangel Explorer as it approached the pilot boarding ground, in night conditions under the night VFR. The airspeed of the helicopter is derived from the ADS-B groundspeed and ground track using the wind velocity and atmospheric pressure recorded by meteorological equipment at a nearby channel marker and corrected for temperature. The helicopter altitude cross-references the ADS-B geometric altitude and the independently measured pressure altitude, adjusted for surface pressure. The geometric altitude is reported in 25 ft increments, the pressure altitude is reported in 100 ft increments. The geometric altitude rate of change was broadcast by the helicopter's ADS-B equipment, in increments of 6.25 ft/min. Breaks in the continuity of the data indicate periods where the ADS-B broadcasts were not being received. The labelled time markings correspond with the positions depicted for the helicopter in Figure 21 and Table 13.

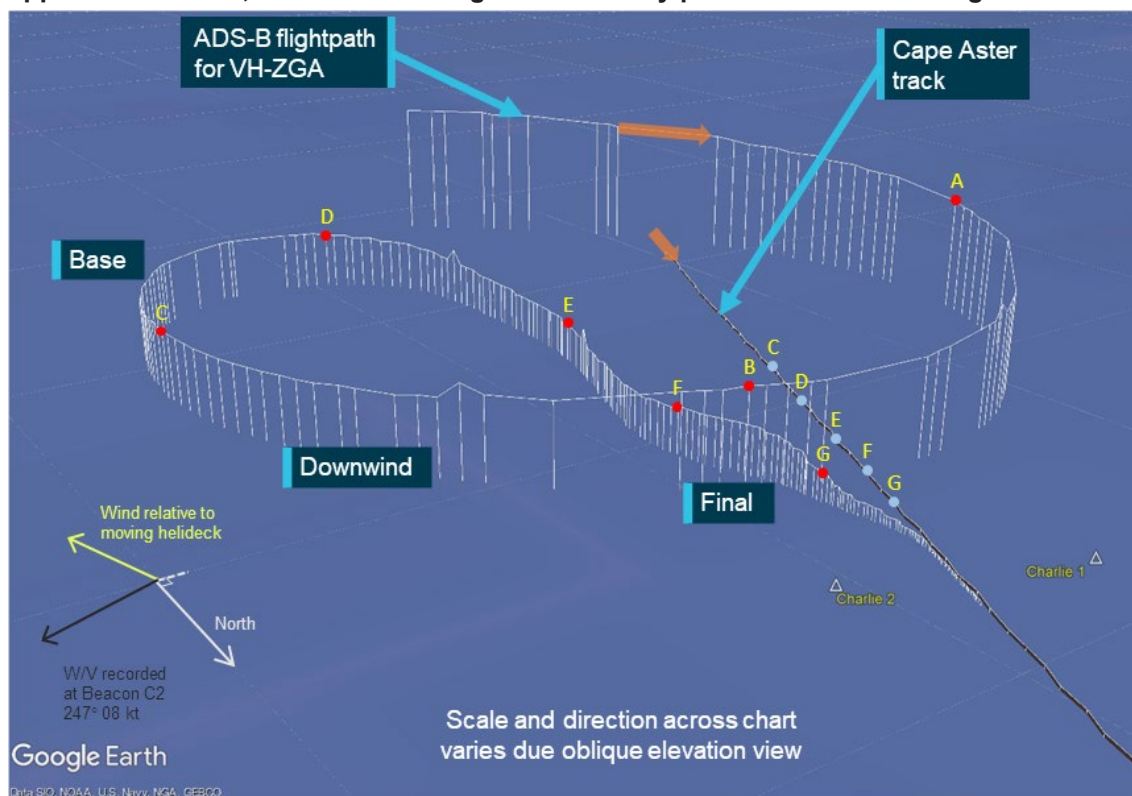
**Figure 23: ADS-B data for VH-ZGA, during a night approach to Cape Aster as it approached C1/C2, which was the flight immediately prior to the accident flight**

Representation of recorded track data during the second night flight, to disembark a marine pilot from Cape Aster at C1/C2. This flight was conducted at night, under night VFR procedures. The white track is positions of VH-ZGA recorded by the ASA ADS-B receivers. The annotated labels correspond to the ADS-B helicopter position relative to the bulk carrier's landing hatch, as derived from shipping data recorded by the Australian Maritime Safety Authority. Data relevant to the annotated labels for VH-ZGA is presented in Table 14 and marked as labelled index points in Figure 24. The bulk carrier was 292 m in length.  
Source: ATSB

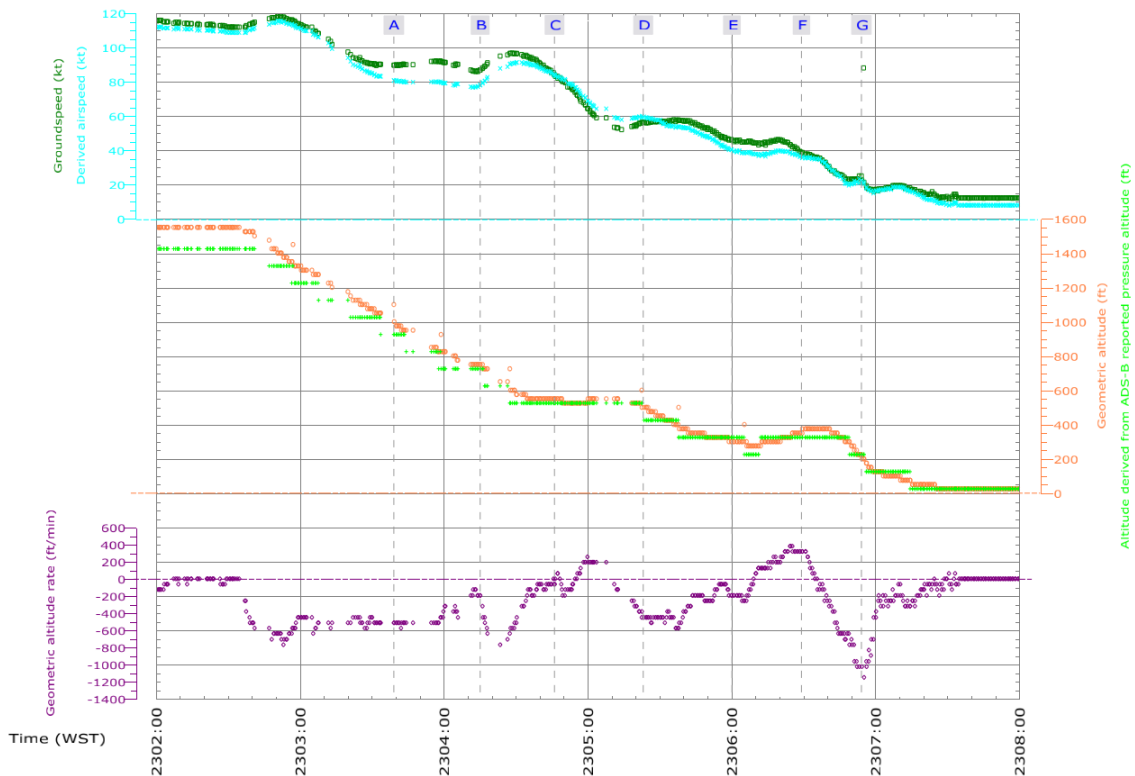
**Figure 24: VH-ZGA derived airspeed, ADS-B reported altitudes and geometric altitude rate of change during a night approach to Cape Aster at C1/C2**

Graphical summary of aggregated ADS-B and derived data during the evening of the accident, while VH-ZGA was being operated in the vicinity of Cape Aster as it approached the C1/C2 channel markers, in night conditions under the night VFR. The airspeed of the helicopter is derived from the ADS-B groundspeed and ground track using the wind velocity and atmospheric pressure recorded by meteorological equipment at a nearby channel marker and corrected for temperature. The helicopter altitude cross-references the ADS-B geometric altitude and the independently measured pressure altitude, adjusted for surface pressure. The geometric altitude is reported in 25 ft increments, the pressure altitude is reported in 100 ft increments. The geometric altitude rate of change was broadcast by the helicopter's ADS-B equipment, in increments of 6.25 ft/min. Breaks in the continuity of the data indicate periods where ADS-B broadcasts were not being received. The labelled time markings correspond with the positions depicted for the helicopter in Figure 23 and Table 14.
