# Loss of control and collision with terrain involving DJI Inspire 2 remotely piloted aircraft

Darling Harbour Sydney, New South Wales on 15 January 2021

## **ATSB Transport Safety Report**

AO-2021-001

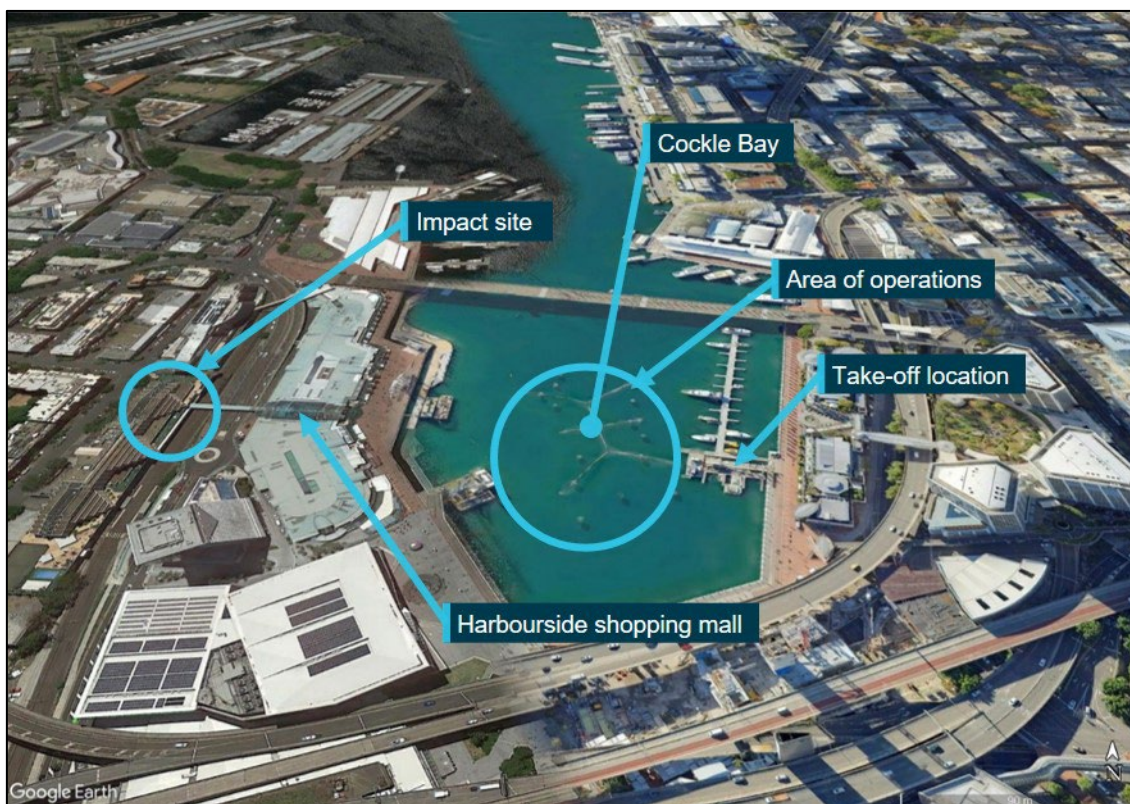
**Figure 2: Area of operations**

After being advised by the client that the subject was ready, the pilot set-up the RPA on the Cockle Bay marina (Figure 2) and conducted pre-flight checks. Pre-flight checks included checking for software updates, ensuring that GPS satellites were acquired, and checking the home point was set to the take-off location. It was reported that the first flight of the day commenced at about 1030 Eastern Daylight-saving Time<sup>1</sup> and lasted about 20 minutes.

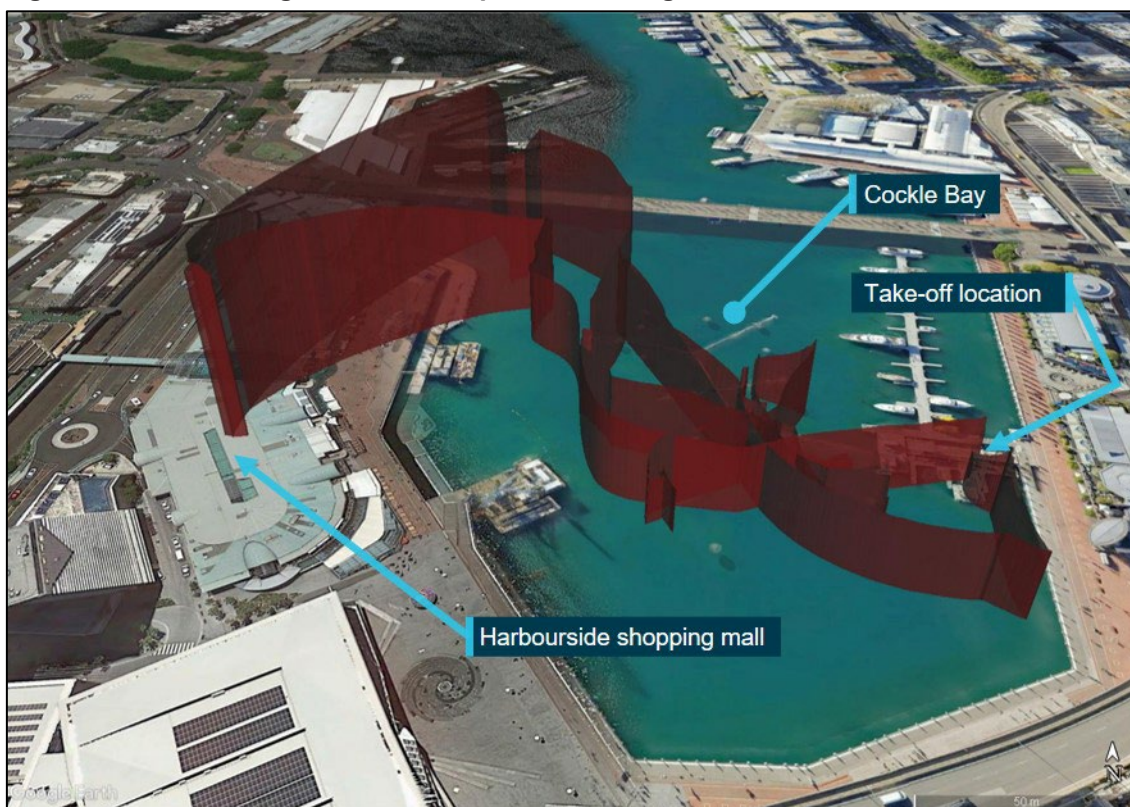
**Figure 4: Recorded flight data for the penultimate flight**

Flight data logs were recovered from the RPA transmitter by the operator and supplied to the ATSB. Flight data logs were also recovered from a Secure Digital (SD) card mounted on-board the aircraft. Data from the penultimate flight (Figure 4) showed that the aircraft commenced the flight at 1048 from the Cockle Bay Marina and climbed to about 24 m above ground level (AGL).

The aircraft was then manoeuvred within Cockle Bay before rising to 70 m (230 ft) AGL at the northern end of the bay. The aircraft was then flown over shore to a position above the Harbourside shopping mall before descending for landing at the take-off location. The flight time for the first flight was just over 17 minutes.

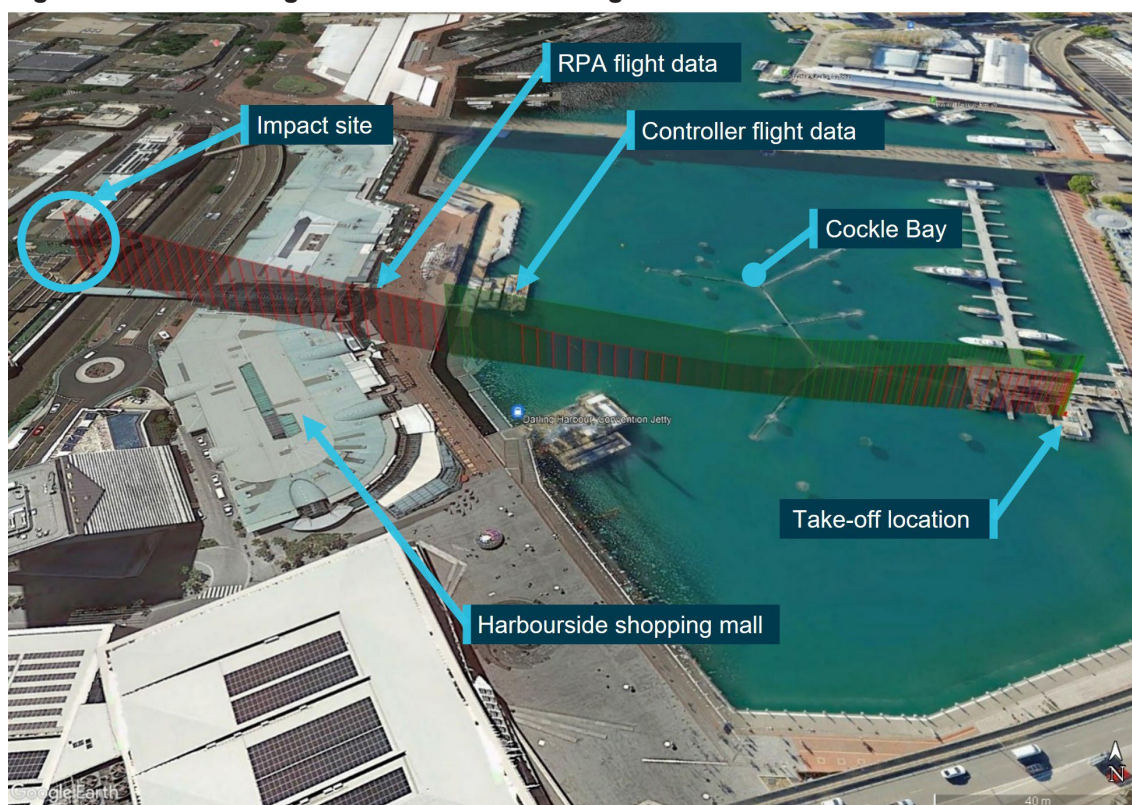
**Figure 5: Recorded flight data of the incident flight**

Data recorded from the incident flight is shown in Figure 5. Data recovered from the controller (shown in green in Figure 5) showed the aircraft taking off at 1140, again from the Cockle Bay Marina and initially climbing to about 20 m AGL.

The aircraft then proceeded in a westerly direction towards the centre of Cockle Bay. Within about 8 seconds of take-off, and having only traversed about 5 m, the aircraft's pitch increased to about 24° nose down and the aircraft quickly accelerated. The direction, altitude and pitch remained largely consistent as the aircraft continued to accelerate westward.

The last data point recorded by the controller was 184 m from the take-off location, as the aircraft approached the western side of Cockle Bay. At this point the aircraft was at 26 m AGL and travelling at its maximum speed of 94 km/h.

Data recovered from the aircraft (shown in red in Figure 5) is consistent with the controller data with regard to heading and speed. The slight off-set in altitude data is likely due to one data set using GPS altitude and the other using barometric altitude. The RPA data shows the aircraft continuing at its maximum speed at a relatively stable heading and altitude for another 150 m until it impacted a building on the western side of Darling Drive.

Despite these control inputs being received by the RPAS, the flight data in Figure 5 shows that the aircraft did not appear to respond to these inputs, as it continued at roughly the same heading, speed and altitude until it collided with the building.

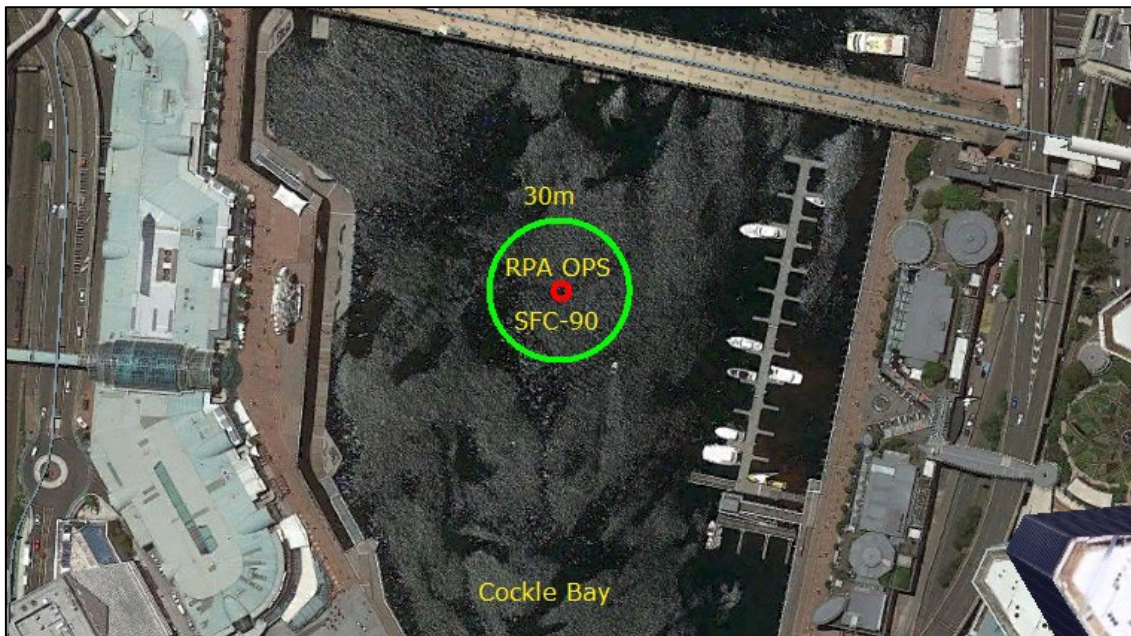
**Figure 6: Operational restrictions for operations within restricted area R405A.**

- the radius of operation was to be within a 30-metre radius of a vessel at the location as shown in Figure 6
- operations were to be between the surface and 90 feet above surface level (ASL)

Other general conditions applicable to all RPA operators included not flying over a populous area and not flying within 30 m of any person not directly associated with the RPA operation. Flight data recovered from the transmitter showed the pilot exceeded a number of these limitations by flying up to 70 m (230 ft) as well as flying over the Cockle Bay shoreline and over the Harbourside shopping mall.
