Engine power loss and collision with terrain involving Piper PA-32-300, VH-CWK

near Moorabbin Airport, Victoria on 22 June 2021

ATSB Transport Safety Report

AO-2021-024

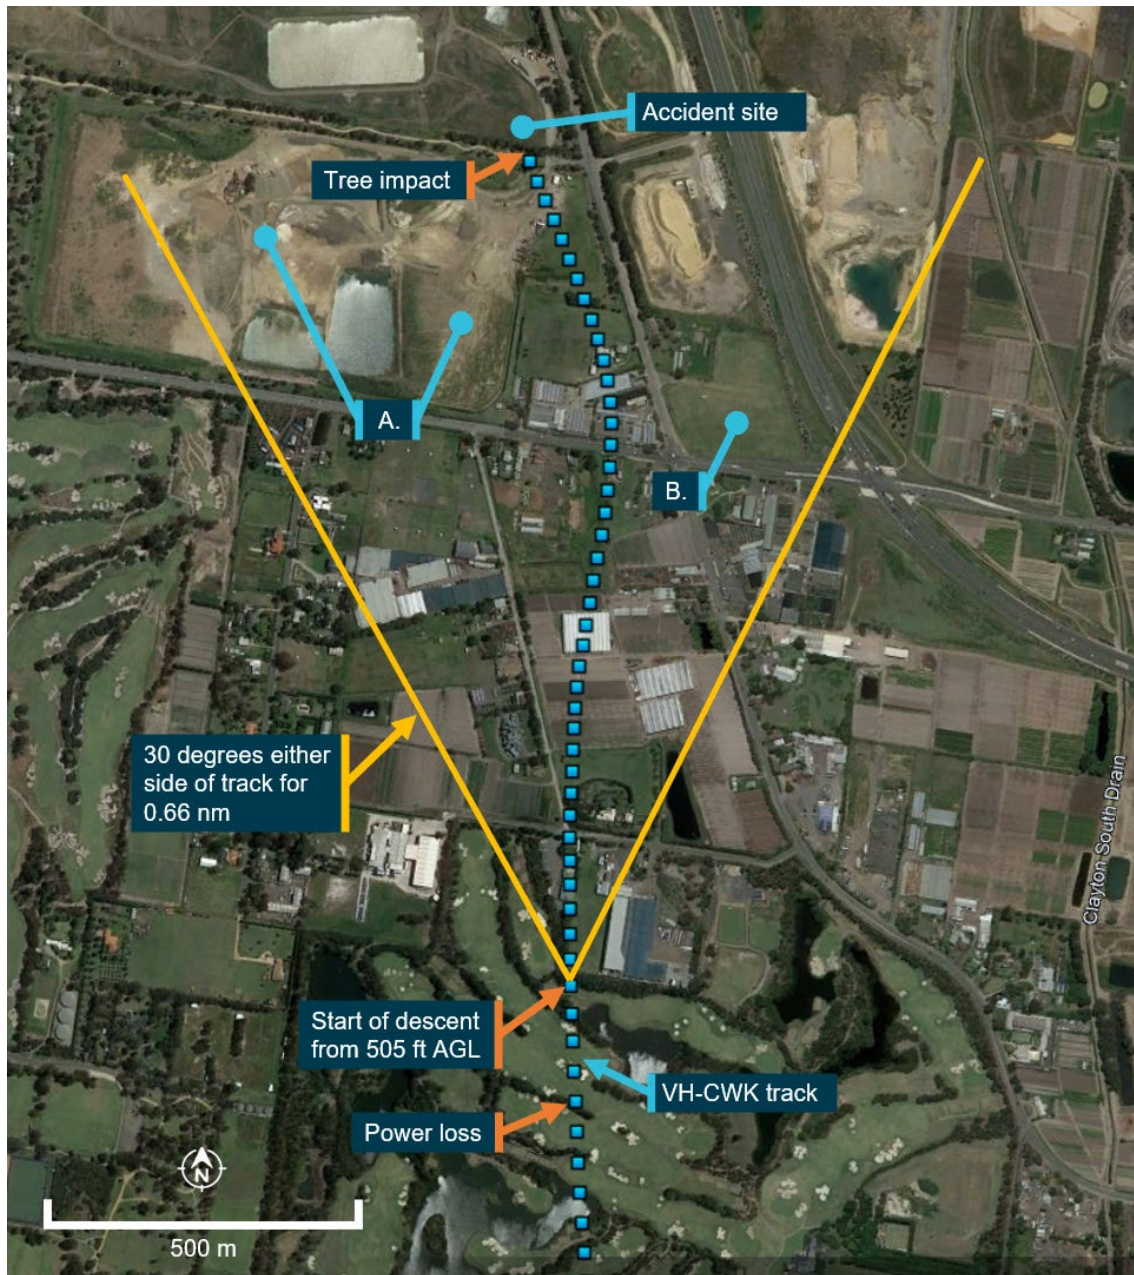
Figure 1: Overview of the flightpath after the power loss

As the descent continued, the pilot targeted a glide speed of 90 kt and searched for a landing site within a 30° arc either side of the aircraft's nose (Figure 1). The pilot identified one of few clear areas available for a forced landing within the gliding capability of the aircraft and manoeuvred the aircraft for a forced landing in that area (see the section titled *Aircraft details*).

Note: Area 'A' was an excavated quarry. Area 'B' had been developed after the satellite imagery was captured and before the accident.

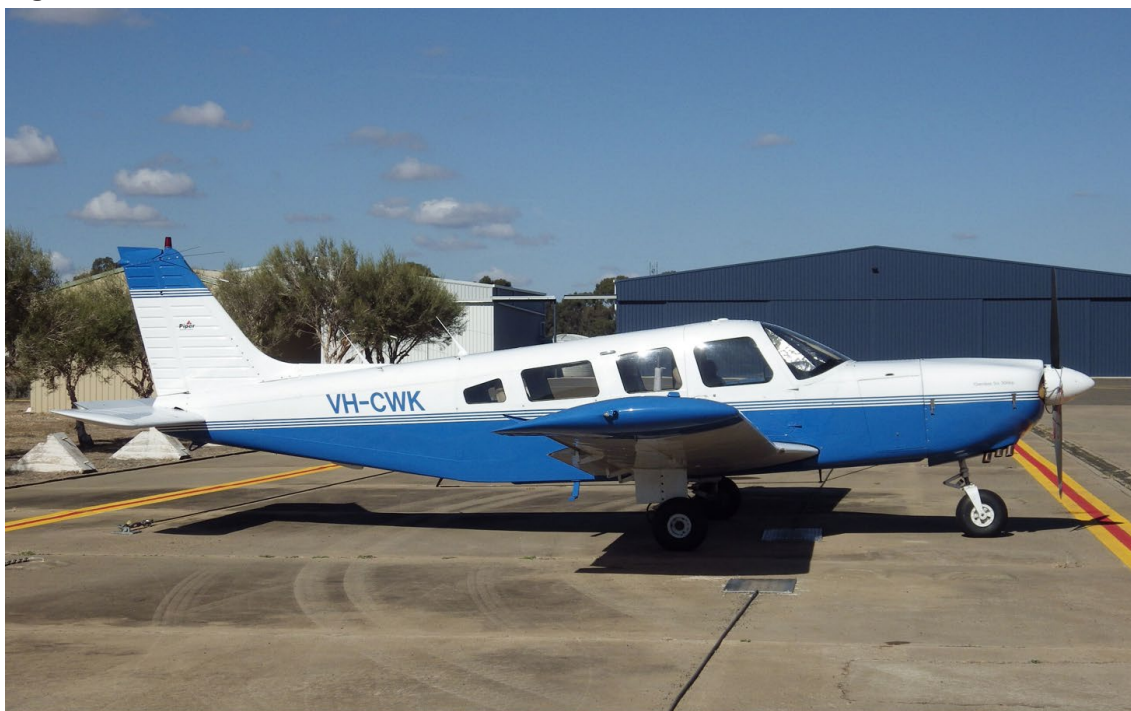
Figure 2: VH-CWK

The Piper PA-32-300 Cherokee Six is a low-wing, piston-engine aircraft with a two-blade variable-pitch propeller, fixed tricycle landing gear and could be fitted with up to 7 seats. VH-CWK, serial number 32-7840052 (Figure 2), was manufactured in the United States in 1977 and first registered in Australia in 1978.

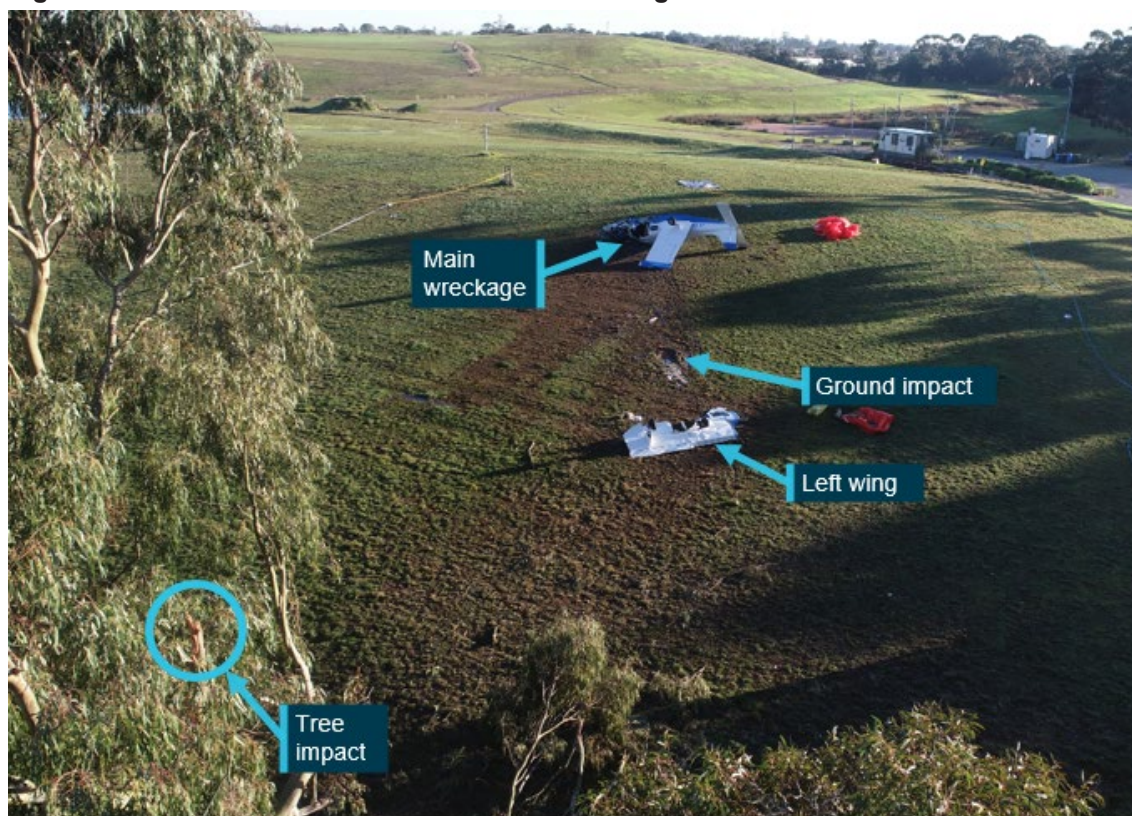
Figure 3: Accident site viewed in the direction of flight

The aircraft impacted the tree about 14 m (Figure 4) above its base with the wing flaps retracted.

The left wing contacted the tree first and separated from the aircraft. Ground impact scars were located on an upslope 35 m from the tree base, 10.2 m below the height of the tree impact. After ground impact, the right wing also separated from the fuselage. The engine and fuselage were the last items in the wreckage trail, coming to rest 55 m from the tree.

Note: The red objects were tarpaulins provided by first responders to the accident.

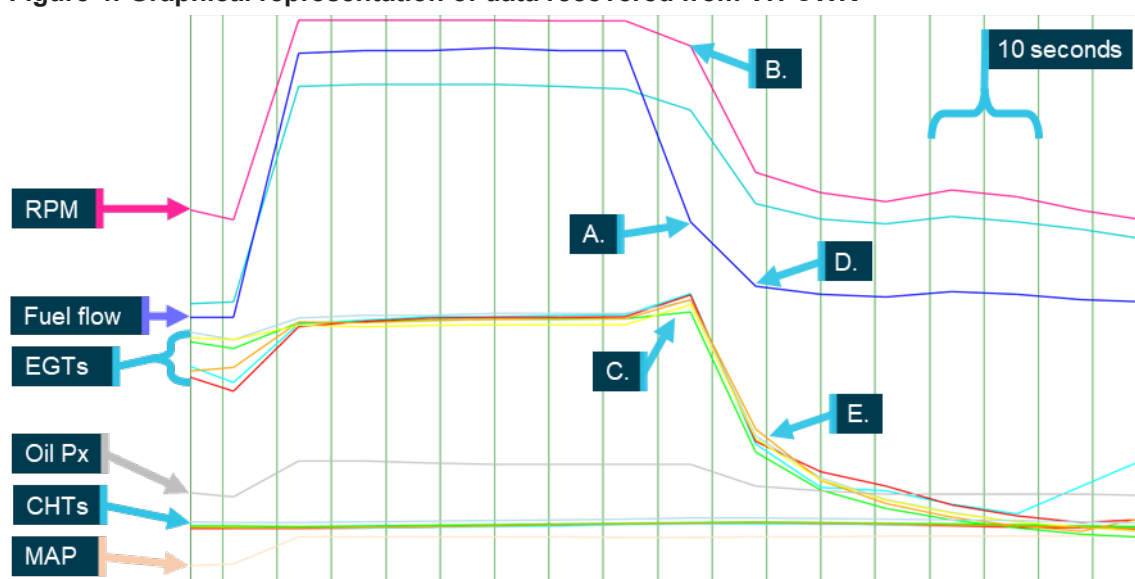
Figure 4: Graphical representation of data recovered from VH-CWK

The aircraft was fitted with a J.P. Instruments EDM-830 Engine Data Management system. Data recovered from this unit captured data points every 6 seconds and included the power loss (Figure 5).

The first abnormal indication was a reduction in fuel flow from 113 litres per hour (l/h) to 47 l/h at 1200:49 (A). At the same time, RPM reduced from about 2,700 to about 2,500 (B) and exhaust gas temperature (EGT) increased across all cylinders (C). The next data point at 1200:55 showed the fuel flow reduced further to 22 l/h (D) and all EGT values, along with RPM, reduced significantly as power was lost (E). Following the power loss, fuel flow varied between 20 l/h and 16 l/h in conjunction with changes in RPM from the windmilling propeller.

No abnormal cylinder head temperature (CHT), manifold pressure (MAP) or oil pressure (Oil Px) indications were recorded before or after the power loss.
