Engine power loss and forced landing involving Robinson R22 Beta, VH-VHE

130 km south-west of Mitchell, Queensland on 11 January 2022

ATSB Transport Safety Report

AO-2022-005

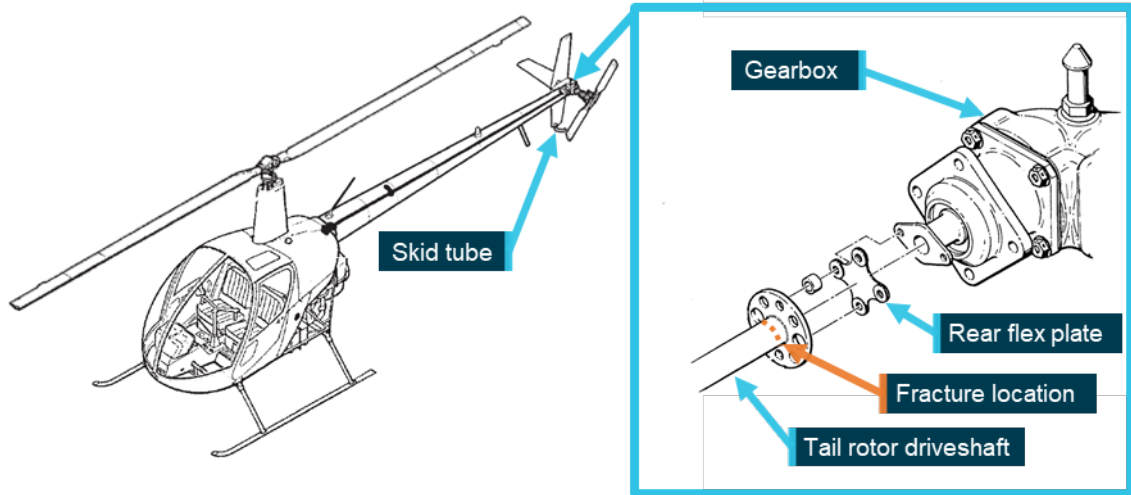
Figure 1: Tail rotor drive shaft fracture location

- the tail rotor drive shaft had fractured approximately 5 mm forward of the rear flange weld (Figure 1 and Figure 2)
- rotational scoring was present on the internal surface of the tailcone adjacent to the fracture location
- the tail rotor blade surfaces were free from evidence of foreign object damage, and the skid tube (shown schematically in Figure 1) was free from contact indications
- there was erosion on the leading-edge of the main rotor blades and the tail rotor blades

*The fracture location is approximately 5mm forward of the rear flange weld.
Source: Robinson Helicopter Company, annotated by the ATSB*

The ATSB examination identified that the tail rotor drive shaft fractured in overstress from torsional loading. The reported pedal control, up until the skids touched the ground, suggested that the drive shaft fracture was concurrent with the helicopter touching the ground.

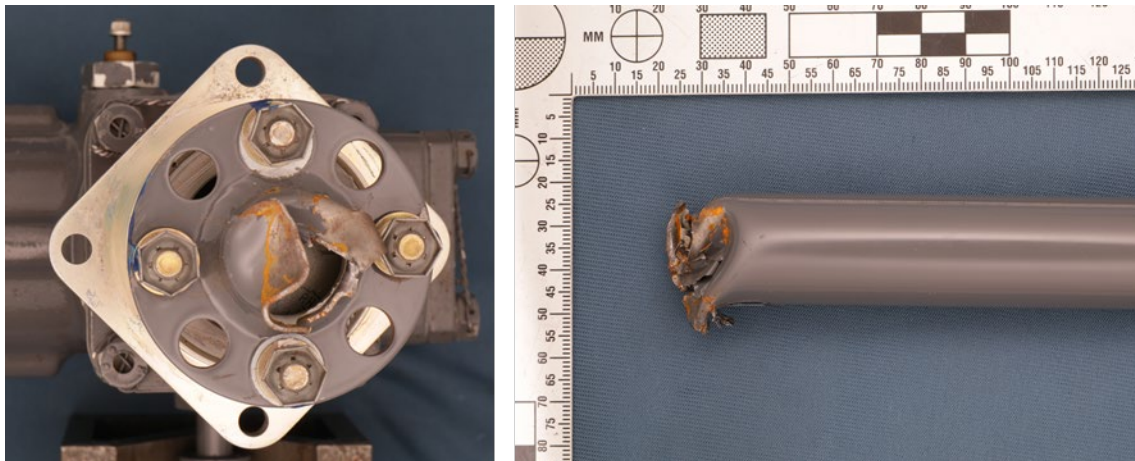
Figure 2: Fractured tail rotor drive shaft

*The fracture shows significant plastic deformation. The corrosion product was not present at time of the occurrence.
Source: ATSB*

The direction of the torsional deformation of the driveshaft was indicative of either drag on the tail rotor assembly or over-torque from the driving side of the failure location.

Examination at high magnification, using both an optical and scanning electron microscope, of the mating fracture surfaces of the drive shaft revealed only gross ductile overstress features. A polished and etched cross section, and hardness measurements taken through the weld connecting the shaft to the flange, found the weld to be heat-relieved, which was consistent with the manufacturer's specifications. Energy dispersive spectroscopic analysis found the composition of the alloy to also be consistent with the manufacturer's specifications.

There were no pre-existing defects identified from manufacture, or operational damage such as surface scoring, fatigue cracking, denting, or corrosion that might have otherwise weakened the shaft and predisposed it to fracture.

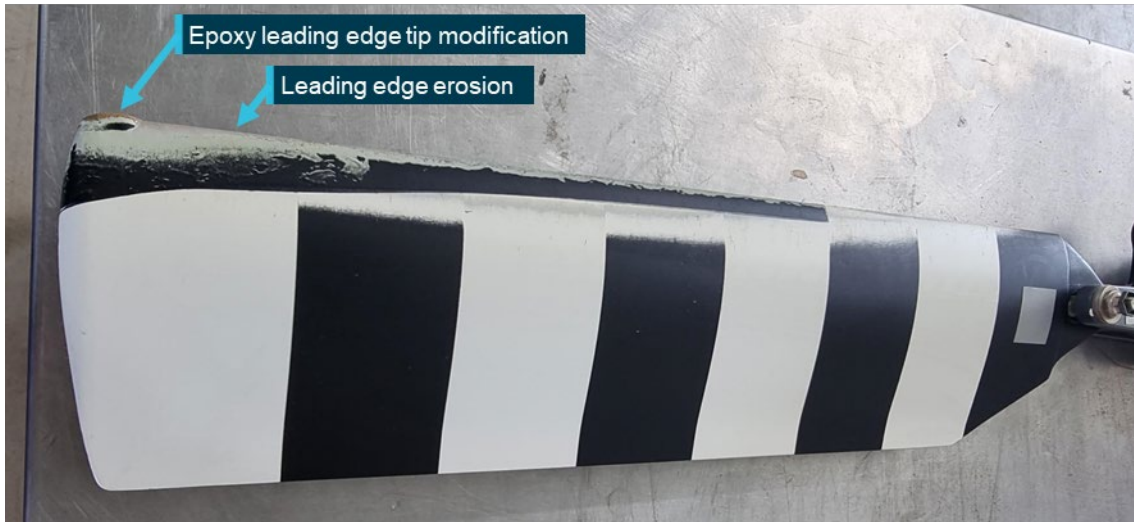
Figure 3: Tail rotor blade leading edge erosion and blade modification

- epoxy additions were present on the tip of the leading-edge of the tail rotor blades (Figure 3), which were reportedly applied to increase blade wear resistance.

Both tail rotor blades exhibited erosion and a leading-edge tip modification. There was no indication consistent with a strike to either tail rotor blade.
Source: Maintenance organisation, annotated by the ATSB

The maintenance organisation had a practise of applying epoxy to the leading edge, adjacent to the tips, of the tail rotor blades to extend the interval between re-painting. The epoxy was applied to the blades at the first instance re-painting was required. The maintenance organisation described the modification as

RHC also advised that the epoxy blade modifications were unapproved and would prevent inspection of the blade surface for cracking or corrosion. In addition, RHC stated that a helicopter could experience a more catastrophic consequence of the blade modification if an out-of-balance condition developed, possibly resulting in the loss of the entire empennage.

The tail rotor blade modifications found on VH-VHE were unapproved and had the potential for significant consequences. Using approved and documented engineering processes to make changes to an aircraft system is important, as it ensures the design complies with applicable airworthiness standards or an equivalent level of safety.

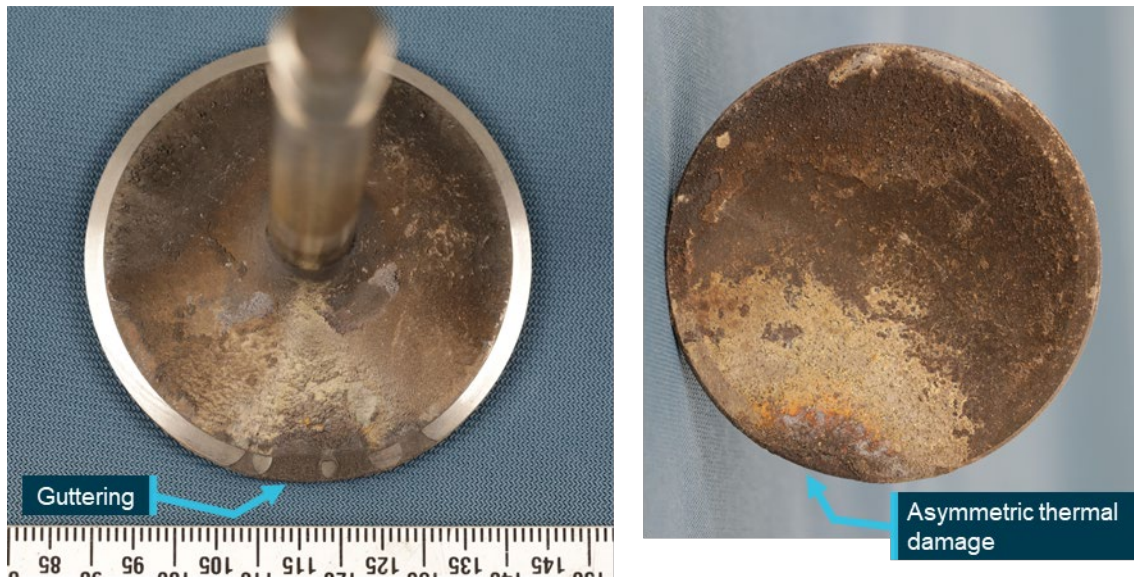
Figure 4: Damaged engine intake valve from number-four cylinder

During the post-occurrence inspection of the engine, maintenance engineers identified that the number-four cylinder was unable to hold pressure when subjected to a hot-compression check. The maintenance organisation removed the cylinder and, on further inspection, identified thermal damage and guttering to the intake valve (Figure 4). The bottom of the valve exhibited an asymmetric burn pattern, which was evidence of severe and uneven heating. The guttering present on the valve face provided a gas leakage path between the cylinder and the intake manifold.

The asymmetric burn pattern on bottom on valve is evidence of severe and uneven heating. The valve face guttering is a leakage path between the cylinder and the intake manifold. The valve was ground by the maintenance organisation, following removal, to 'clean' the face to enhance the appearance of the thermal damage. The appearance of the face immediately following the occurrence was not recorded.

Approximately 25 minutes into a mustering flight VH-VHE experienced an engine power reduction, induction backfire(s), and yawing event resulting in a forced landing. The unusual engine behaviour was likely due to thermal damage to the intake valve from the number-four engine cylinder, which reduced the effectiveness of the seal between the valve face and the seat.

- Damage to the number-four engine cylinder intake valve allowed the fuel and air mixture, and exhaust gases into the air induction system. This resulted in the degraded engine performance and the forced landing of the helicopter.

When a loss of engine power or abnormal operation is encountered, an appropriately-licensed maintenance engineer should complete an engine cylinder inspection in accordance with the helicopter and engine manufacturer’s requirements before further flight.
