ATSB TRANSPORT SAFETY REPORT
Occurrence Investigation Report AO-2007-046
Final

Collision with terrain
Doongan Station, WA
25 September 2007
VH-HCN
Robinson Helicopter Company R22
Beta II

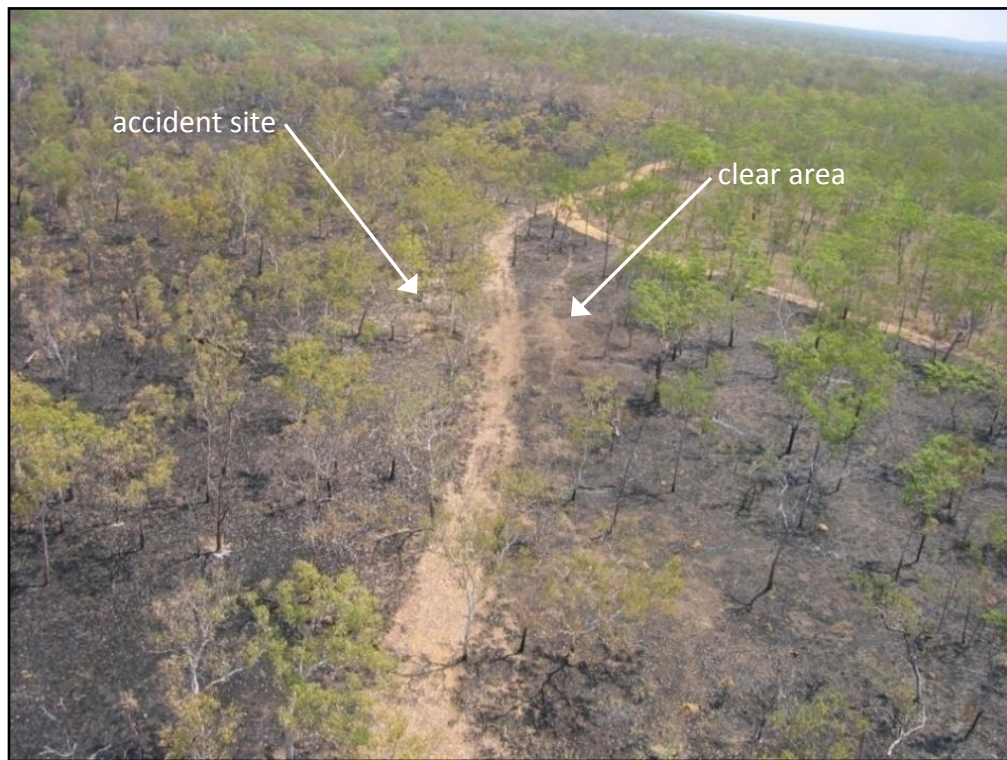
Figure 5: Accident site looking along the approximate flight path

The accident occurred over flat terrain with numerous small and medium eucalypt trees covering the site and surrounding area. The elevation of the accident site was about 1,200 ft above mean sea level (AMSL). Due to the surrounding trees, the accident site was not considered suitable to land an R22, although an adjacent clear area could have accommodated the helicopter (Figure 5).

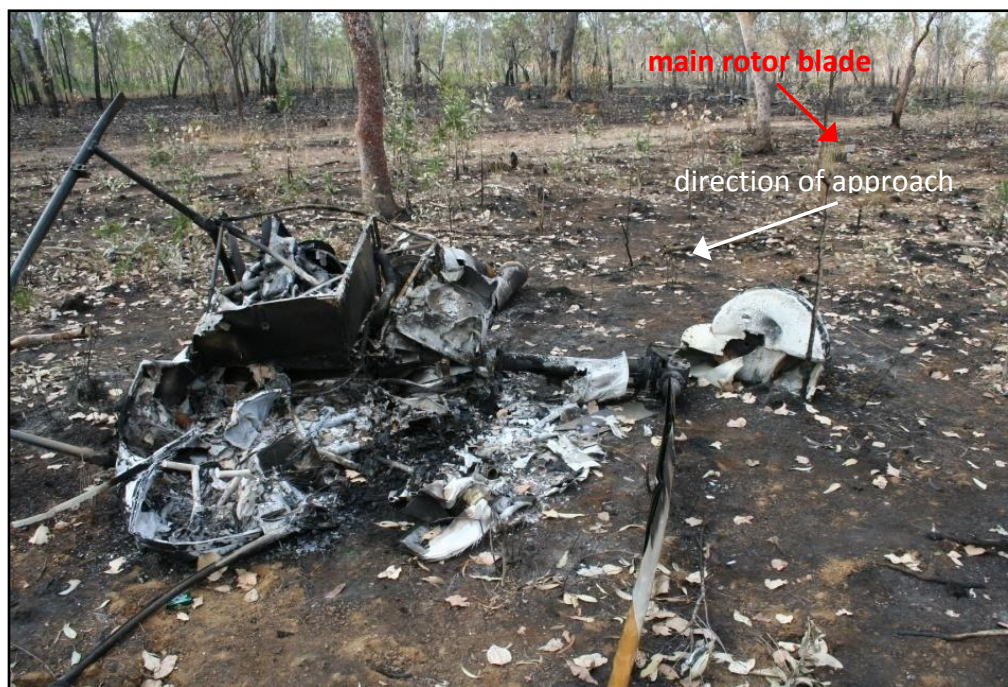
Figure 6: Helicopter wreckage

The helicopter contacted four trees before impacting the ground in a steep nose-down, left skid-low attitude. The helicopter came to rest on its left side a further 13 m along the direction of approach (Figure 6). One of the main rotor blades had fractured and separated from the helicopter and was located about 15 m from the wreckage (Figures 6 and 7). A severe fire consumed the majority of the helicopter and ignited the surrounding vegetation.

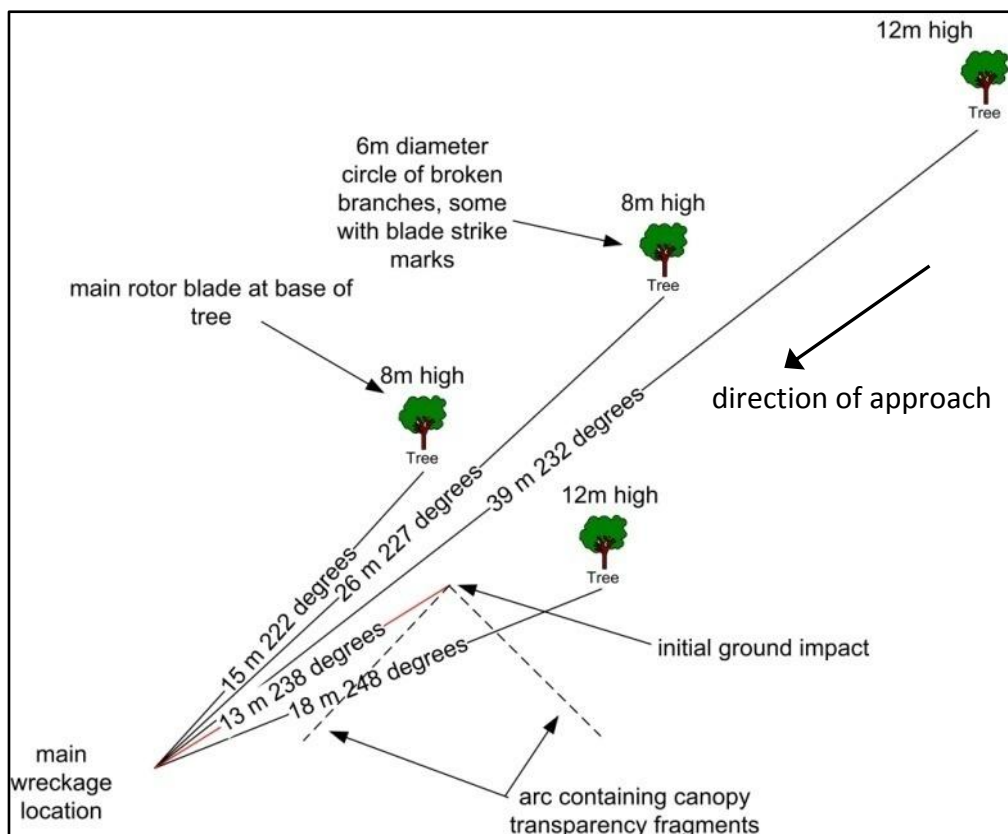
Figure 7: Wreckage diagram

On-site examination of the wreckage accounted for all major parts of the helicopter. It was not possible to verify the integrity of the entire flight control system as sections of the aluminium control tubing were destroyed by fire. However, all steel components associated with the collective, cyclic and tail rotor pedal flight controls

Both V-belts were destroyed by the fire, although charred remains of the V-belts were noted on the ground in the area of the engine and adjacent structure of the main wreckage. No evidence of the V-belts was found within the grooves of either the upper or lower sheaves.

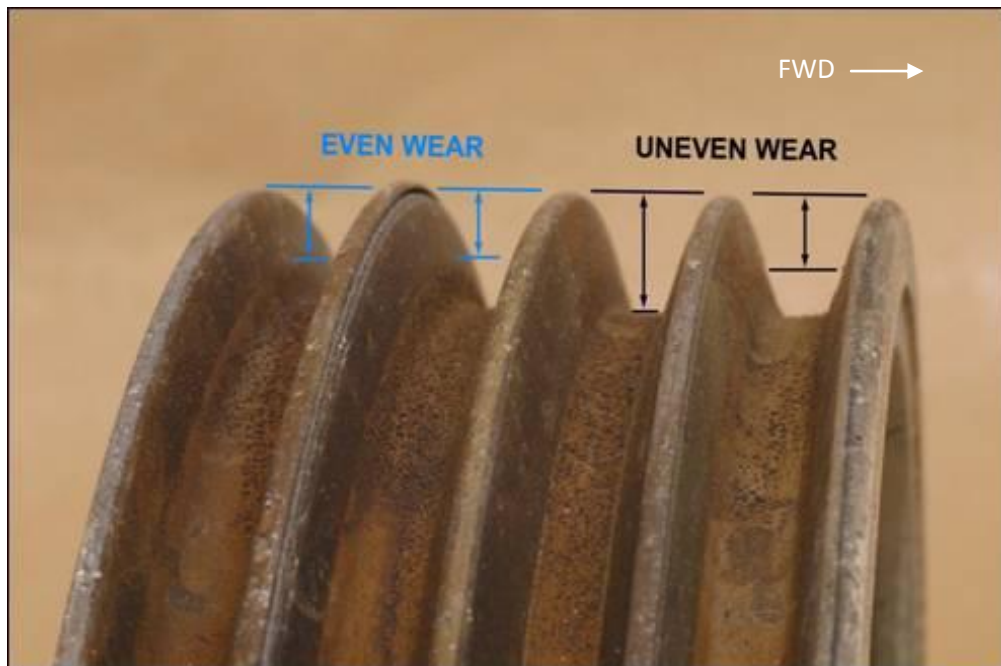
Figure 8: Upper sheave wear pattern

Examination of the upper drive sheave identified that the wear-resistant metallised coating was in a generally poor condition, with complete wear through to the aluminium alloy substrate in some areas.

Additionally, there was considerable variation in the primer wear pattern within the grooves of the upper sheave (Figure 8). The helicopter manufacturer advised that such variation in wear pattern was consistent with the front V-belt operating in a significantly damaged condition. The operator advised that the primer had been applied to the sheave as part of the recent replacement of the V-belts.

Sectioning of both sheaves indicated a variation in the thickness of the wear-resistant coating that was indicative of the helicopter's belt drive system operating out of alignment for some period of time. It was not possible to determine if the sheaves were misaligned at the time of the accident as the wear pattern could have been due to previous extended periods of misaligned operation. Examination of the sprag clutch and bearings (see section on *R22 rotor drive system*) did not reveal any damage, other than due to fire, which would have prevented normal operation.
