ATSB TRANSPORT SAFETY REPORT  
Aviation Occurrence Investigation AO-2009-009  
Final

# Collision with terrain

## 8 km NW of Donors Hill Station, Qld

### 24 February 2009

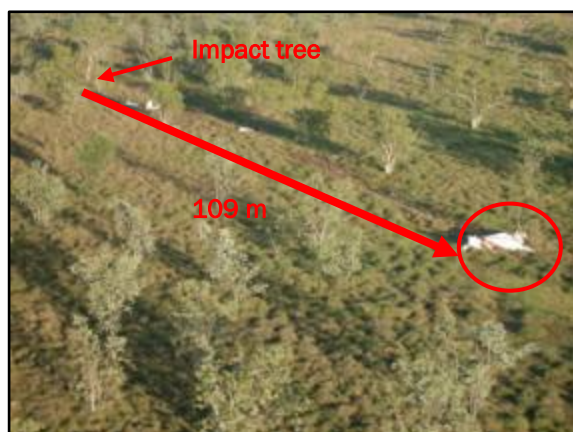
**Figure 1: Aerial view of wreckage site<sup>3</sup>**

The wreckage trail extended about 109 m from the aircraft's initial impact with a tree to the main wreckage (Figure 1). The wreckage path was oriented on a track of approximately 085° M. The elevation of the wreckage site was 235 ft above mean sea level (AMSL).

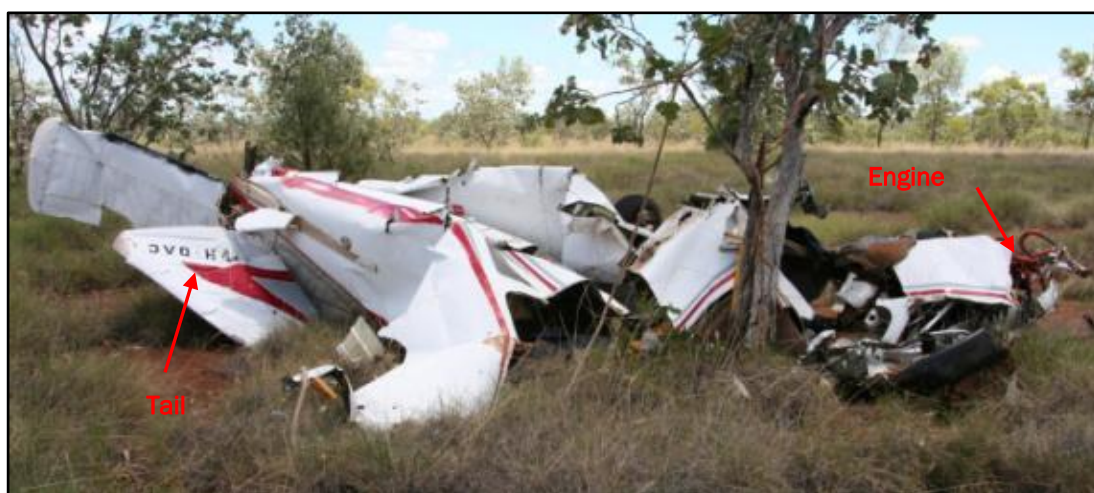
Figure 2: View of the wreckage

The cockpit and cabin area (Figure 2) sustained extensive, non-survivable impact damage.

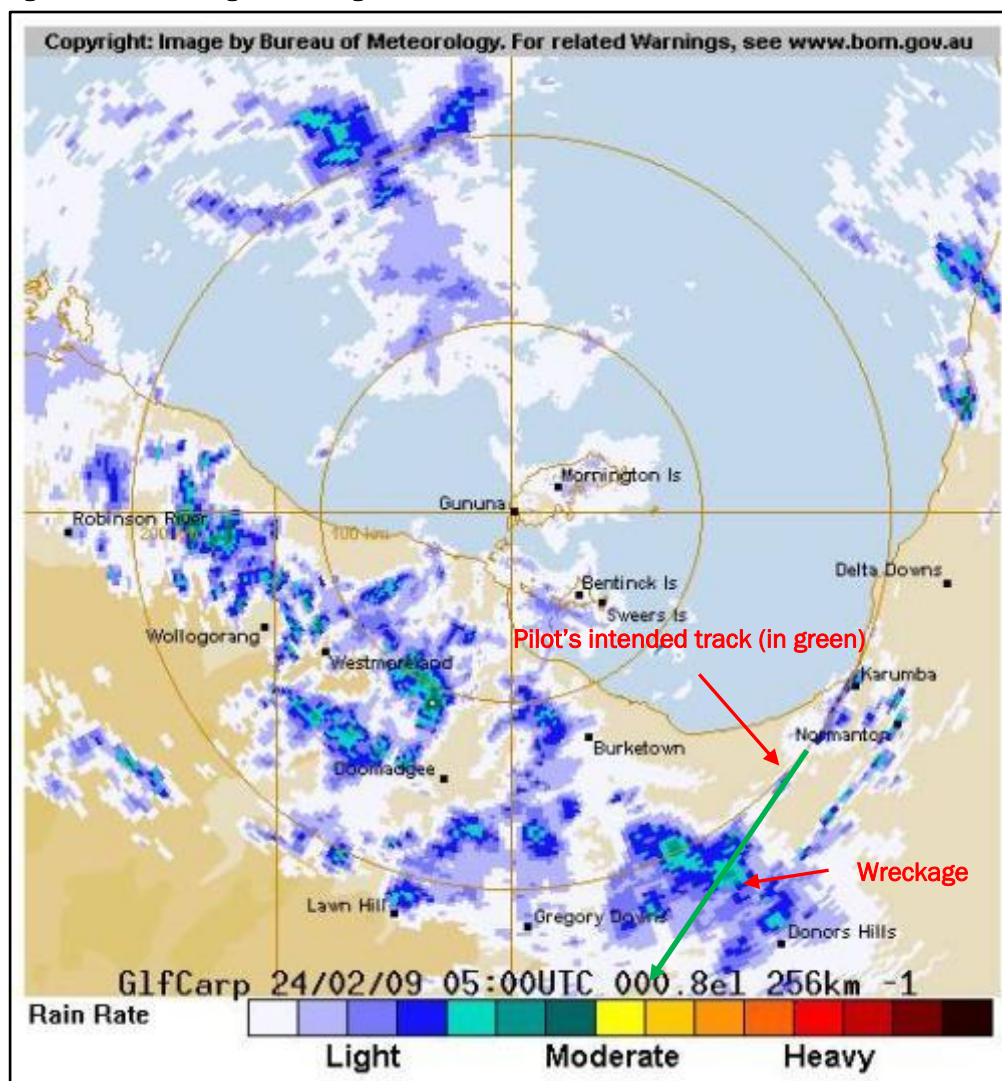
**Figure 4: Radar image of the flight area**

Images from the BoM Mornington Island weather radar for 1500 on 24 February 2009 confirmed that there was precipitation in the area of the intended flight, and was consistent with the later witness estimates about the movement of the weather system (Figure 4).

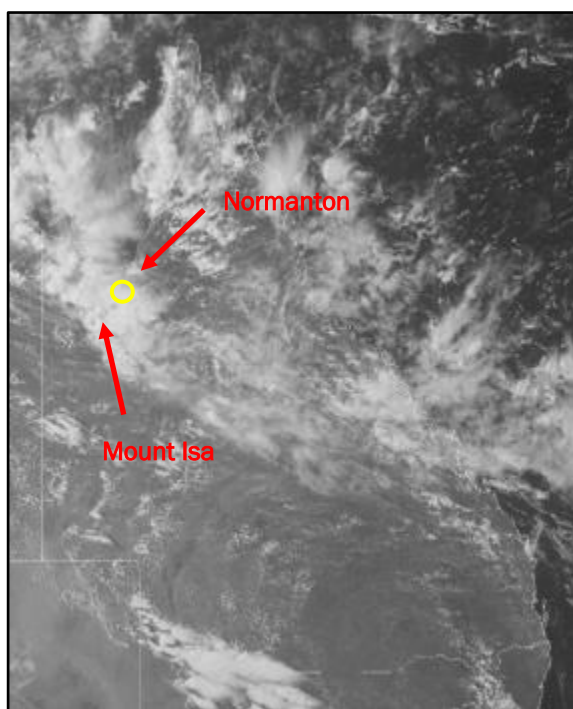
**Figure 5: Satellite image of flight area (area of the accident circled in yellow)<sup>7</sup>**

Satellite images recorded at 1430 on 24 February 2009, indicated that showers and thunderstorms were present in the general area of the accident site (Figure 5).
