ATSB TRANSPORT SAFETY REPORT
Aviation Occurrence Investigation AO-2009-070
Preliminary

Collision with terrain

21 km SE of Kojonup, WA

17 November 2009

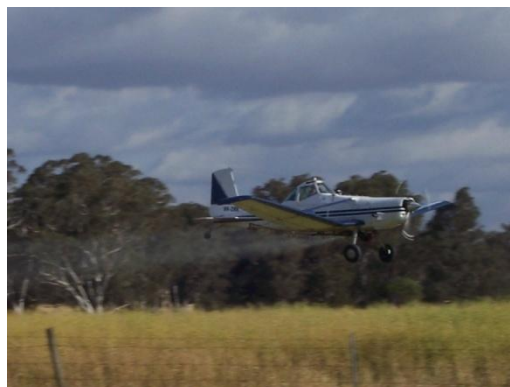
Figure 1: VH-ZRR conducting spraying operations

On 16 November 2009, the pilot of a Cessna Aircraft Company A188B Agwagon aircraft, registered VH-ZRR (Figure 1), flew from the aircraft's base to a property about 12km east-south-east of Kojonup, WA and then
