# Collision with terrain

## Dorrigo, NSW

### 9 December 2009

On 9 December 2009, the pilot of a Bell Helicopter Co. 206L-1 Longranger, registered VH-MJO, was conducting a visual flight rules (VFR) flight at Dorriggo NSW, with one passenger on board. Shortly after takeoff, he encountered reduced visibility conditions due to low cloud. Subsequently, all visual reference with the horizon and the ground was lost. The pilot attempted to conduct a landing but the helicopter impacted the ground with a significant vertical force. As a result, the pilot was seriously injured and the passenger was fatally injured. The helicopter was seriously damaged. The investigation is continuing.

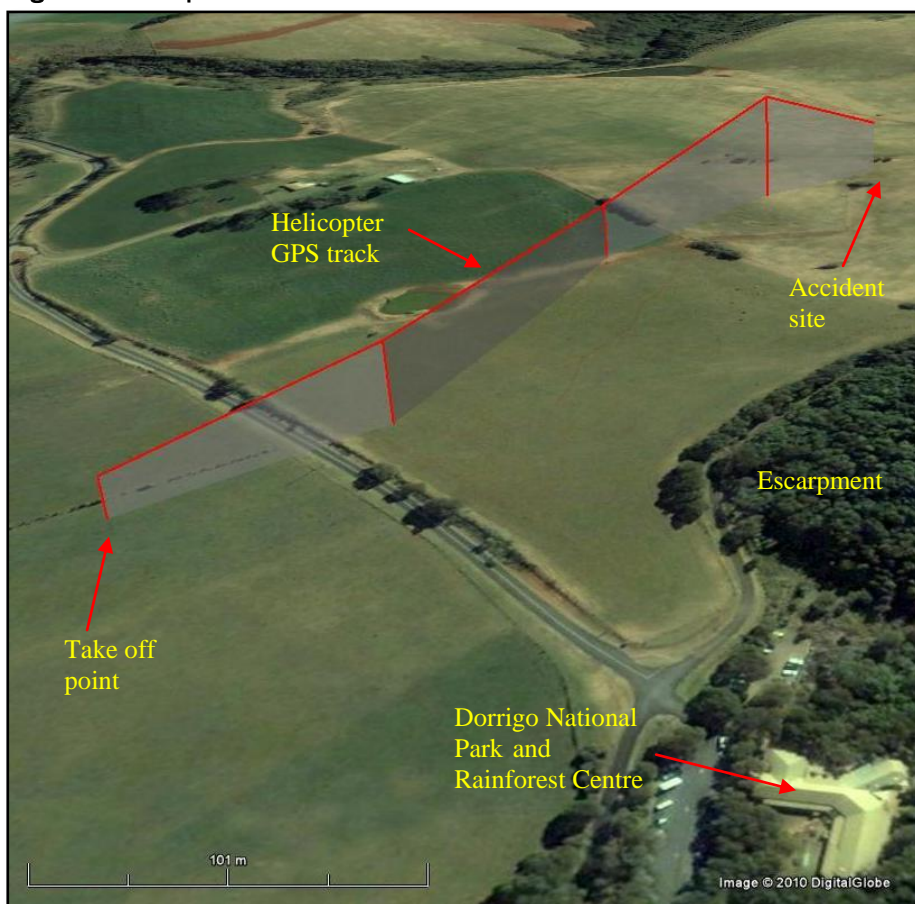
Figure 1: Helicopter GPS track

The pilot attempted to maintain a neutral hover in the expectation of regaining adequate visibility to land, however, the helicopter was inadvertently moving to the north at a slow speed (Figure 1). The pilot stated that he then saw trees and a spur line through the cloud and that the helicopter appeared to be in a sideways crab motion to the left. With limited visual reference, the pilot attempted to land, however, the helicopter impacted the ground with significant vertical force and came to rest on its right side (Figure 2).

The helicopter was fitted with a Garmin 296 Global Positioning System (GPS). The GPS was taken to the Australian Transport Safety Bureau (ATSB) technical facilities where its stored data was successfully downloaded. The data showed the helicopter's movements on the day of the accident. The information included time and date, latitude, longitude and altitude position which was recorded at distance intervals of 0.1 NM (185 m). The GPS recorded five positions during the accident flight and the information was overlaid on a Google Earth map of the area<sup>3</sup> (Figure 1). The duration of the flight, not including start up and static hover, was approximately 1 minute and 20 seconds. During that time, the helicopter travelled a distance of approximately 550 m.

<sup>3</sup> The GPS recorded 5 positions during the period of the accident flight, the red line depicting the helicopter's flight path, while reasonably accurate at the points recorded, does not accurately illustrate the position of the helicopter at any point between the recorded locations.

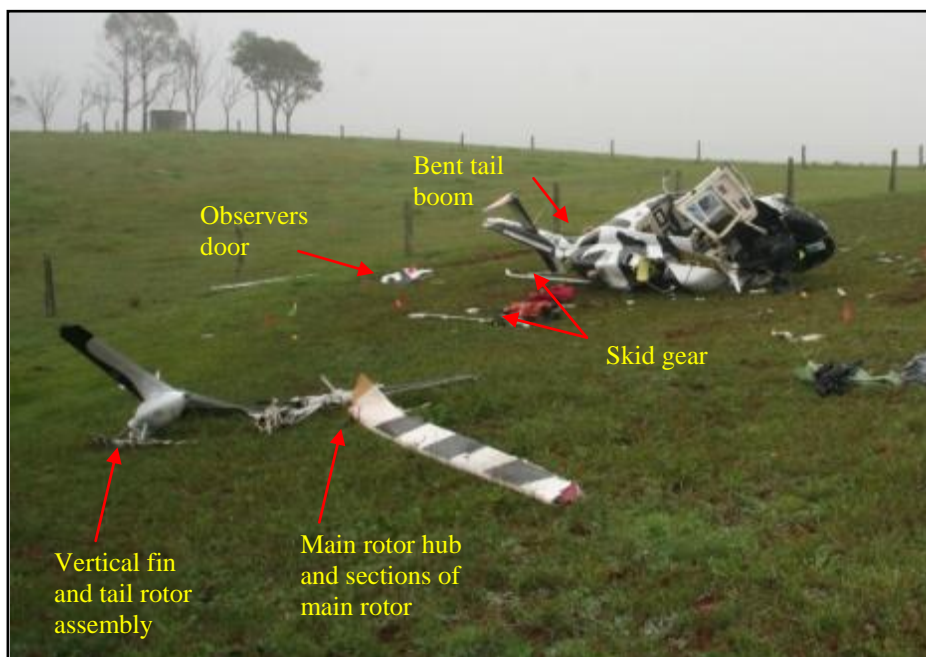
Figure 2: Accident site

The helicopter was seriously damaged<sup>4</sup> by impact forces (Figure 2). Examination of the wreckage showed that the vertical fin assembly, main rotor assembly, skid gear and observer's side door had separated from the helicopter during the accident sequence. The tail boom showed signs of downward bending and the skid gear cross tubes had been rotated and splayed, indicating a high vertical decent rate at impact. The lack of ground impact marks outside the immediate wreckage area also indicated a low forward velocity when the helicopter impacted the ground. The extent of damage observed on the main rotor blades indicated that the engine was operating at impact.
