ATSB TRANSPORT SAFETY REPORT  
Aviation Occurrence Investigation AO-2007-044  
Final

Go-around event  
Melbourne Airport, Victoria  
21 July 2007  
VH-VQT, Airbus Industrie A320-232

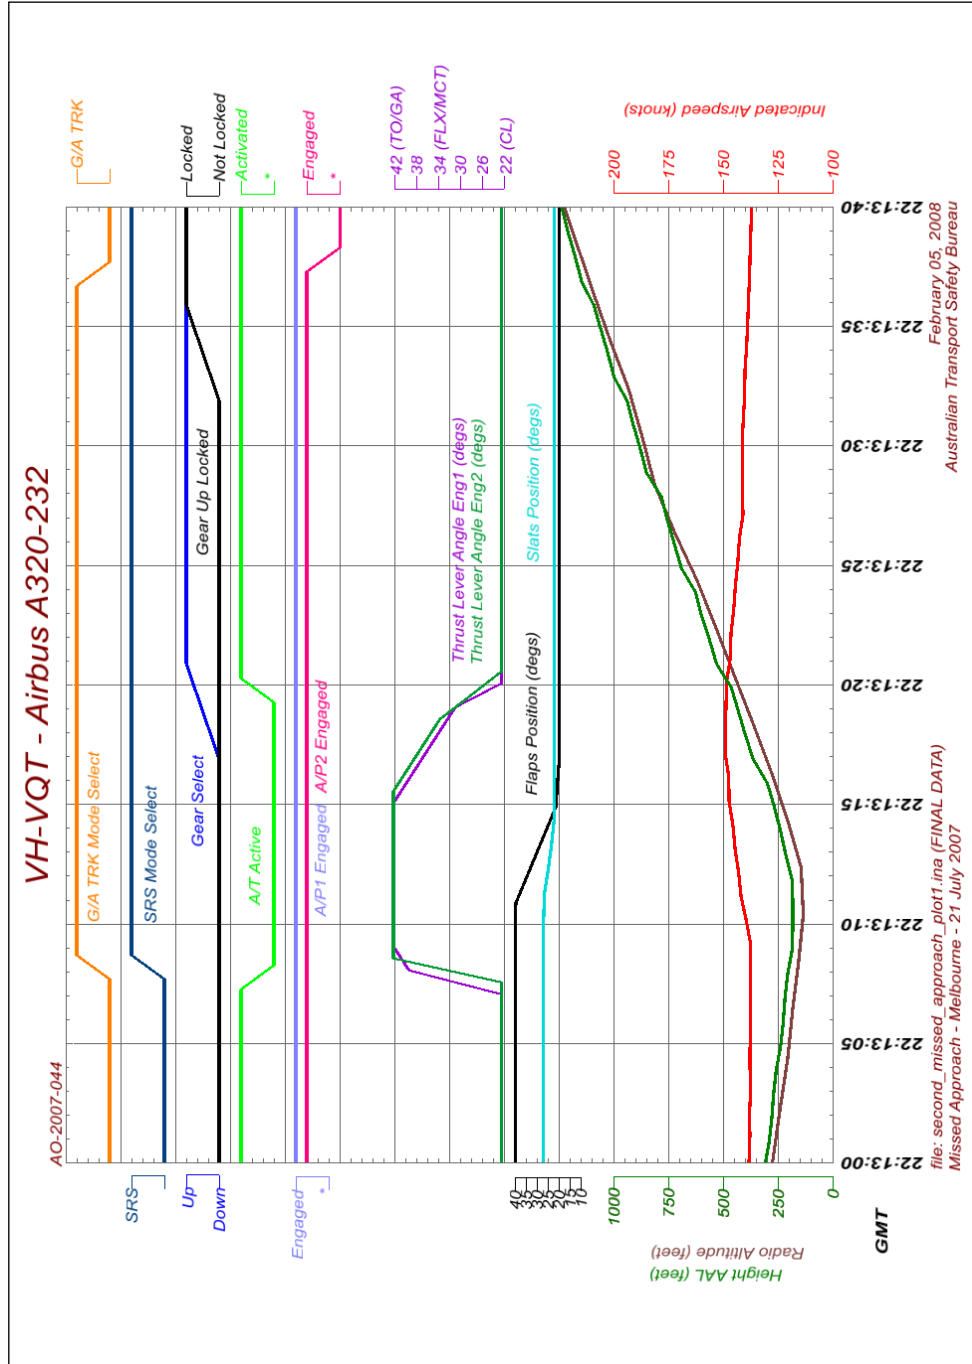
**Figure 7: Graphical representation of a number of recorded parameters during second missed approach**

Examination of the flight data for the second missed approach revealed that, at the commencement of the go-around, the thrust levers were moved to the TO/GA position and that the SRS and GA TRK modes engaged. Eleven seconds after the thrust levers were placed into the TO/GA detent, they were retarded to the CL detent, and the landing gear was selected up 2 seconds later. There were no

recorded alerts or warnings during the missed approach. A number of recorded parameters relating to the second missed approach are shown at Figure 7.
