ATSB TRANSPORT SAFETY REPORT
Aviation Occurrence Investigation AO-2008-007
Final

Hard landing
Darwin Airport, Northern Territory
7 February 2008
VH-NXE
Boeing Company 717 – 200

Hard landing - Darwin Airport, Northern Territory - 7 February 2008 - VH-NXE, Boeing Company 717 – 200

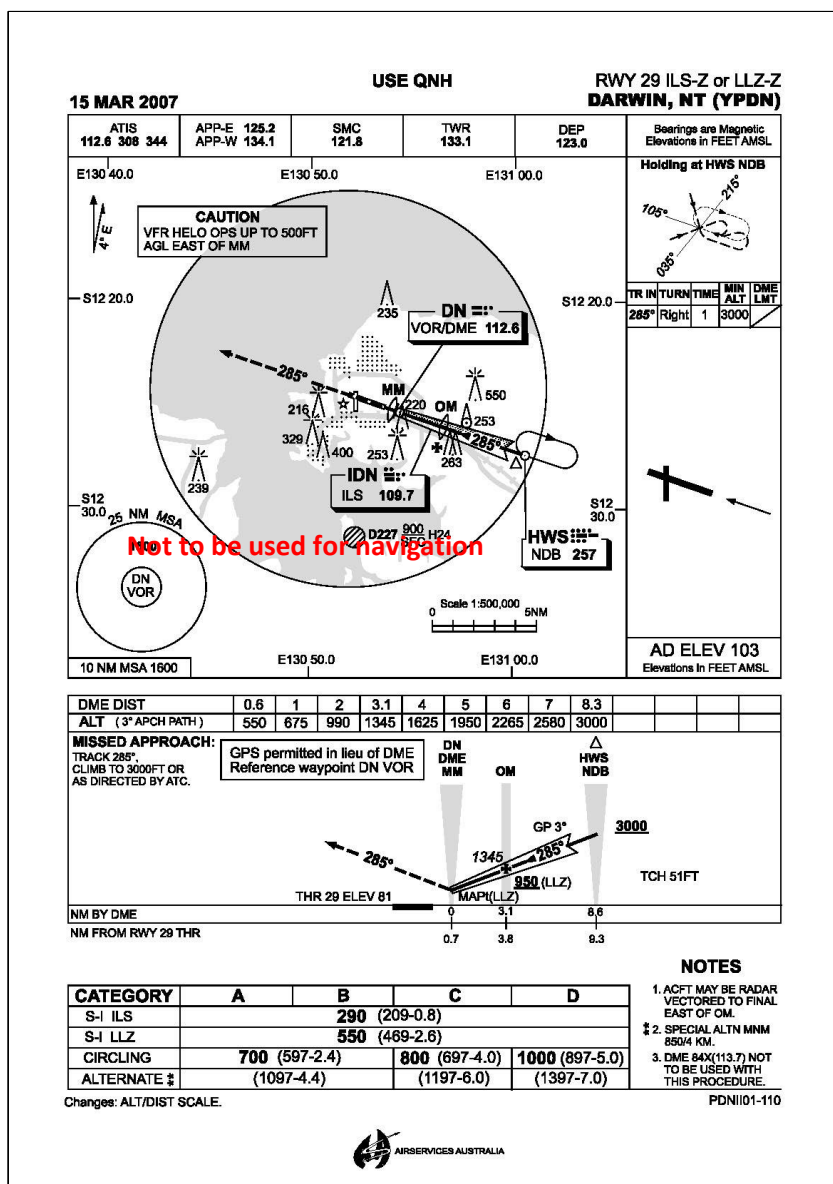
Figure 1: Aeronautical Information Publication (AIP) Darwin Runway 29 ILS approach chart

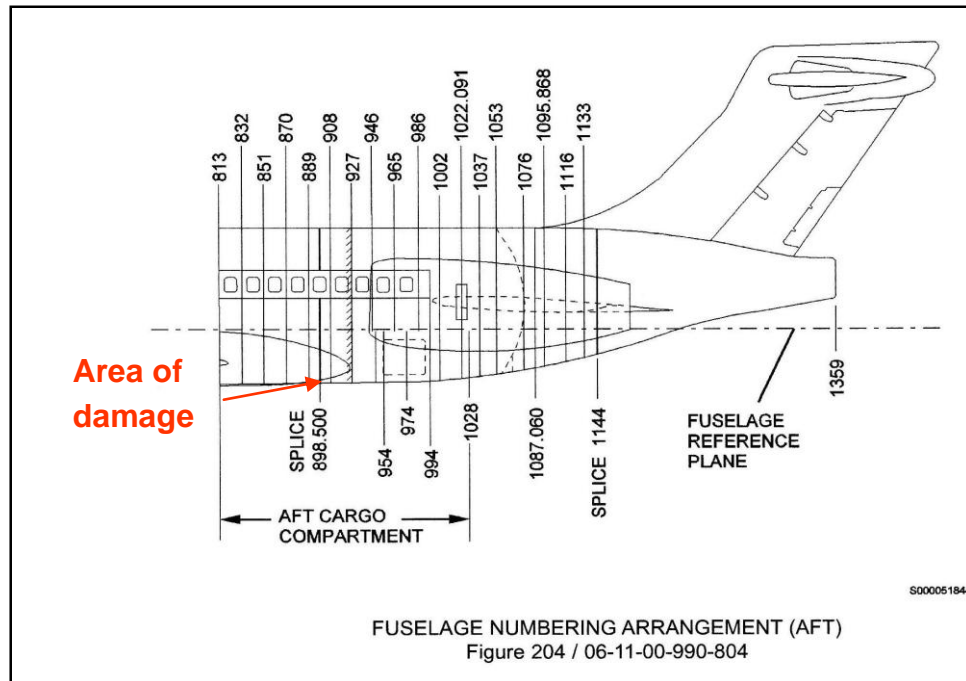
The damage to the aircraft included several creases to the fuselage skin above the wing area and to the underside of the fuselage behind the wing (Figures 2 and 3). Several longerons⁹ in the rear cargo area were also damaged. The left main landing gear was removed and inspected in response to minor damage to the upper wing above the landing gear assembly. The outer left main landing gear tyre was also damaged.

Figure 2: Rear of the aircraft showing the area of damage

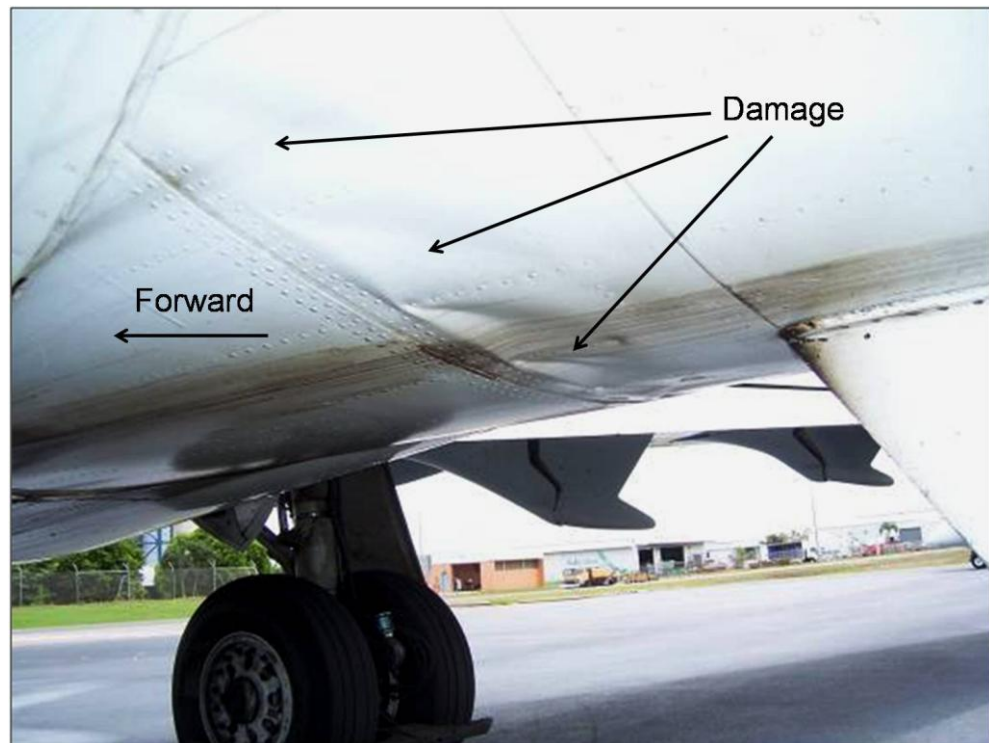
Figure 3: Damage to the rear underside of the aircraft

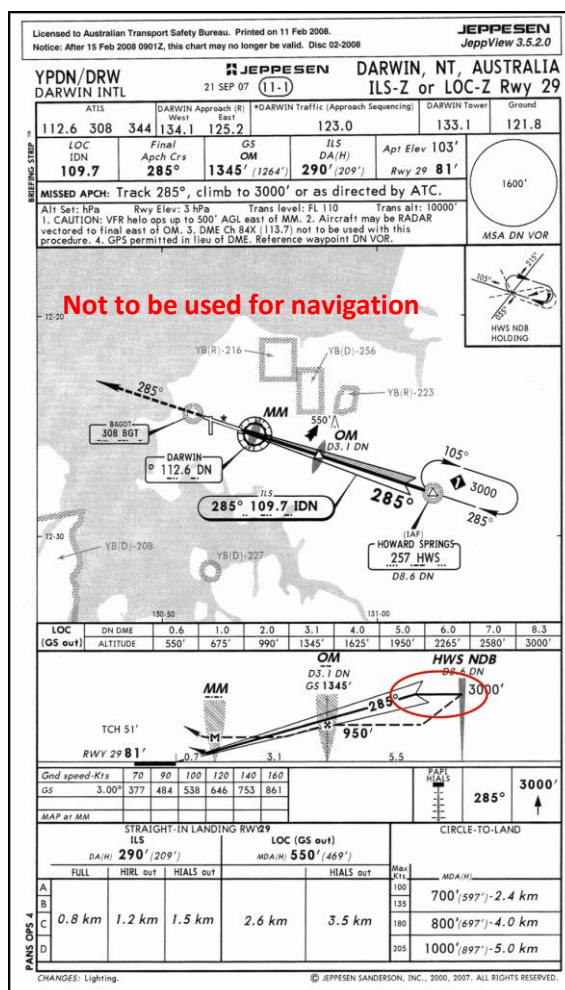
Figure 4: Jeppesen-Sanderson Darwin Runway 29 ILS approach chart dated 21 SEP 07 (level segment highlighted within red ellipse)

The ATSB is satisfied that the action taken by Jeppesen Sanderson Inc. adequately addresses the safety issue.

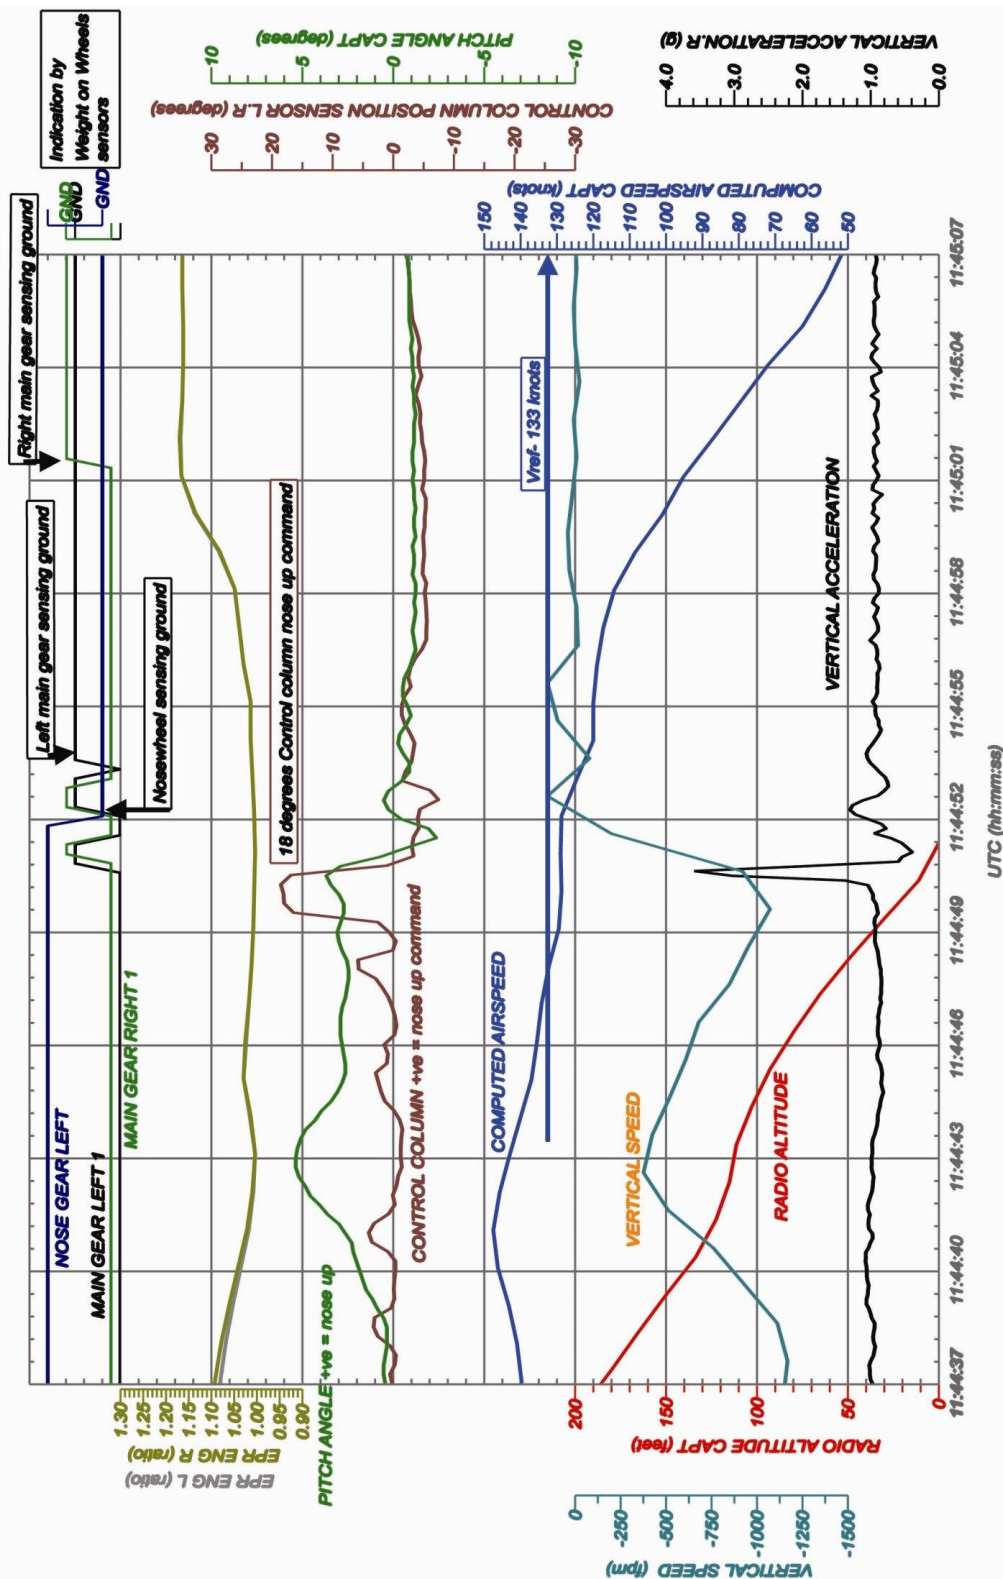
APPENDIX B: FLIGHT RECORDER DATA – SHORT FINAL

At 2114:51, the aircraft landed heavily on the left main landing gear at 128 kts, with a recorded vertical force of 3.6 g⁷ resulting in damage to the aircraft (Refer page 5 Aircraft damage) The touchdown was within 300 m of the runway threshold, to the left of the runway centreline, and with a ROD of 1,072 ft/min. The relevant FDR information, from a radio altitude of 180 ft until after touchdown, is provided in Appendix B.

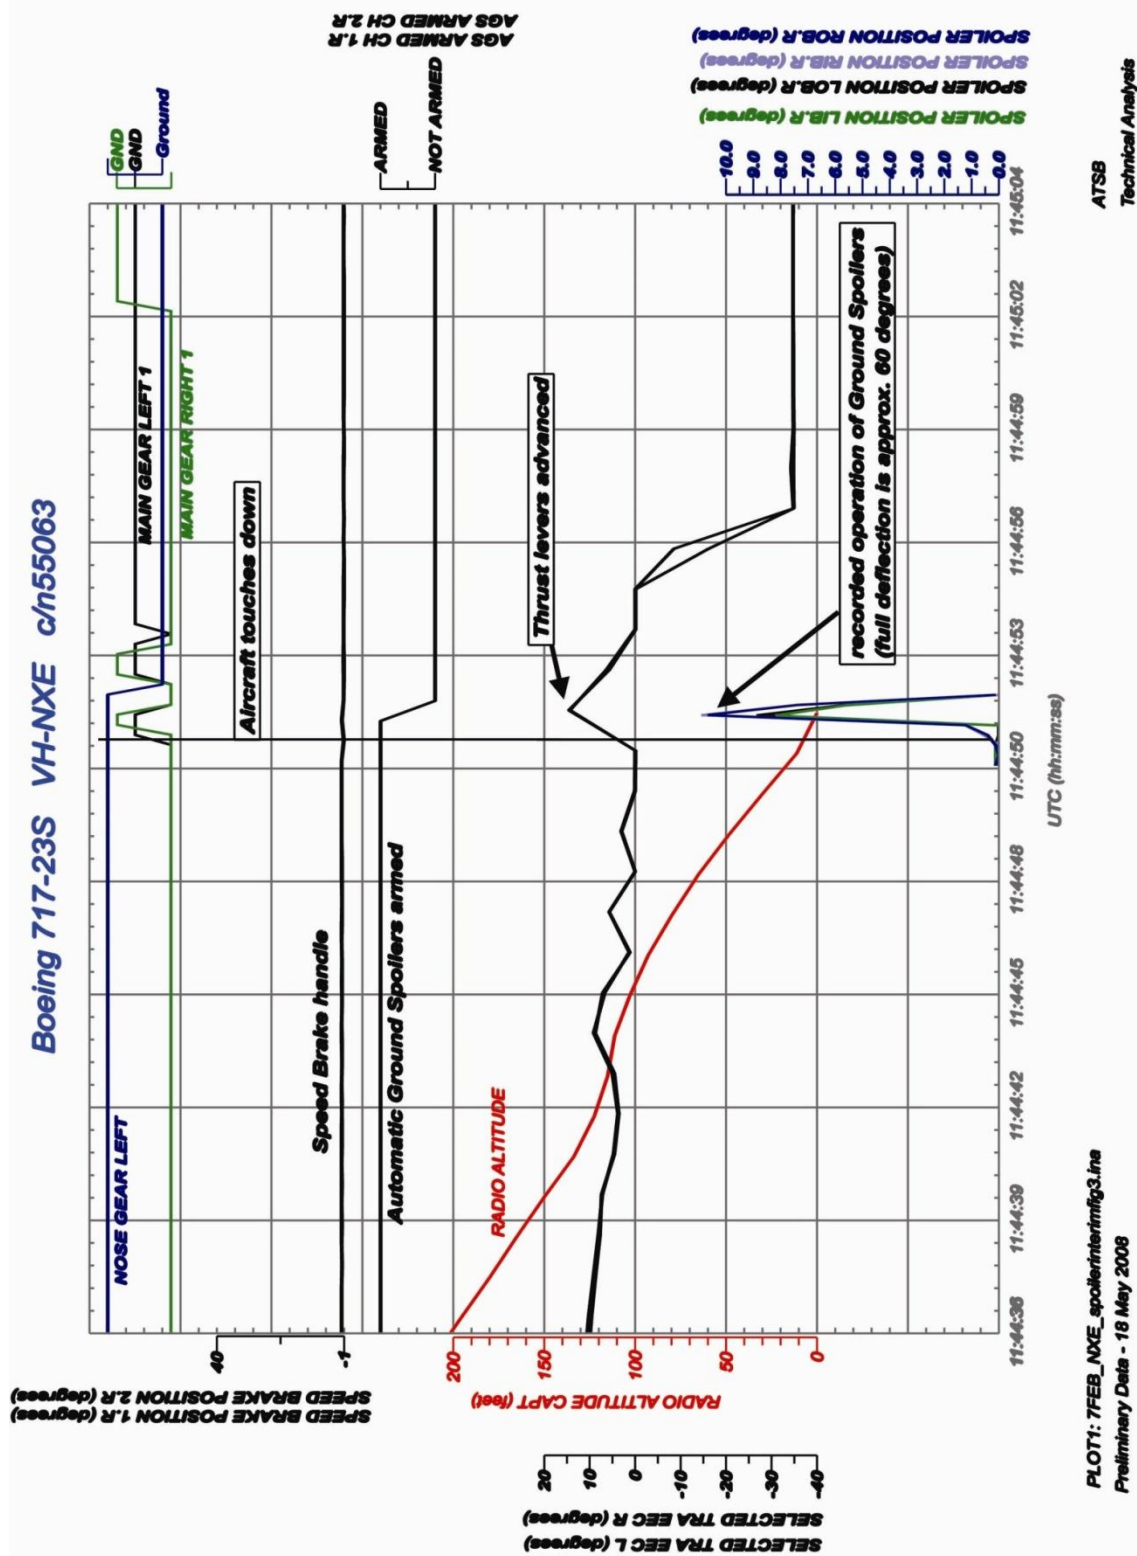
APPENDIX C: FLIGHT RECORDER DATA – SPOILERS

- After touchdown, the thrust levers were advanced, inadvertently cancelling the deployment of the ground spoilers and resulting in unstable conditions while transitioning from flight to the ground.
