Loss of control involving Robinson R22, VH-HGI

Adelaide River Station, 19 January 2013

ATSB Transport Safety Report Aviation Occurrence Investigation AO-2013-021 Final – 17 May 2013 Released in accordance with section 25 of the Transport Safety Investigation Act 2003

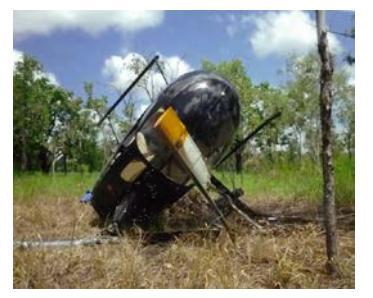
VH-HGI

At about 40 ft above ground level, and at an airspeed of between 25 to 30 knots, the helicopter suddenly yawed to the right and completed 3 to 4 revolutions before impacting trees. The helicopter came to rest inverted and was seriously damaged. The pilot was able to exit with minor injuries and assisted the passenger, who was seriously injured, to exit the helicopter.

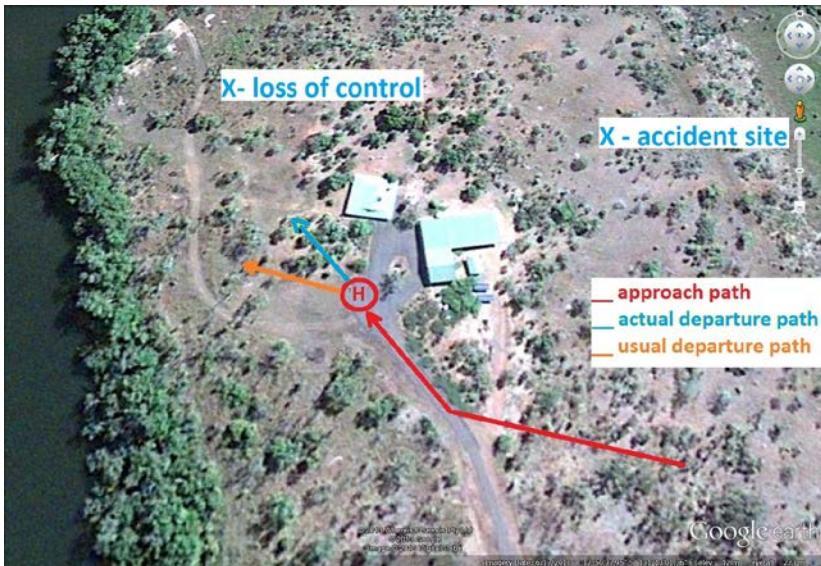
Figure 1: Approach and departure paths

At about 1220, HGI was returning to the homestead and approaching the landing area located nearby (Figure 1). As the helicopter approached the landing area and, prior to terminating in the hover², the pilot turned the helicopter to face

The pilot reported that he had difficulty maintaining control of the helicopter in the hover and he elected to conduct a go-around. As the pilot had previously turned the helicopter to face the north, his departure path was not the usual one he used and required a steeper profile to clear trees located near the landing area.

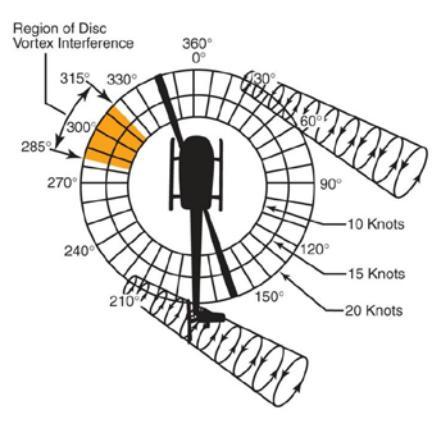
Figure 2: Main rotor disc vortex interference

- wind from the left front of the helicopter at between 285° to 315° relative to the nose of the helicopter (Figure 2).
- left crosswind between 210° and 330° relative to the nose of the helicopter (Figure 3).
- tailwind from 120° to 240° relative to the nose of the helicopter (Figure 4)

Any manoeuvre which requires the pilot to operate in a high-power, low-airspeed environment with a left crosswind or tailwind creates an environment where unanticipated right yaw may occur. During the go around, the pilot may have inadvertently placed the wind relative to the helicopter in the critical azimuth area, between 288° and 315°, where main rotor vortices may interact with the tail rotor, increasing the likelihood of LTE.
