Flight preparation event involving Airbus A350-941, 9V-SHH

Brisbane Airport, Queensland, on 27 May 2022

ATSB Transport Safety Report Aviation Occurrence Investigation (Short) AO-2022-032 Preliminary – 19 August 2022 Released in accordance with section 25 of the Transport Safety Investigation Act 2003

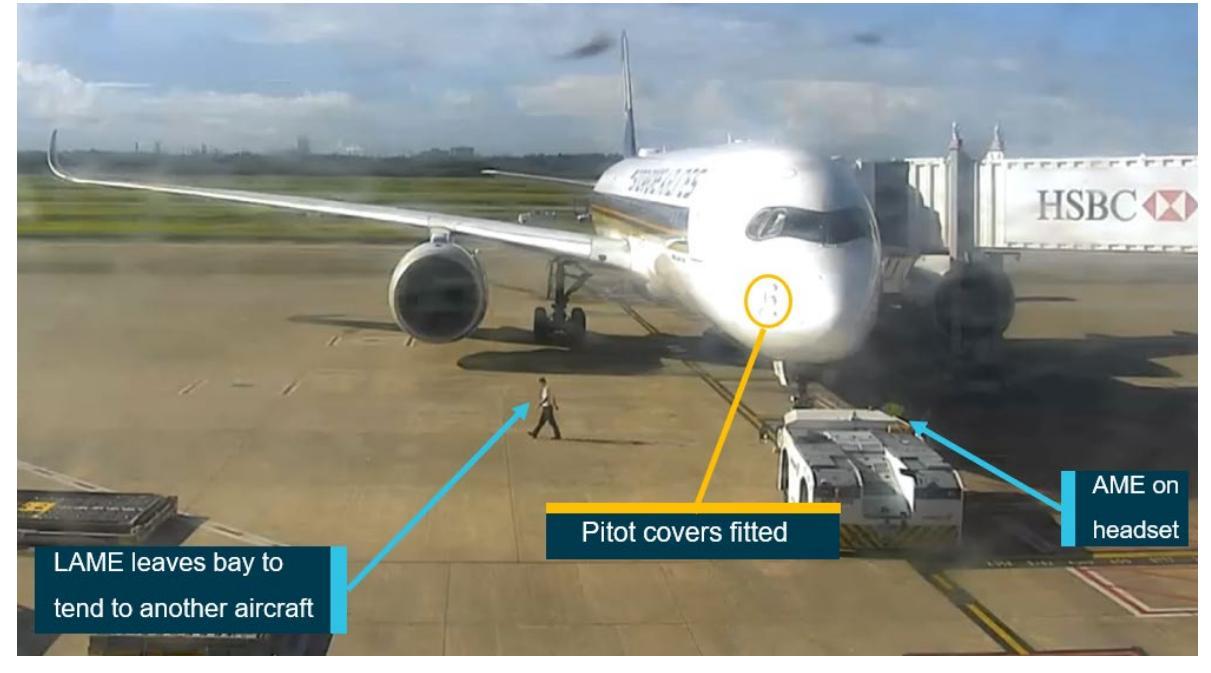
- At 0913, the LAME returned to the tarmac at the nose of the aircraft and conversed with the AME for about 3 minutes. With 4 minutes remaining until the expected pushback³ time, the LAME told the AME that they were going to the adjacent bay to complete the refuelling of another aircraft. The AME remained at bay 81 to conduct the pushback headset duties (Figure 1).

Figure 1: Security footage of bay 81 showing SQ256 4 minutes before pushback with the pitot covers fitted and the LAME moving towards the adjacent bay

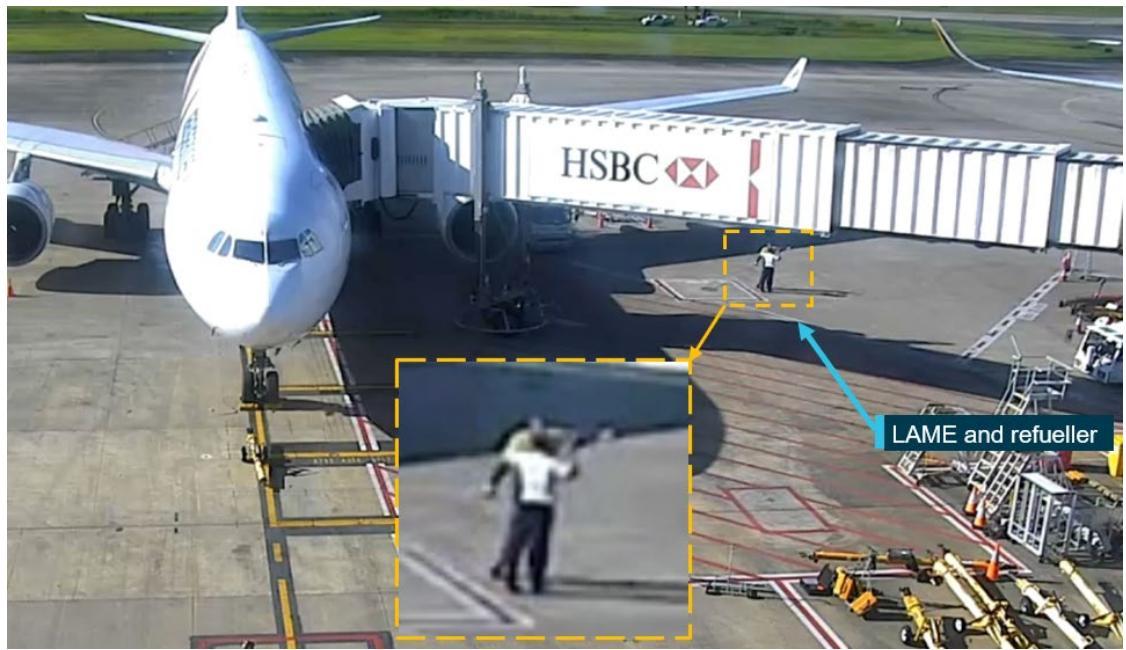
- An aircraft refueller on an adjacent bay observed that the Singapore Airlines aircraft appeared ready to pushback, but the pitot covers were still fitted. When the LAME reached the aircraft at the adjacent bay, the refueller immediately pointed to the SQ256 and informed the LAME that the pitot covers were still fitted (Figure 2).

Figure 2: Security footage of the refueler pointing towards SQ256 and informing the LAME that the pitot covers were fitted

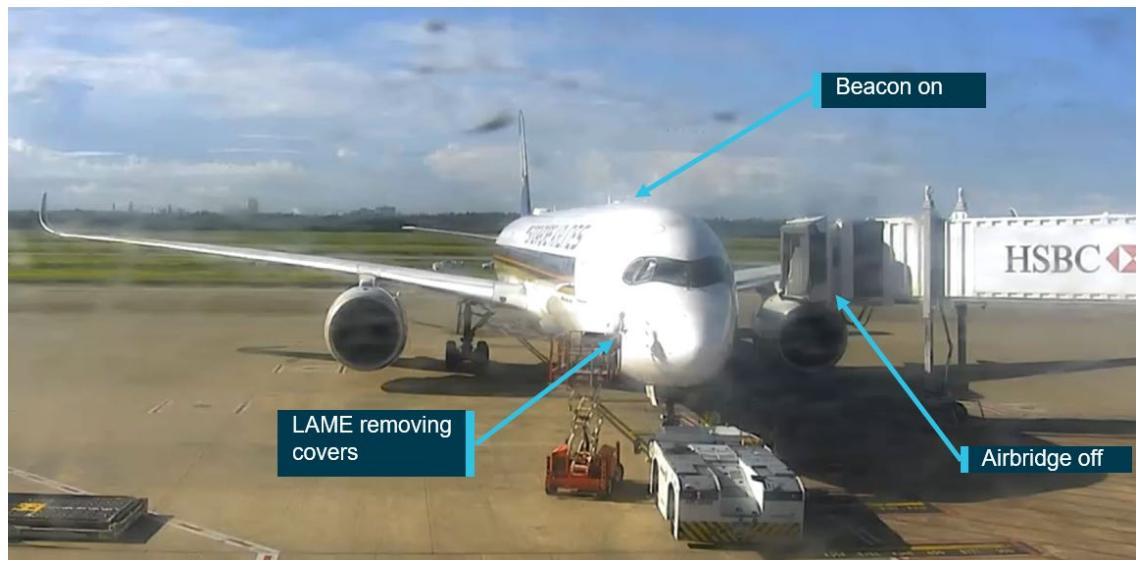
Figure 3: LAME removing pitot covers 1 minute prior to departure time

- With 2 minutes remaining until the expected departure time, the LAME positioned an elevated work platform on each side of the nose to remove the pitot covers (Figure 3). Pushback commenced just after the covers were removed.
