Collision with terrain involving Hughes Helicopters 269C, VH-OBK

near Moorabbin Airport, Victoria on 30 November 2022

ATSB Transport Safety Report Aviation Occurrence Investigation (Short) AO-2022-063 Final – 30 March 2023 Released in accordance with section 25 of the Transport Safety Investigation Act 2003

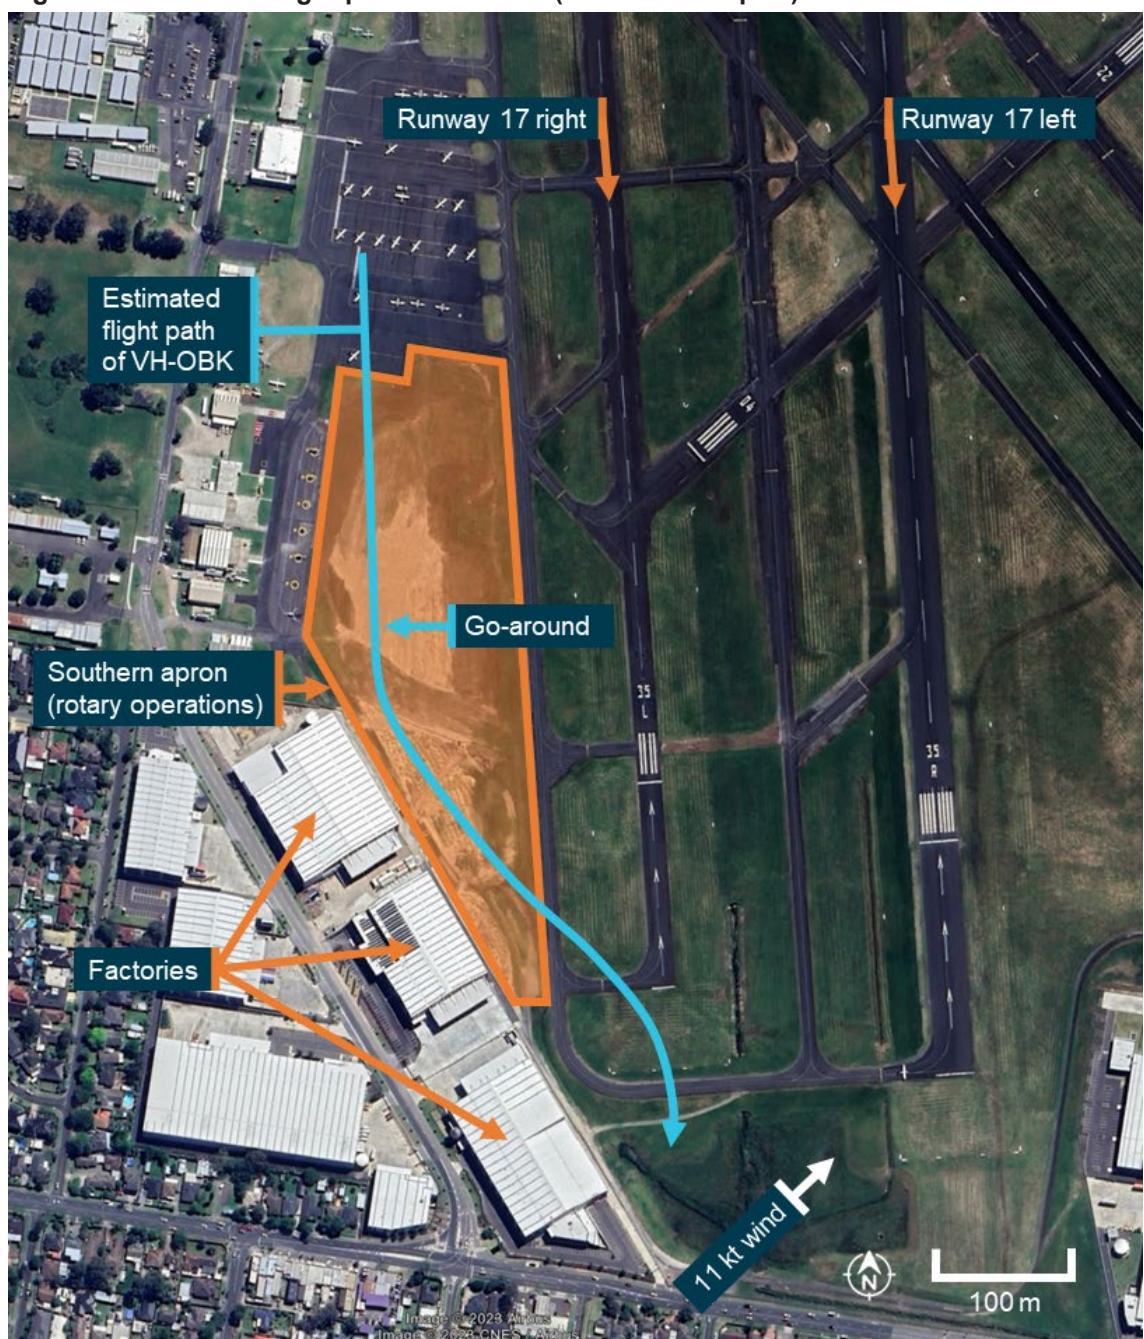
Figure 1: Go-around flight path of VH-OBK (Moorabbin airport)

During the go-around, the pilot observed factories located immediately south of the apron and made a left turn, opposite to the right circuit direction, to provide sufficient room to climb over the factories (Figure 1). This left turn unintentionally took the helicopter toward the departure path of the active runway 17 right, and air traffic control instructed the pilot to make an immediate right turn. The pilot turned the helicopter right and continued climbing on the crosswind leg of the circuit.

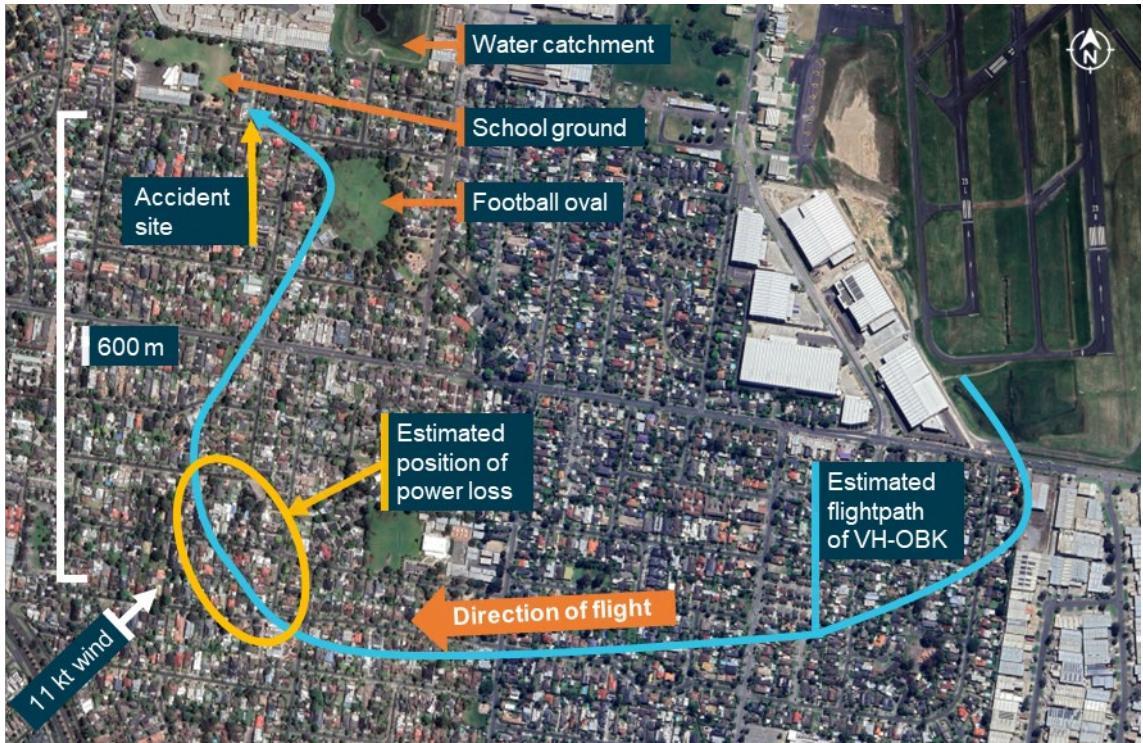
As the aircraft descended to about 100 ft AGL, the pilot recognised that the descent rate had increased, and a forced landing was required. At that time, a football oval was likely positioned under or slightly ahead and to the right of the helicopter, but the pilot did not see it possibly because it was obscured by the airframe or instrument panel. The pilot identified a water catchment and a school ground as suitable areas for a forced landing and turned the helicopter left toward the school ground to attempt an autorotation³ landing (Figure 2). The helicopter did not have sufficient height to reach the school ground and collided with the rooftops of 2 houses. The pilot sustained serious injuries and the helicopter was substantially damaged.

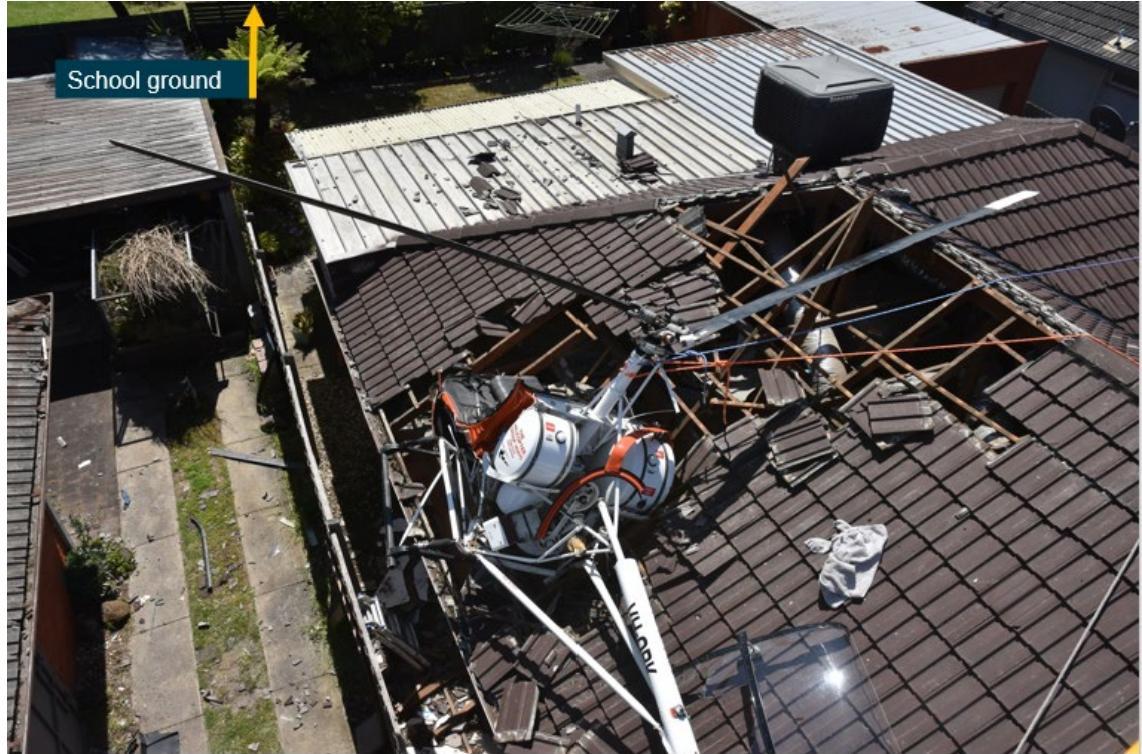
Figure 3: Accident site

The helicopter impacted 2 houses immediately adjacent to the school ground targeted for the forced landing (about 600 m from the estimated position of the power loss). The helicopter came to rest embedded in the roof of one of the houses. After recovery of the wreckage, an inspection of the helicopter's fuel tanks found at least 60 litres of fuel on board.⁵

Note: The forward section of the fuselage was cut away by first responders to facilitate removal of the pilot. Source: Victoria Police, annotated by the ATSB

A detailed examination of the airframe or engine was not performed. However, a visual inspection of the engine cooling fan and fan shroud indicated that the engine was not running at the time of the accident. The degree of damage to the rotor blades also indicated that the engine was providing little or no power.

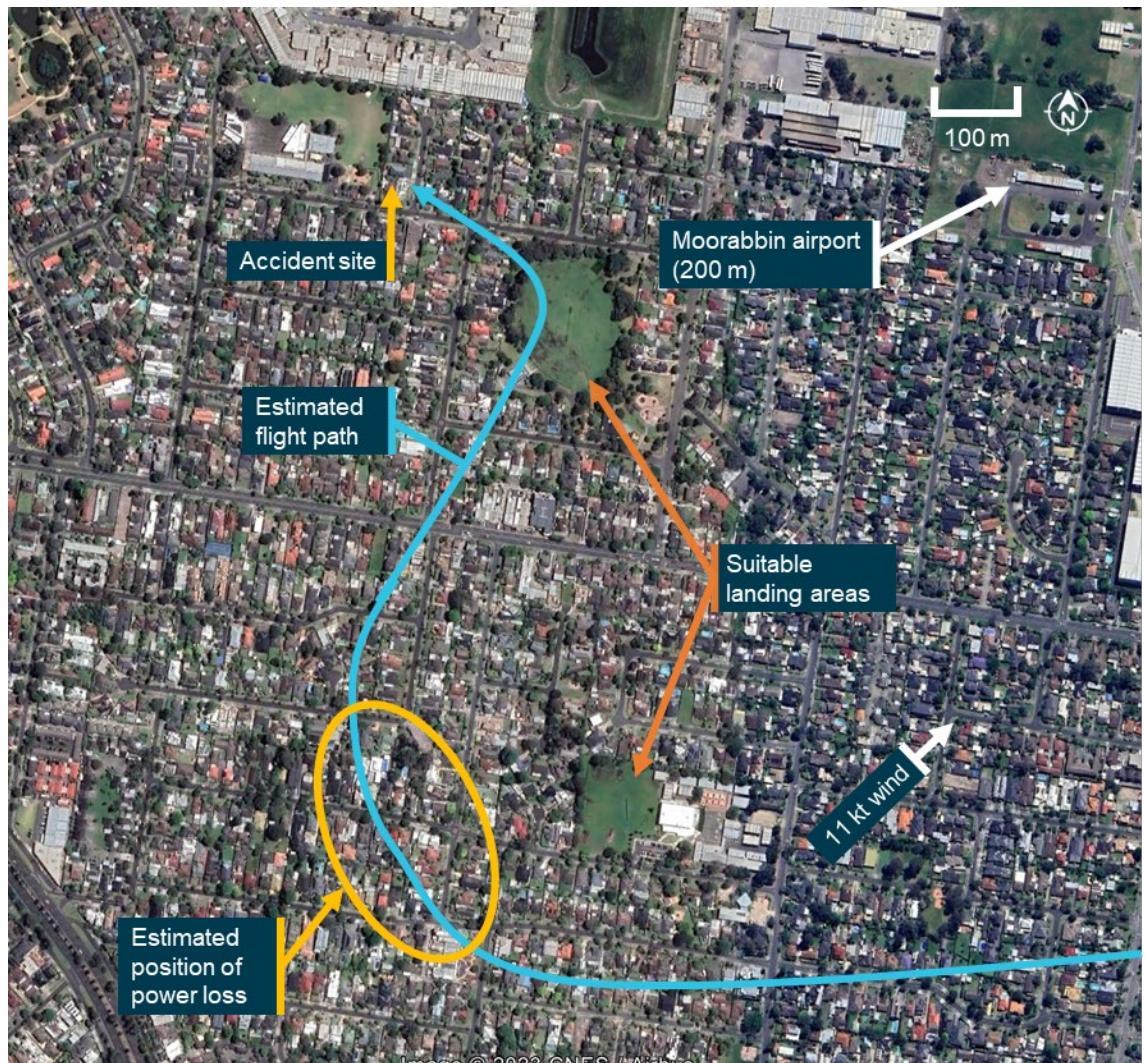
Figure 4: Flight path of VH-OBK following the engine power loss

The engine power loss occurred at low height over a densely populated area presenting a challenging scenario for the inexperienced student pilot. The pilot did not immediately identify that power was lost and attempted to return to the airport while troubleshooting the reduced helicopter performance. During this time, the helicopter passed 2 suitable forced landing sites (Figure 4).

When the pilot recognised that a forced landing was required, the football oval was likely the closest suitable area, but the pilot did not identify the oval, possibly due to it being obscured by the airframe or instrument panel. The pilot identified the school ground and attempted a landing there. However, the helicopter did not have sufficient height to reach the selected site and the helicopter collided with rooftops. While the helicopter did not reach the intended area, the pilot maintained sufficient control of the helicopter and rotor RPM to conduct an autorotation landing into the rooftops, which maximised survivability.
