# Collision with terrain involving Aquila AT01, VH-OIS

Coombing Park Airstrip, 27 km south of Orange, New South Wales on 4 November 2020

ATSB Transport Safety Report

Aviation Occurrence Investigation (Defined) AO-2020-059 Final – 4 May 2023 Released in accordance with section 25 of the Transport Safety Investigation Act 2003

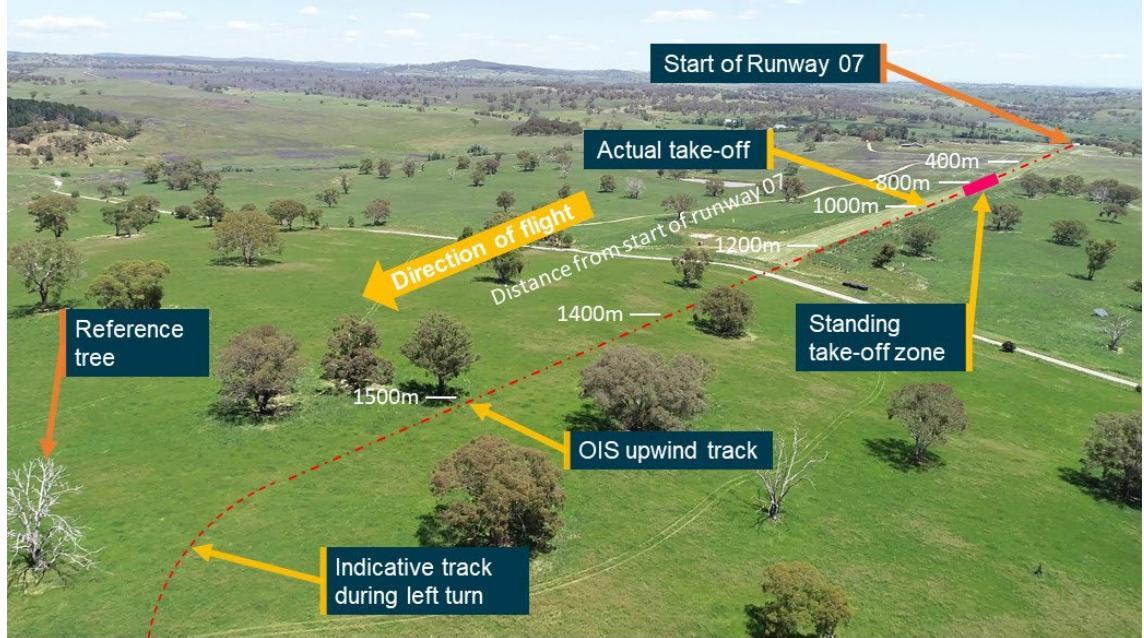
# Figure 6: Upwind track of OIS following touch-and-go at Coombing Park ALA, (view looking south-west)

From this analysis, the standing take-off length at Coombing Park was estimated to be between 630 and 836 m. The estimated zone along Coombing Park runway 07 where OIS would have climbed to 50 ft from a standing take-off is shown in pink in Figure 6. This figure also shows the location of the start of runway 07, the actual take-off for OIS, the upwind track in red-dashed lines, and an indicative track for the start of the left turn. The reference tree is shown for continuity between figures in this report.

Image showing upwind track of OIS (red dashed lines), actual take-off position of OIS and estimated take-off zone if a standing take-off was conducted Source: ATSB

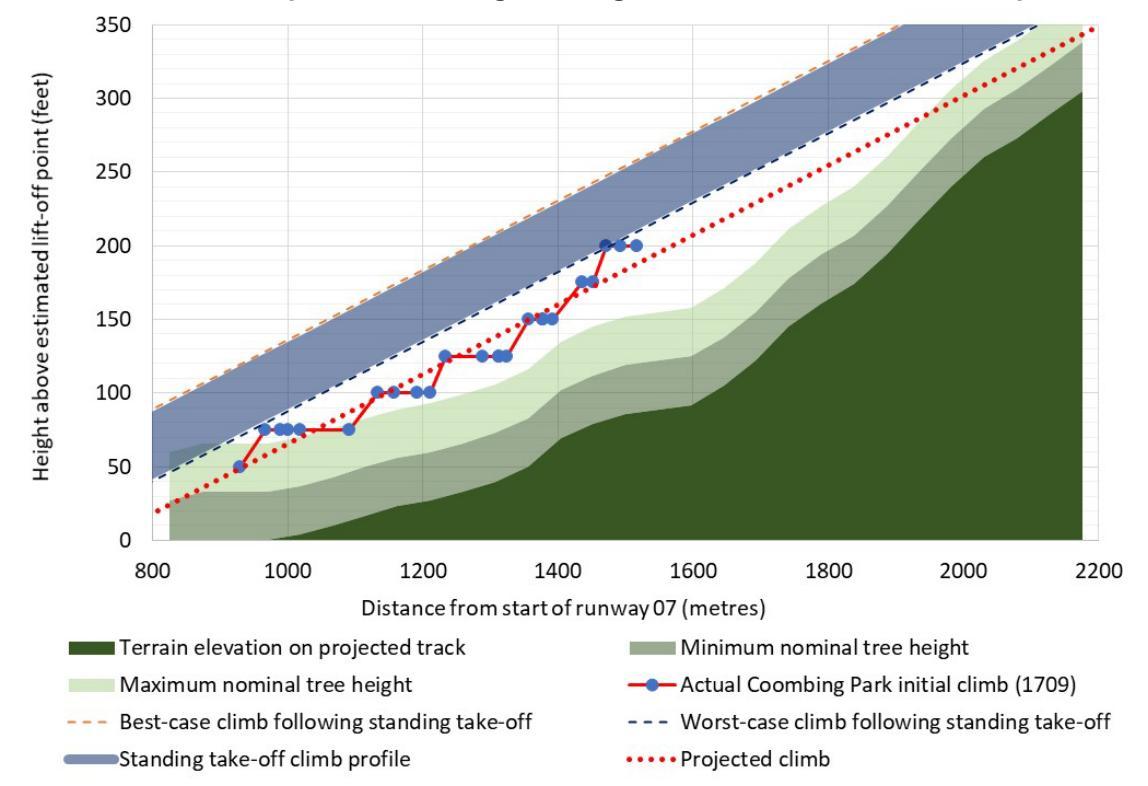
Figure 7: Height of initial climb profile for OIS at Coombing Park ALA, including estimations for climb profiles following standing take-off and estimated terrain profile

This analysis used the estimated standing take-off distances described in the section above and is illustrated in Figure 7. The vertical axis shows the height above the estimated point of lift off and the horizontal axis shows the distance from the start of runway 07 at Coombing Park ALA, and also corresponds to the markers shown in Figure 6.

The actual initial climb profile of OIS conducted at 1709 is shown in Figure 7 by the series with red lines and blue circles. The last data point of this series indicates the relative height of OIS immediately prior to the left turn. The red dotted series is the line of best fit for the 1709 initial climb and shows an estimated projection of the climb if the climb rate was maintained and OIS tracked in a straight line instead of turning left. The top right corner of Figure 7 show the projected climb passing within about 45 ft (14 m) of the terrain, below the maximum nominal height.

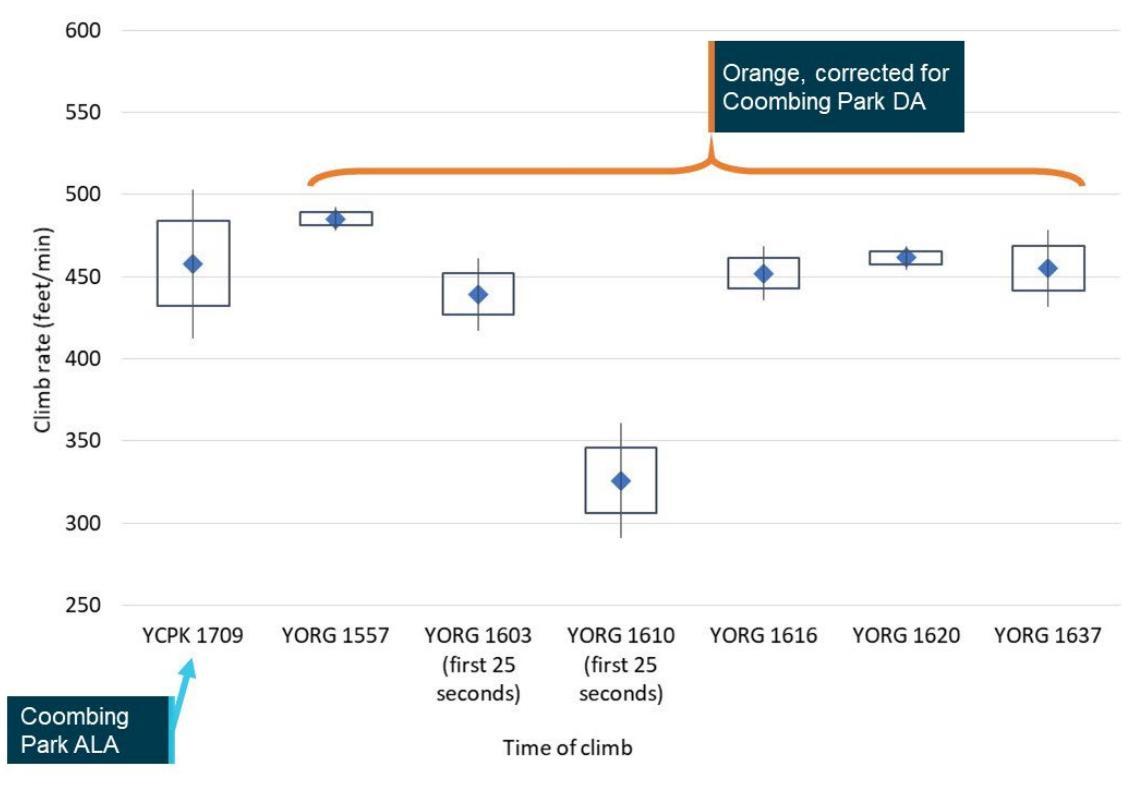
The ATSB evaluated the climb rate of OIS after take-off from Coombing Park compared to climbs after take-offs at Orange Airport, earlier in the flight. Climbs after take-off were evaluated from 50 ft above the surface, to reduce uncertainty associated with the transition from the ground roll to a stable climb, including ground effect. Corrections for density altitude were performed on the climbs at Orange (increasing the actual values by 3.6%) to compare with the Coombing Park initial climb which had a lower elevation. Figure 8 shows the results of this comparison.

Chart showing comparisons between initial climbs conducted at different times during the flight Source: ATSB

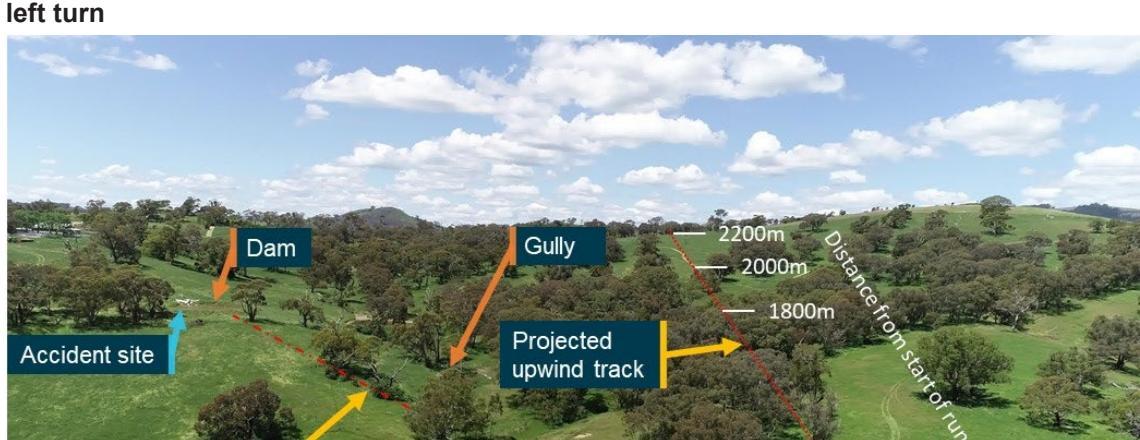
Figure 9: Image looking uphill at a similar height and position to OIS immediately prior to left turn

Flight data indicated that immediately prior to turning left, OIS was approximately 125 ft above the ground (Figure 7), tracking toward steeper terrain with a significant number of trees. Figure 9 shows an image facing in a similar direction and at a similar height to the pilots just prior to where the left turn was initiated. The projected upwind track with distance markers shows the rising terrain corresponding to the elevation profile shown in Figure 7, with the same reference tree as shown in Figure 6. The projected upwind track provides a relative guide for analysis of climb performance covered in other section, and does not necessarily indicate the intended track of OIS.

Image showing upwind track of OIS, approximate track during left turn and projected track if OIS continued in a straight line Source: ATSB

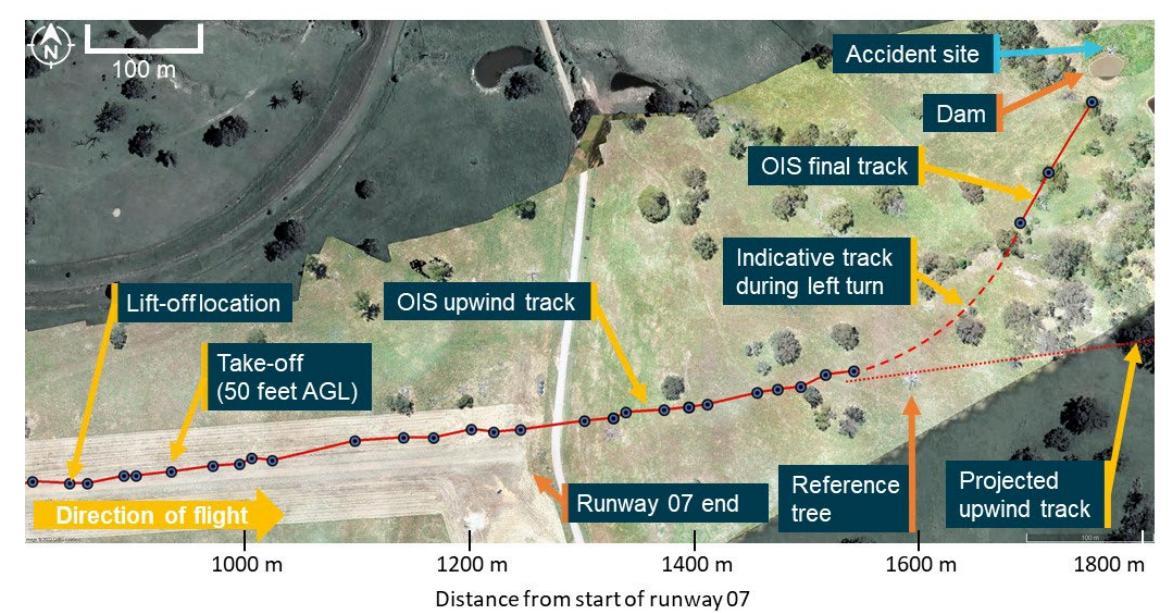
Figure 10: Image looking down on upwind area of Coombing Park runway 07 showing track of OIS and accident site

Down-looking image of runway 07 end of Coombing Park ALA and flight track of OIS Source: Google Earth, with image overlay and annotations by ATSB

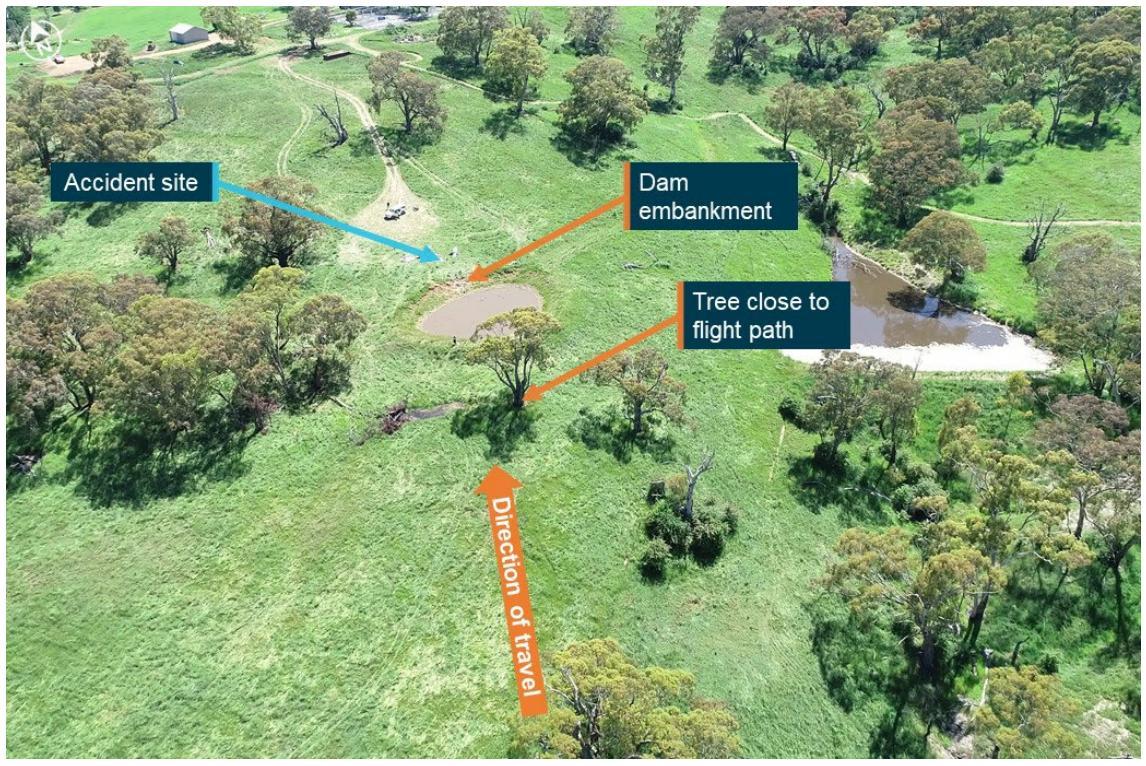
Figure 11: Image looking down on accident site and surrounding trees viewed from the direction of travel

Site and wreckage examination did not identify any aircraft defects or anomalies that might have contributed to the accident. Examination of the area surrounding the accident site, including the tree close to the likely flight path (labelled), did not identify any trees or terrain that might have been struck by OIS prior to the wreckage location (Figure 11).

Image showing accident site and surrounding trees Source: ATSB

The aircraft struck the embankment of a small dam in an upright attitude. Flight data and ground scars marks indicated that OIS was tracking in a generally northerly direction at the time of the

The damage to OIS was consistent with significant upward and rearward forces being transferred through the aircraft structure during the collision. The left wing and left-wing flight controls, aircraft canopy, cockpit area, nose landing gear, engine cowling, propeller and tail section of the aircraft were severely disrupted by impact forces. The counter-clockwise rotation during the collision was likely induced by the left side of the aircraft (mostly from the left wing that was completely destroyed) colliding with the dam embankment prior to the right side of the aircraft.

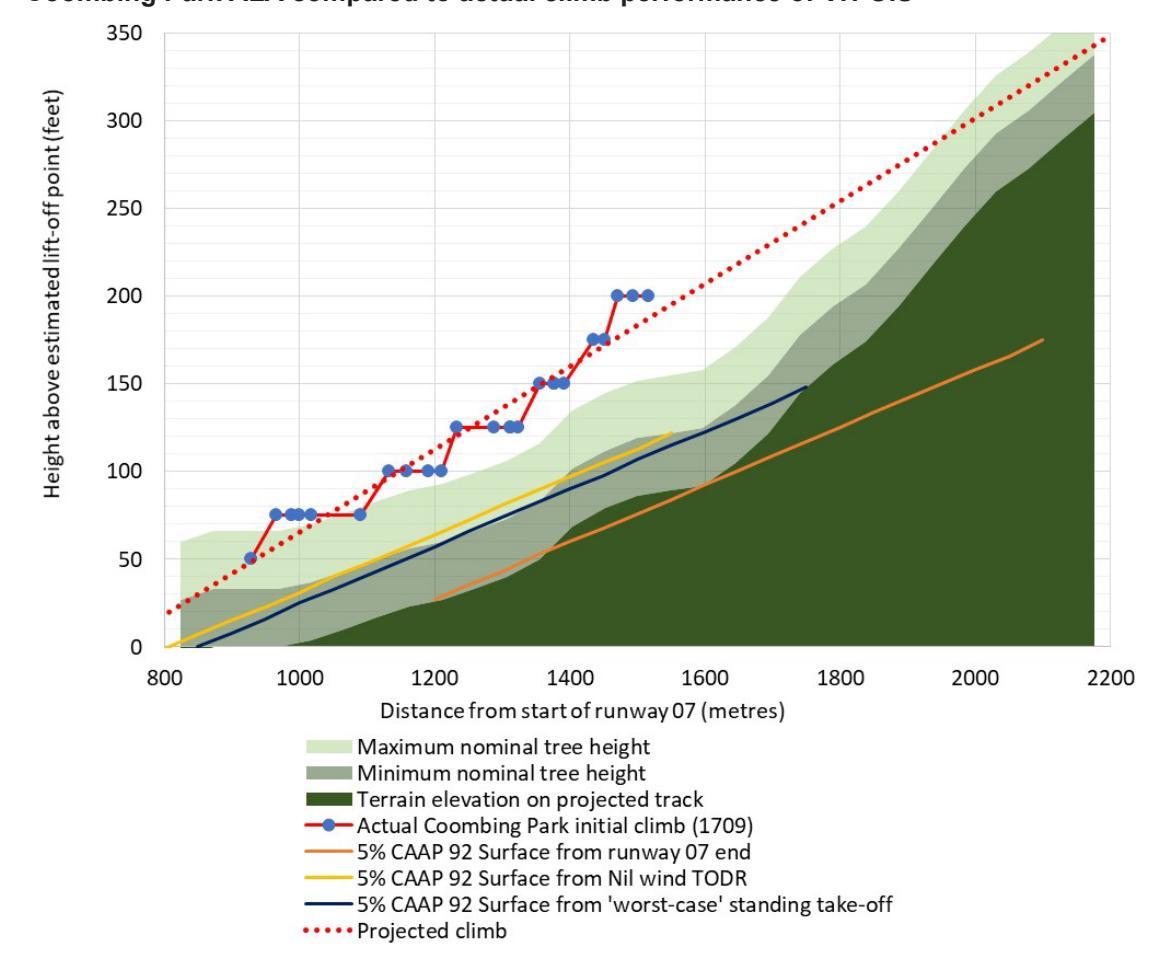
Figure 16: CAAP 92(1)-1 Runway approach and take-off obstacle clearance slope from various theoretical runway end positions projected onto the terrain profile of Coombing Park ALA compared to actual climb performance of VH-OIS

The assessment against CAAP 92-1(1) recommendations revealed that Coombing Park ALA likely did not meet obstacle clearance recommendations for VH-OIS at the time of the accident. Approach and take-off area slopes are illustrated in Figure 16 relative to the terrain profile (and upwind climb profile of OIS for reference), as also shown in Figure 7. These slopes are shown by the yellow, blue and orange lines, and have labels prefixed with 'CAAP 92 surface...' in Figure 16. Each of the 3 obstacle clearance slopes terminated 900 horizontal metres from the (simulated and actual) runway ends, as per the recommendations in CAAP 92-1(1). For reference, the horizontal axis shows the distance from the start of runway 07, corresponding to figures shown earlier. This shows that the CAAP 92-1(1) obstacle clearance surface originating from the end of runway 07 penetrated the rising terrain about 150 m from the runway end (orange line), as also noted in Table 1.
