Loss of control involving Cessna Aircraft Company U206G, VH-FRT

Caboolture Airfield, Queensland | 22 March 2014

ATSB Transport Safety Report

Aviation Occurrence Investigation AO-2014-053 Final – 23 June 2017

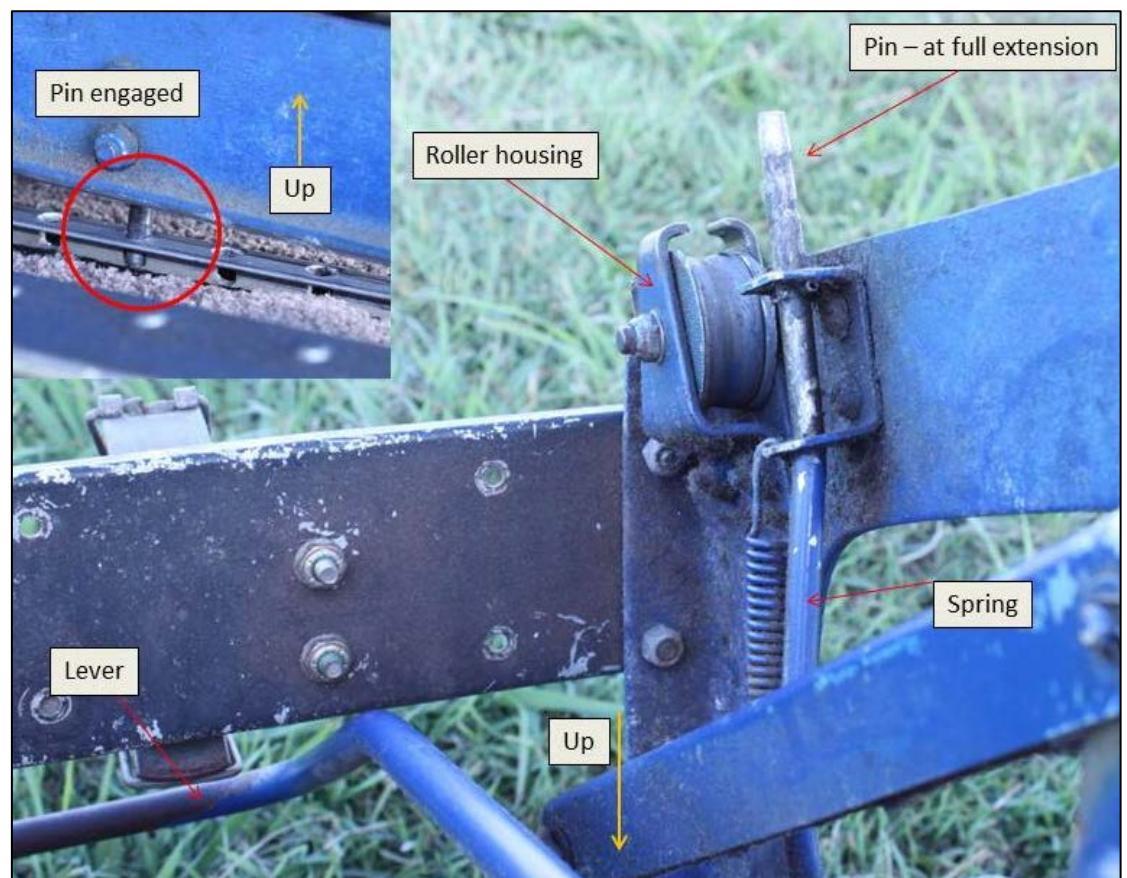
Figure 3: Exemplar primary seat stop mechanism showing the primary seat stop (latch) pin engaged in the seat rail at left inset (circled in red)

Each seat rail has 15 locator holes, which allow the pilot to select their desired fore/aft position in relation to the flight and engine controls. Lifting the control lever raises two primary seat stop pins clear of the locator holes and allows the pilot to move the seat fore and aft on the rails. Releasing the lever allows spring pressure to pull the latch pins down and engage in the holes on both seat rails to prevent further movement (Figure 3).

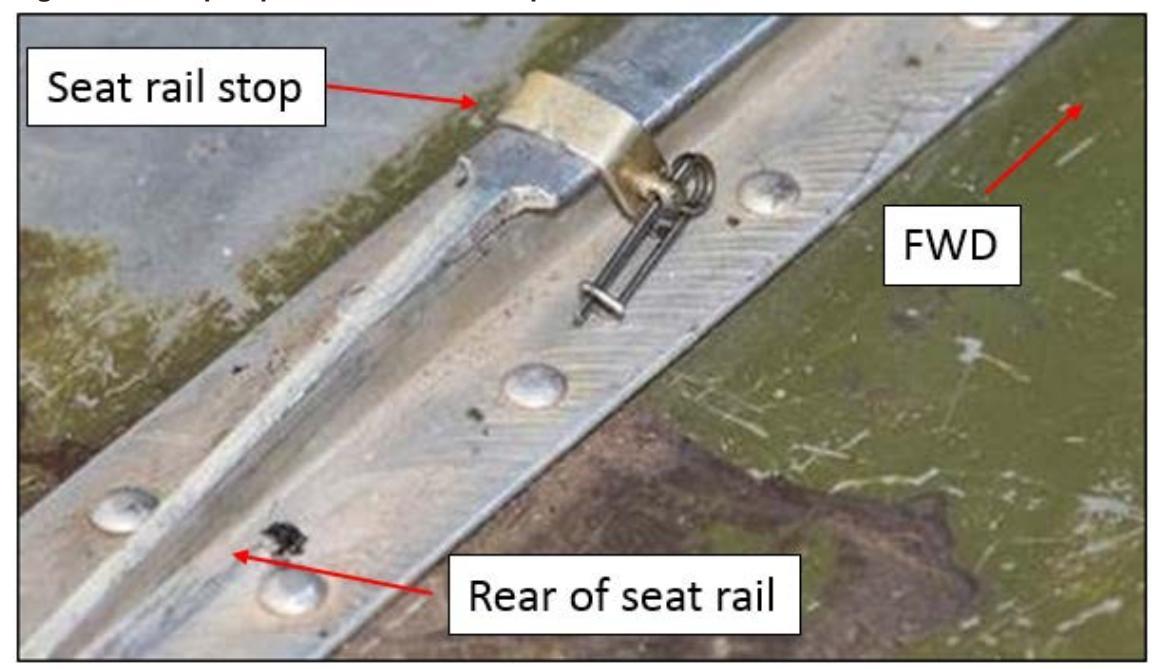
Figure 5: Exemplar pilot seat rail rear stop

Figure 5 shows an example of a U-shaped seat rail stop fitted in the rear of a pilot's seat rail.

A report from a person who observed FRT while it was on the ground a week before the accident reported that the pilot's seat rear rail stop was missing at that time. In addition, it was reported that the rear feet of the pilot's seat were sitting outside the rear of the rails when the seat was fully back. The person, who was also a qualified pilot, further stated that they placed the seat feet back in the seat tracks and reported the issue to the pilot. The operating pilot that day was the same as was operating the aircraft at the time of the accident.

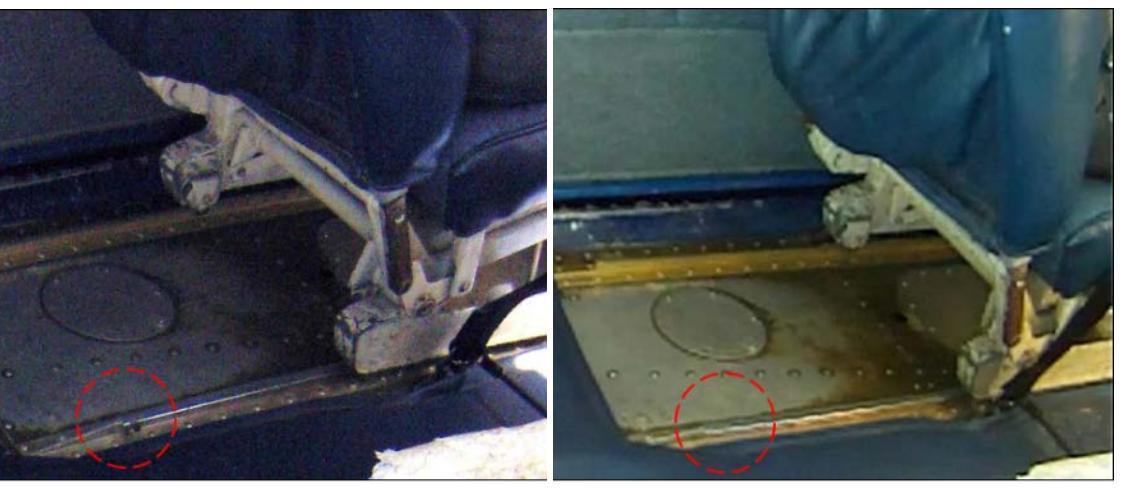
Figure 6: Seat rail stop fitted

Review of a number of parachuting videos from previous flights identified that the pilot's seat rear rail stop was in place up until 16 February 2014 (Figure 6). Several other videos confirmed that the rear rail stop was missing for flights after that date, including the flight immediately prior to the accident (Figure 7). It could not be determined from the videos if the seat feet were outside the seat rails during any of those flights.

Figure 7: Seat rail stop not fitted

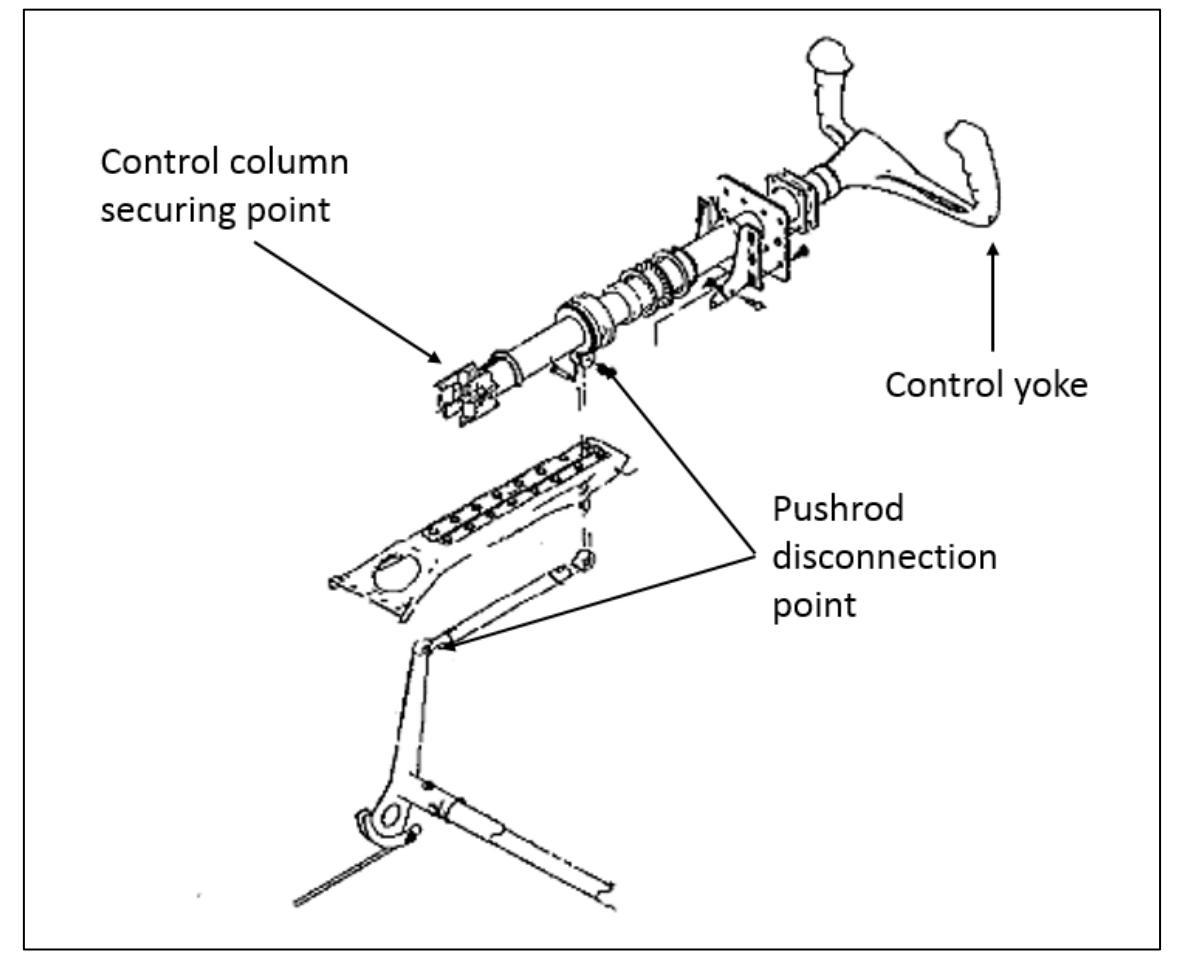
Figure 8: Copilot's control column assembly showing the elevator pushrod disconnection points and control yoke

- removal of all seats with the exception of the pilot seat
- replacement of the right passenger double doors with a retractable wind deflector (blind), which could be manually closed by the pilot once the parachutists had departed the aircraft
- installation of two external grab handles, a step, six single-point restraints and a parachuting floor mat
- disconnection of the copilot's control column (corresponding with the right control seat) by removal of the elevator pushrod and the control yoke, including a duplicate inspection (Figure 8).

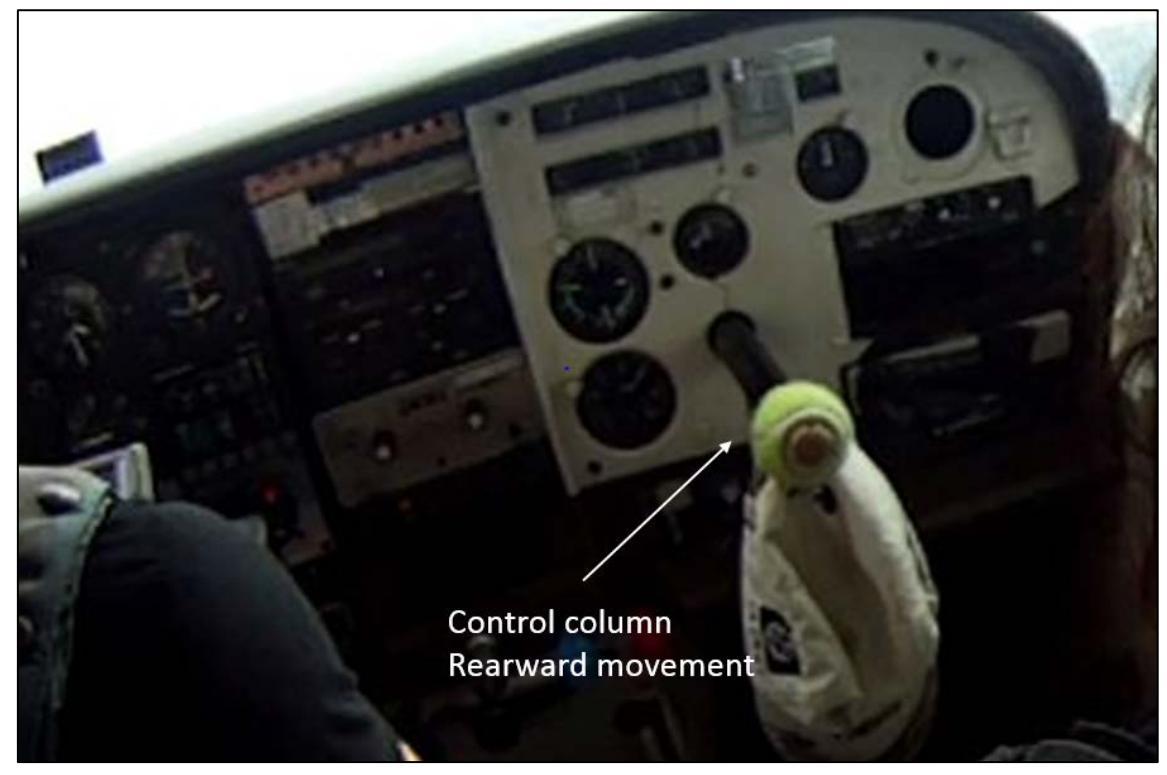
Figure 9: VH-FRT in flight on 8 February 2014 with the copilot's control column protruding out of the control panel

Video footage taken on 8 February 2014 from inside FRT during a parachute flight showed that the copilot's control column had moved a substantial distance out of the control panel (Figure 9). That indicated that the control column was not secured to a stationary point behind the instrument panel as indicated by the LAME who supervised the original modification for parachuting operations.

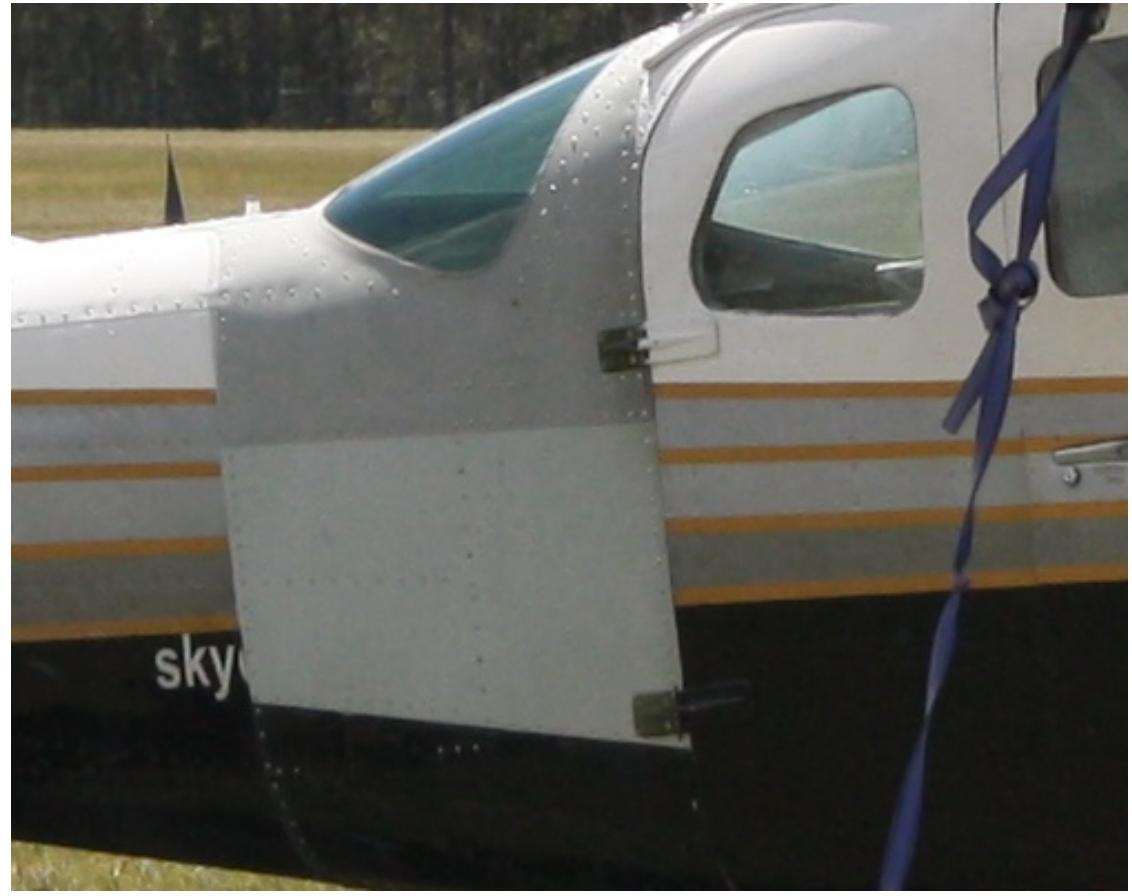
Figure 11: Right-rear fuselage repair (the extent of the repair is indicated by the two-tone, unpainted grey area)

Maintenance documentation recorded a significant structural repair to the rear fuselage between 26 July and 23 August 2013. An insurance report indicated that the:

- rear fuselage bulkhead frame was buckled on the right top and bottom edges
- right-rear fuselage skin below the quarter window was creased (Figure 10)
- right fuselage skins and corresponding stringers aft of the double door opening were dished inwards and that all required replacement.

The deformations seen in the aft fuselage skin and in the FS 138 Bulkhead, are consistent with damage seen on other Cessna model 206's after the cargo door was not latched properly and the rear half of the door came open in flight.

While the cause of the fuselage damage to FRT could not be determined, Cessna indicated that the level of damage sustained would have required inspection by a suitably-qualified engineer to assess the aircraft's serviceability before further flight. Cessna stated further that after engineering inspection, the two aircraft that sustained damage similar to that by FRT were permitted to remain in limited service, prior to repairs/replacement of damaged skins and bulkheads. Cessna also noted that the damage to FRT was '...most likely not extensive enough to have made the aircraft's tailcone incapable of withstanding 206 Type Design Loads.'

Figure 11 shows the extent of the repair to the right-rear fuselage.

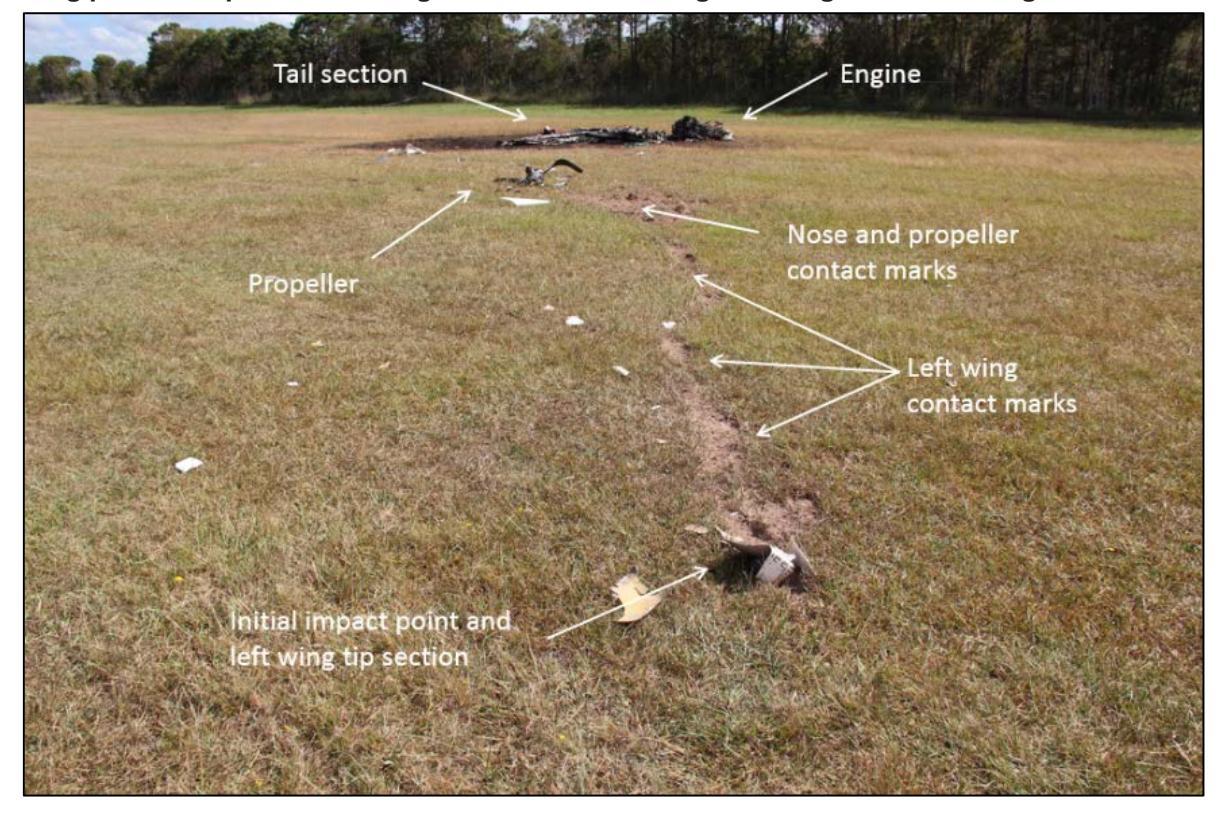
Figure 14: Main wreckage and accident site looking north-north-west, showing the left wing point of impact in the foreground and the fuselage and engine in the background

The accident site was located in the area between runway 12 and the airfield perimeter fence. Ground scarring and impact marks indicated that the aircraft's left wingtip touched the ground first, then the nose section, before the aircraft came to rest, inverted, about 35 m beyond the initial impact point (Figure 14). The wreckage trail was orientated on a magnetic bearing of about 340°.

All major aircraft components were identified in the wreckage. Additionally, a search of the aircraft's flight path did not reveal any other aircraft components outside the immediate area of the main wreckage, or any evidence of a bird or animal strike. Most of the aircraft, including the cabin area, was destroyed by the post-impact, fuel-fed fire. This precluded a detailed examination of numerous components. However, no pre-accident structural defects were identified.

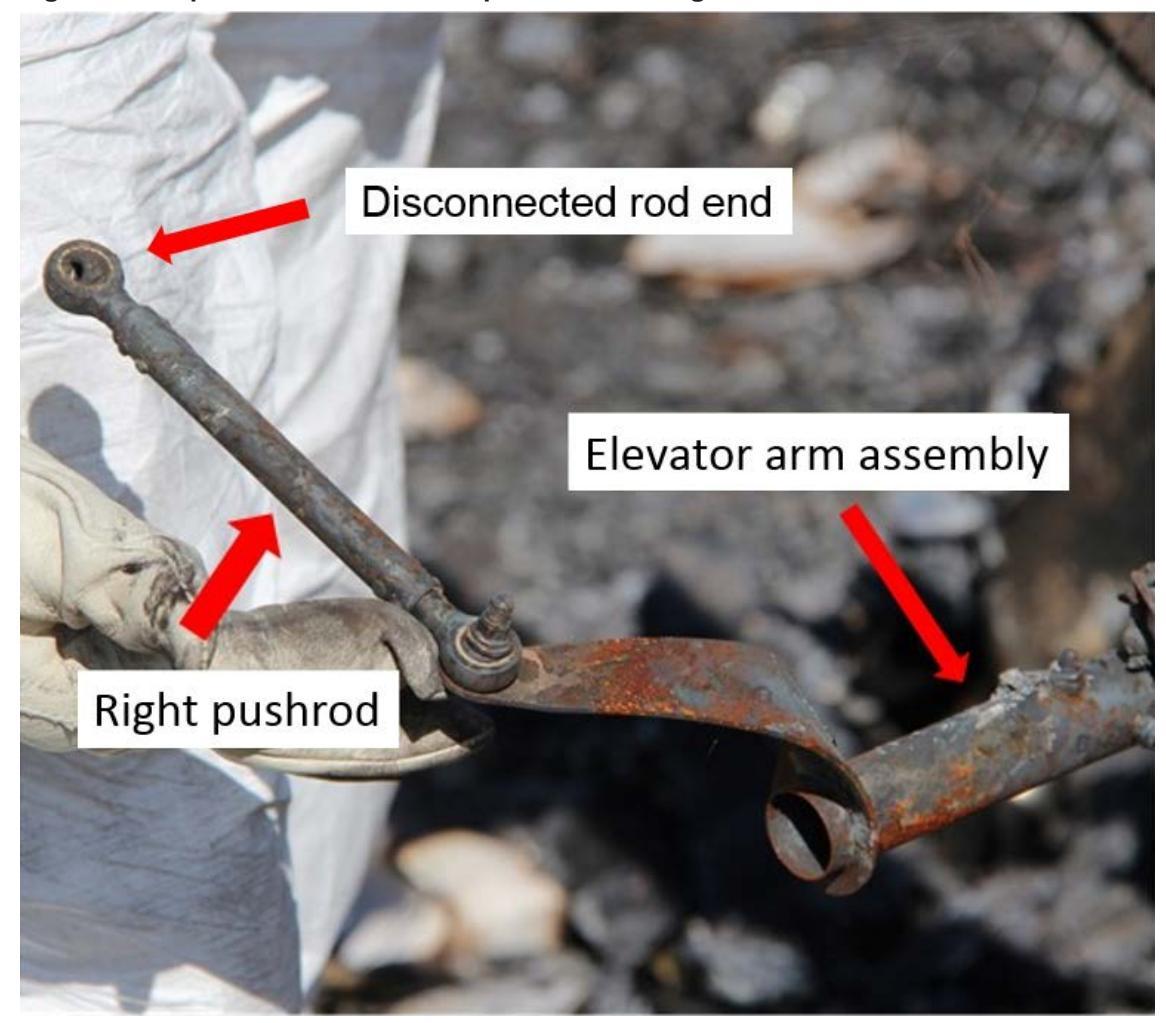
Figure 15: Copilot's elevator control pushrod showing the disconnected rod end

The copilot's control yoke was not located in the wreckage and information provided later revealed that it was removed as part of the modification of the aircraft for parachute operations. The pushrod that connected the copilot's elevator arm assembly to the control column was also found disconnected and the associated bolt was not located. However, the pushrod was still attached to the elevator arm assembly (Figure 15).

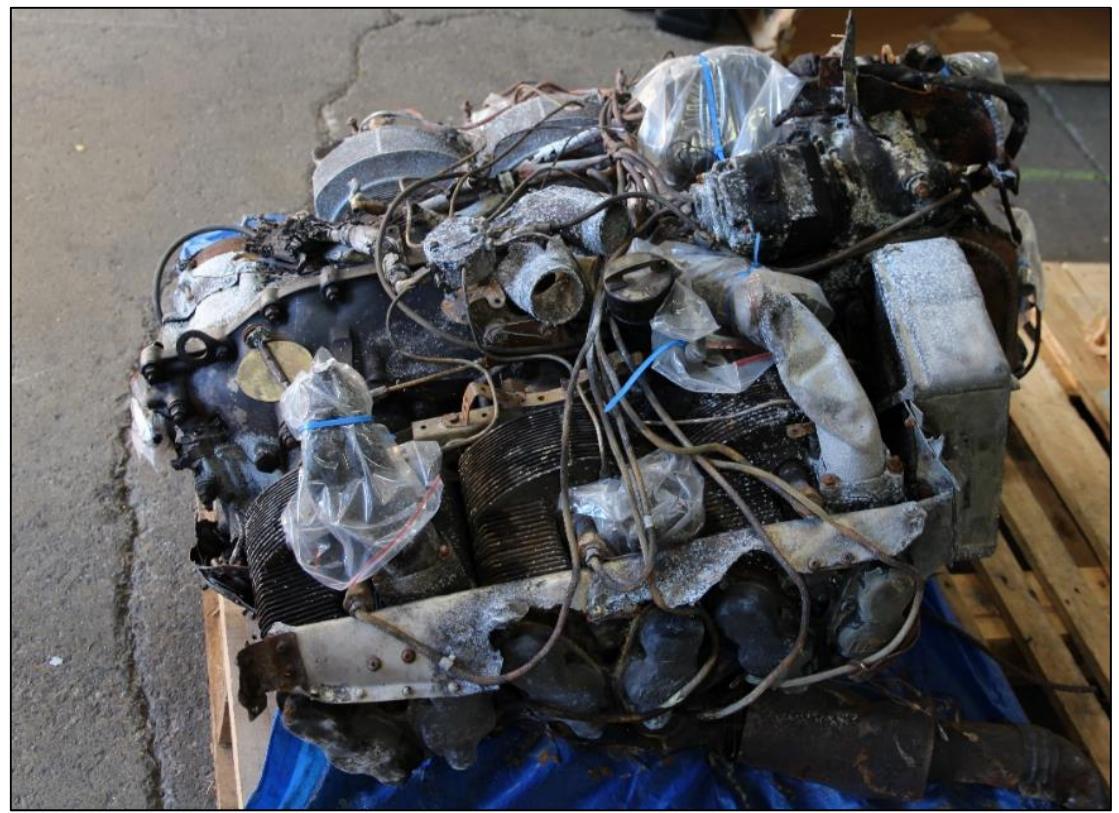
Figure 16: Upright engine assembly viewed from the left side showing extensive fire damage

The engine was disassembled and examined at a CASA-approved engine overhaul facility under the supervision of the ATSB. The engine showed evidence of ground impact damage on the forward-left corner and extensive fire damage. The section of crankshaft that connected to the propeller had failed due to overstress associated with the ground impact (Figure 16).

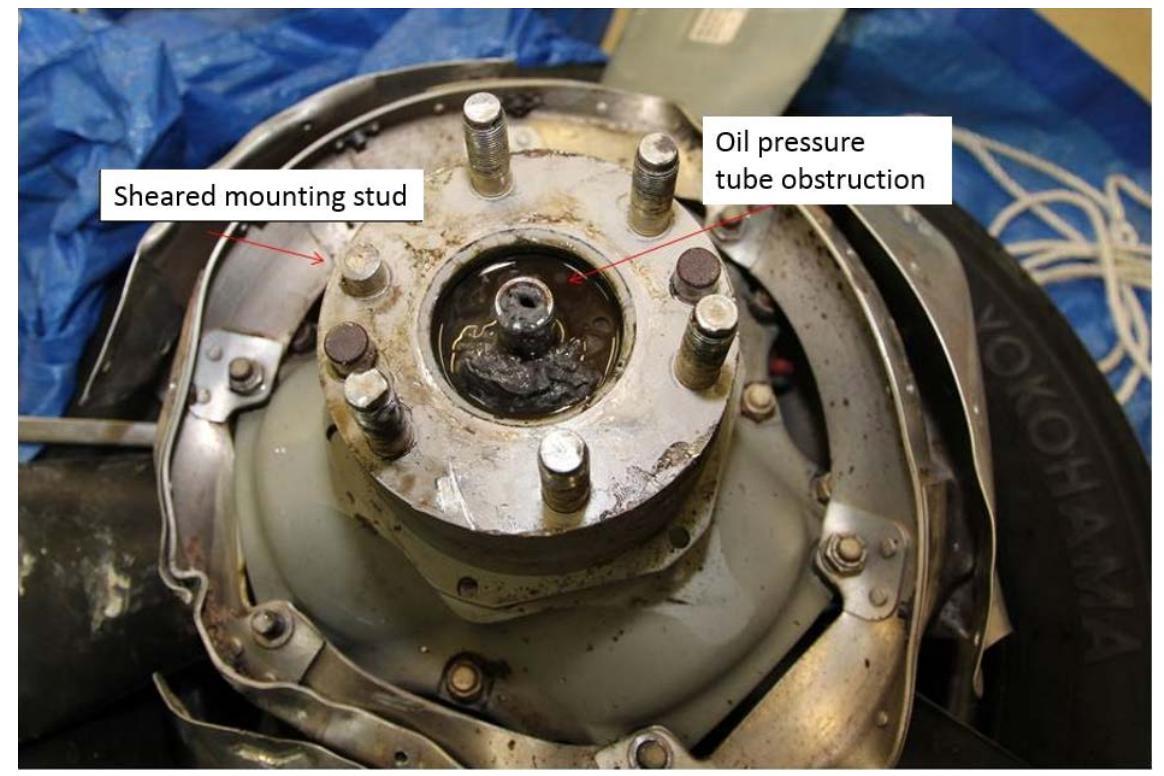
Figure 17: Rear of the propeller hub showing the obstruction of the oil pressure tube by the build-up of grey, solidified substance

The effect of the obstruction would be that the propeller was less responsive to pitch changes commanded by the propeller governor or from pilot-initiated control changes. The initial actuator tests showed that the propeller was still capable of adjusting the pitch of the propeller blades. The propeller overhaul facility personnel noted that the build-up of grey material was not unusual, but that it was unusually large for a propeller that had only run about 600 flight hours. The ATSB assessed that the obstruction did not contribute to the accident.

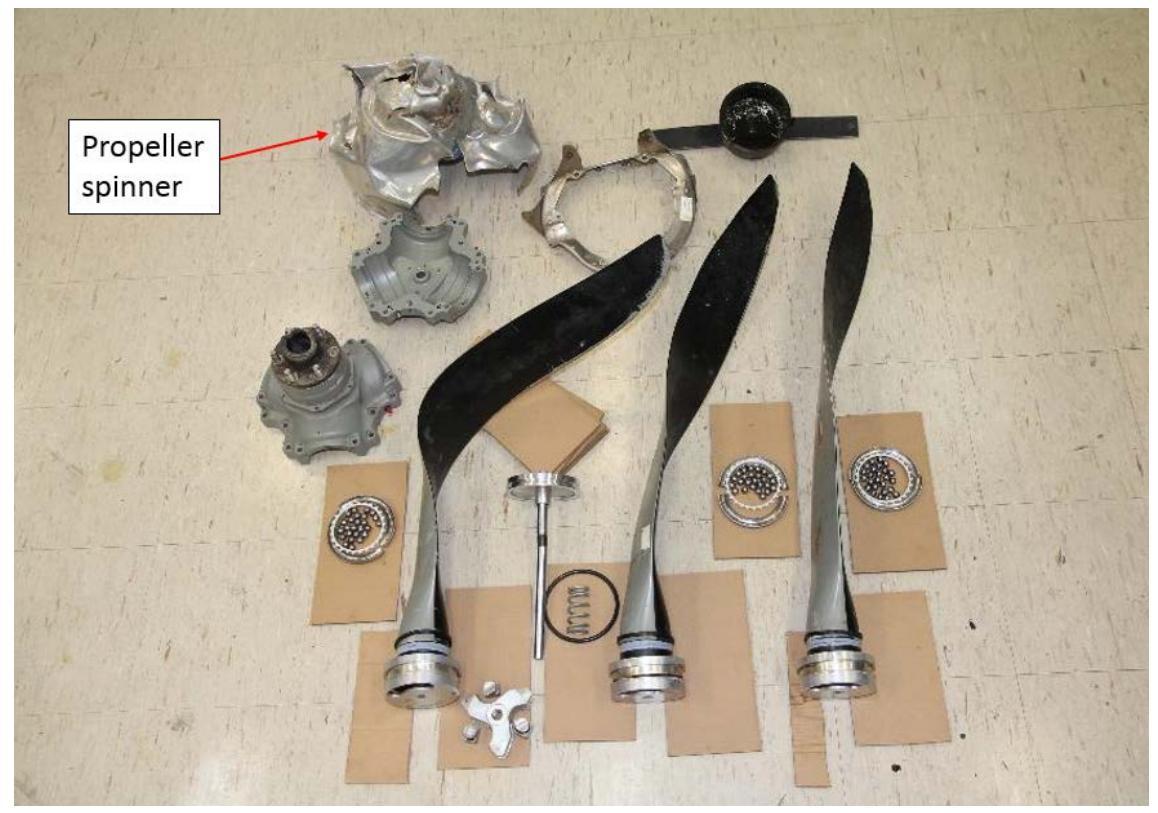
Figure 18: Disassembled propeller showing the propeller blade and spinner damage. Note that the propeller blades are viewed from the trailing edge

Inspection of the propeller blades showed chordwise paint abrasion and twisting damage and rearward bending (Figure 18). Examination of the spinner showed deformation opposite to the direction of rotation. The propeller hub showed impact marks indicative of rotational and rearward propeller blade loading. The pitch change links had sheared due to twisting loads. Inspection of the remaining section of crankshaft and propeller hub attachment pad showed that it failed predominantly due to side loads.

The propeller damage indicated that the engine was operating and driving the propeller when it impacted terrain. The exact amount of engine power was unable to be determined; however, it was considered to be significant. No pre-accident defects were identified in the propeller system that would have contributed to the accident.

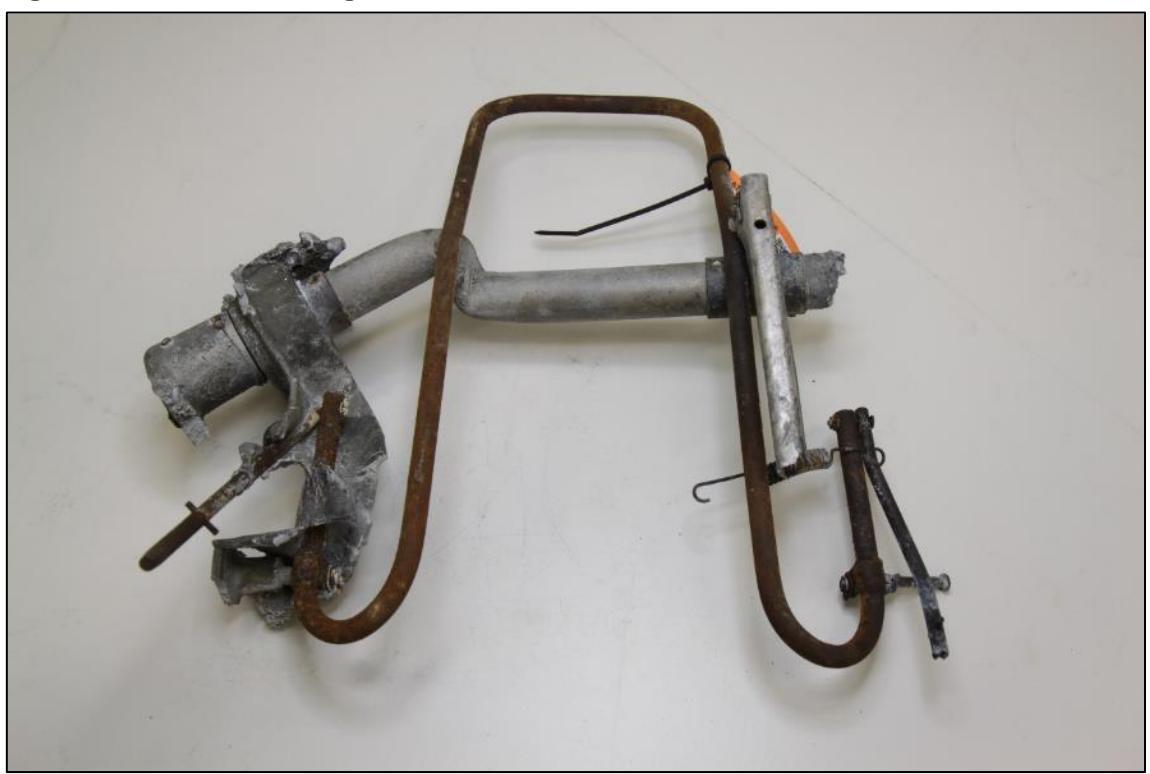
Figure 19: Pilot seat locking mechanism and a section of the seat frame

The primary locking mechanism and three of the four seat feet were the only components from the pilot's seat available for inspection (Figure 19).

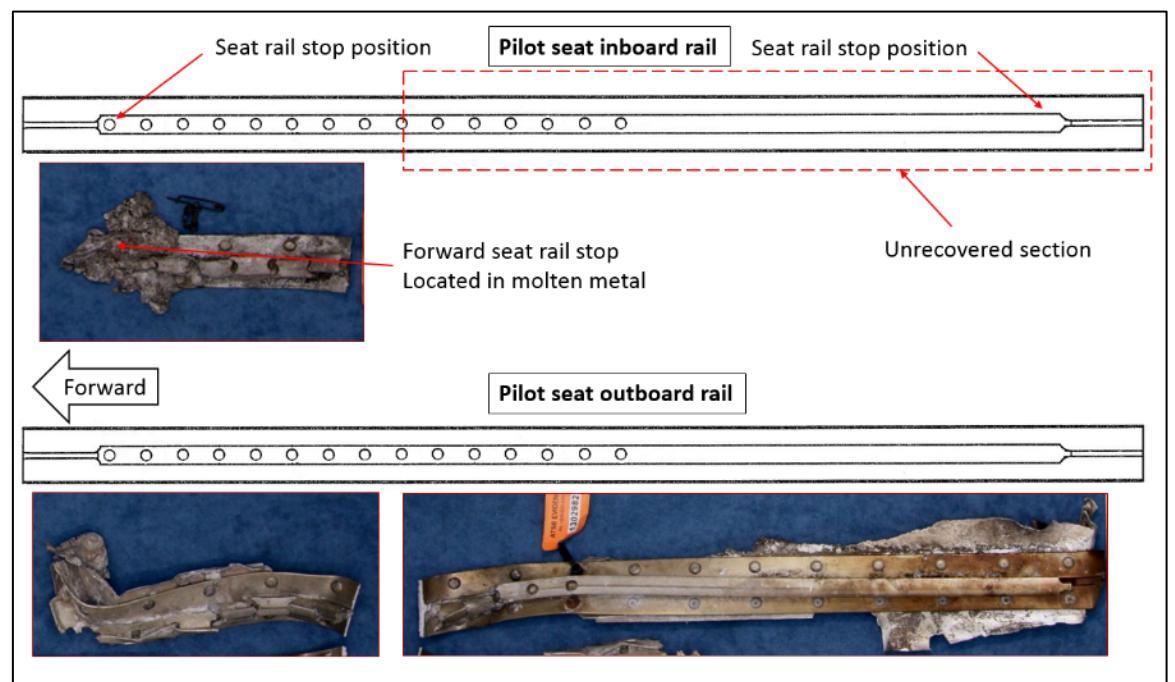
Figure 20: Recovered sections of the pilot's seat rails

The entire outboard pilot seat rail and the front third of the inboard pilot seat rail were recovered from the accident site. The remainder of the inboard rail was thought to have been destroyed by fire (Figure 20).

Where possible, the seat rails were checked for pre-accident serviceability in accordance with the aircraft manufacturer's requirements and were found to be within the stipulated wear limits.

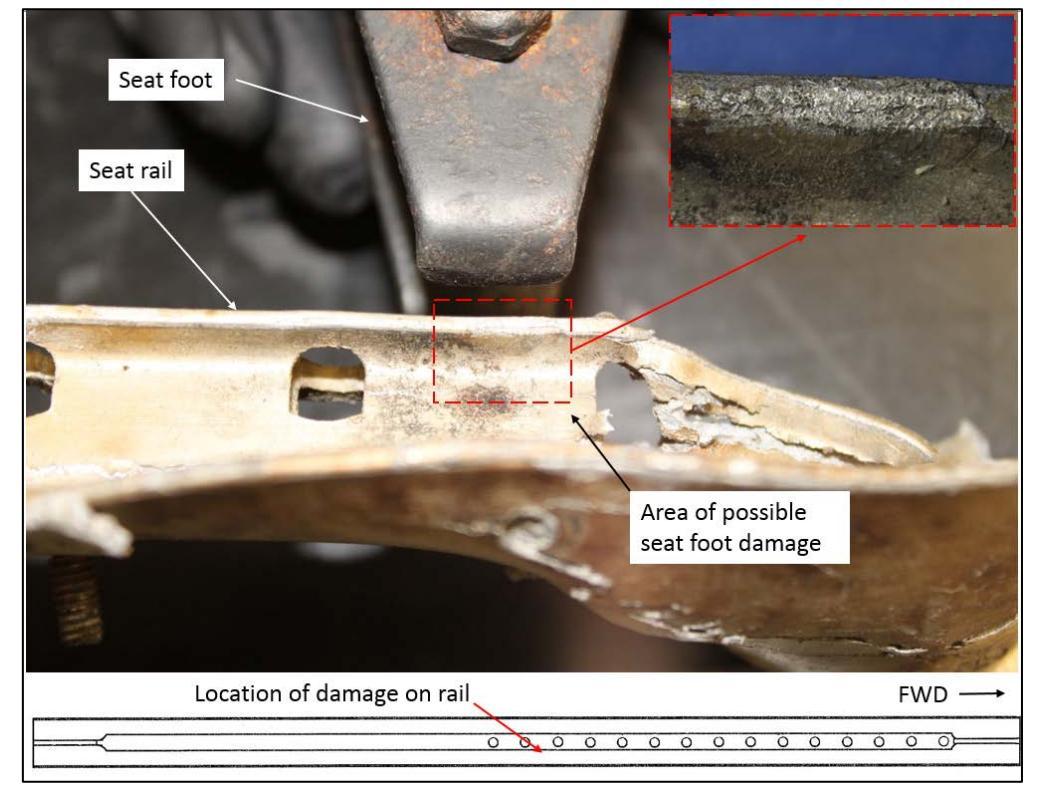
Figure 21: Pilot seat outboard rail viewed from the right side showing possible pull out damage from the seat foot and the location of the damage

A contact mark was identified that may have been indicative of a seat foot position at the time of the impact with terrain. That mark was located on the outboard rail between the second and third seat stop holes from the rear of the rail (Figure 21). However, it could not be determined if the mark was made by the forward or rear foot of the pilot's seat, or if the seat had moved position before the mark was made. It was therefore not possible to determine the pilot's seat position at the time of the accident.

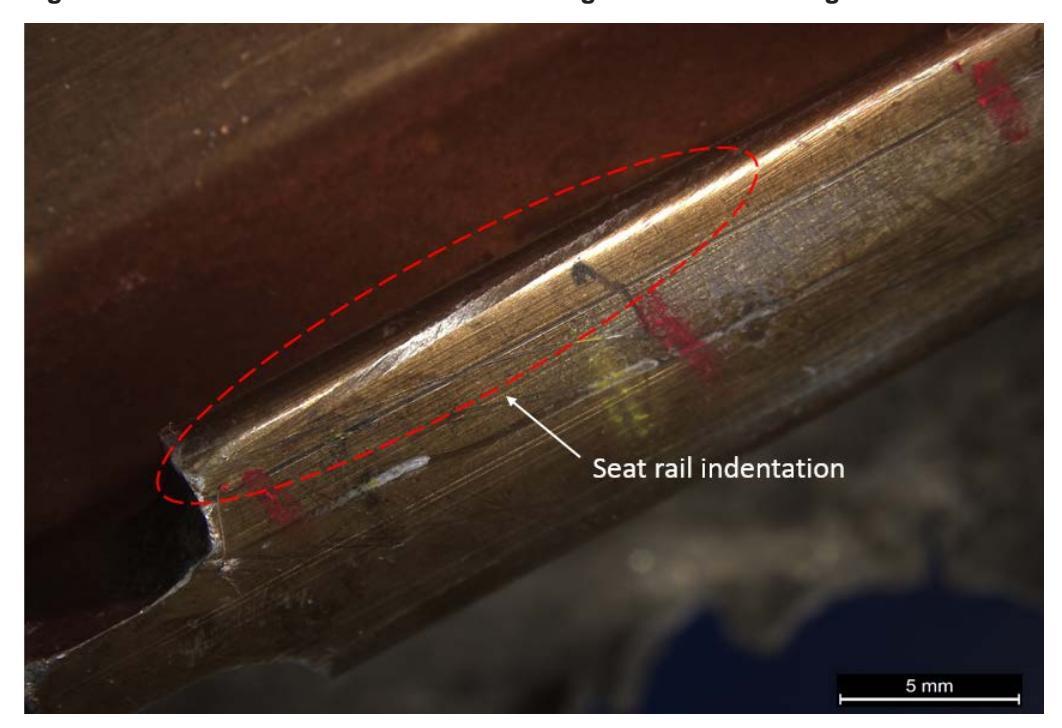
Figure 22: Rear of outboard seat rail showing indentation damage

Further damage was noted at the rear of the outboard rail (Figure 22), possibly indicating that one seat foot had disengaged from the track on at least one occasion and was sitting on top of the rail with pressure applied. It was not possible to determine when the damage occurred.
