Mid-air collision involving Jabiru J430, VH-EDJ, and Piper PA-25-235, VH-SPA

Caboolture Airfield, Queensland, on 28 July 2023

ATSB Transport Safety Report

Aviation Occurrence Investigation AO-2023-036 Preliminary – 8 September 2023 Released in accordance with section 25 of the Transport Safety Investigation Act 2003

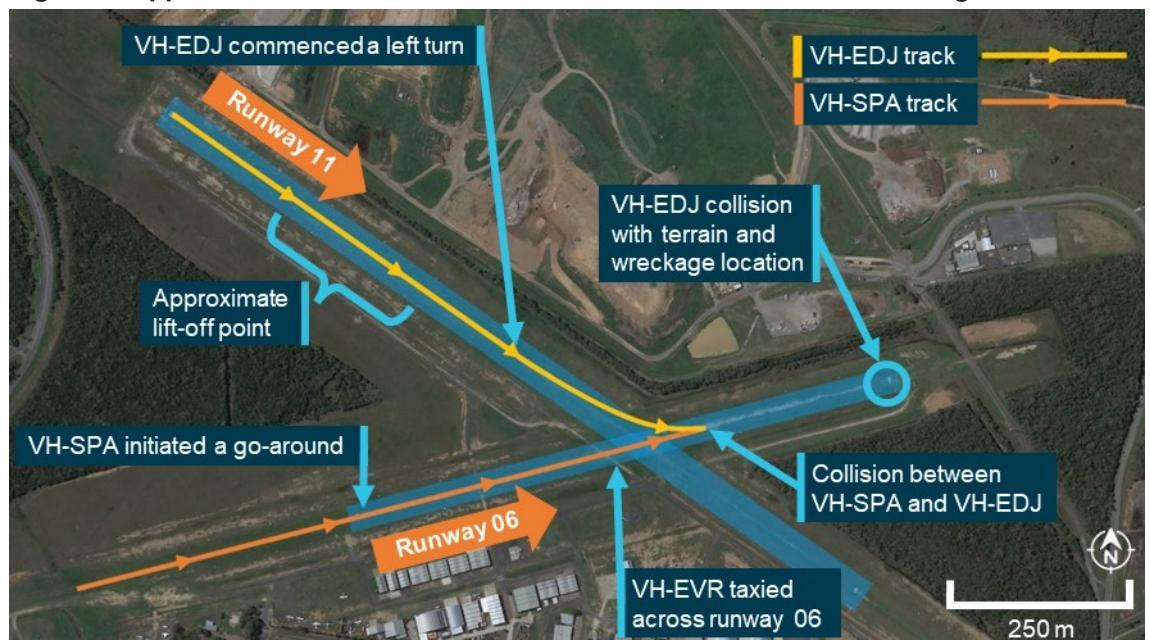
At 1030:55, VH-SPA began climbing while maintaining a runway 06 heading as VH-EDJ lifted off runway 11 before the runway intersection. About 5–10 seconds later, while the aircraft were climbing on crossing tracks, the pilot of VH-EDJ commenced a left turn, likely in an attempt to avoid a collision.

At 1031:11, the two aircraft collided on similar tracks above runway 06, just north-east of the 06/11 intersection, at a height of about 200–300 feet (Figure 1).

Figure 1: Approximate tracks of VH-EDJ and VH-SPA based on video footage

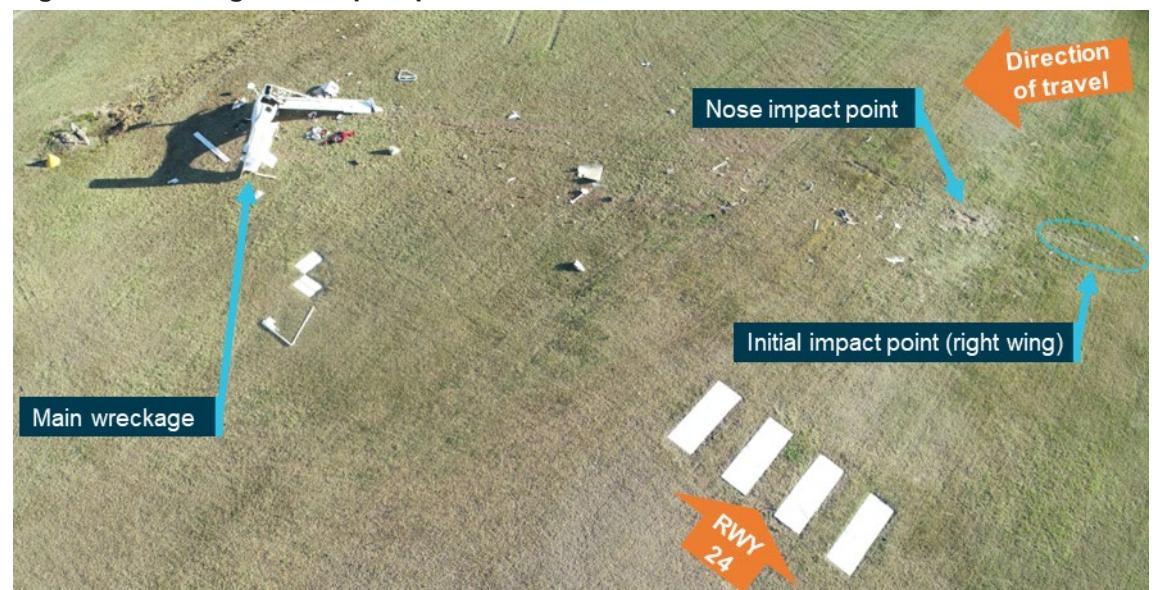
The ATSB conducted an on-site examination of the aircraft wreckage. The right wing of VH-EDJ collided with the ground forward of the threshold marking for runway 24. The nose then struck the ground, and the aircraft tumbled to a stop 45 metres from the initial impact point (Figure 2).

Figure 2: Wreckage and impact point of VH-EDJ

VH-EDJ came to rest right-side down, and was later disturbed by first responders attempting to reach the pilot and passenger. First responders reported both the pilot and passenger were wearing seatbelts. The right wing tip and a section of the right aileron was recovered near the intersection of runway 11/06, near the point at which the two aircraft collided.

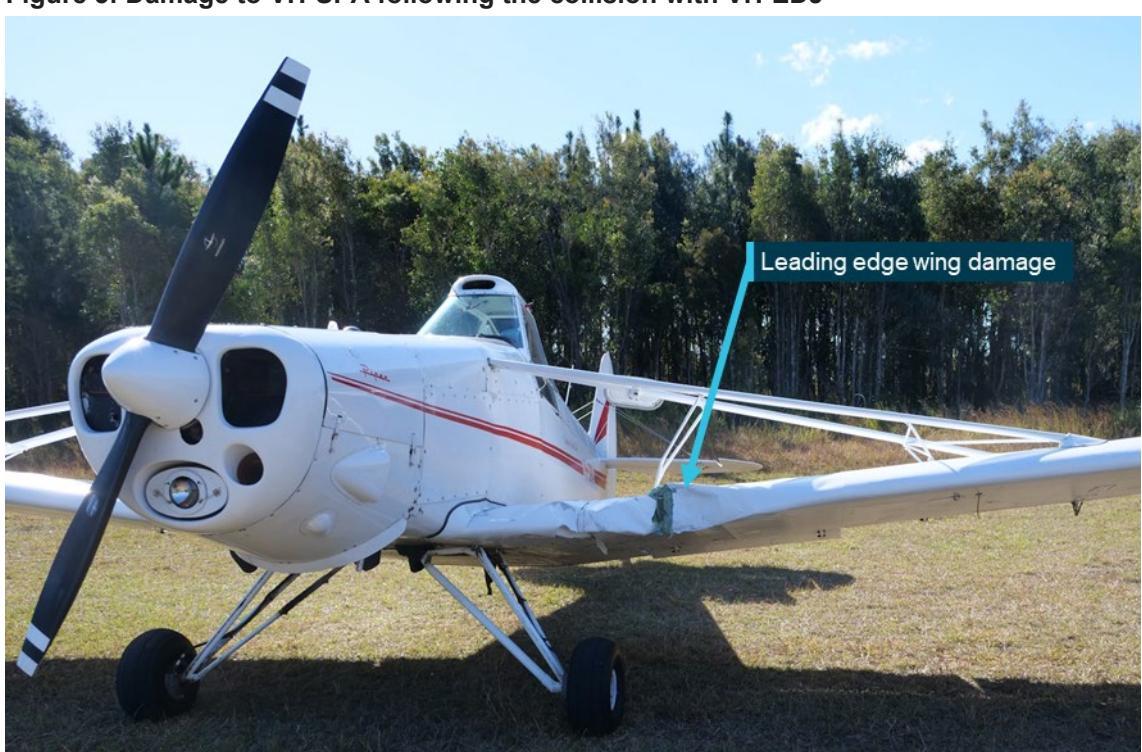
The leading edge of the inboard left wing of VH-SPA struck VH-EDJ's right wing at the outboard trailing edge, resulting in separation of the right wing tip and part of the right aileron. VH-EDJ rolled to the right while rapidly losing altitude. VH-EDJ collided with terrain in a nose-down, right-wing-down attitude near the end of runway 06. The pilot and passenger were fatally injured.

VH-SPA sustained impact damage to the leading edge of its left wing as a result of the collision (Figure 3).

Figure 3: Damage to VH-SPA following the collision with VH-EDJ

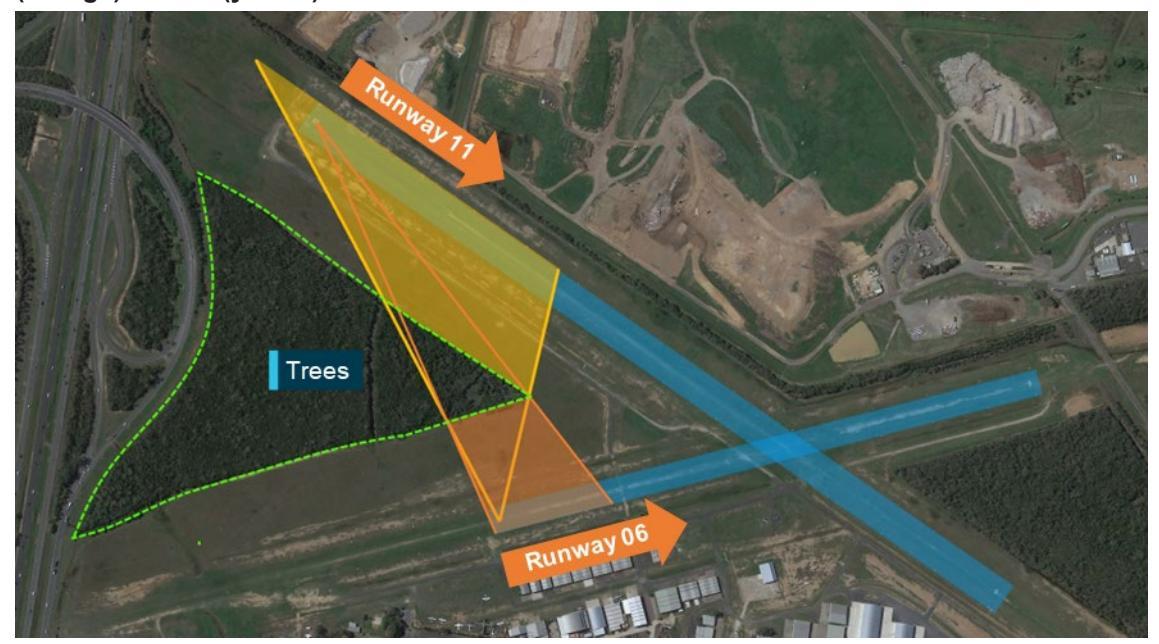
Caboolture Airfield was an aircraft landing area,² located about 3.5 km east of Caboolture, Queensland. It had an elevation of 40 ft above mean sea level, and two intersecting runways with magnetic orientations of 114°/294° (runway 11/29), and 065°/245° (runway 06/24). Their lengths were 1,129 m and 820 m respectively. Both runways were unsealed grass, except for a sealed portion at the beginning of runway 11. Trees about 10–14 m high between the intersecting runways obscured parts of adjacent runways (Figure 4).

Figure 4: Obscured parts of the adjacent runway from the thresholds of runways 11 (orange) and 06 (yellow)
