# Aircraft preparation event involving Saab 340B, VH-ZLJ

Cairns, Queensland on 16 November 2022

ATSB Transport Safety Report

Aviation Occurrence Investigation (Defined) AO-2022-058 Final – 26 October 2023 Released in accordance with section 25 of the Transport Safety Investigation Act 2003

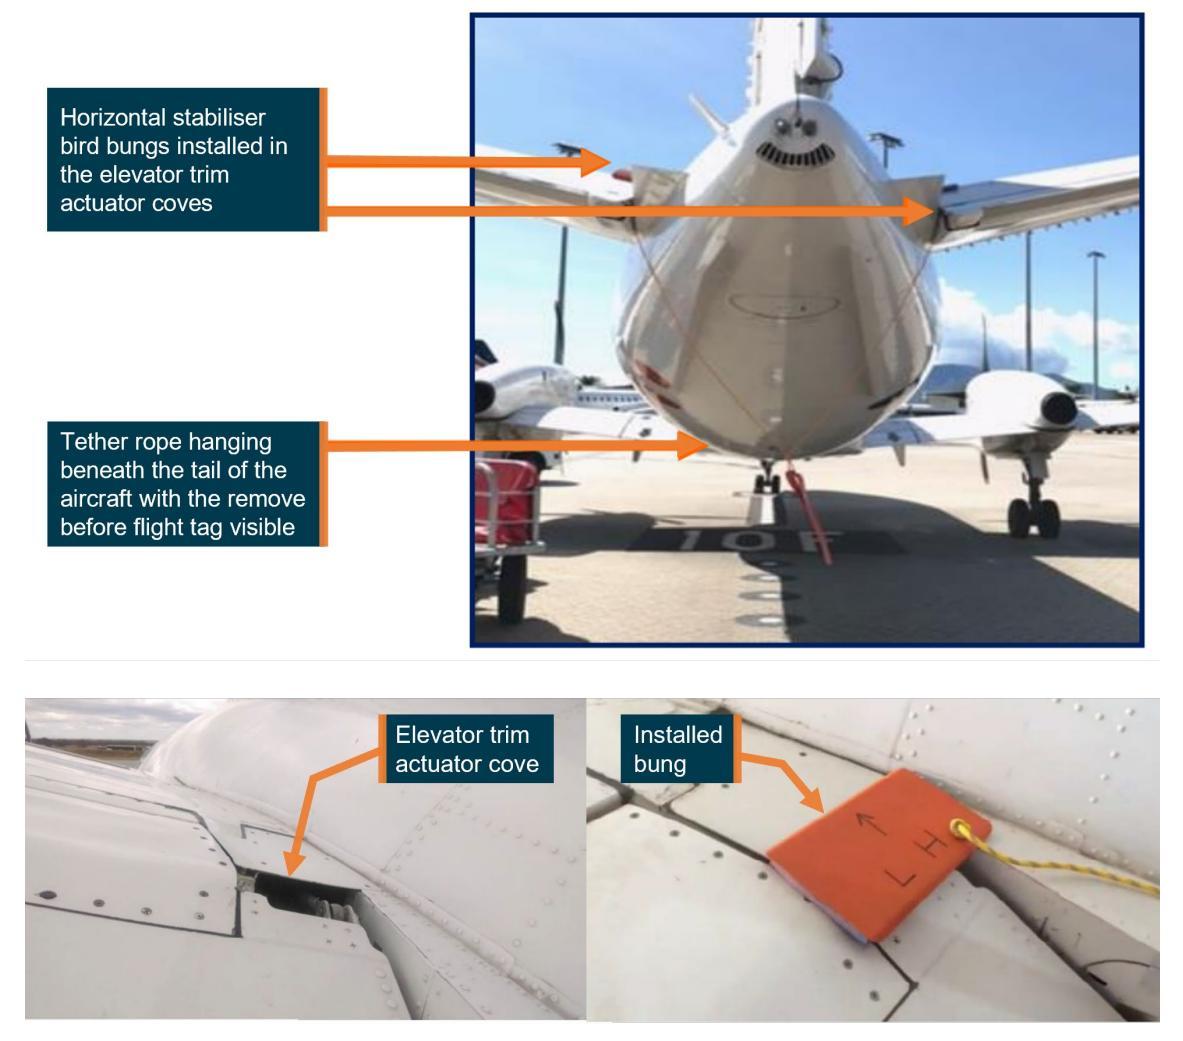
#### Figure 1: Horizontal stabiliser bungs

The subsequent inspection revealed the horizontal stabiliser bungs had not been removed. The right bung was found hanging from the tail, still attached to the left bung installed in the trim actuator cove by the tether rope.

The procedure for the use of horizontal stabiliser bungs (bungs) was implemented by the operator in March 2017 at both Cairns and Townsville Airports. This followed an increase in the number of occurrences where birds had nested in the tail section of aircraft parked overnight during the warmer, humid months. The operator's engineering department devised a solution with the design and fabrication of bungs to be installed in the elevator trim actuator coves on the upper surface of the horizontal stabilisers (Figure 1).

Video footage of ZLJ parked on the bay on the day of the occurrence, revealed that ground handling staff passed the rear of the aircraft multiple times while completing the pre-flight duties. During interview, the ground handler in charge advised that neither the bungs nor the tether rope were visible at any time. Further, they advised that they were easily detected when installed correctly and could not be missed with the conspicuity tag normally hanging below the tail and next to the rear cargo door (Figure 1).

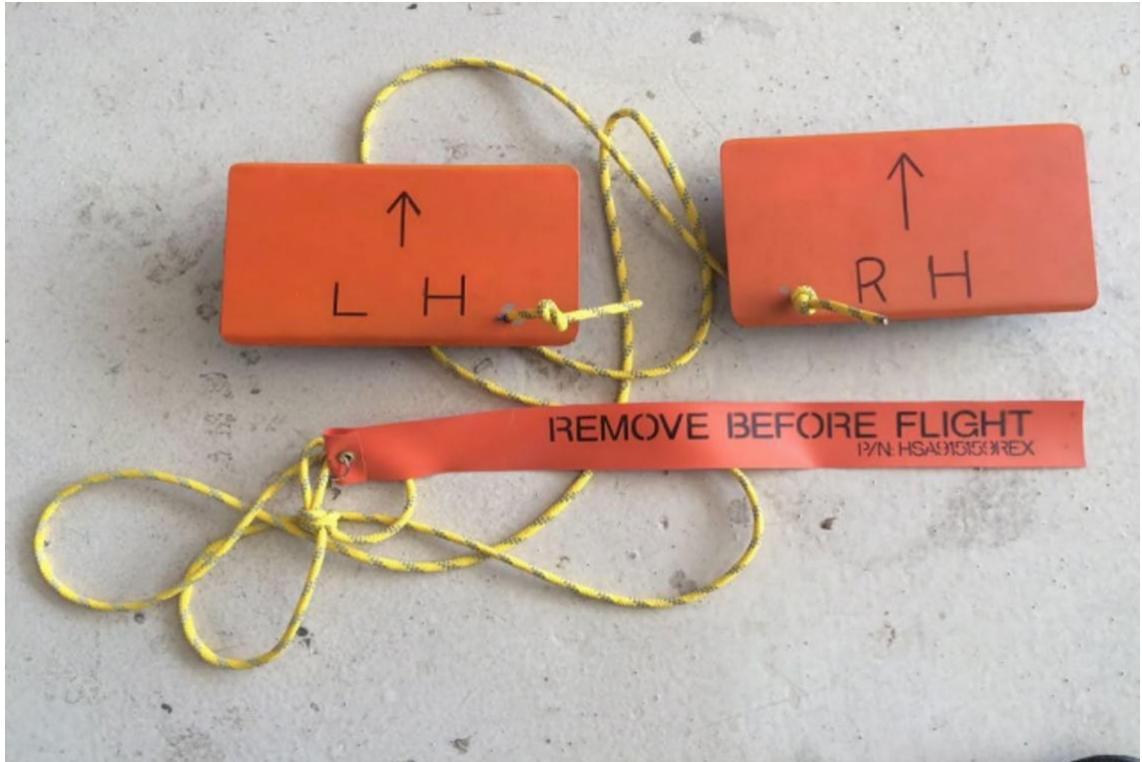
Figure 2: Horizontal stabiliser bungs

Both flight crew reported that during these checks they did not detect the tether rope with the 'remove before flight' conspicuity flag (Figure 2), which attached to each bung and hung under the back fuselage as a visual cue that the bungs were in place (Figure 1). The flight crew completed the internal and external checks prior to passengers arriving. At 1404, the FO completed the final external inspection.

The horizontal stabiliser bungs (Figure 2) were listed as site-specific equipment for use at both Townsville and Cairns. They consisted of a foam pad, which fitted into the actuator cove, attached to a board for both the right and left elevator. They were connected by a tether rope which had a conspicuity flag marked 'remove before flight'.

- The horizontal stabiliser bungs were most likely incorrectly installed or possibly the tether rope with the 'remove before flight' conspicuity flag was not hanging from the horizontal stabiliser as designed. This resulted in them not being detected during pre-flight preparations and the aircraft being dispatched with the bung installed.
- There were no formal procedures for the storage and accountability of horizontal stabiliser bungs after they were removed from the aircraft. (Safety issue)
- The design of the horizontal stabiliser bungs did not consider aspects that would ensure the identification of an installed bung, or the safe operation of the aircraft if the bungs were not removed prior to flight. (Safety issue)

The Australian Transport Safety Bureau recommends that Regional Express Pty Ltd further reviews the horizontal stabiliser bungs design and pre-flight procedures to ensure that installed bungs are readily identifiable and will not adversely affect the continued safe operation of the aircraft if not removed prior to flight.

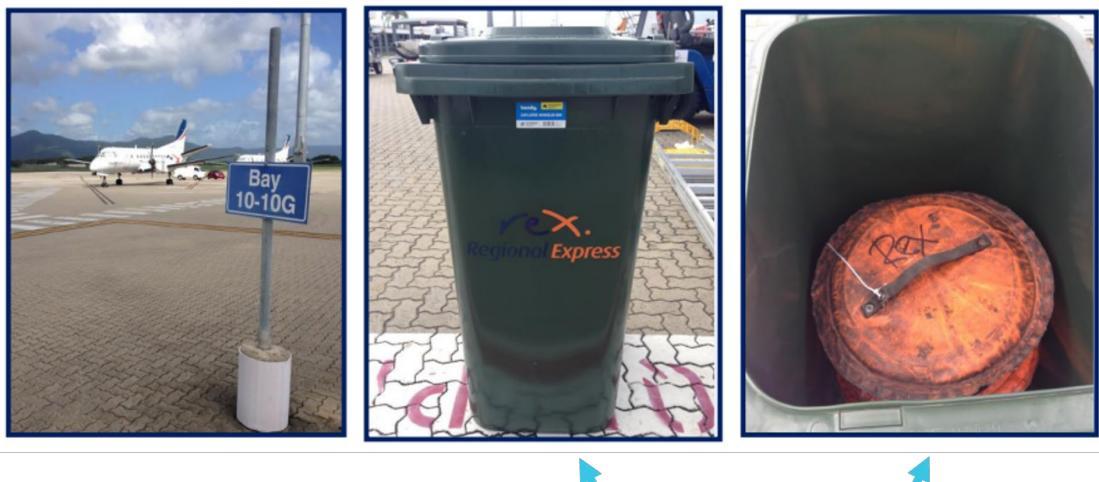
#### Figure 3: Exhaust bung storage bins

The training presentation, used to familiarise ground handling staff with the bungs, included the use of engine exhaust bungs (exhaust bungs) at Cairns. These exhaust bungs were also retained by the ground handling agent, however, the presentation included guidance for where these bungs should be stored (Figure 3). Similar to the horizontal stabiliser bird bungs, multiple sets were stored together in the designated storage bins.

The training package provided to the ground handling agent indicated that the horizontal stabiliser bird bungs were to be retained by the agent, but did not specify how or where the bungs were to be stored. As the containers utilised by the agent stored multiple sets of bungs together, it could not be determined what equipment had been removed from what aircraft. This prevented any positive assurance check by ground handlers or flight crew that the bungs had been removed. This was also the case for the engine exhaust bungs.

The Australian Transport Safety Bureau recommends that Regional Express Pty Ltd continues reviewing the use of horizontal stabiliser bungs and takes action to address the limitations associated with the current procedures around the storage and accountability of equipment removed from an aircraft.

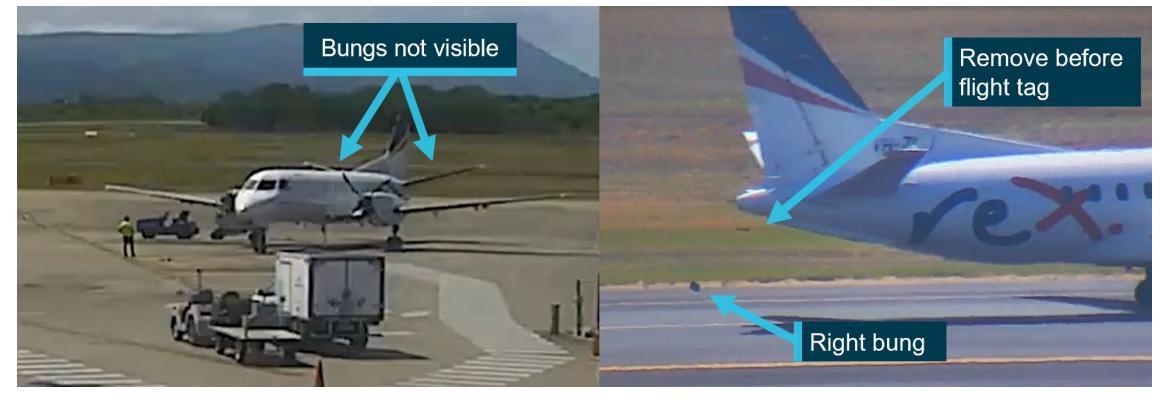
#### Figure 4: Airport CCTV footage

During analysis of the airport CCTV footage (Figure 4), the bung was not visible while the aircraft was being prepared, nor was it visible as the aircraft taxied away from the bay. However, the aircraft was not clearly visible in the footage. Later, when the bung was observed hanging from the aircraft, the left bung was still inserted into the trim actuator cove and the tether rope and right bung was hanging from the left horizontal stabiliser.

The ATSB analysis of the CCTV footage also did not detect the bungs while the aircraft was parked at the bay, nor as the aircraft taxied to the runway. Together, this would indicate that the bung was not installed correctly or possibly the tether rope with the 'remove before flight' conspicuity flag was not hanging from the horizontal stabiliser, as designed.
