Mid-air collision involving SIAI Marchetti S-211s, VH-DZJ and VH-DQJ

25 km west of Tyabb Airport, Victoria, on 19 November 2023

ATSB Transport Safety Report

Aviation Occurrence Investigation AO-2023-057 Preliminary – 17 January 2024 Released in accordance with section 25 of the Transport Safety Investigation Act 2003

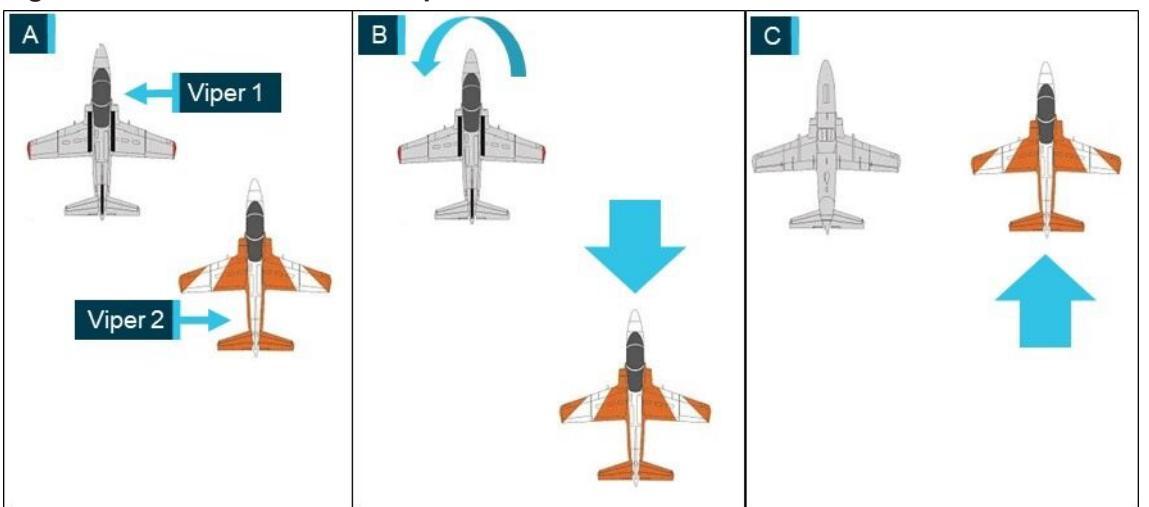
Prior to commencing the flight, the crews conducted a brief of the planned manoeuvres. The first of the manoeuvres involved Viper 1 flying inverted, straight and level, while Viper 2, flying upright, moved to the right line abreast position for filming (Figure 1). From that position, Viper 2 would move as required for the filming while maintaining separation from Viper 1. The crews planned to conduct this manoeuvre with Viper 2 starting in the right echelon position (panel A in Figure 1) before moving rearward to allow Viper 1 sufficient room to roll inverted (panel B in Figure 1). After Viper 1 rolled inverted, Viper 2 was to move forward and climb or descend as needed to reach the line abreast position at the same altitude, for filming (panel C in Figure 1). During the manoeuvring, the pilots would communicate on a discrete radio frequency.

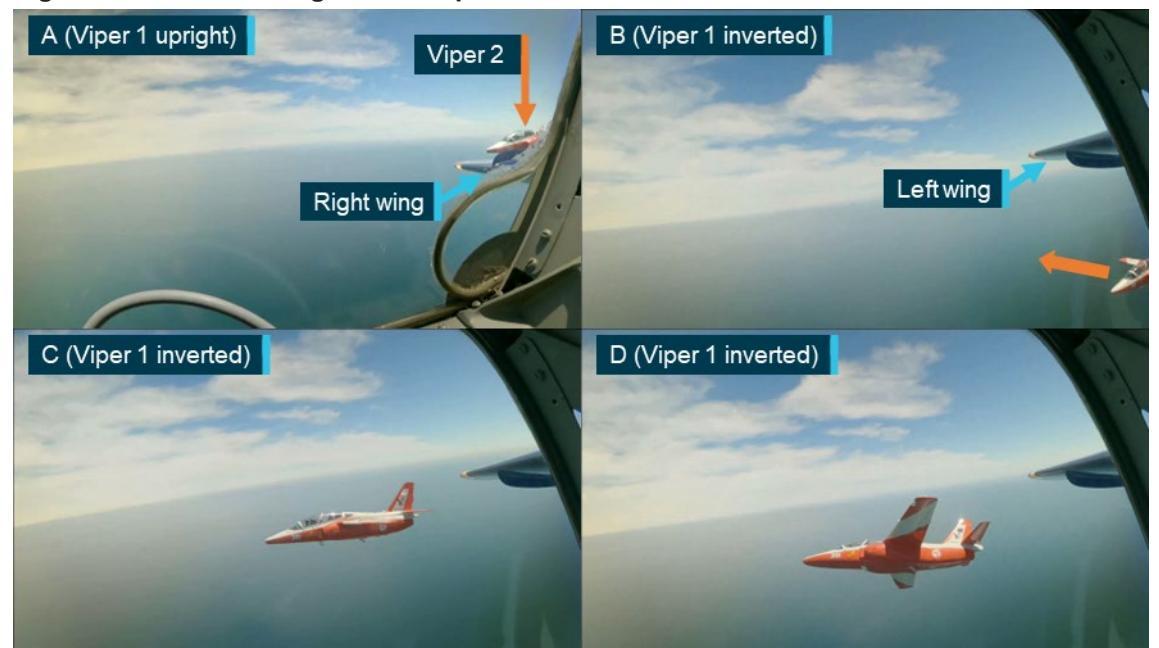
Figure 2: Recorded images from Viper 1 of first manoeuvre

The crews completed the brief and, at 1324 local time, the aircraft departed Essendon towards Port Phillip Bay. About 6 minutes later, while the aircraft were operating at about 3,000 ft above mean sea level and at a speed of about 200 kts, the crews began manoeuvring for the planned sequence. Viper 2 moved rearward (panel A in Figure 2) and Viper 1 rolled inverted (panel B in Figure 2). From a low right echelon position, Viper 2 moved forward and climbed toward the line abreast position while also moving laterally closer to Viper 1 (panel C in Figure 2). The rate of closure between the aircraft increased and before Viper 2 could stabilise in the line abreast position, the pilot banked away and moved out of the formation (panel D in Figure 2). Viper 1 then rolled upright.

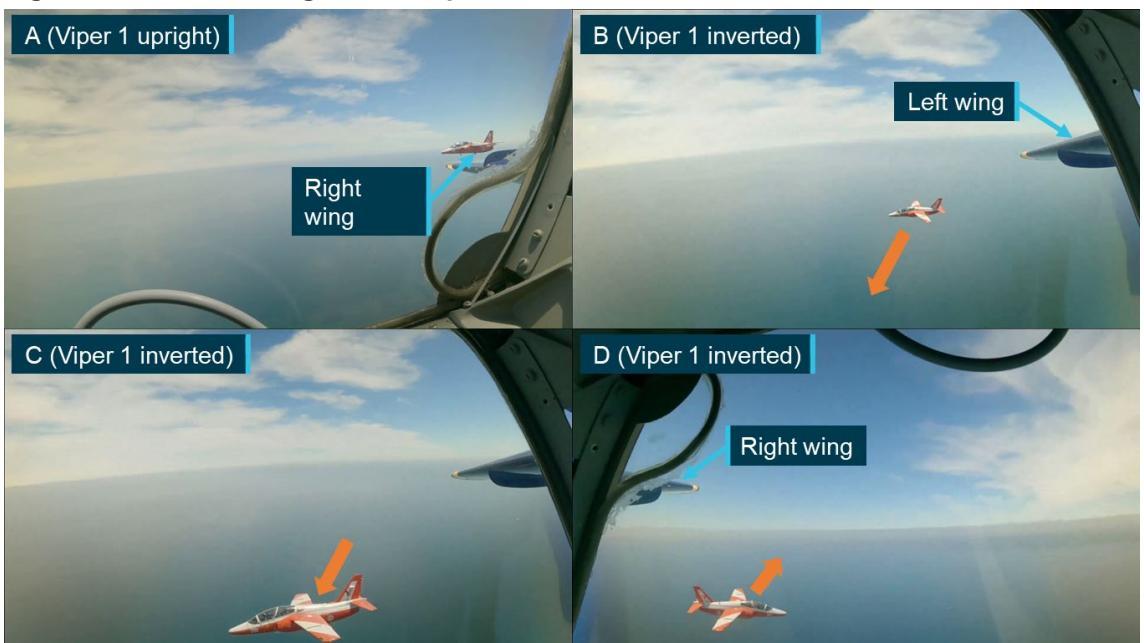
Figure 3: Recorded images from Viper 1 of second manoeuvre

Viper 2 rejoined the formation in the right echelon position (panel A in Figure 3) and shortly after, Viper 1 rolled inverted for a second attempt (panel B in Figure 3). On this occasion, instead of moving toward the line abreast and level position, the pilot of Viper 2 manoeuvred to pass below (panel C in Figure 3) and to the left of Viper 1 (panel D in Figure 3).

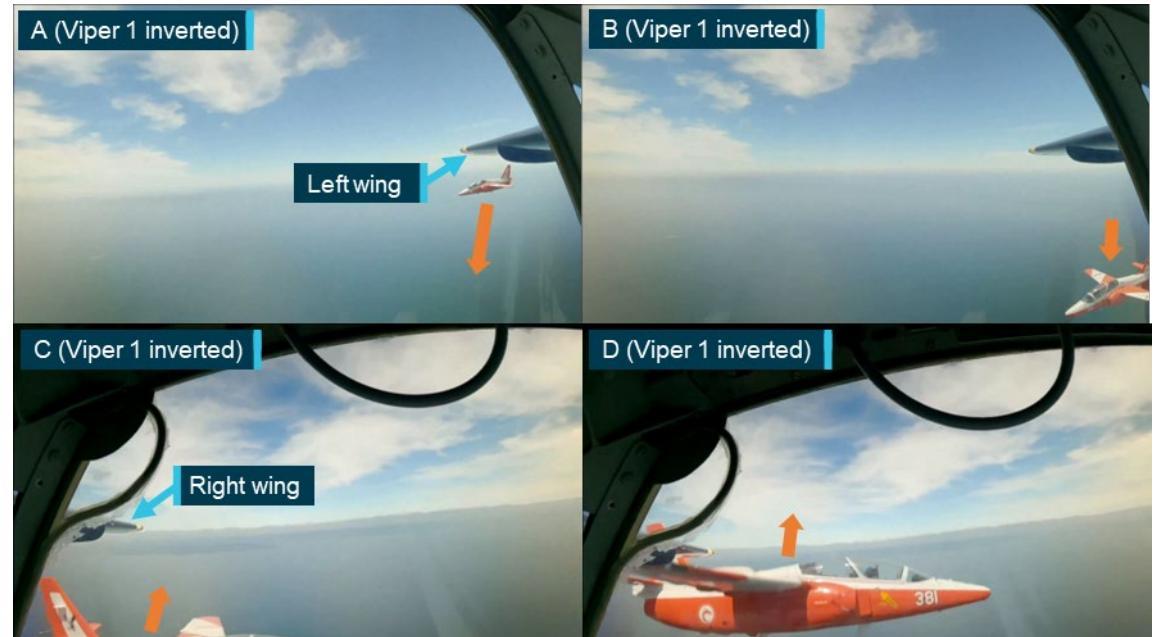
Figure 4: Recorded images from Viper 1 of third manoeuvre and collision

As with the previous attempt, Viper 2 moved rearward to allow Viper 1 to roll inverted. As Viper 1 stabilised in the inverted attitude (panel A in Figure 4), Viper 2 began manoeuvring to pass beneath Viper 1 (panel B in Figure 4). Viper 1 then stabilised in the inverted attitude and as Viper 2 approached, the vertical separation between the 2 aircraft reduced. Viper 2 passed beneath and began to pitch up and bank away from Viper 1 (panel C in Figure 4). At 1333, as Viper 2 climbed and banked left, the right wings of each aircraft collided (panel D in Figure 4).

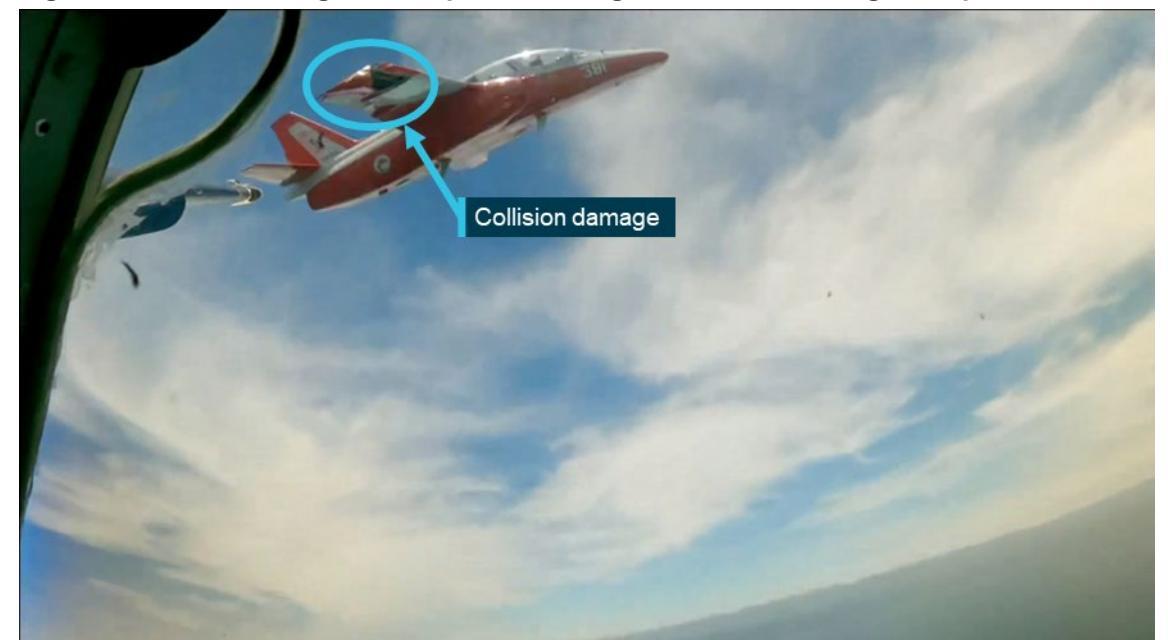
Figure 5: Recorded image from Viper 1 showing the collision damage to Viper 2

After the collision and with the right wing severely damaged (Figure 5), Viper 2 continued to climb and began rolling right, passing above and behind Viper 1. Viper 2 rolled to an inverted attitude and quickly assumed a near vertical, nose-down flight path toward the water and commenced a slow right roll until impacting the water at high speed. Both occupants were fatally injured.

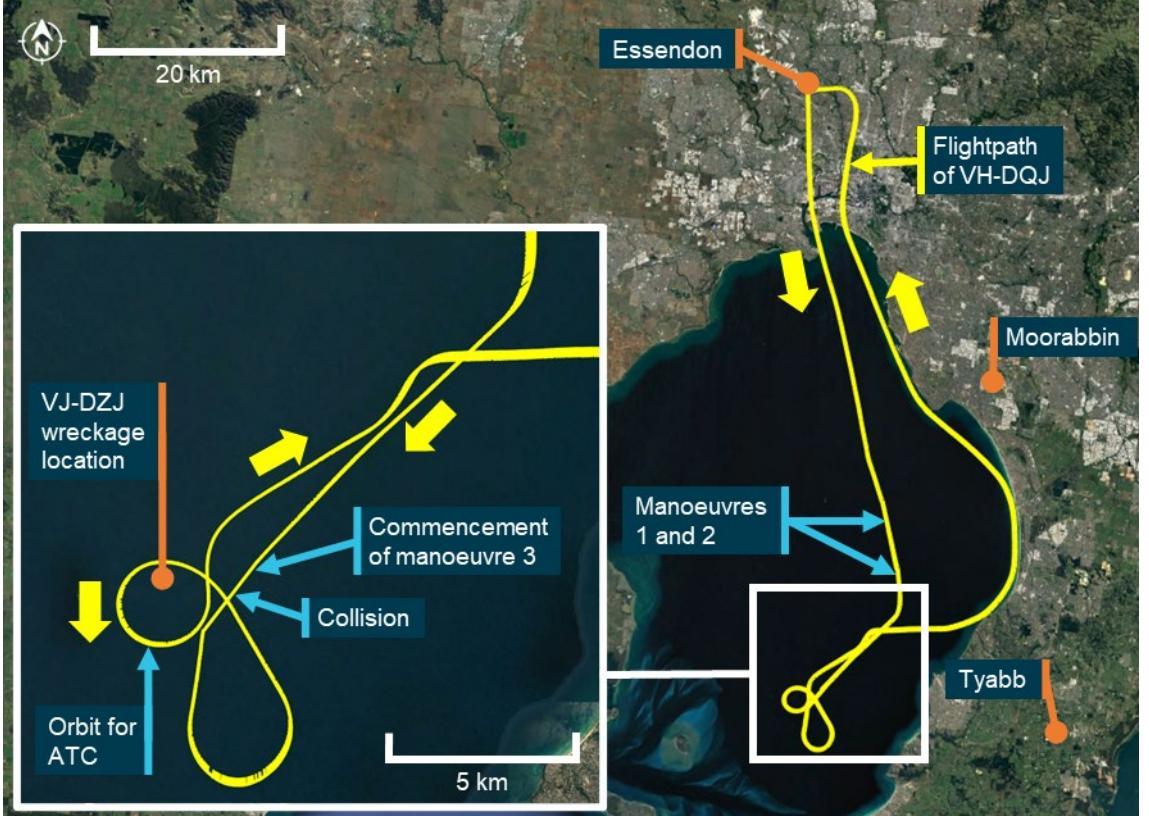
Figure 6: Recorded flight path of VH-DQJ

The pilot of Viper 1 turned the aircraft back towards the location of the collision where the safety pilot observed a splash mark and debris from Viper 2 on the water's surface. The pilot of Viper 1 contacted air traffic control to advise of the mid-air collision and broadcast a 'mayday'.¹ Viper 1 then orbited the location of the splash mark to assist air traffic control (ATC) in marking the location for search and rescue purposes (Figure 6).

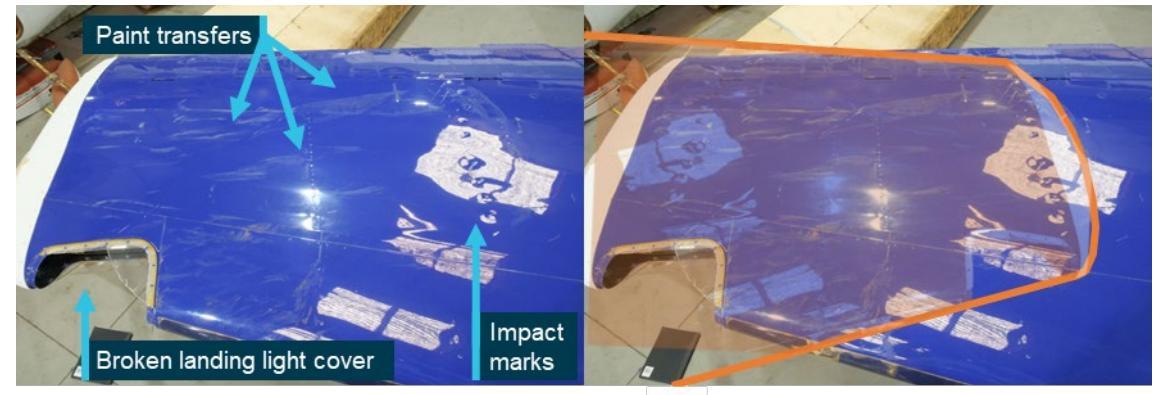
Figure 9: VH-DQJ collision damage (left) and overlay representation of the right wing of VH-DZJ (right)

VH-DQJ sustained minor damage in the collision. Several impact marks and paint transfers from VH-DZJ were present on the upper surface of the right wing (Figure 9) and the landing light cover was shattered. There was no significant wing structure damage identified.

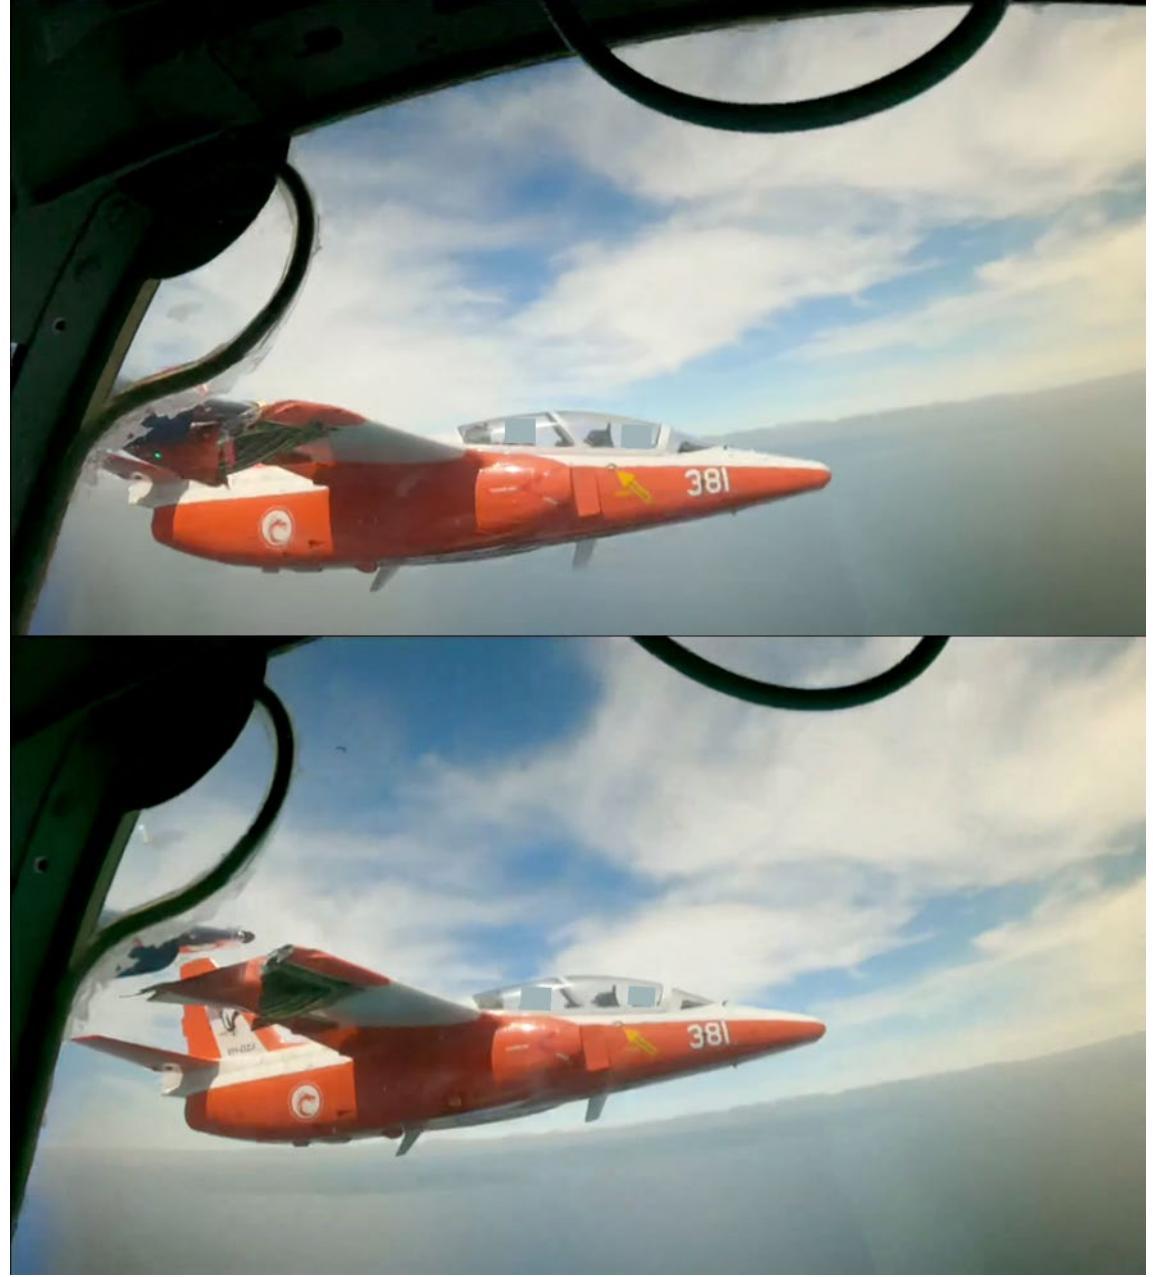
Figure 10: Recorded images showing VH-DZJ during the collision (top) and immediately after (bottom)

Examination of the recorded imagery also identified no pre-impact faults. The imagery showed that as the aircraft collided, the outer right wing structure of VH-DZJ immediately failed, with deformation to the forward wing spar and separation of the lower wing skin (Figure 10). The right aileron control system also appeared to be significantly damaged.
